Rail Accident Report

Runaway incidents on Blackpool Transport Services Tramway, 21 November, 3 and 10 December 2005

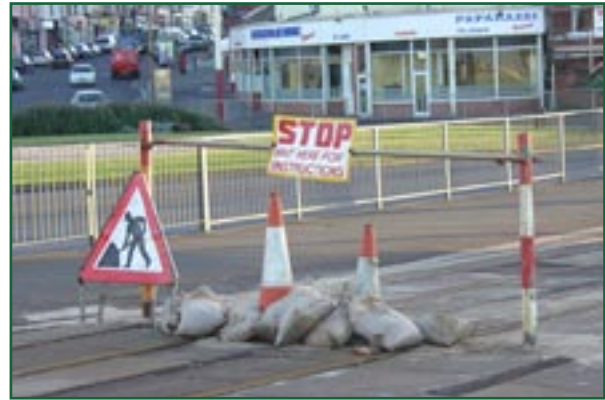
Figure 4: Fixed barrier at Gynn Square

- 42 In the second incident, the tram would not have run away if the driver had followed the correct procedure and applied the *emergency brake* before leaving the cab. Omitting this step meant that as soon as the controller shaft was 'flipped', the brakes were released and the tram rolled down the hill, being stopped by the *emergency brake* and by running into the barrier at the start of the track under repair.

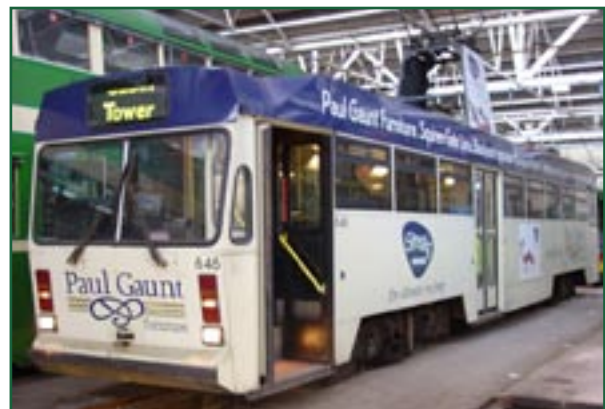
Figure 6: Tram 646, involved in two of the incidents

- 21 BTS operates a variety of stock of varying ages on the Blackpool tramway. During the winter months, the service on the tramway is mainly provided by the most modern vehicles in the BTS fleet, the 'Centenary' and 'Jubilee' tramcars. The eight single deck 'Centenary' cars (see Figure 6 above) are mechanically and electrically similar to the two double deck 'Jubilee' cars, and all ten date from the 1980s. They incorporate *thyristor control* systems operated through a single combined power/brake controller. The detachable controller handle engages with a spigot on the controller shaft, and the shaft end cover plate is designed to ensure that the controller handle can only be removed when the shaft is in the 'brakes fully applied' position. The shaft end cover plate is secured in place with three screws.

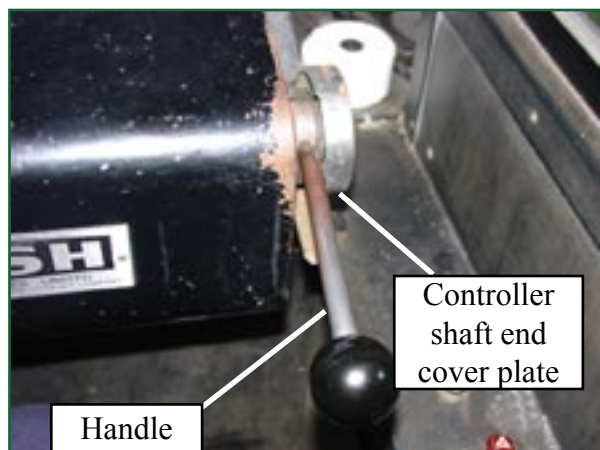
Figure 7: Controller with handle in place

22 The photographs below (Figures 7 and 8) show the controller with and without the handle in position. The handle is pushed fully forward to apply power, and pulled back to brake. A foot pedal must also be depressed to obtain power, but release of this pedal does not apply the brake. The controller has a central neutral position. It is possible to withdraw the controller handle in such a way that in disengaging from the shaft it ‘flips’ the controller shaft from the brake to the neutral position (see diagrams, Figure 9). If this happens it is impossible for the driver to replace the handle. A special fork tool must be used to reset the shaft position. This tool is carried by operating supervisors and fitters, but not by drivers.

- 35 The loose controller end cover meant that the controller handle was not properly retained on the spigot and could be inadvertently removed when being moved to the “power” setting. This left the driver able to shut off power by removing his foot from the pedal, but with no means of applying the *service brake*. He therefore attempted to use the *emergency brake*, which failed to operate. Any compressed air system which uses air from the atmosphere will (unless special dryers are used) contain water, which condenses from the atmosphere in the normal operation of the system. System dryers are used to remove this condensate, but when the external air temperature drops below freezing increased quantities of moisture will be carried around the system. It is therefore important that valves are used regularly to reduce the risk of freezing.

- 4 Inspection and maintenance procedures for the controllers were reviewed following the first incident. Controllers are now inspected daily and the screws securing the covers tightened if necessary, and records are kept of this check.

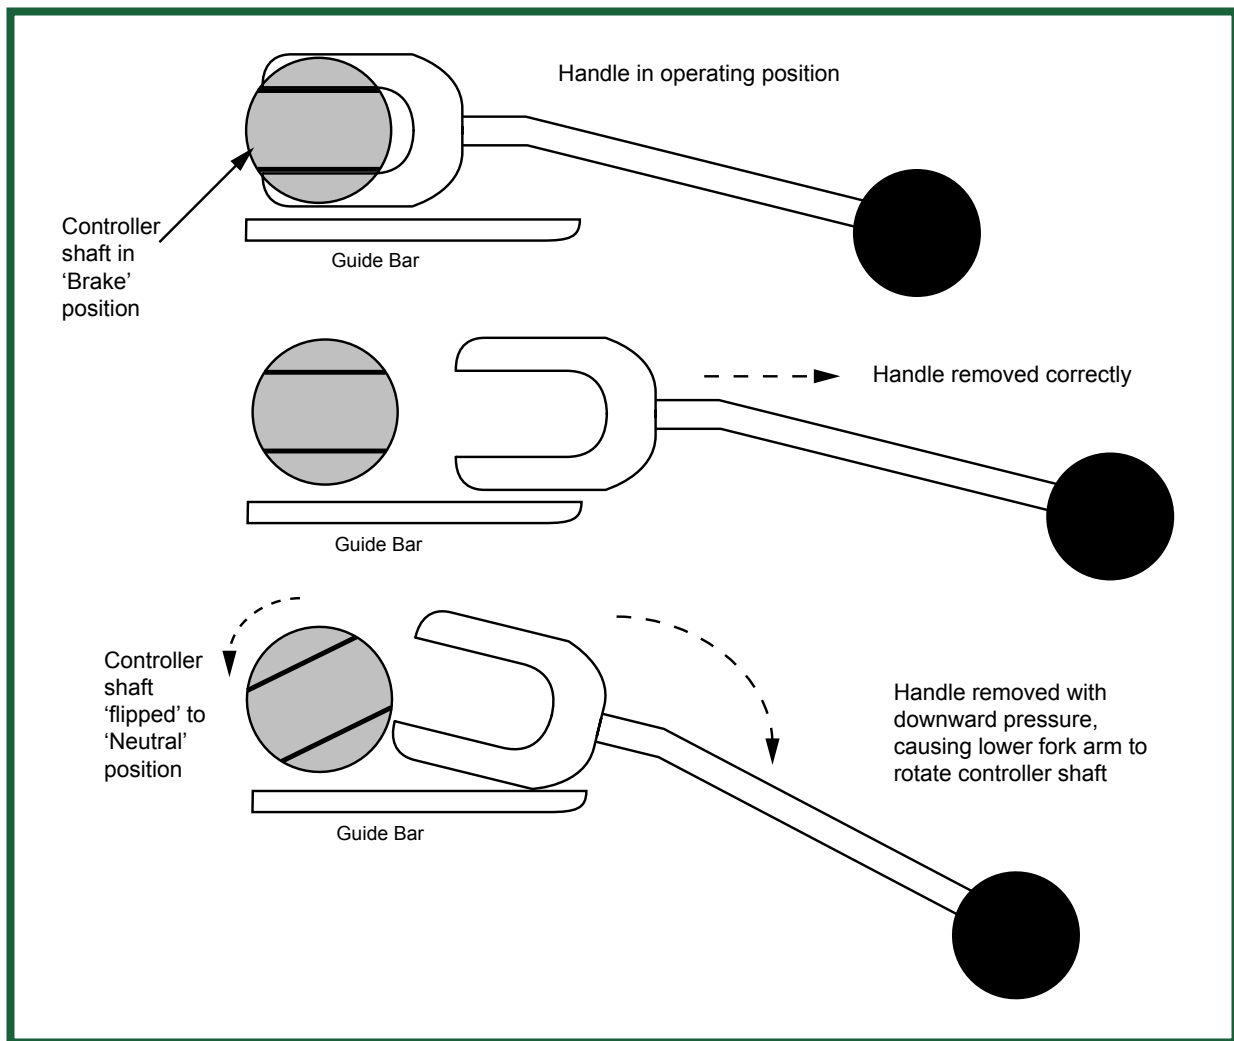
Figure 9: Removal of handle and 'flipping' of controller shaft

- 30 On Saturday 10 December 2005, car 646 was again in service southbound at Gynn Square. The driver, assisted by the Single Line Supervisor, carried out the manoeuvre onto the west track. He then released the *emergency brake* and started the tram, but when he applied the *service brake* to stop at the tram stop immediately south of the crossover the tram did not respond. The driver tried the *service brake* two or three times, but there was still no response, so he operated the *emergency brake* button and the tram stopped in about two metres, having travelled onto the single line section about 25 metres past the point where the driver was intending to stop. On investigation, the controller in the north end cab was found to be ‘flipped’ to the ‘neutral’ position (see Figure 9).

- 39 The second and third incidents had in common the ‘flipping’ of the controller shaft when the handle was withdrawn, as shown in Figure 9. Tests showed that this can be done relatively easily if the driver leans on the handle while getting up from the seat and at the same time pulling the handle out of the controller - a combination of actions which is quite normal for a heavily built person in easing themselves from the driver’s seat.

- 45 The immediate cause of the second and third incidents was the inadvertent 'flipping' of the controller shaft by the drivers as the control handle was removed.

- 3 After the second incident, BTS designed a modification to the controller end cover which prevents the shaft from turning while the handle is being removed. A prototype was inspected during the RAIB's investigation. A production version has since been fitted to all ten trams with this type of controller.
