Rail Accident Investigation Branch

Rail Accident Report

Derailment at Blackpool Pleasure Beach 6 July 2006

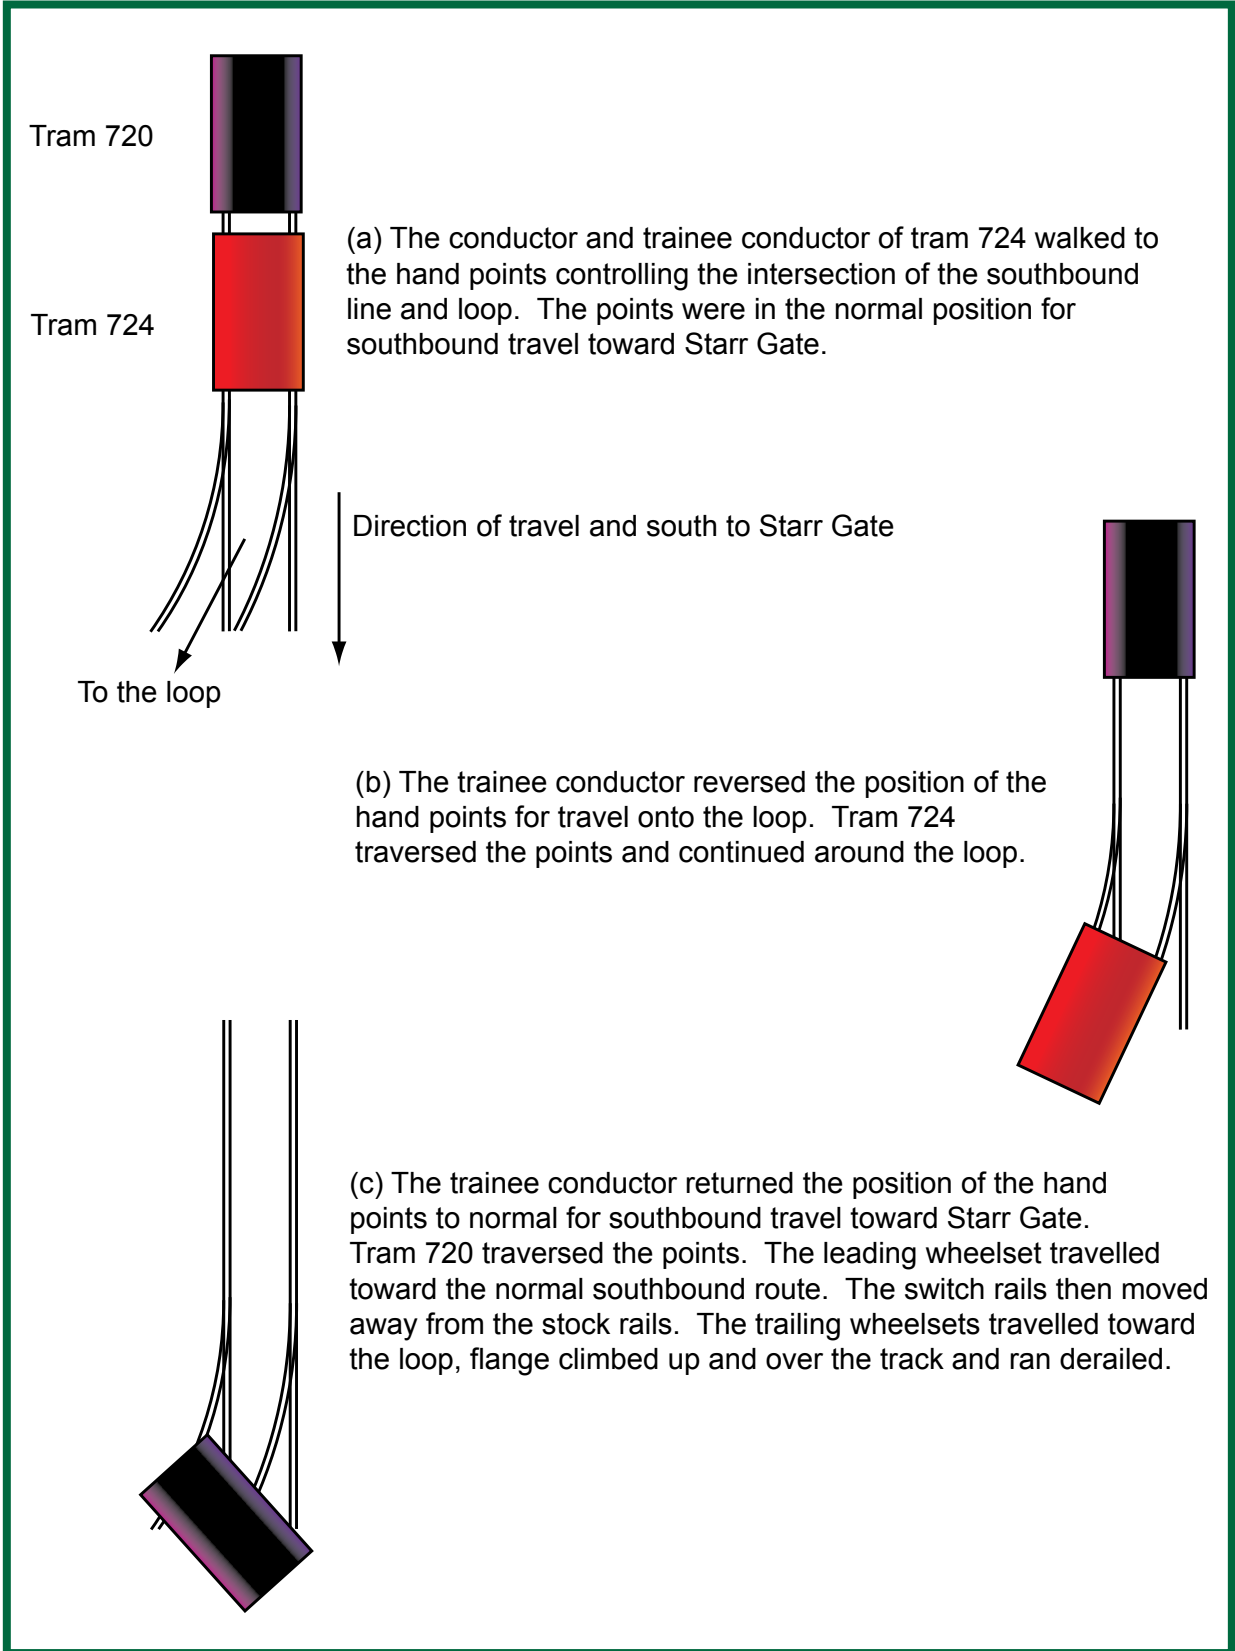
Figure 3: Sequence of events during the incident

- 21 Tram 720 traversed the points. The leading wheelset travelled toward the normal, southbound route. The switch rails then moved away from the *stock rails* and the trailing wheelsets travelled toward the loop, *flange climbed* up and over the track and ran derailed. See Figure 3 for the sequence of events.

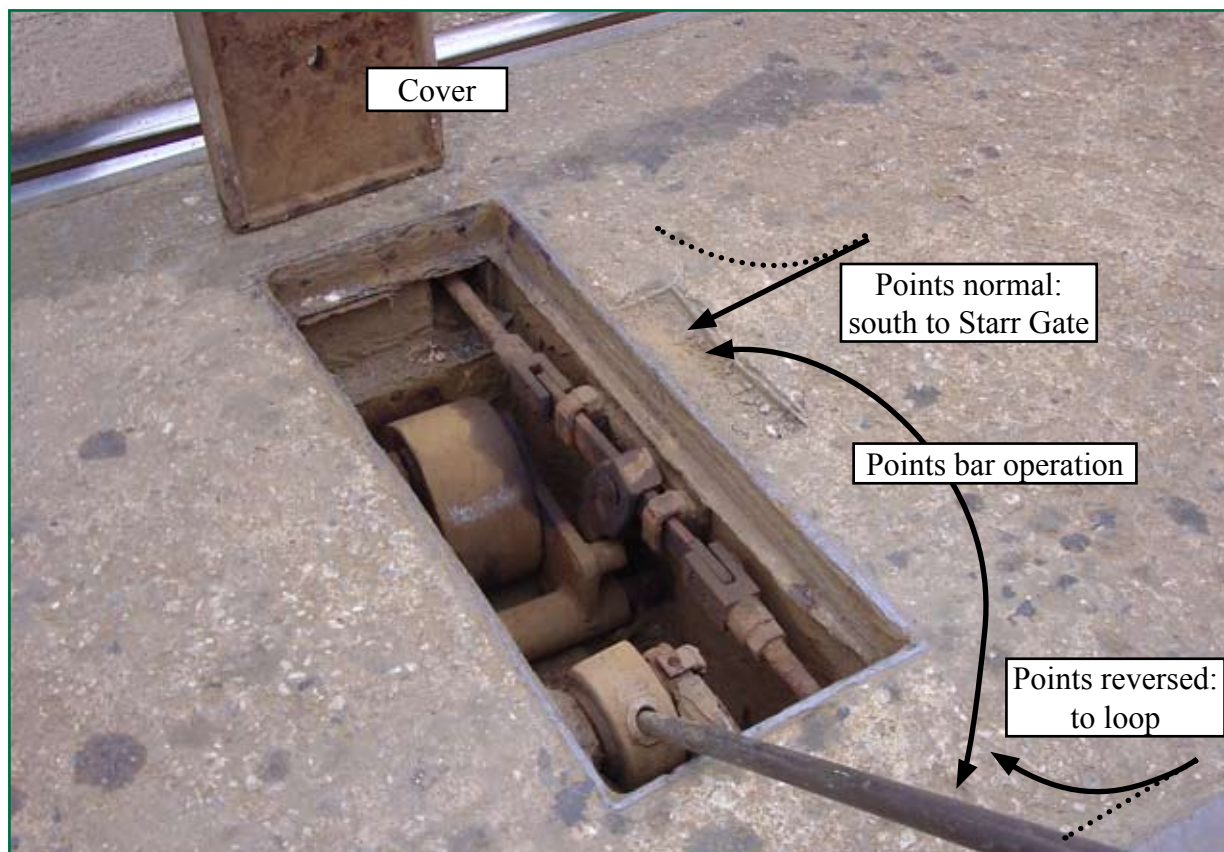
Figure 4: Operation of hand points using a points bar (cover removed)

- 25 BTS custom and practice for operating the hand points mechanism is as follows:
- a points bar is inserted into a slot in the mechanism cover;
 - the points bar is pulled or pushed until the switch rails locate against the stock rails;

- the points bar is removed and then used to lever within the space between both pairs of stock and switch rails to confirm that the switch rails are satisfactorily located (Figure 4).

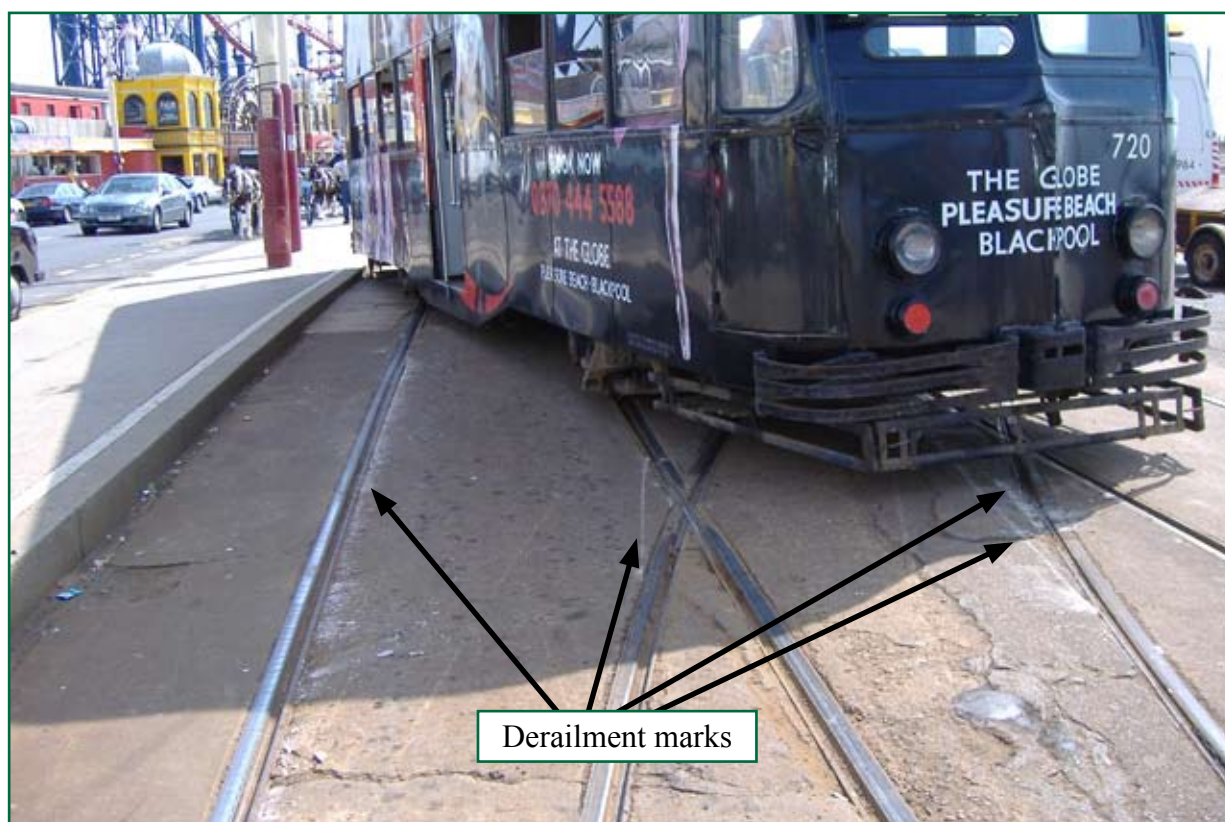
Figure 5: Tram 720 from the rear and derailment marks in the concrete

- 30 Tram 720 was examined after the incident and no faults were found, nor was there evidence of any abnormal operation in traffic immediately prior to the incident. Therefore the condition of tram 720 was considered neither causal nor contributory to the incident.
- 31 The switch and stock rails were examined after the incident and no faults were found. Therefore the condition of the infrastructure was considered neither causal nor contributory to the incident.
- 32 Indentation marks were found on both switch tips. The marks corresponded with the tram wheel profile and were separated by a distance that corresponded with the back to back dimension of the tram wheels.
- 33 Derailment marks in the concrete corresponded with the paths taken by the trailing wheelsets after they had flange climbed from the loop track and ran derailed (Figure 5).

- 34 The position of the tram post-derailment and the marks on switch rails and concrete confirmed that the immediate cause of the derailment was the trailing wheelsets travelling toward the loop after the leading wheelset correctly travelled toward the normal, southbound route.

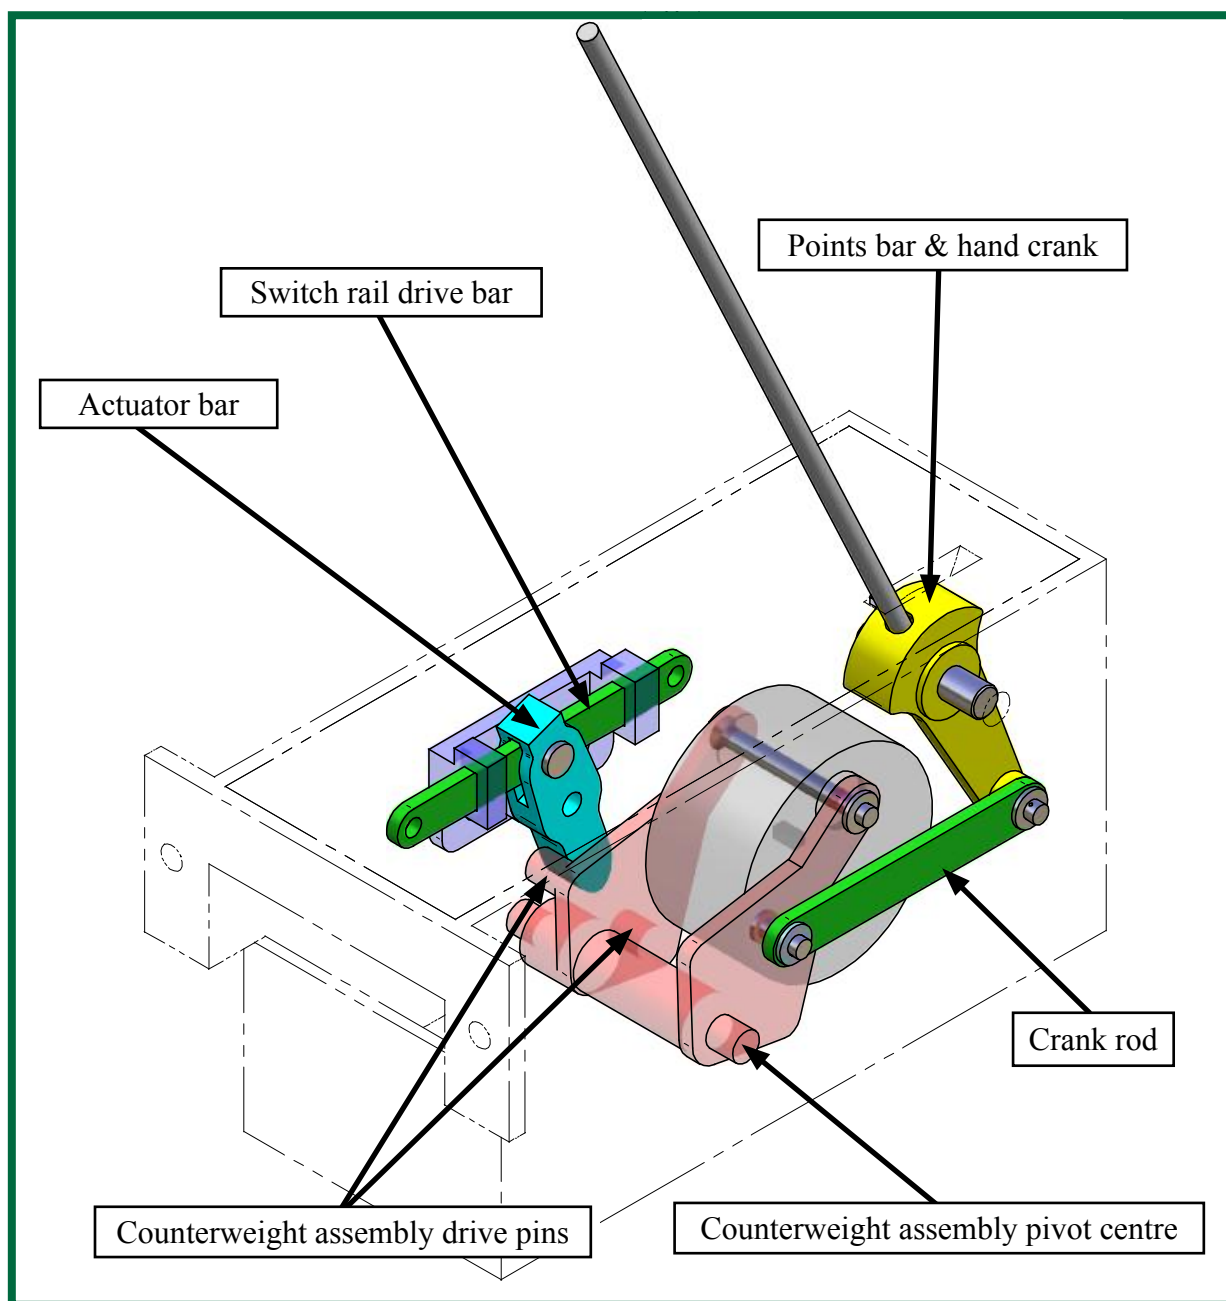
Figure 6: The components of the hand points operating mechanism

- 35 The hand points are operated by a manually levered mechanism. The components of the hand points mechanism are shown in Figure 6.
- 36 The switch rails are moved by the drive bar via connecting rods and are held in position by the counterweight lying fully over its pivot centre.

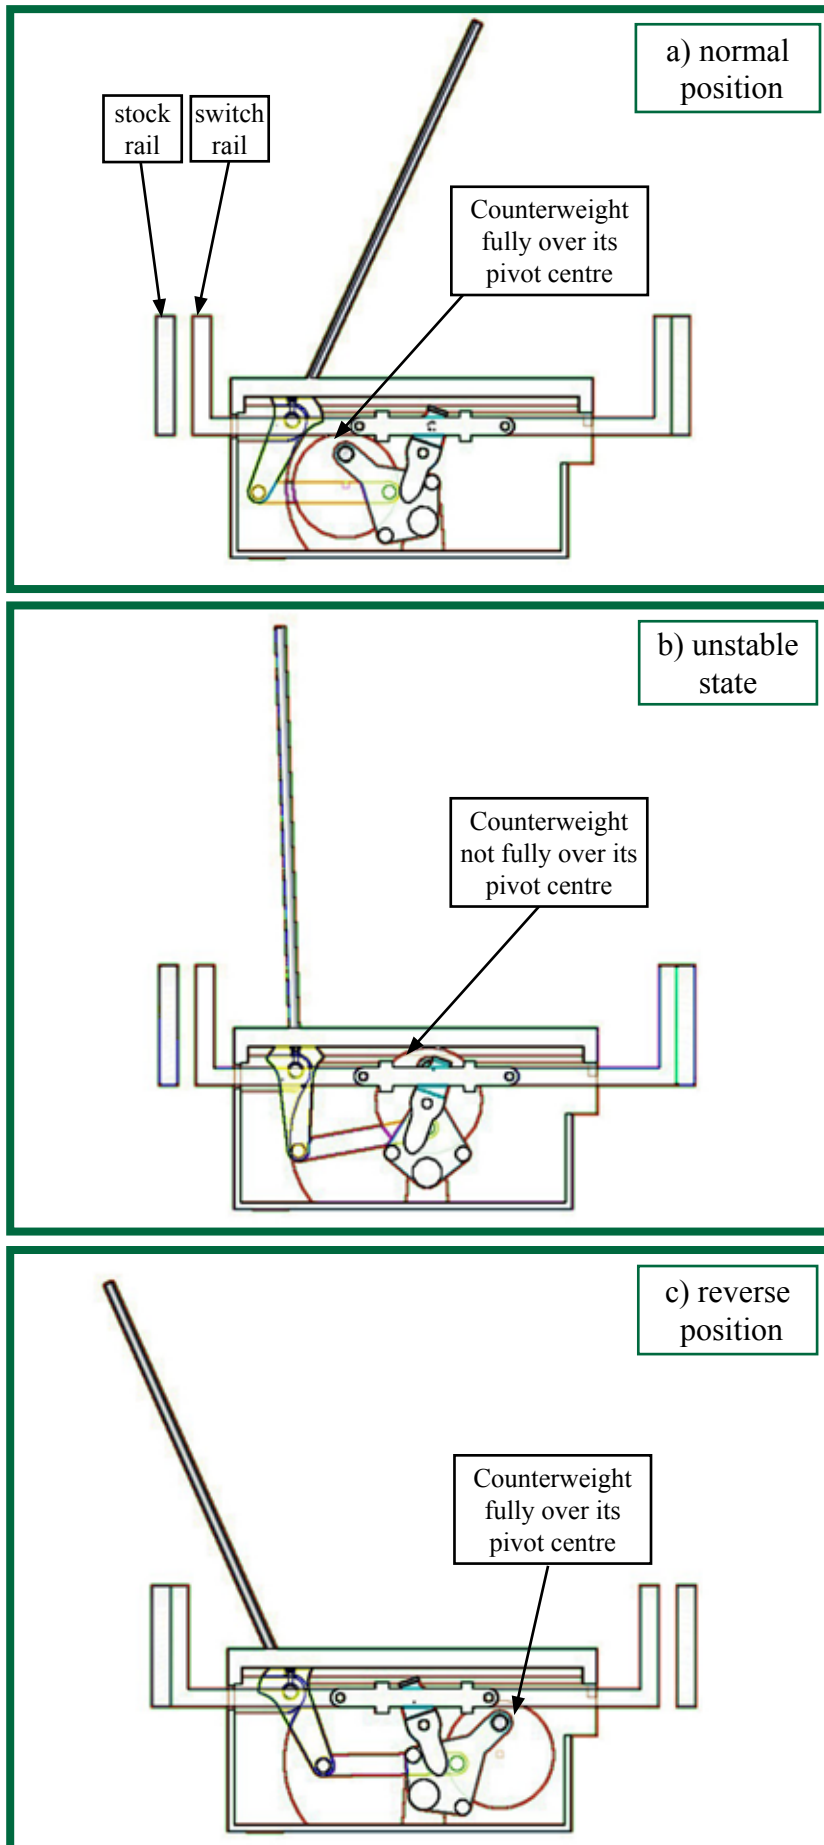
Figure 7: The hand points mechanism under operation

- 37 The RAIB testing undertaken after the incident demonstrated that the switch rails could be closed against the stock rails with the counterweight held by friction and not lying fully over its pivot centre. In this unstable state, a disturbance can cause friction to be overcome, the counterweight to move and the switch rails to open away from the stock rails in either normal or reverse positions (Figure 7). The causal factor of the derailment was that the hand points mechanism had not been correctly returned to the normal position and was in an unstable state before the passage of tram 720.

- 38 The conductor and trainee conductor found that the hand points were stiff to operate before the incident despite the mechanism and switch rail motion being clean and free from debris. This was confirmed by a BTS induction trainer who had operated the hand points mechanism while instructing trainees the day before the incident and by RAIB testing undertaken after the incident.

- 1 Blackpool Transport Services should develop and document a method of hand points operation to ensure that the mechanism is not placed in an unstable state (paragraph 55).
- 2 Blackpool Transport Services should put in place a system to ensure that the method identified in Recommendation 1 above is correctly trained at induction and applied in day to day operations by staff throughout their employment (paragraph 55).
