Rail Accident Investigation Branch

Rail Accident Report

Derailment at Archway 2 June 2006

Report 24/2006
December 2006

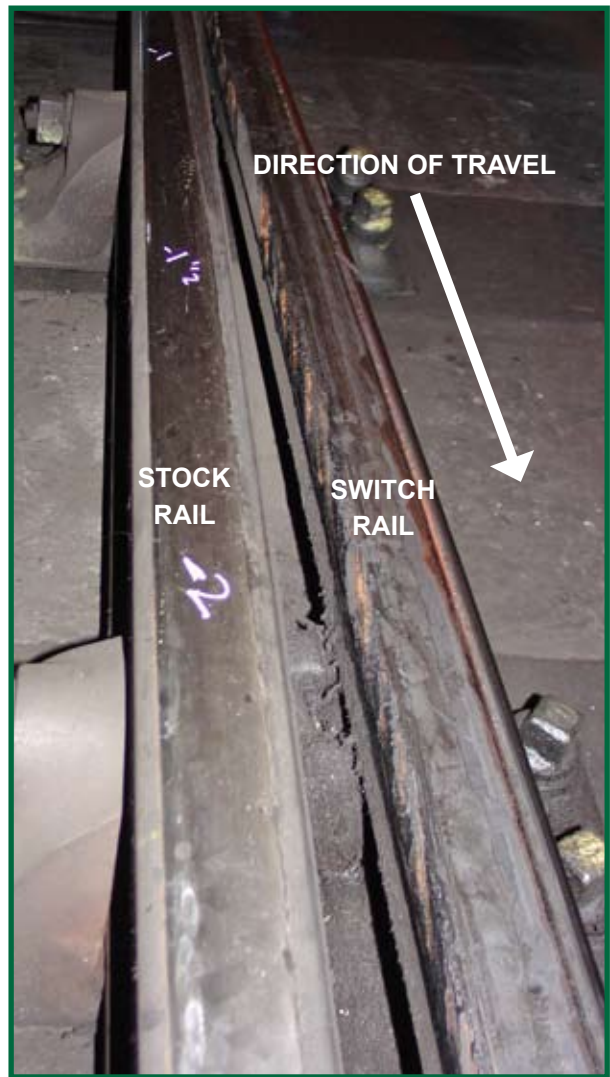
- 40 There were marks on the broken switch consistent with wheel flanges running along the top surface of the rail, and then dropping off on the right hand side, beginning with the leading wheels of the train. The remainder, except for the last bogie, followed the path taken by the wheels in front (Figures 5 and 6).

Figure 6: Right-hand switch rail showing wheel marks.

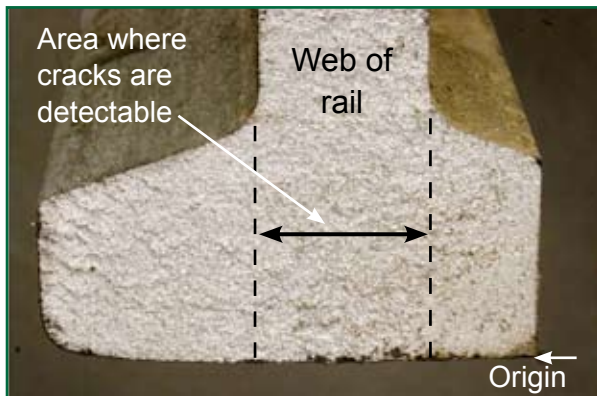
- 43 Laboratory examination of the fractured rail section showed that the failure of the rail was caused by the growth of a single fatigue crack which had originated on the bottom machined edge coincident with a piece of surface scale. It is likely that the surface scale was present since the time of manufacture as it is a common type of rolling defect. The presence of the scale defect and a shallow indent that it had made on the lower surface of the rail acted as a stress-concentration, initiating a crack at this particular location (Figures 7 and 8).

Figure 7: Broken end of rail showing fracture origin and limits of area in which crack detection is possible.

- 44 The fracture occurred 1.81 m from the switch tip approximately mid-way between rail supports, at a position where the lower surface would have been under maximum tensile stress when trains were passing. The bright, clean and undamaged nature of the fracture surface indicates that the crack had occurred relatively recently. Laboratory analysis confirmed that the features of the surface were consistent with a fatigue crack.

- 1 LUL should modify their design specification for bullhead switch rail to include a chamfer or other means of reducing the likelihood of stress raisers occurring on the machined lower edge of the rail (paragraph 77).
- 2 LUL should assess the risk arising from the continued use of unmodified bullhead switch rails in junction work (particularly facing points) and replace such rails where appropriate (paragraph 77).
- 3 Tube Lines should carry out a review of their track inspection system to ensure that faults are being consistently detected and correctly identified, and the appropriate level of remedial action is being programmed (paragraph 78).

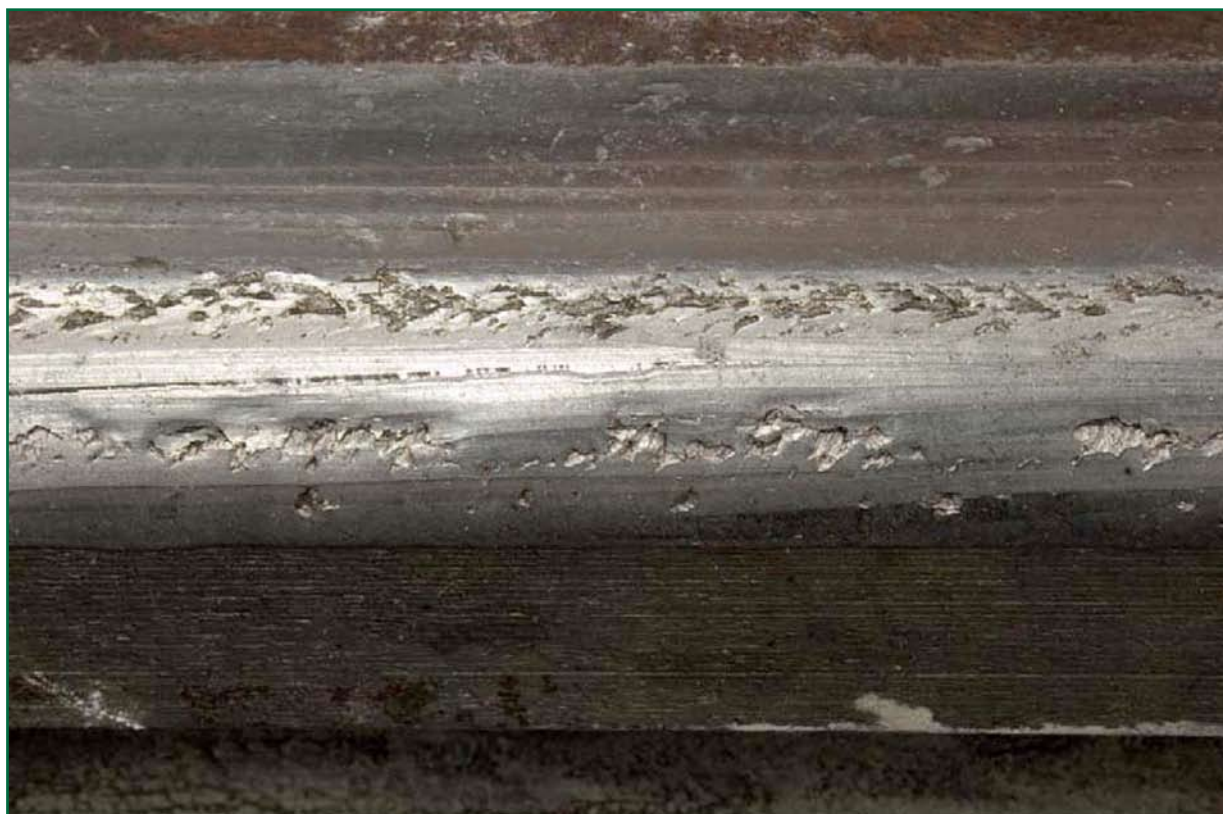
- 64 Whilst the head and gauge face of the broken rail showed evidence of *rolling contact fatigue* (Figure 10), the degree of wear was not significant (paragraph 74).

Figure 10: Rolling contact fatigue marks on the switch rail, overlaid by wear on the gauge corner.
