# Rail Accident Report

**Broken Rails at Urchfont and Kennington  
following the passage of a freight train  
5 January 2006**

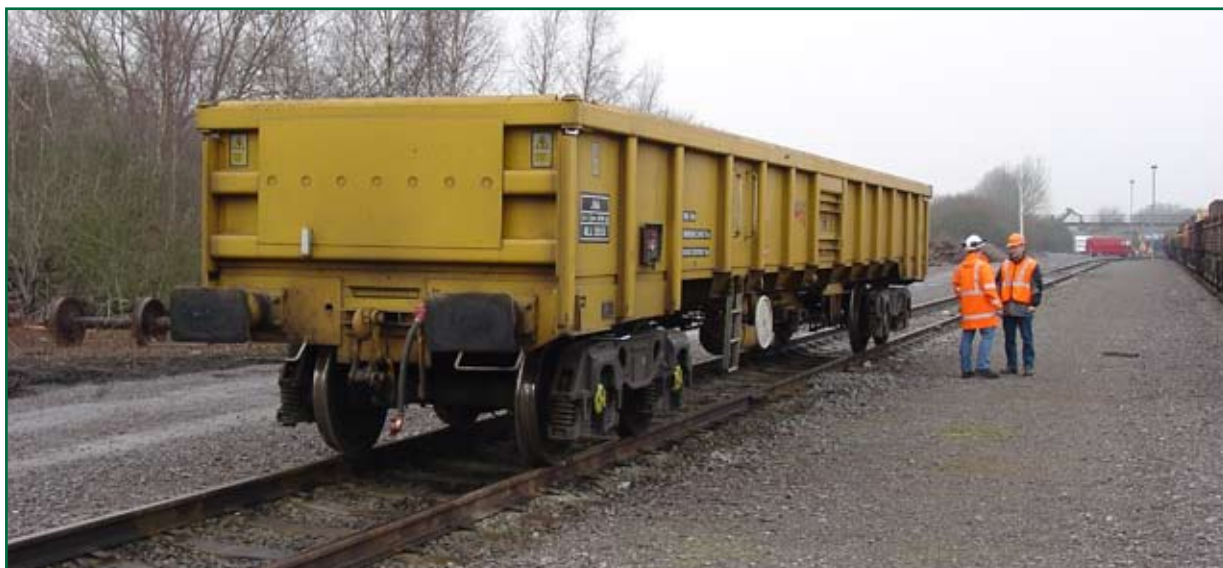
Figure 2: Wagon NLU 29553 at Hinksey Yard on 6 January 2006.

- 53 The only significant damage to wagon NLU 29553 was the wheel flats on axle 3. There was some minor damage to suspension components on the affected bogie and the wheel bearings had also lost some of their grease due to the harsh vibration caused by the wheel flats.

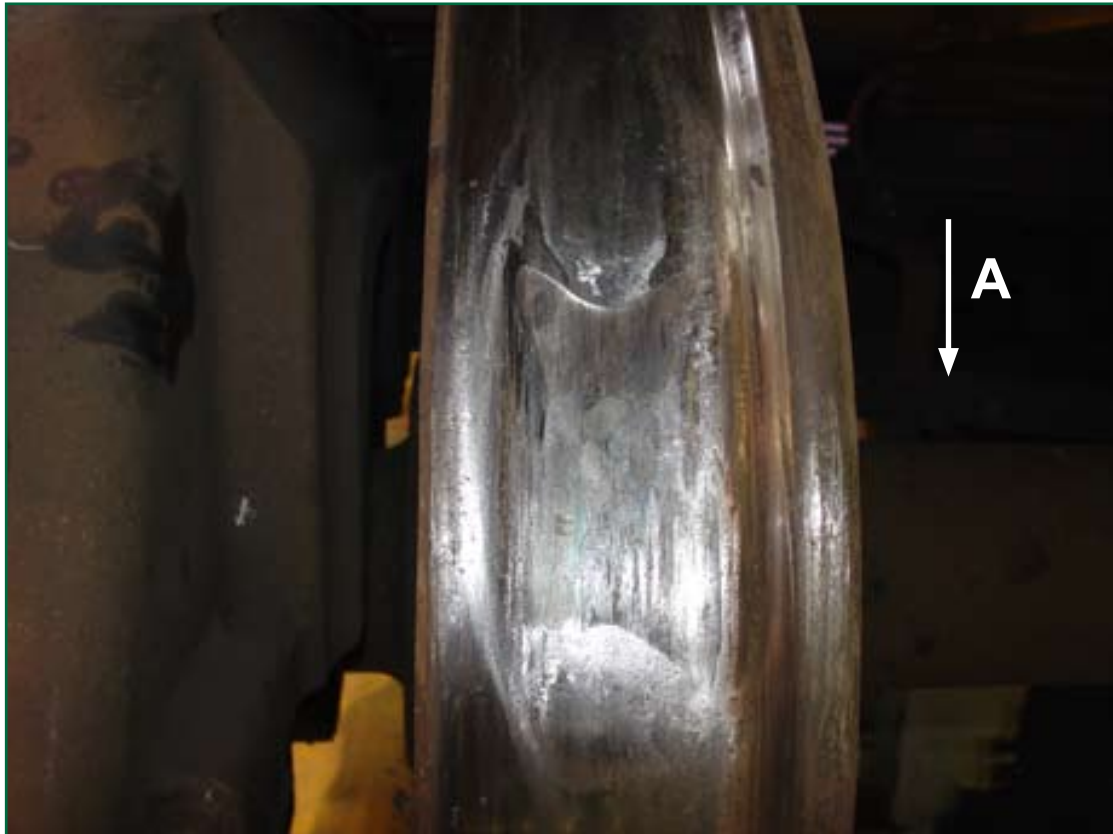
- 58 Each wheel flat (Figure 5) measured approximately 120 mm in length, but the wheels were damaged over a greater portion of their circumference of between 255 and 285 mm in length (including the flatted portions). The majority of the deformation was above the upper edge of the flat as shown in Figure 5. Between Exeter and Hinksey the wheel would have been rotating as shown by arrow A in Figure 5. The depth of the flats were measured at 6.9 mm on wheel 3 and 8.1 mm on wheel 6. These depths are 3-4 mm greater than would be expected for a freshly slid flat 120 mm long, and correspond to a flat length of approximately 160-170 mm. This indicated that, at some point in the journey, the flat length had been longer than the final visible length of 120 mm. The forces generated by such severe flats is discussed later in paragraphs 77 and 122.

- 59 The fore and aft edges of the flat were battered, confirming that the wheel had been rotating for some considerable distance after the flats had been created. This battering of the edges also explains how a longer flat of the order of 160-170 mm had reduced in size to the final 120 mm length. There was also evidence of metal flow at the edges of the flat portions, as seen by the curved upper and lower edges of the flat in Figure 5. The shape of the edges indicated that the flat had formed first at some point in the journey from Meldon to Exeter, followed by rotation and further skidding in the Exeter - Hinksey direction of travel.

*Figure 5: Flat on wheel 3 of axle 3 (serial no. ZB 362/9/057) on wagon NLU 29553*

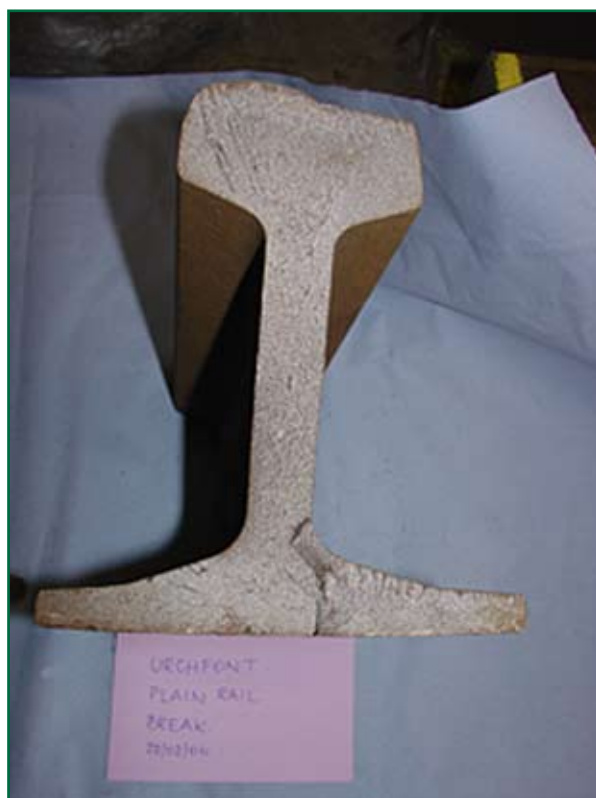
- 73 Detailed metallurgical examination of the broken rail from Urchfont (Figure 6) showed that it contained a rolled-in lack of fusion defect in the rail foot which had been there since the rail was manufactured circa 1970. The inclusion of such defects was inherent in the manufacturing process used at the time. The rail foot is in tension as rails bend under vertical loading. However, the size of the defect was too small to have been detected using the standard in-situ manual and train based ultrasonic scanning equipment used on the network. The fracture faces were consistent with mechanical overload and there was no evidence of any fatigue crack growth.

Figure 6: Broken left-hand rail from Urchfont

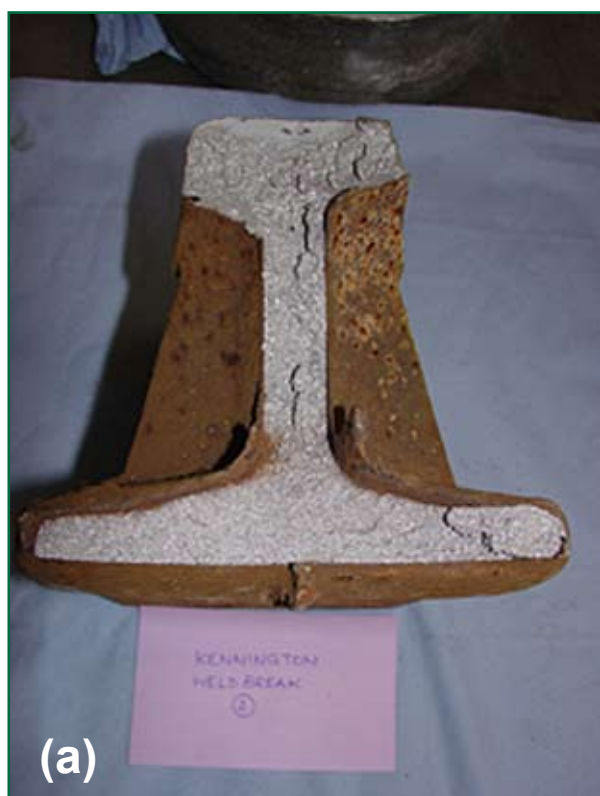
- 74 Examination of the broken left hand rail from Kennington (Figure 7a) revealed that it had fractured rapidly from the bottom of the rail foot at the edge of the weld collar, where there were three small fatigue cracks, the largest of which had a surface length of 4 mm and depth of 1 mm. The fatigue cracks had initiated at slag inclusions formed during the weld manufacture in 1968. The crown of the rail had been weld repaired at some unknown point in its history, leaving a horizontal defect.

Figure 7: Broken left (a) and right (b) rails from Kennington

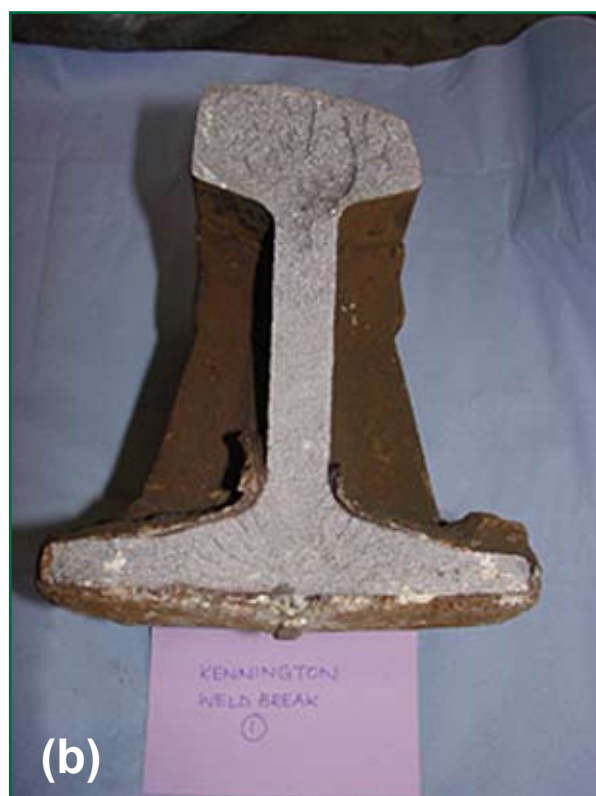
- 75 The right hand rail from Kennington (Figure 7b) had also fractured rapidly from the edge of the weld collar, having initiated at 2 fatigue cracks, 1 mm deep and 3.5 mm deep at the bottom of the rail foot. The rail and weld were manufactured in 1968.
