Rail Accident Investigation Branch

# Rail Accident Report

**Signal T172 passed at danger at Purley station,  
Surrey  
18 August 2006**

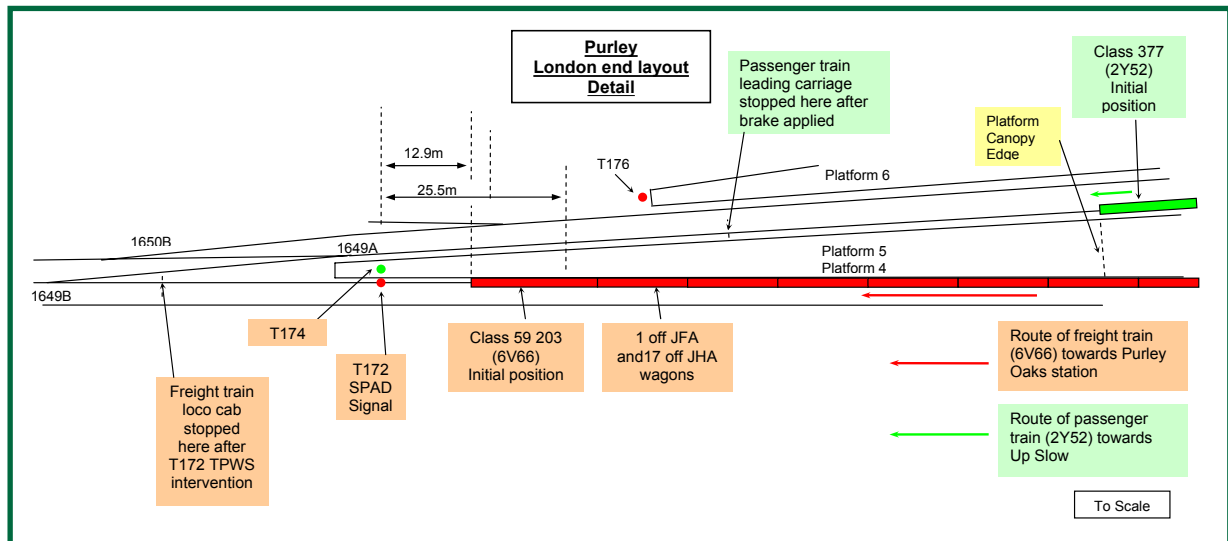
Figure 3: Detailed plan of incident site showing initial and final positions of trains at Purley station

- 20 The freight train was automatically stopped following a TPWS intervention, 35 m (38.27 yards) past signal T172.

11:02:02	Train 6V66 comes to a stand 12.9 m (14.10 yards) on the approach to signal T172. See Figure 3. (Note: The driver cannot see signal T172 when in his seat.)

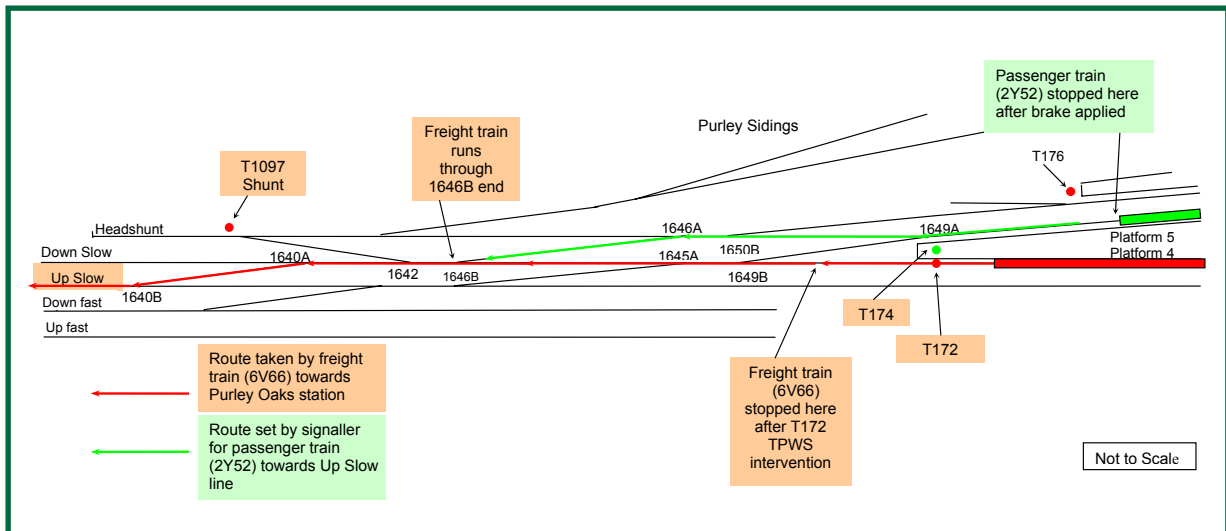
Figure 6: Purley station and the London end layout showing routes set and taken of both trains

11:03:13	The driver of train 2Y52 applies his brake into the full service position and his train comes to rest 54.5 m (59.60 yards) on the approach to signal T174 (See Figure 6).

11:04:42	Train 6V66 runs through 1646B points to take the up slow route towards Purley Oaks station (see Figure 6).

- 45 Following the TPWS reset, the driver of train 6V66 continued travelling towards London on the up slow line. As a consequence, train 6V66 ran through 1646B points which had been set for the passenger train, 2Y52. The driver of train 6V66 did not see the points set against him and was unaware of the run through.
- 46 The run through of 1646B points caused some minor damage to the front *stretcher bar* and a broken *stretcher bar* bracket which initially left the points usable only in their *normal* position. This resulted in the blocking of the routes into and out of the London end of platform 6.
- 47 There was no damage to either train.
- 48 The driver of train 2Y52 avoided a possible collision with train 6V66 by controlling his train to a stop while still in platform 5.
- 49 The passenger train was travelling at 11.9 mph (19.15 km/h) when the driver braked.

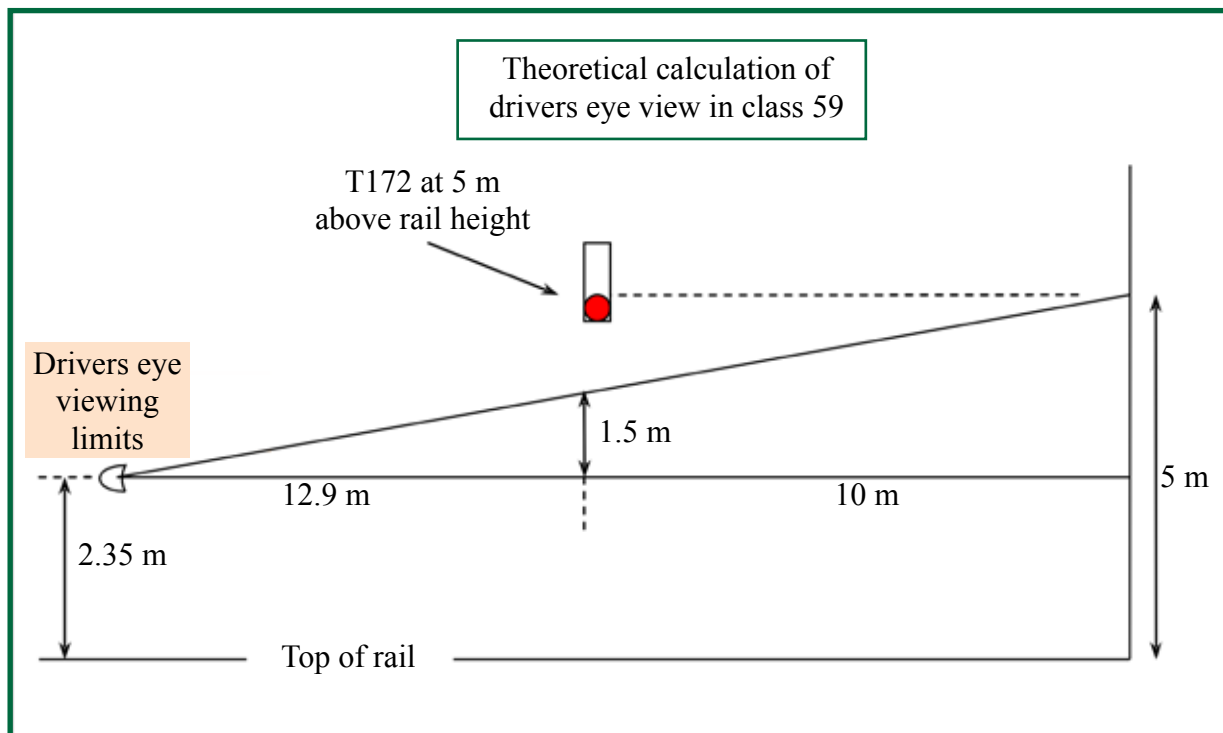
Figure 7: Elevation plan of driver's viewing range showing driver at 12.9 m and 22.9 m on the approach to signal T172

- 83 The driver of train 6V66 then stopped the front of the locomotive only 12.9 m on the approach to signal T172 signal. See Figures 3, 7 and 8. At this position the driver could not see signal T172 on the gantry directly in front of him, but could clearly see the incorrect signal T174, platform 5's starter signal.
- 84 Figure 7 shows the viewing range of a driver seated in his seat. It demonstrates that at 12.9 m (14.10 yards) from signal T172, the driver would not have seen the signal, and at 22.9 m (25.04 yards), only the red aspect could have been seen. For a driver to see a green aspect, (the physically highest aspect of signal T172), the locomotive must be 25.5 m (27.88 yards) from the signal. This distance was measured after a reconstruction of the move with a class 59 into platform 4 from Purley yard.

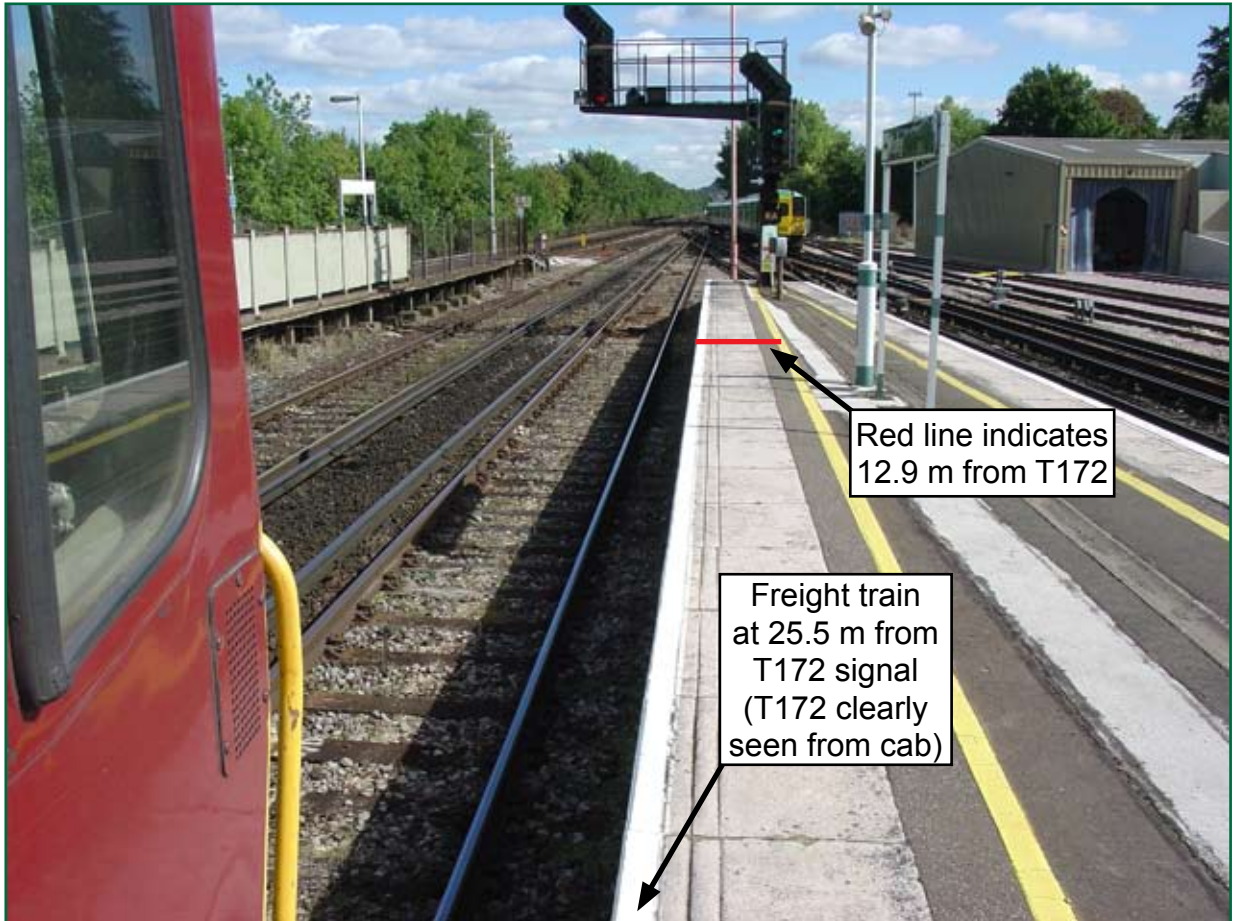
Figure 8: Photograph taken from platform 4, (adjacent to the driving cab and at the same height of a train driver seated in the driving seat) of the position of a Class 59 locomotive 25.5 m from signal T172

- 85 Figure 8 shows the relative positions of a class 59 at 25.5 m (27.88 yards) on the approach to signal T172 and where the locomotive stopped on the 18 August, only 12.9 m (14.10 yards) on the approach.
- 86 The correct route for the passenger train from Purley platform 5 to Purley Oaks, when set by the signaller, (after the freight train had come to a rest behind signal T172) had resulted in all signals on the route between those two points on the up slow line showing green. Two of these signals were visible to the freight train driver when at signal T172.

- the driver had positioned his locomotive incorrectly and could not see signal T172 from where he had stopped (**Recommendation 1**); and
- no specific stop marker was provided on platform 4 (**Recommendation 1**).

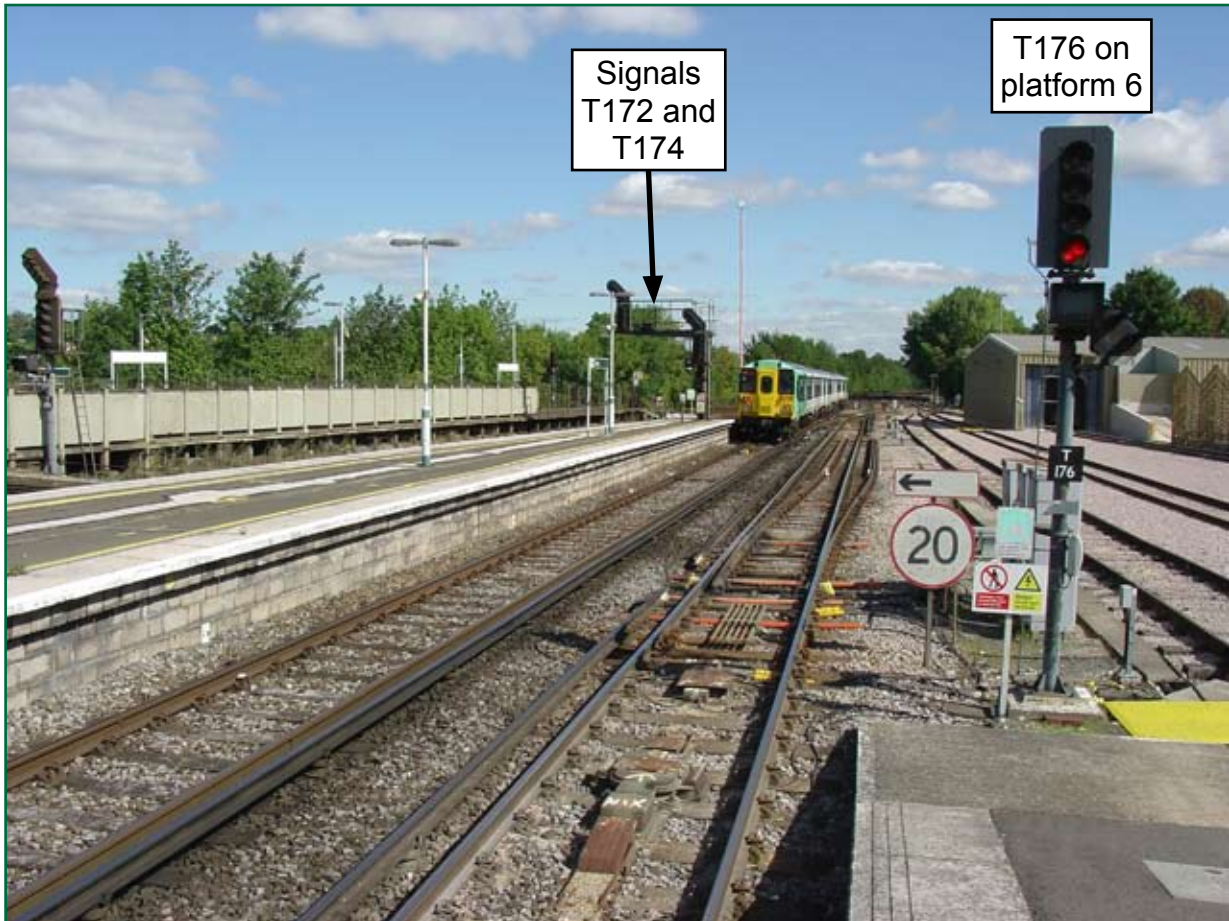
Figure 9: Signal T176 at the London end of platform 6 at Purley showing similarity to T174 on platform 5

- 94 As discussed earlier, the driver made more moves to and from platform 6 than from the other two platforms combined. Signal T176, at the London end of platform 6 is also on the right hand side of the driver after he has propelled back from the headshunt into the station. Signal T176 is also at the same height as signal T174. See Figure 9.

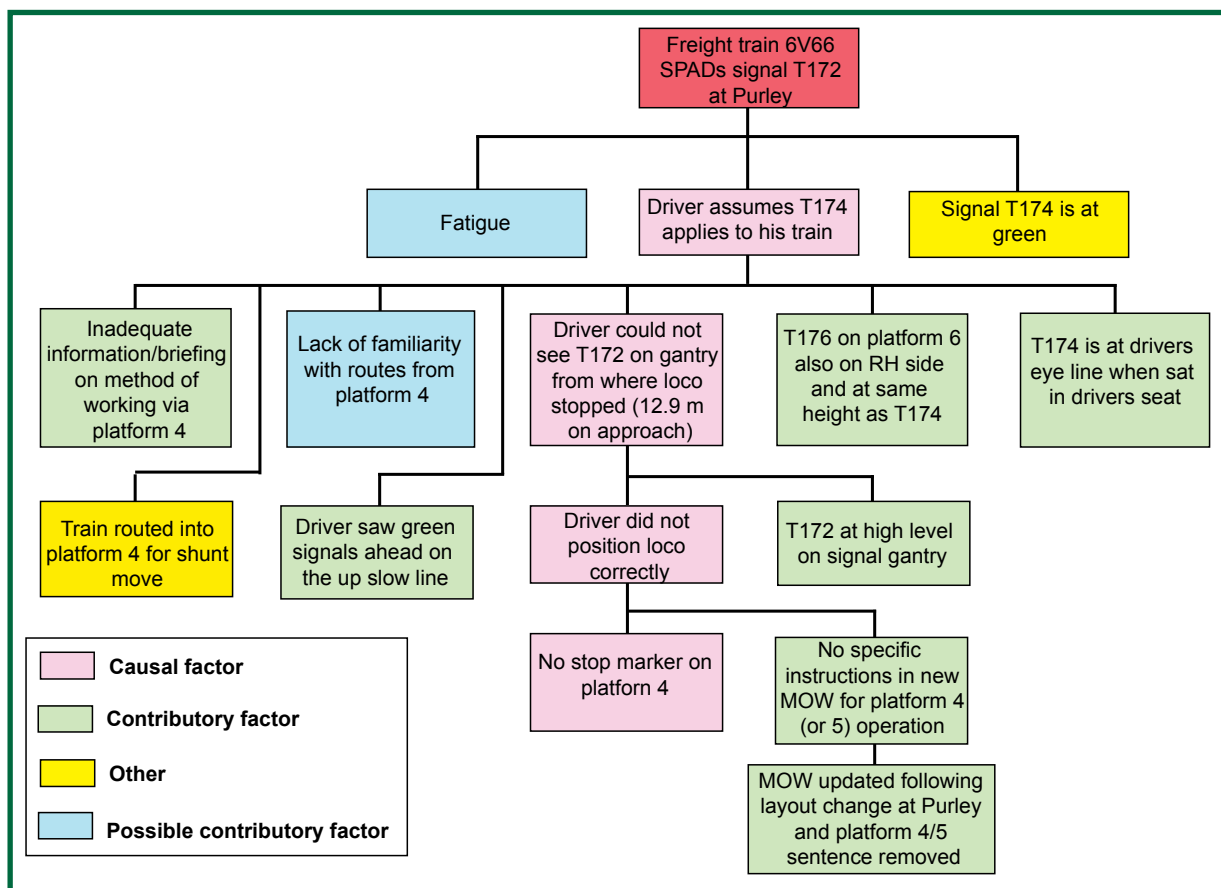
Figure 10: Causal analysis diagram of the SPAD

- 167 The relationship and categorisation of the factors associated with the SPAD are described in the casual analysis diagram in Figure 10.

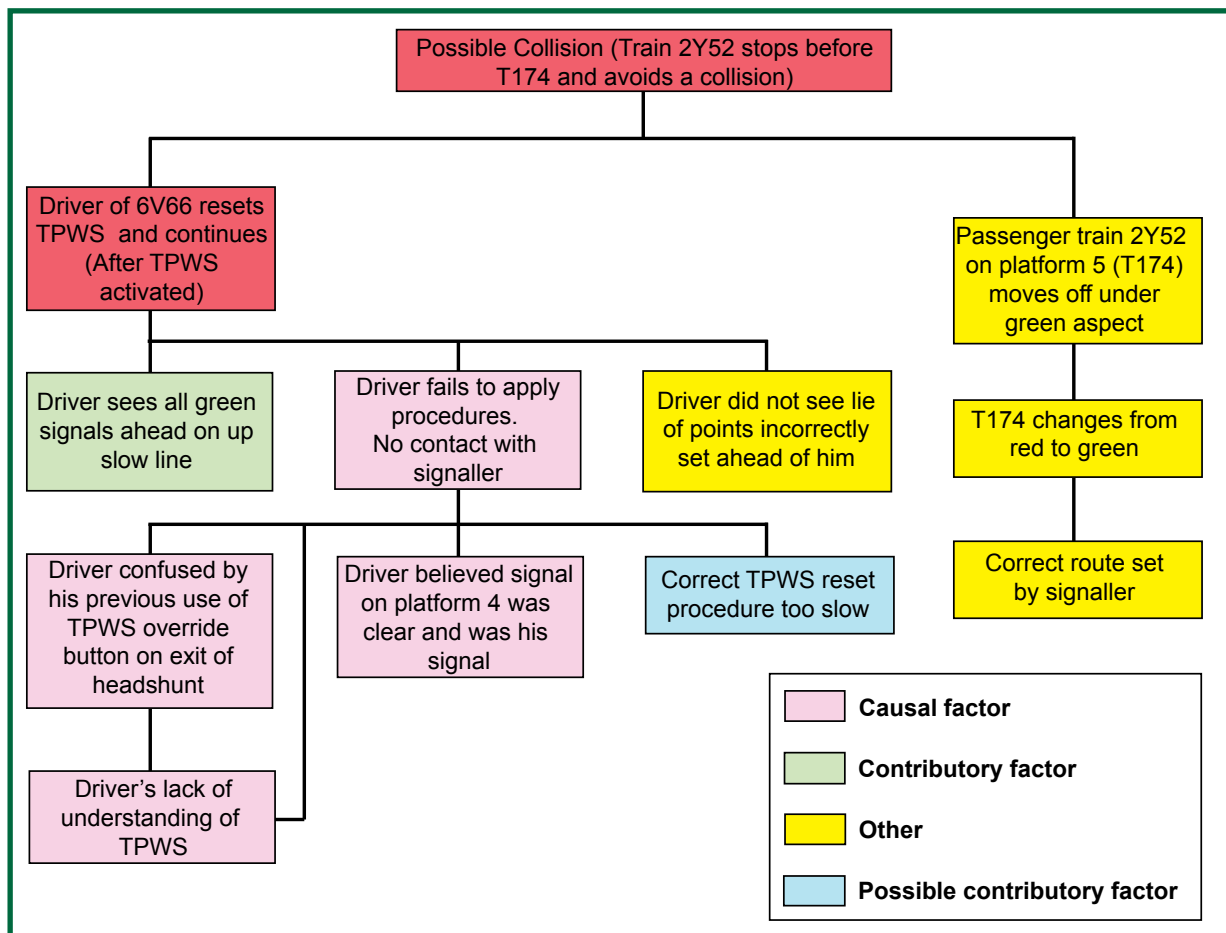
Figure 11: Causal analysis diagram of the incorrect resetting of the TPWS following the SPAD

172 The relationship and categorisation of the factors associated with the incorrect resetting of the TPWS are described in the casual analysis diagram in Figure 11.
