Rail Accident Investigation Branch

Rail Accident Report

**Collision between a train and a road vehicle,
M20 overline bridge, Aylesford
5 February 2007**

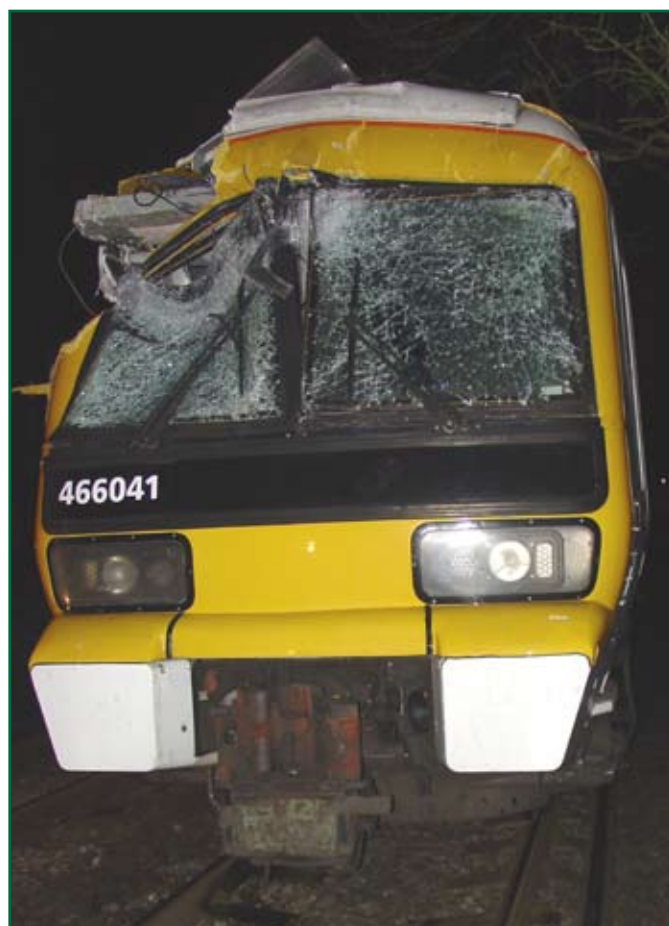
- 9 InterRoute hired in a 'Moog' 25 m long under-bridge inspection gantry from E.S. Access Platforms (NE) Ltd. This gantry is deployed from a large road vehicle (see Figure 3).
- 10 The Moog operator lowered the gantry from the motorway bridge span that crosses the railway when the railway line was open for normal traffic operation.
- 11 At 22:25 hrs on 5 February 2007 Southeastern train 2T83, the 21:57 hrs Paddock Wood to Gillingham (Kent) struck the 'Moog' gantry which was foul of the *up line*. The train was a 2 car electric unit of class 466, and was carrying a driver and one passenger.
- 12 The collision speed was 65 mph (105 km/h). The leading carriage suffered substantial damage to the cab and forward saloon areas. The driving cab roof was ripped open at the right hand side (see Figure 2).

Figure 2: Leading carriage 78352 of unit 466041 showing the external damage sustained

- 39 The lowest point of the Moog gantry remaining after the impact was measured at 3100 mm above rail level. The class 466 vehicles forming the train are built to 3800 mm static height above rail level. The lowest point of impact on the train was at 2915 mm above rail level.

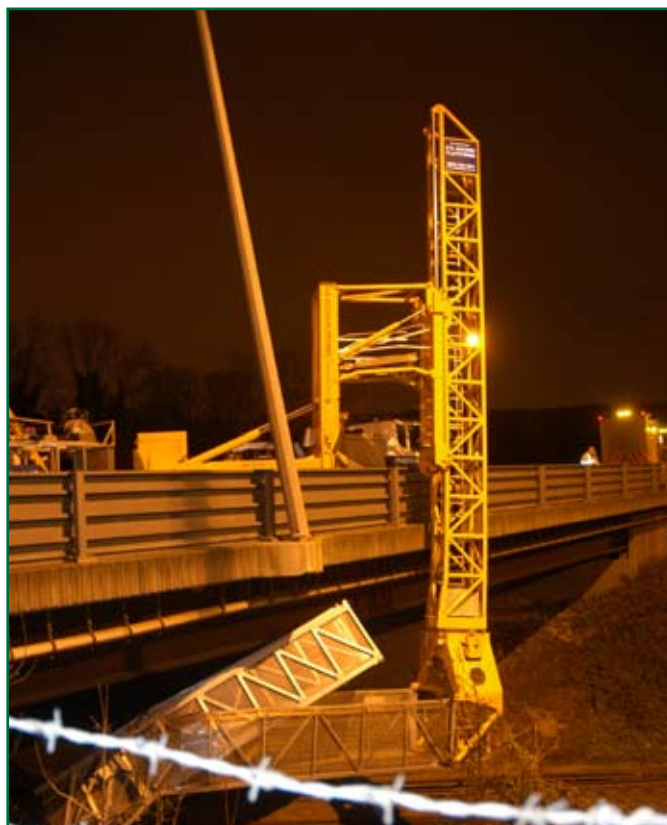
Figure 3: 'Moog' bridge inspection gantry viewed from motorway level after the collision (Photograph courtesy of the British Transport Police)

- 37 Before the Moog operator could climb down onto the inspection platform it was struck by train 2T83. The impact ripped two of the three sections off the platform and left the damaged parts strewn north along the railway line for over 100 m. The train driver did not see the obstruction before impact due to the area being in darkness and there being a left hand curve in a cutting on the approach to the M20 bridges over the railway.

- 38 The Moog lorry unit on the M20 rocked so severely that witnesses reported that they believed anyone who was on it would have been catapulted off it.

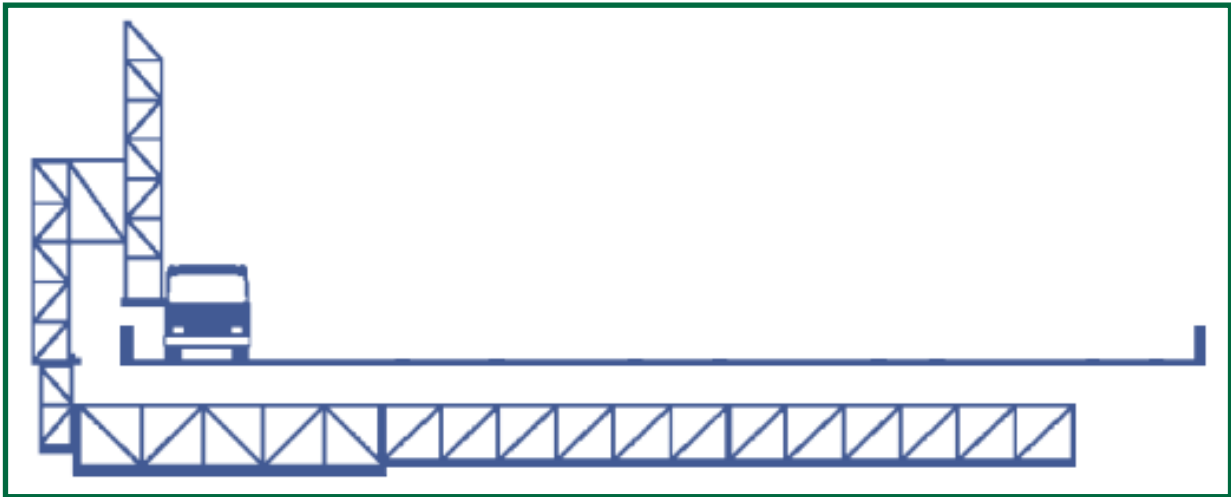
- 20 InterRoute's staff at its Coldharbour (Aylesford) office identified the requirement for specialist equipment for the bridge inspection (see Figure 4). They passed this requirement to staff at their Gillingham (Kent) office. Gillingham staff approached a regularly used subcontractor to procure an under-bridge inspection unit, but there was not one available for hire on the specified night. Gillingham staff then telephoned E.S. Access Platforms (NE) Ltd to arrange the hire.

Figure 4: Sketch of how the under-bridge inspection gantry should look when deployed (courtesy of E.S. Access (NE) Ltd)
