Rail Accident Investigation Branch

Rail Accident Report

Incident at Wellesley Road on Croydon Tramlink 15 June 2007

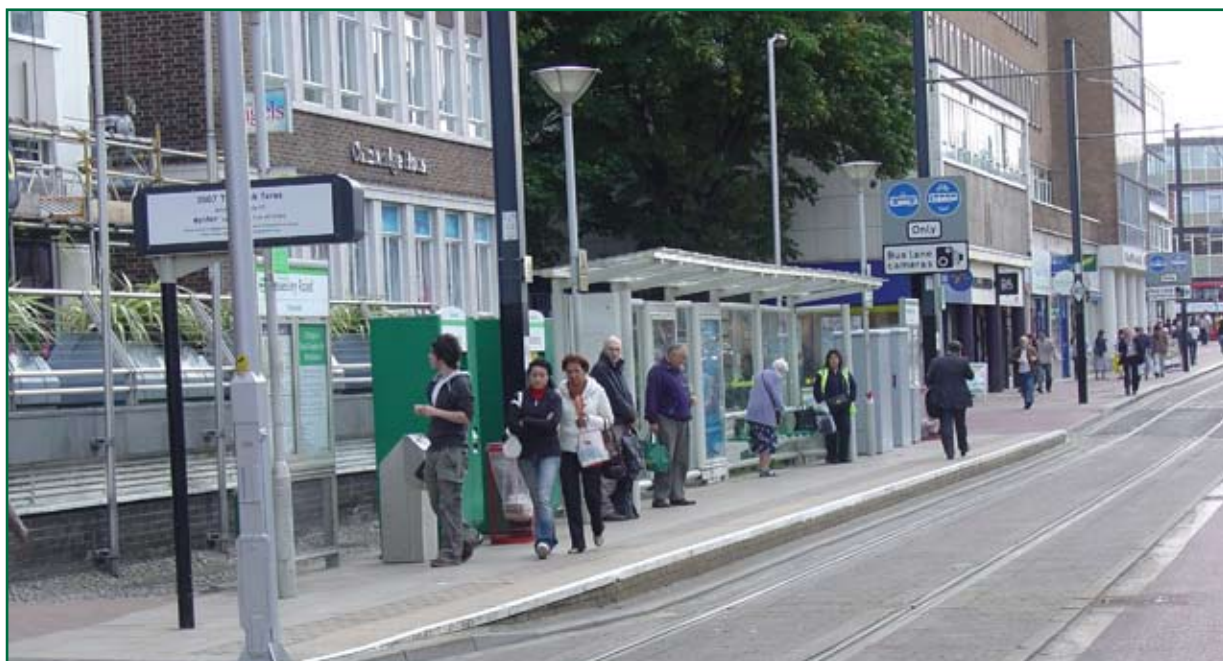
Figure 2: Wellesley Road tram stop

- 10 The Wellesley Road tram stop is on the single track loop between West Croydon and East Croydon stations, which is used only by eastbound trams. The raised platform is straight, like all the tram stops on the Tramlink system, and is on the east side of the dual carriageway of Wellesley Road. It occupies the whole width of the footway of the road at this point.

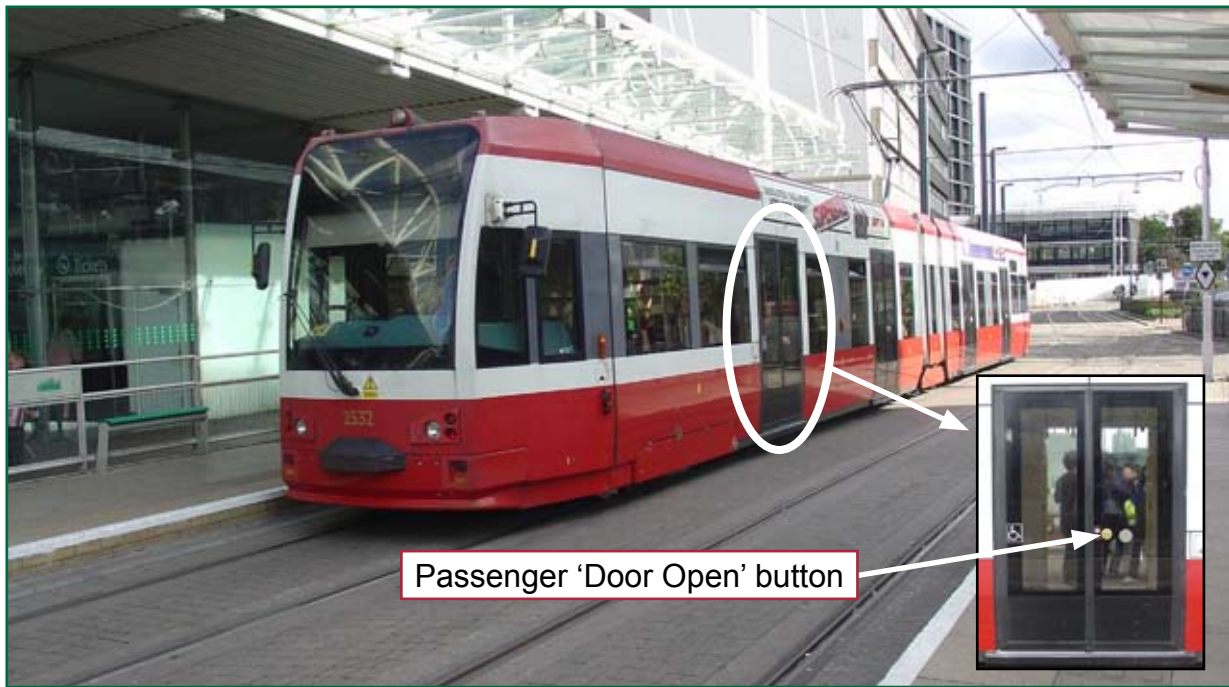
Figure 3: Croydon tram, showing doors and push button (inset)

- 12 The vehicle involved was tram 2542, one of the 24 units that make up the Tramlink fleet. It was built by Bombardier Transportation in Austria in 1998. There are four sets of *sliding plug* double doors on each side of the tram, all of which have 'doors open' buttons on the right-hand door (as seen from the outside).
