Rail Accident Investigation Branch

Rail Accident Report

Fire on prototype tram 611 at Blackpool 24 January 2007

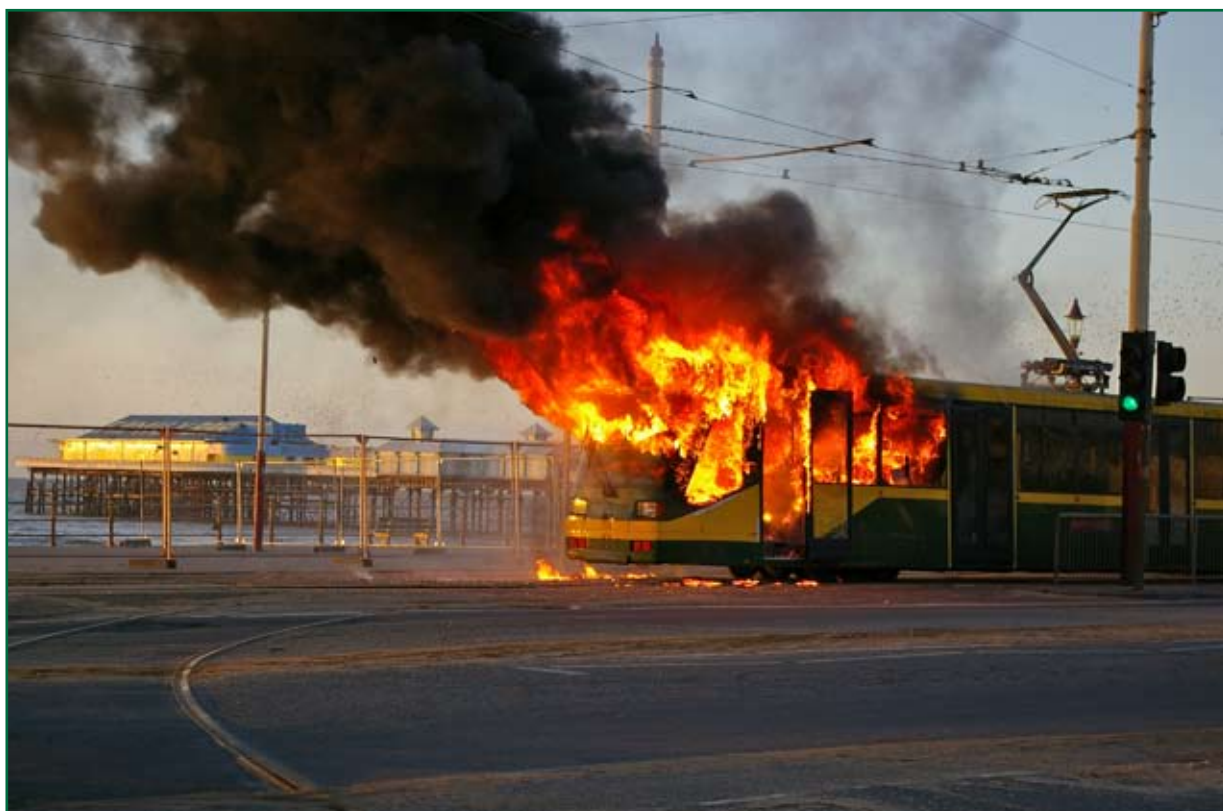
- 12 Once outside the vehicle, the driver realised that he had not lowered the pantograph as required in an emergency. The driver then went to the rear of the tram and opened the A end driver's door. He realised that he would not be able to lower the pantograph from this position as the control panel could not be enabled without the use of the driver's key. He could not retrieve the key as the fire at the B end was by then too intense. The driver was unable to enter the passenger saloon from the A end and lower the pantograph manually, due the presence of smoke. Figure 3 shows the tram during the fire.

Figure 3: Tram 611 during the fire (courtesy of Blackpool Transport Services Ltd)

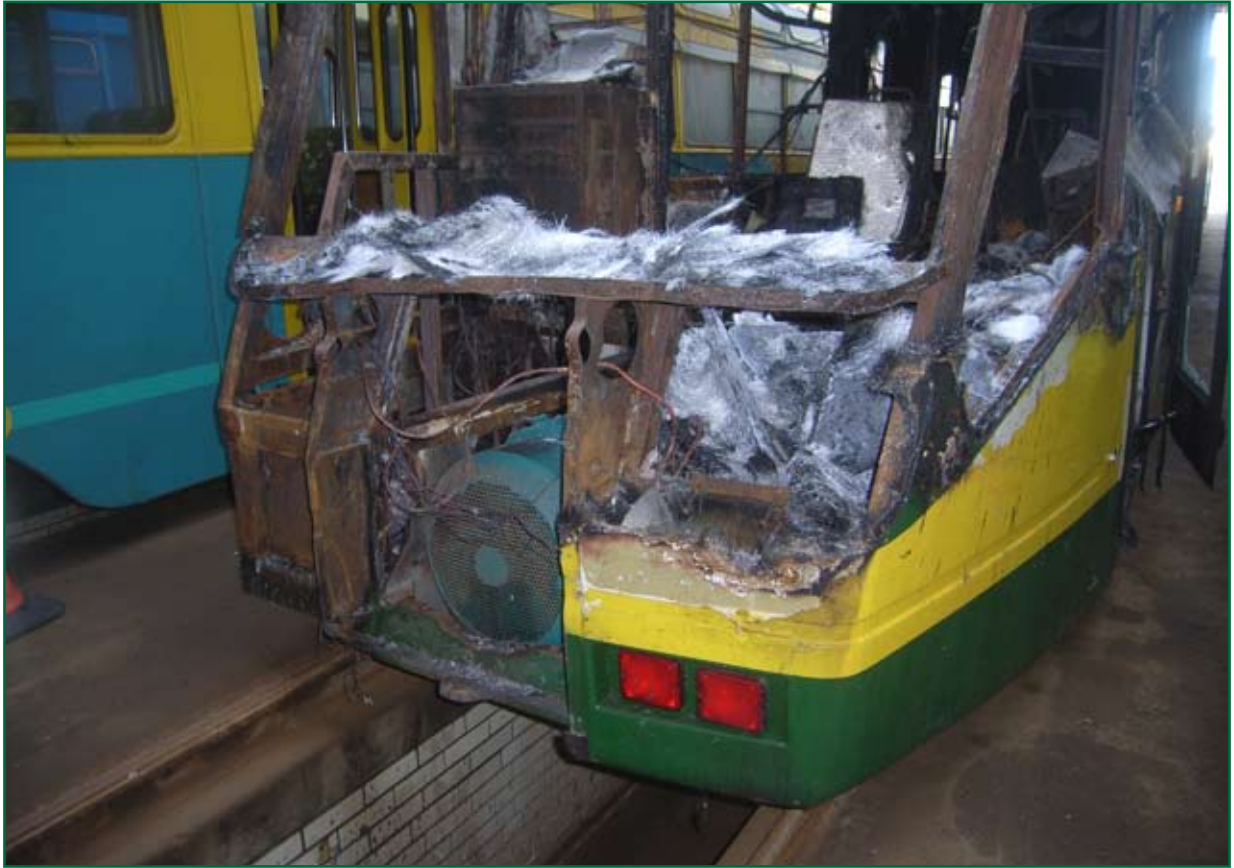
- 16 The RAIB carried out an inspection of the tram on Monday 29 January. The interior seating and panels, control and power equipment and external glazing and cladding of the tram sustained significant damage at the B end due to the fire. The remainder of the vehicle was damaged by smoke. Figure 4 and Figure 5 show details of the fire damage.

Figure 4: Fire damage to the exterior at the B end

- 18 The RAIB examination of the tram indicated that the seat of the fire was in an under-floor compartment below the first, rearward facing, passenger seat behind and to the right-hand side of the B end driving position. This compartment is constructed of plywood and houses both low and high voltage electrical equipment including rheostatic brake resistors. The air to cool this compartment is drawn from a central channel that houses the traction motor.

- 19 There was no evidence of a defect or failure within the high voltage power control system. The low voltage wiring in the underfloor compartment was severely damaged and a conclusive analysis was not possible. It is probable that the fire began within the low voltage electrical system. This view is shared by the forensic fire specialist.

1. Blackpool Transport Services should develop vehicle acceptance procedures and integrate these into the “management of change” procedure within the Safety Management System (paragraph 43).
2. Trampower Ltd should carry out an appropriate risk assessment relating to the design, construction and operation of the vehicle with reference to Regulation 3 of the Management of Health and Safety at Work Regulations. Part of this assessment should consider whether components and systems are appropriately constructed and installed in a way that is fit for their intended use. This risk assessment, and related currently-applicable technical documentation, should be provided to the operators of any network where the vehicle is used (paragraph 41).

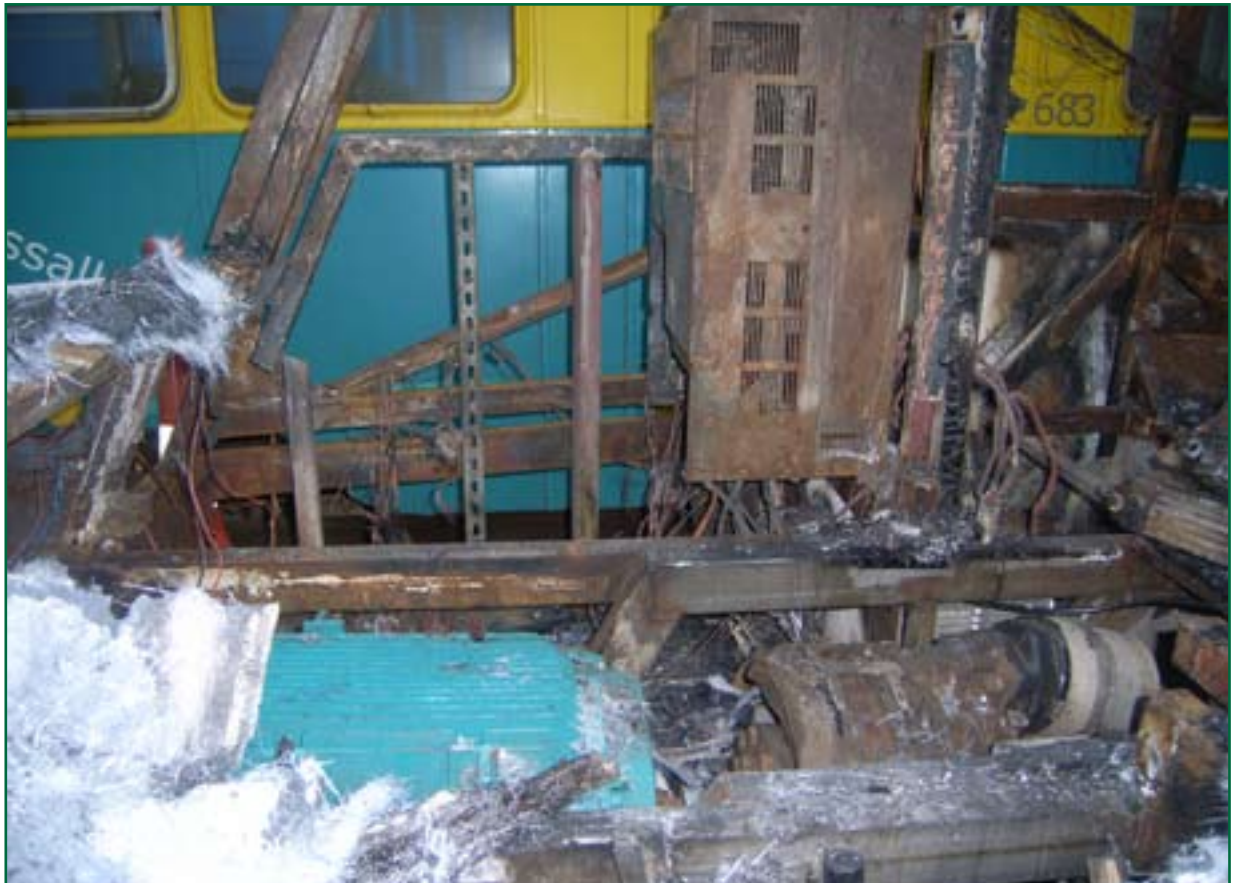
Figure 5: Fire damage to the B end driving position
