Rail Accident Investigation Branch

Rail Accident Report

**Collision between a train and tractor on
crossing XL202 near Limavady Junction,
Northern Ireland
2 August 2007**

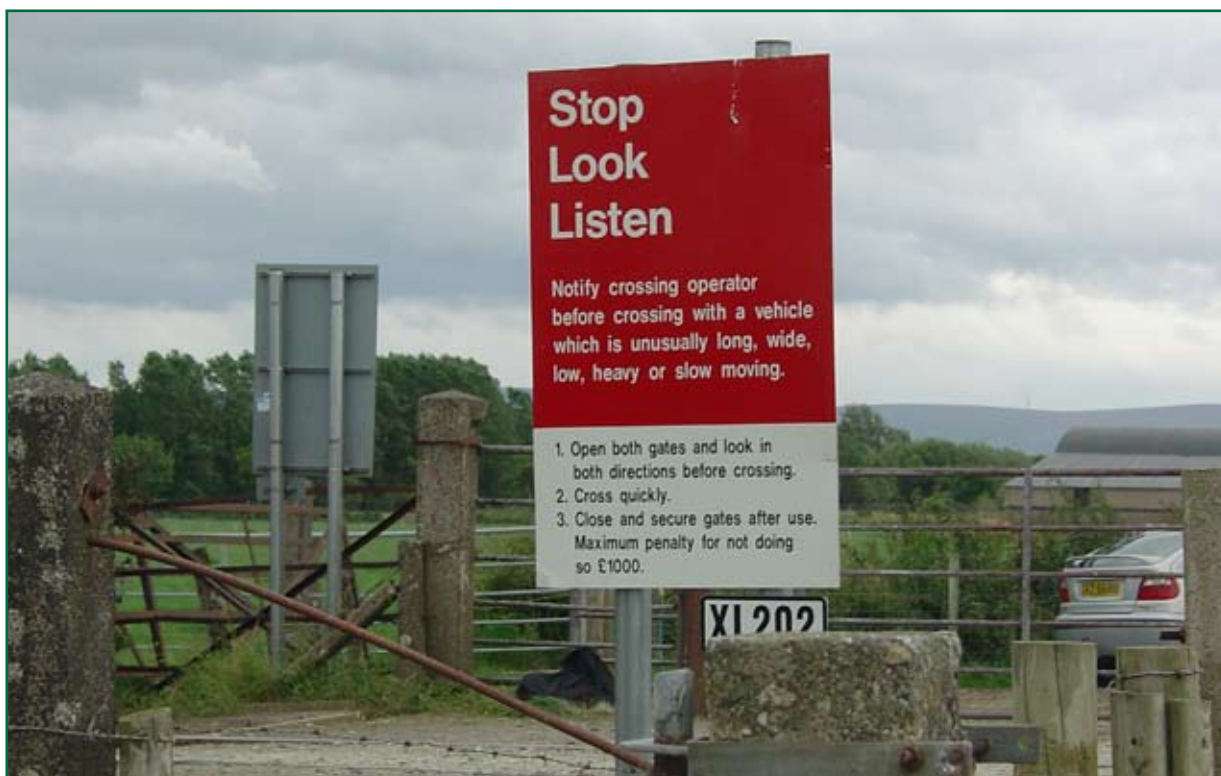
Figure 2: Signage at crossing XL202 (3 August 2007)

- 132 The existing sign does not include contact details for Castlerock signal box. In the event that a problem was encountered by a person not carrying the relevant telephone number with them, they would not know who to contact. A formal inquiry into a collision between a train and a car on a UWC at Woodtown (located nine miles east of crossing XL 202, between Bellarena and Castlerock) on 11 May 2004 recommended that NIR should review the signs at UWCs with one objective being to provide users with the most appropriate means of contacting the crossing operator.

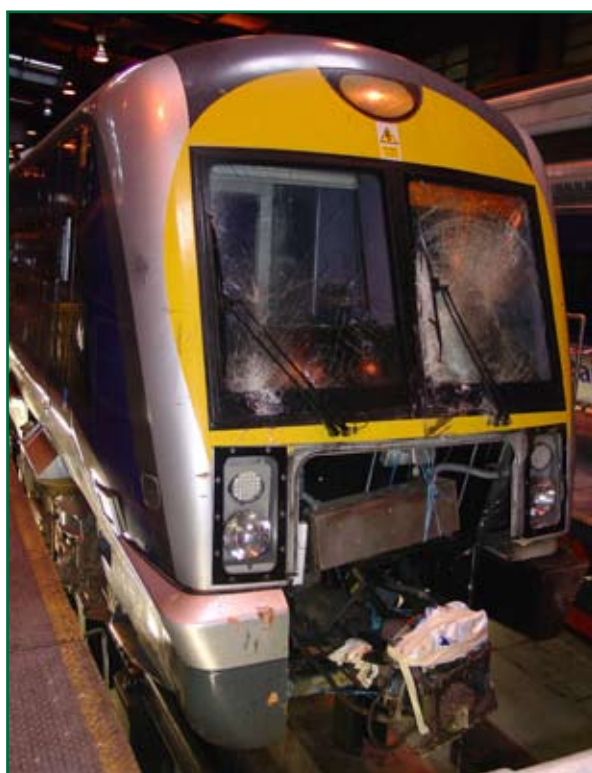
Figure 3: Damage to the front of unit 3014 (3 August 2007)

- 36 The tractor driver was thrown from the tractor on impact and suffered fatal injuries.
- 37 The train driver suffered shock and was taken to hospital.
- 38 The conductor and all the passengers were uninjured.
- 39 The tractor was destroyed in the accident.
- 40 The train was damaged during the collision (Figure 3). The damage affected the leading vehicle and comprised:
 - extensive distortion of the coupler;
 - damage to the panels on the front of the train;
 - both windscreens smashed (but the glass remained in the frame); and
 - various items of equipment dislodged, damaged or disconnected including flexible hoses and lighting boxes.

41 Following repair, the train returned to traffic on 7 September 2007.

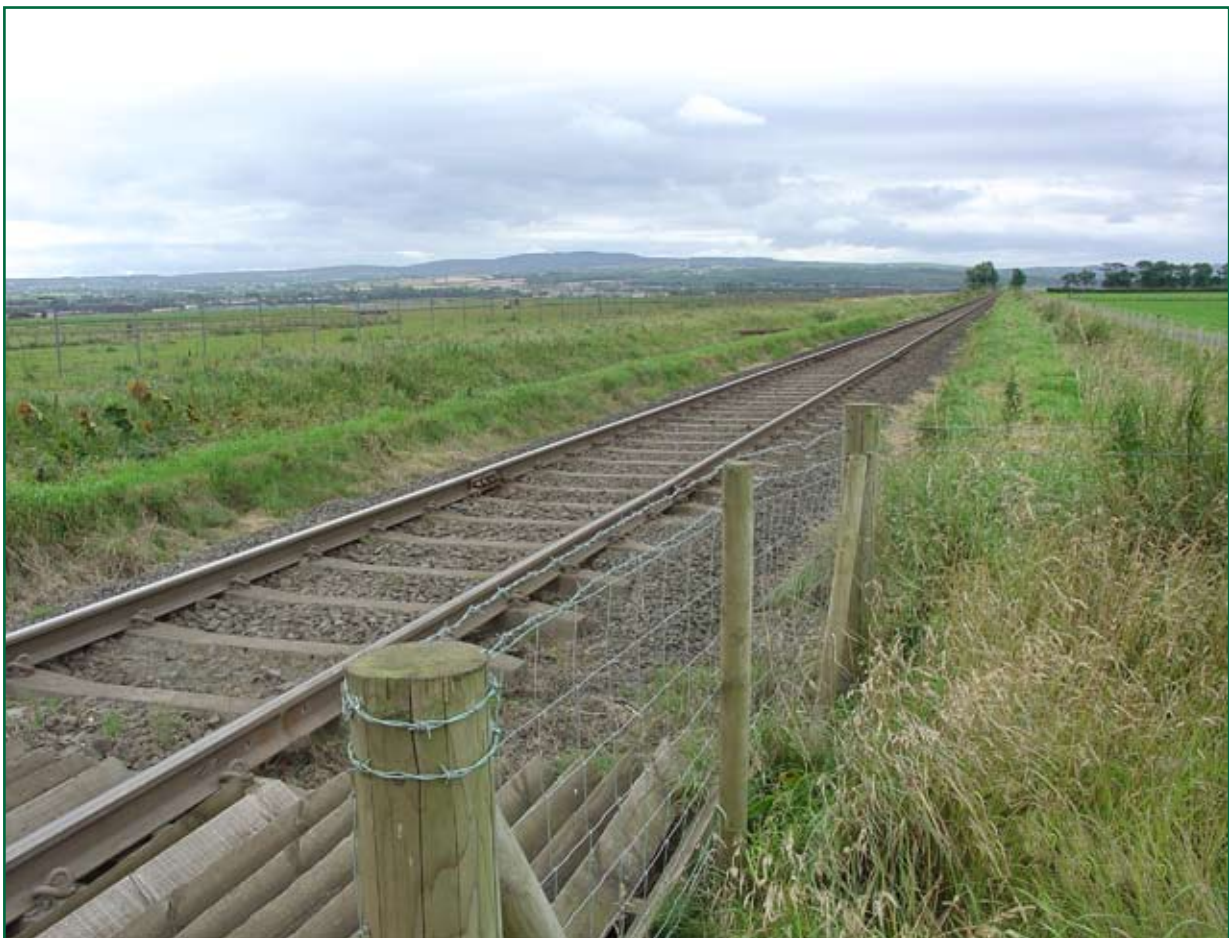
Figure 4: The view towards Londonderry from the north side of crossing XL202 (3 August 2007)

83 The signs at the crossing make reference to the need for users to look for approaching trains. For a tractor driver approaching the crossing from the north side, the view towards Londonderry is good, with no obstructions (Figure 4). The railway is straight at this point and affords a clear view over a significant distance (at least 1000 m) for a road user. The tree to the right of the line in Figure 4 is approximately 600 m from the crossing and train B413 passed the tree approximately 20 seconds before the collision occurred.

- 87 When approaching at right angles to the crossing on the north side, the only vegetation that could obstruct a tractor driver's view towards Londonderry was the tree located at 600 m and 20 seconds running time from the crossing (paragraph 83). Although a tractor driver's view of the train would have been partially obstructed before it passed the tree, the high intensity lights on the front of the train would have helped to improve its visibility to a road user before it reached that point.

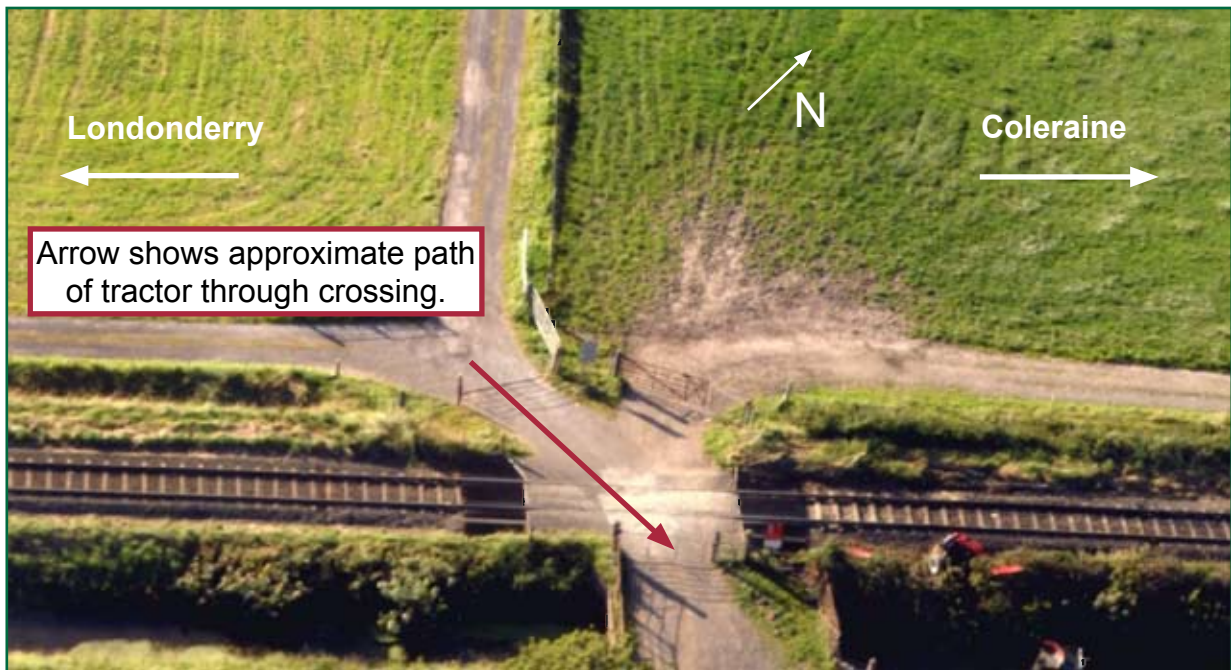
Figure 5: Aerial photograph of crossing XL202 showing 'dog-leg' (2 August 2007) (Photograph courtesy of PSNI)

- 88 When the roadway is running at right angles to the crossing, the tractor driver has a good view of trains approaching from the right. However, just before the crossing is reached, the roadway went through a 'dog-leg' (Figure 5). The gates on either side of the crossing were not directly opposite each other and the tractor driver crossed at an angle to the railway.

- 89 When crossing at an angle, the tractor driver's view to the railway on the right could have been affected by the tractor's roof support pillar when the tractor driver was sitting upright in the seat. This would have started to occur just as the tractor was approaching the railway (approximately three seconds before it reached the point where conflict with the train was inevitable and approximately six seconds before the time when impact occurred) and continued until the time of impact. The presence of the roof support pillar may have impeded the tractor driver's peripheral vision, preventing him becoming aware of the train until it was too late. Even if he had glanced quickly to his right, the presence of the pillar and the bright sunlight coming in through the tractor's right-hand window may have combined to make seeing the approaching train difficult.

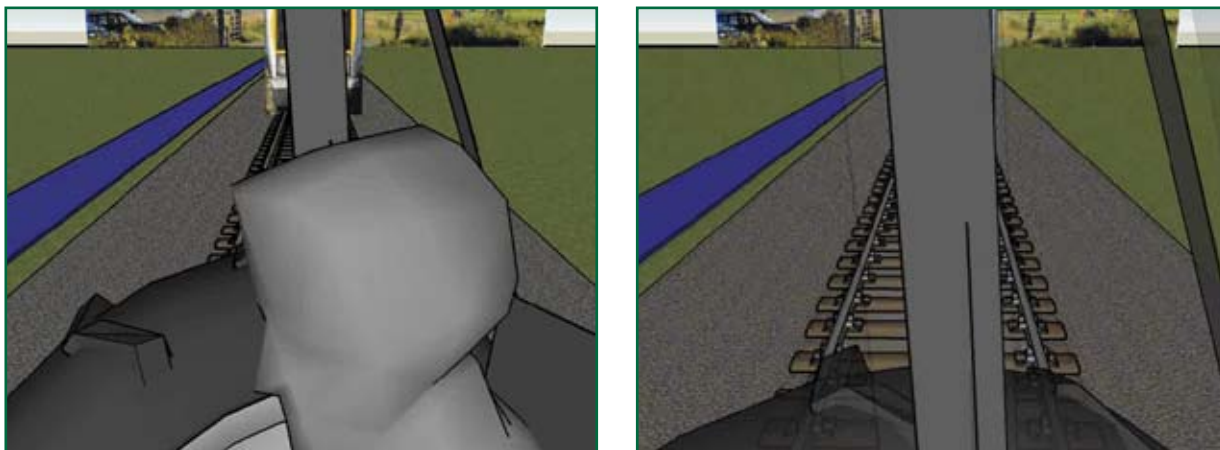
Figure 6: Graphic showing the possible effect of the roof support pillar on a tractor driver's vision at Crossing XL202

90 Figure 6 illustrates the possible problem caused by the roof support pillar when the train is 19 m from the crossing and is based on the design and dimensions of the model of tractor involved in the accident and the dimensions of the Class 3000 DMU. The left-hand graphic shows the position of the tractor driver sitting upright in his seat with the train located 19 m from the crossing, while the right-hand graphic provides an indication of the peripheral vision available to the tractor driver in equivalent circumstances, and shows the roof support pillar obstructing the view of the approaching train. The skewed nature of the crossing, in conjunction with the position of the roof support pillar on the off side of the tractor are possible contributory factors for this accident.

- 91 The position of the sun and the effect of the roof support pillar on the tractor driver's vision may help to explain why he was not alerted to the presence of the train as he drove through the dog-leg. However, the train was clearly in view for at least 20 seconds before the accident occurred. The RAIB considers that the most likely explanation of why the tractor driver did not see the approaching train before he reached the dog-leg at the approach to the crossing is because he did not look for it.
