Rail Accident Investigation Branch

# Rail Accident Report

**Minor collision between an engineering unit and  
two manual trolleys near St. John's Wood  
25 October 2007**

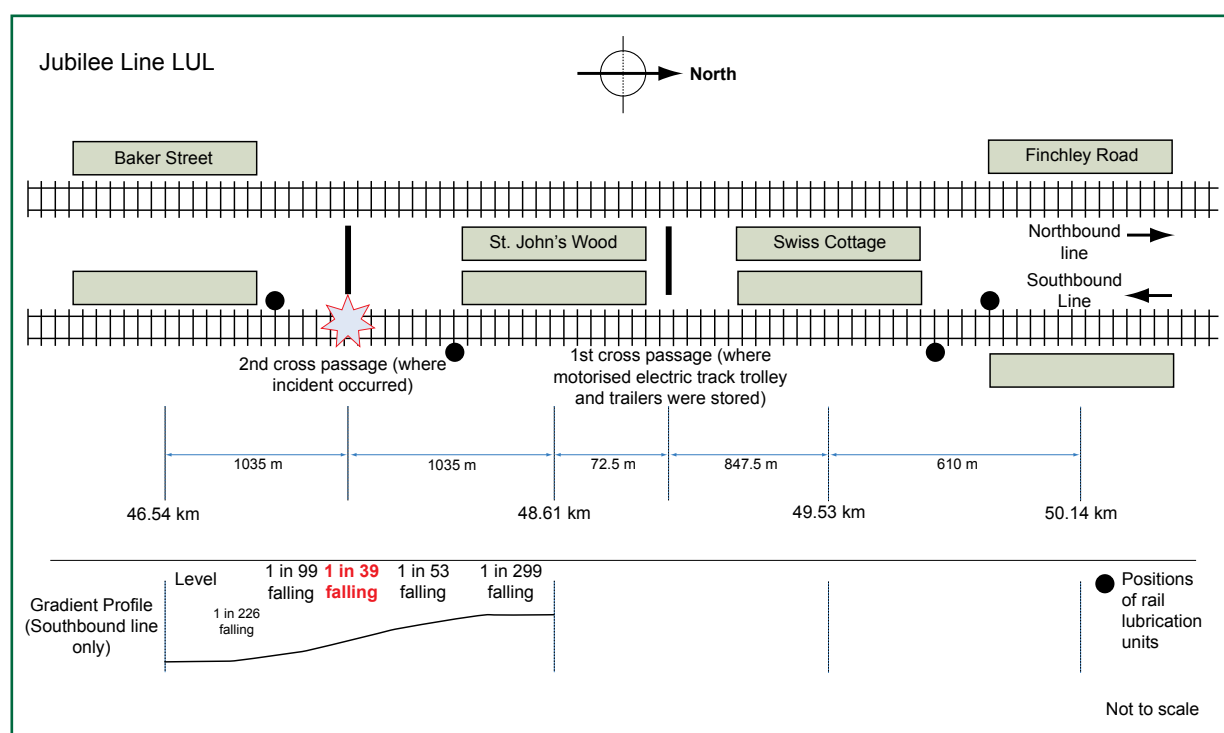
- 11 At 02:40 hrs on 25 October 2007, an engineering unit (consisting of a motorised electric track trolley carrying four persons and two loaded trailers) being used in connection with engineering works on the Jubilee Line of London Underground failed to slow down at the rate the driver expected. The engineering unit was travelling at approximately 10 mph (16 km/h) from St. John's Wood station towards Baker Street station on the southbound line, which was on a 1 in 39 falling gradient. See Figure 2.

Figure 2: Diagram of the location showing incident on the southbound line. Both lines are in tunnel

- 21 The railhead was dry, but there was some grease on and around the railhead. There are four *rail lubrication units* installed between Finchley Road and Baker Street stations on the southbound line (see Figure 2). Grease is provided through these rail lubrication units connected to the rail (usually in the vicinity of curves) to prevent excessive wear to the wheels and rail and to prevent *flange climb*.

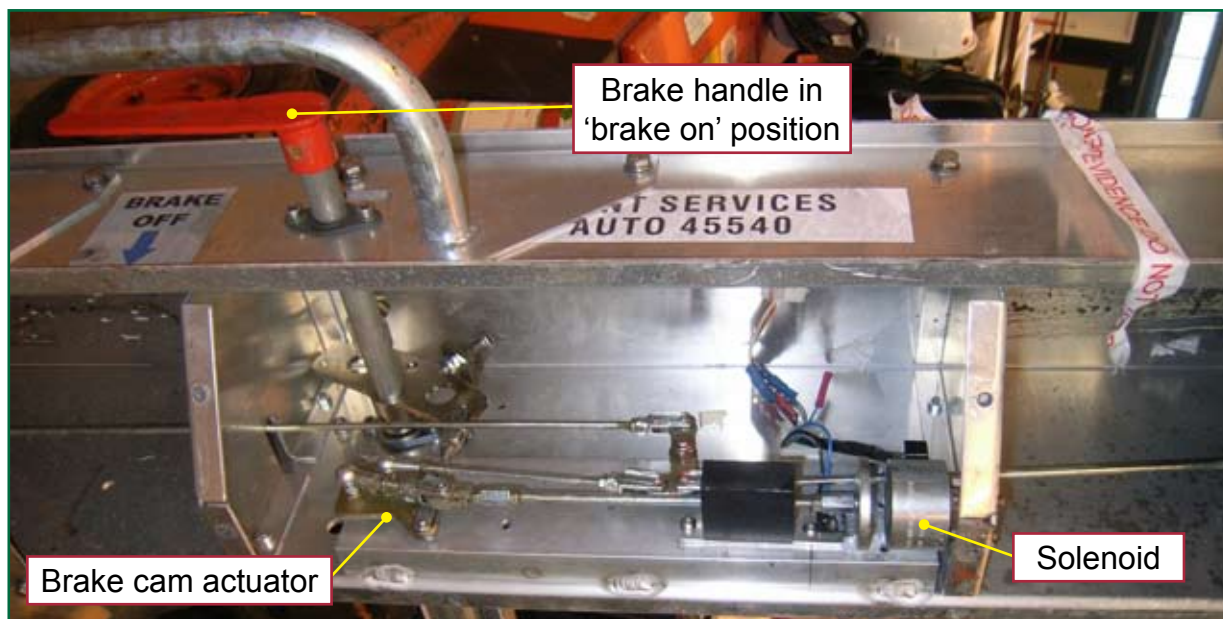
68 Each trailer has combined parking and emergency braking in the form of spring applied shoe brakes (one per wheel). These brakes are initially placed in the 'off' position by the Track Trolley Operator moving the brake lever to the 'brake off' position while the brake release function from the electric track trolley is active. The release function energises an electrical solenoid on the trailer which holds the brakes off. The brakes are automatically applied if either (a) the ignition on the electric track trolley is switched off, (b) the emergency stop button is operated or (c) the electrical connection between the electric track trolley and the trailer is broken i.e. in each case the solenoid is de-energised. A photograph of the braking system in its 'brake on' position is shown in Figure 7.

Figure 7: Trailer side showing brake system with brake on and solenoid de-energised

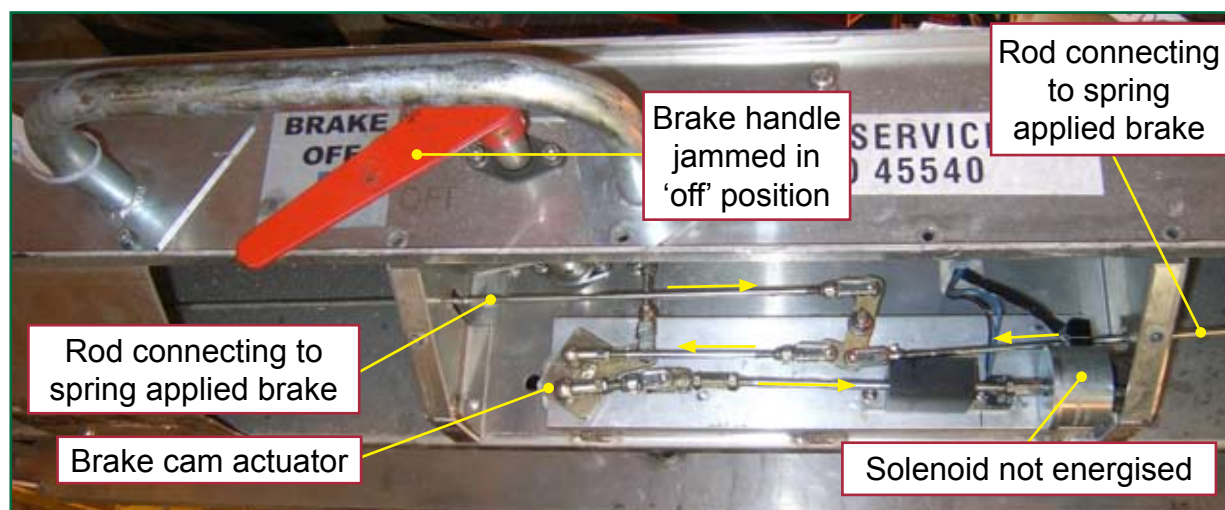
- 131 On examination of trailer ACT795735, it was found that the brakes could be jammed in the off position by the operation of the brake handle. This happened intermittently and the brakes would operate if the brake handle was lightly touched or the trailer was knocked by a person's hand.
- 132 Tests were undertaken including the step by step dismantling of the braking system to ascertain what particular component was causing the brakes to jam in the off position. Figures 10 and 11 show the brake system in the jammed position.

Figure 10: Trailing side showing brake handle and brake cam actuator with connecting rods in jammed position

- 133 No individual component was identified as the cause of the jamming. However, the system was sensitive to the angle of the brake rods connected to the brake cam actuator and its turning moment. The number and thickness of washers in the assembly appeared also to have an affect on the operation, although when these were altered, jamming of the brakes would still occur under some conditions.
- 134 Following reassembly of the braking system in accordance with the Consillia MTRL-1 Build Manual (ref 19/5/2007-iss 2) and measurements taken prior to dismantling, oil was applied to the moving parts of the braking system. This caused the brakes to operate more reliably although jamming in the off position was still observed occasionally.

- 1 Consillia Ltd should undertake a review of the design of the braking system on its MTRL-1 trailers. The purpose of the review shall be:
  - to determine sensitivity to the initial set-up, adjustment, lubrication and subsequent mechanical damage; and

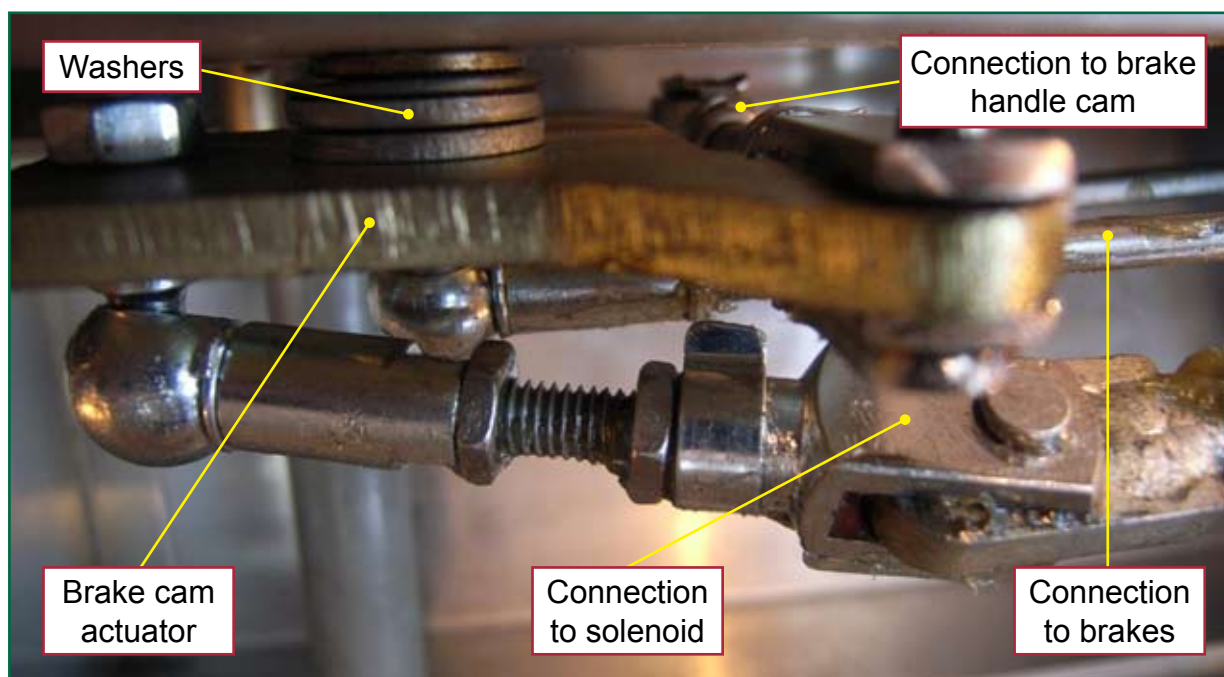
Figure 11: Detailed view of brake cam actuator with washers and connecting rods and clevis

135 Tests were also undertaken using updated set-up values from Consillia<sup>5</sup> and it was found that the jamming of the brakes in the off position would still occur intermittently. The brakes were then re-assembled to their original configuration and the brakes could not then be jammed in the ‘off’ position.
