Rail Accident Investigation Branch

# Rail Accident Report

**Derailment of a freight train near Stewarton,  
Ayrshire  
27 January 2009**

Report 02/2010  
February 2010

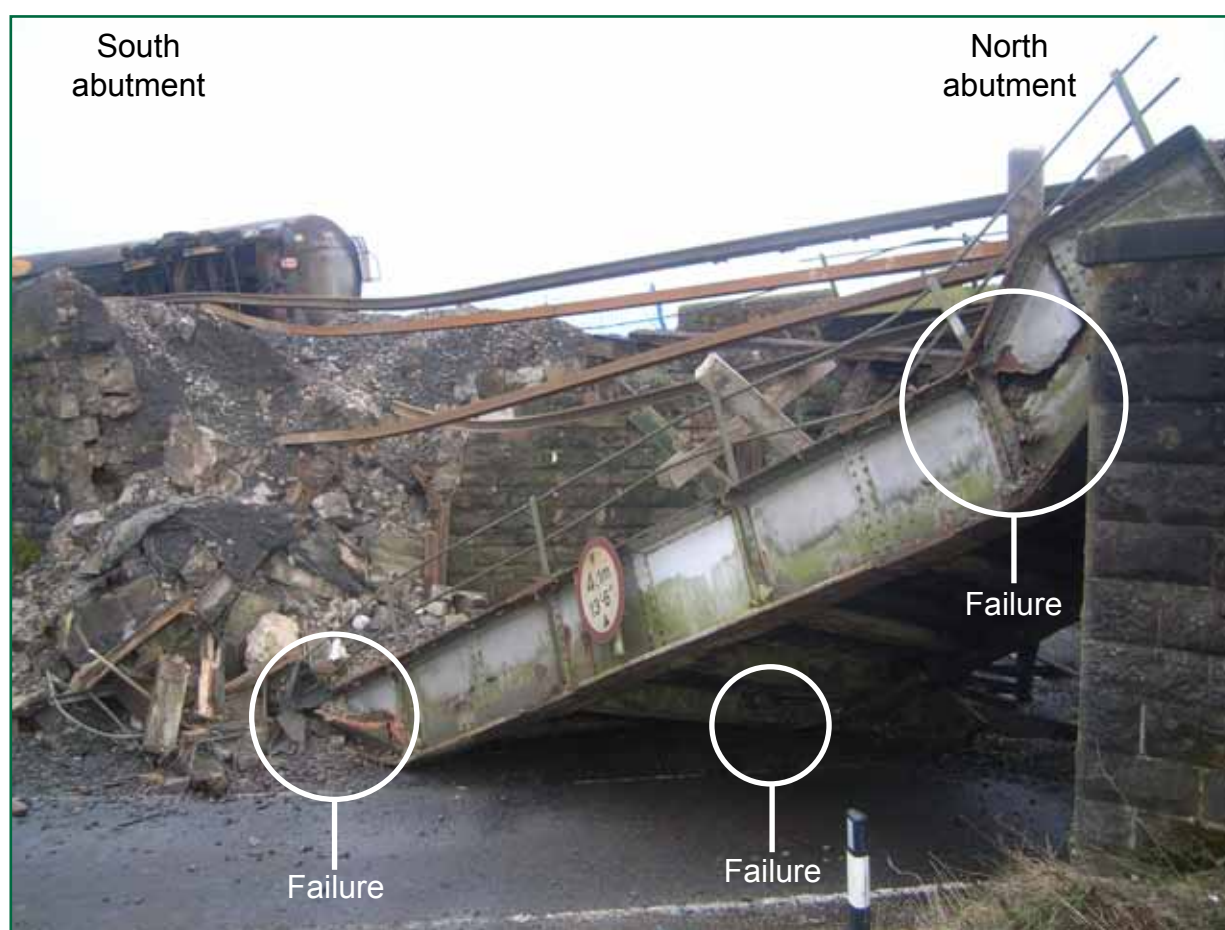
- 13 The main girders that supported the east side of Bridge 88 failed and fell to the A735 road below, together with other debris and masonry from the south *abutment*, a major part of which was destroyed.

Figure 9: Bridge 88 after the derailment - east side (reflective yellow and black hatching road sign has been removed to reveal the condition of the east main girder)

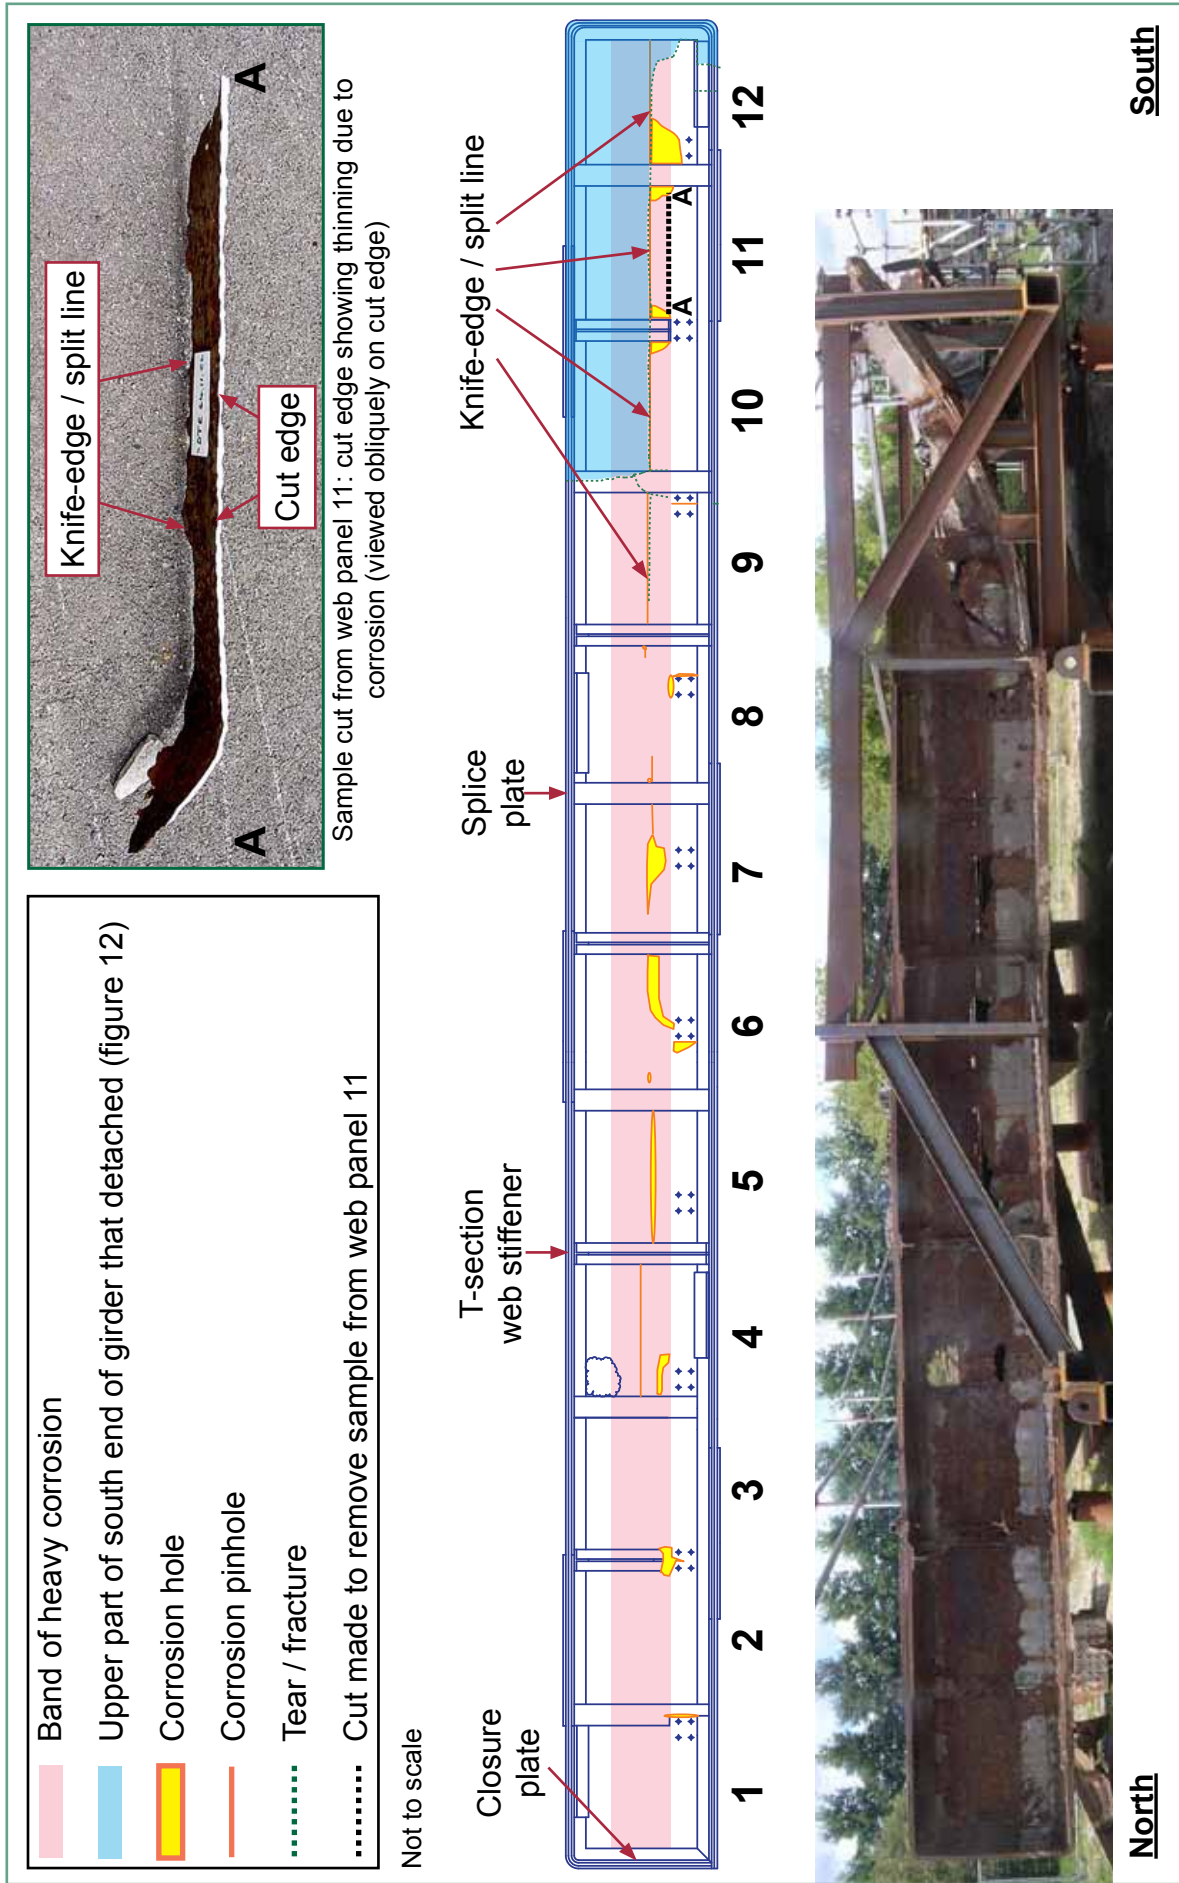
Figure 10: Condition of the centre main girder. Inset shows sample cut from web panel 11 (Note: due to the damage that occurred as a result of the bridge collapse and the limitations in recording the nature of the corrosion, the shape and size of the defects are shown for illustrative purposes only)

- 103 The horizontal band of heavy corrosion affected both surfaces of the centre main girder web plate - there was material loss throughout its length. At mid-span, web panels 4 to 7, the corrosion was so severe that significant holes had formed. At the south end, the web thickness had reduced to a knife-edge that extended along a horizontal line, at mid-height, from the centre of web panel 9 through to panel 12. Pinhole-like perforation had occurred along the knife-edge and both panels 11 and 12 had holes in them. The key features of the centre main girder condition are illustrated in figure 10. The inset shows a sample cut from the web plate at panel 11. It is from just below the horizontal knife-edge line and illustrates the thickness reduction that had occurred.

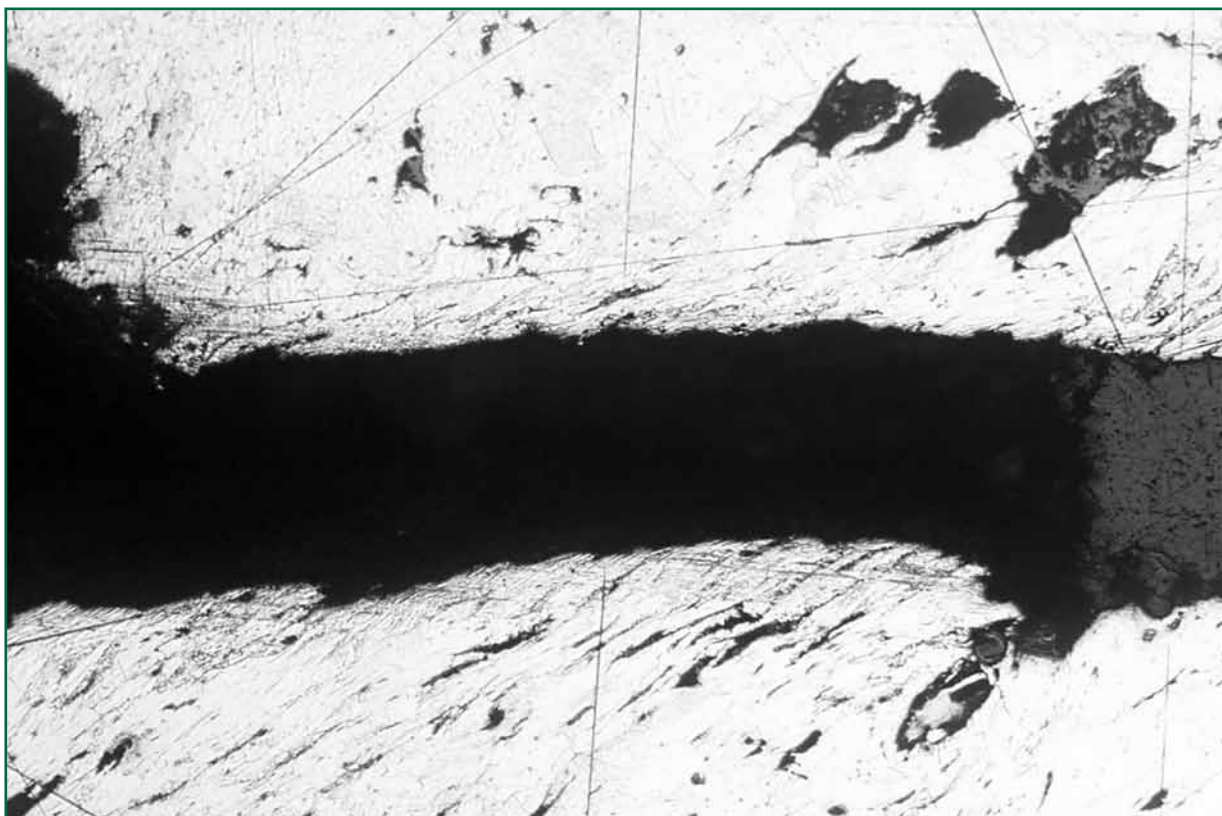
- 107 The failure at the south end of the centre main girder was of particular interest. Here, the girder had split along the horizontal knife-edge line (paragraph 103), and a section, comprising the upper parts of web panels 10 to 12, became detached (figure 10). One of two samples taken from this interface showed evidence of slip, of a microscopic scale, along this line (figure 11). This indicates that horizontal movement had been occurring along the split, and therefore that the web plates were no longer carrying the shear stresses required for the upper and lower parts of the I-beam to work together as a single effective structural member.

Figure 11: Micro-section through the mating surfaces along the knife edge line that had formed on the web plate on the south end of the centre main girder - sample taken from web panel 11

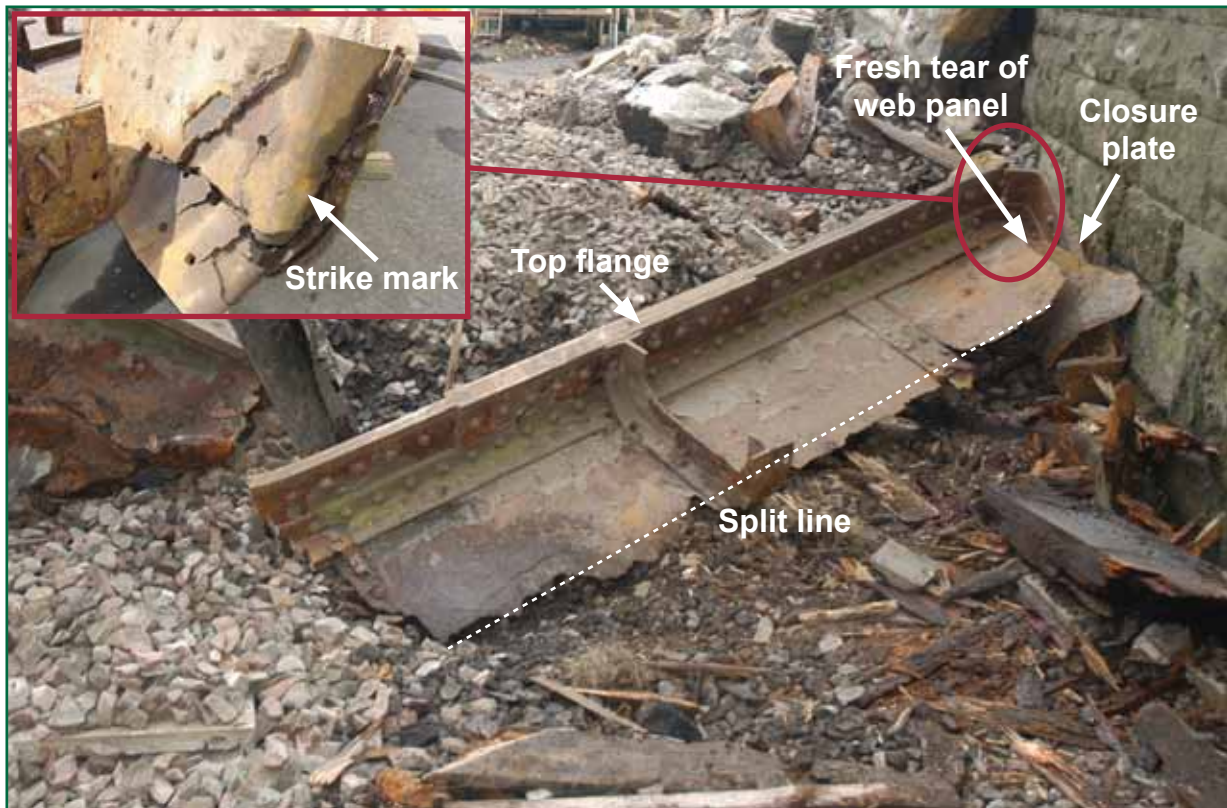
108 On the section that detached, the *closure plate* (the vertical plate at the end of the girder) had folded to form an acute angle with the top flange. To accommodate this, the web tore to the upper corner, and the outer layers<sup>11</sup> of the flange fractured and parts broke off (figure 12). There was a strike mark on the flange material freshly exposed by this de-layering that was consistent with impact from the train (figure 12 inset); there was no corresponding mark on the part that broke off. This supports the scenario of the flange fracturing suddenly, and while the girder was still in an elevated position - exposed to the passing train. The folding is therefore unlikely to be a consequence of the girder falling and then hitting the road. It is, however, consistent with upper and lower parts of the beam flexing independently, because the web plate could not carry the required shear stress, and then the flanges, suddenly having too much load transferred to them, fracturing, resulting in catastrophic failure. There was no evidence to indicate failure due to pre-existing fractures on the flanges – for instance, due to *fatigue* crack growth.

Figure 12: Upper part of the south end of the centre main girder showing the horizontal split line, the folded closure plate and fractured flanges (main photograph courtesy of British Transport Police)

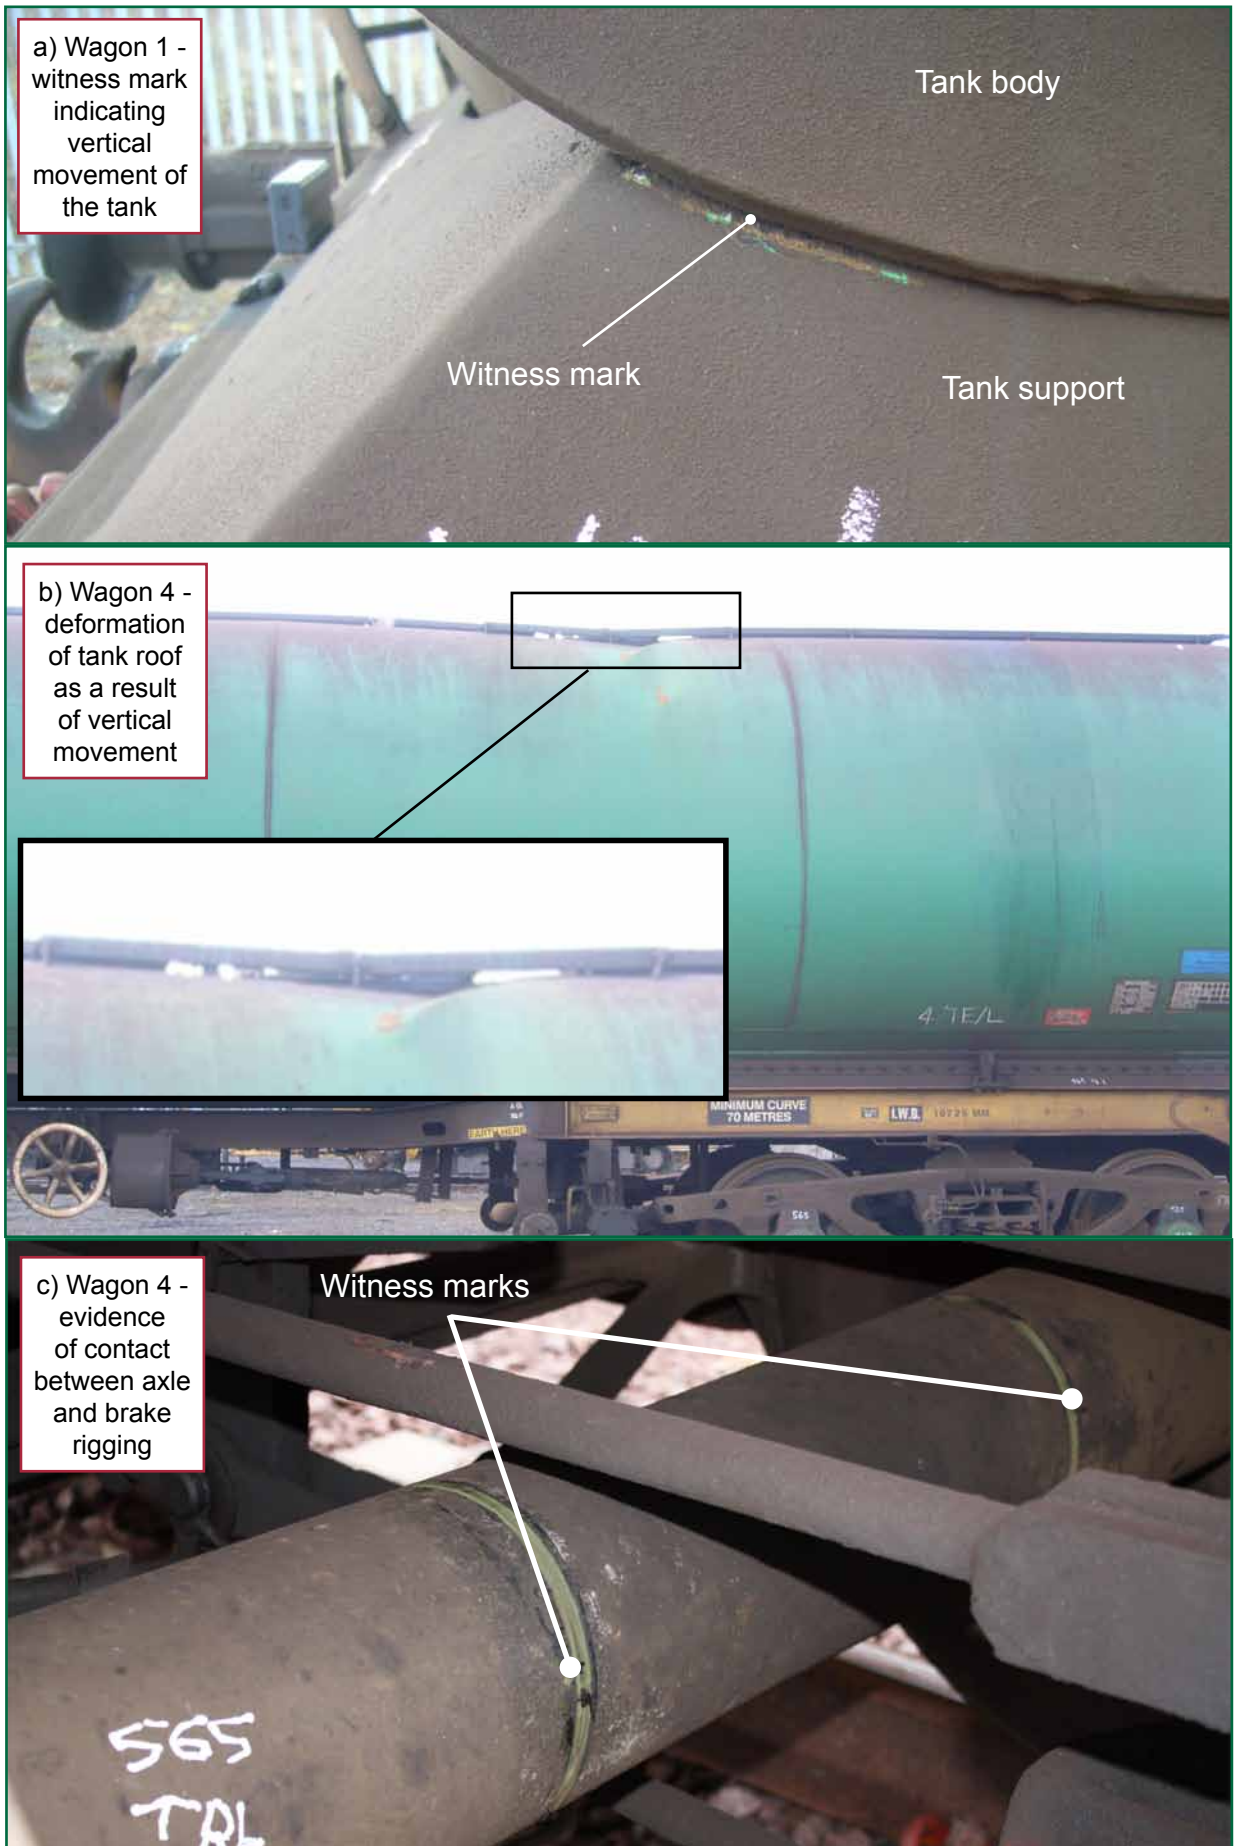
Figure 14: Witness marks and damage on the wagons that did not derail

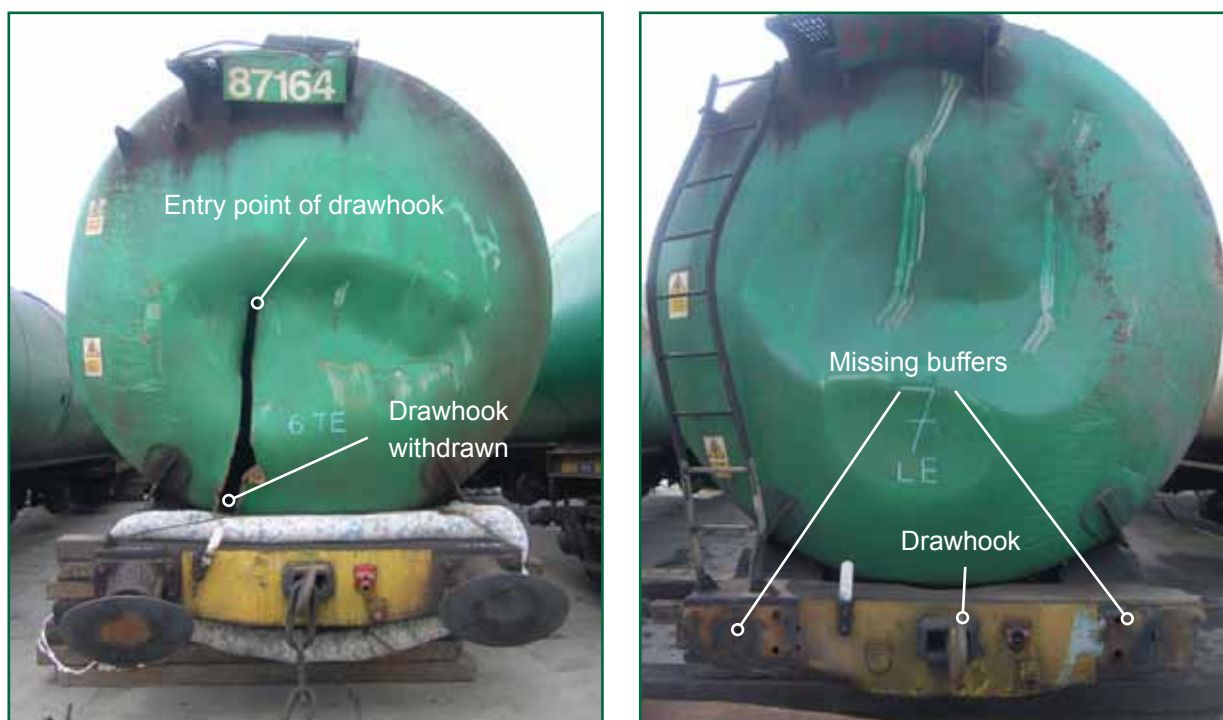
Figure 15: Vertical gash on the tank of wagon 6 (left) caused by the adjacent drawhook on wagon 7 (right)

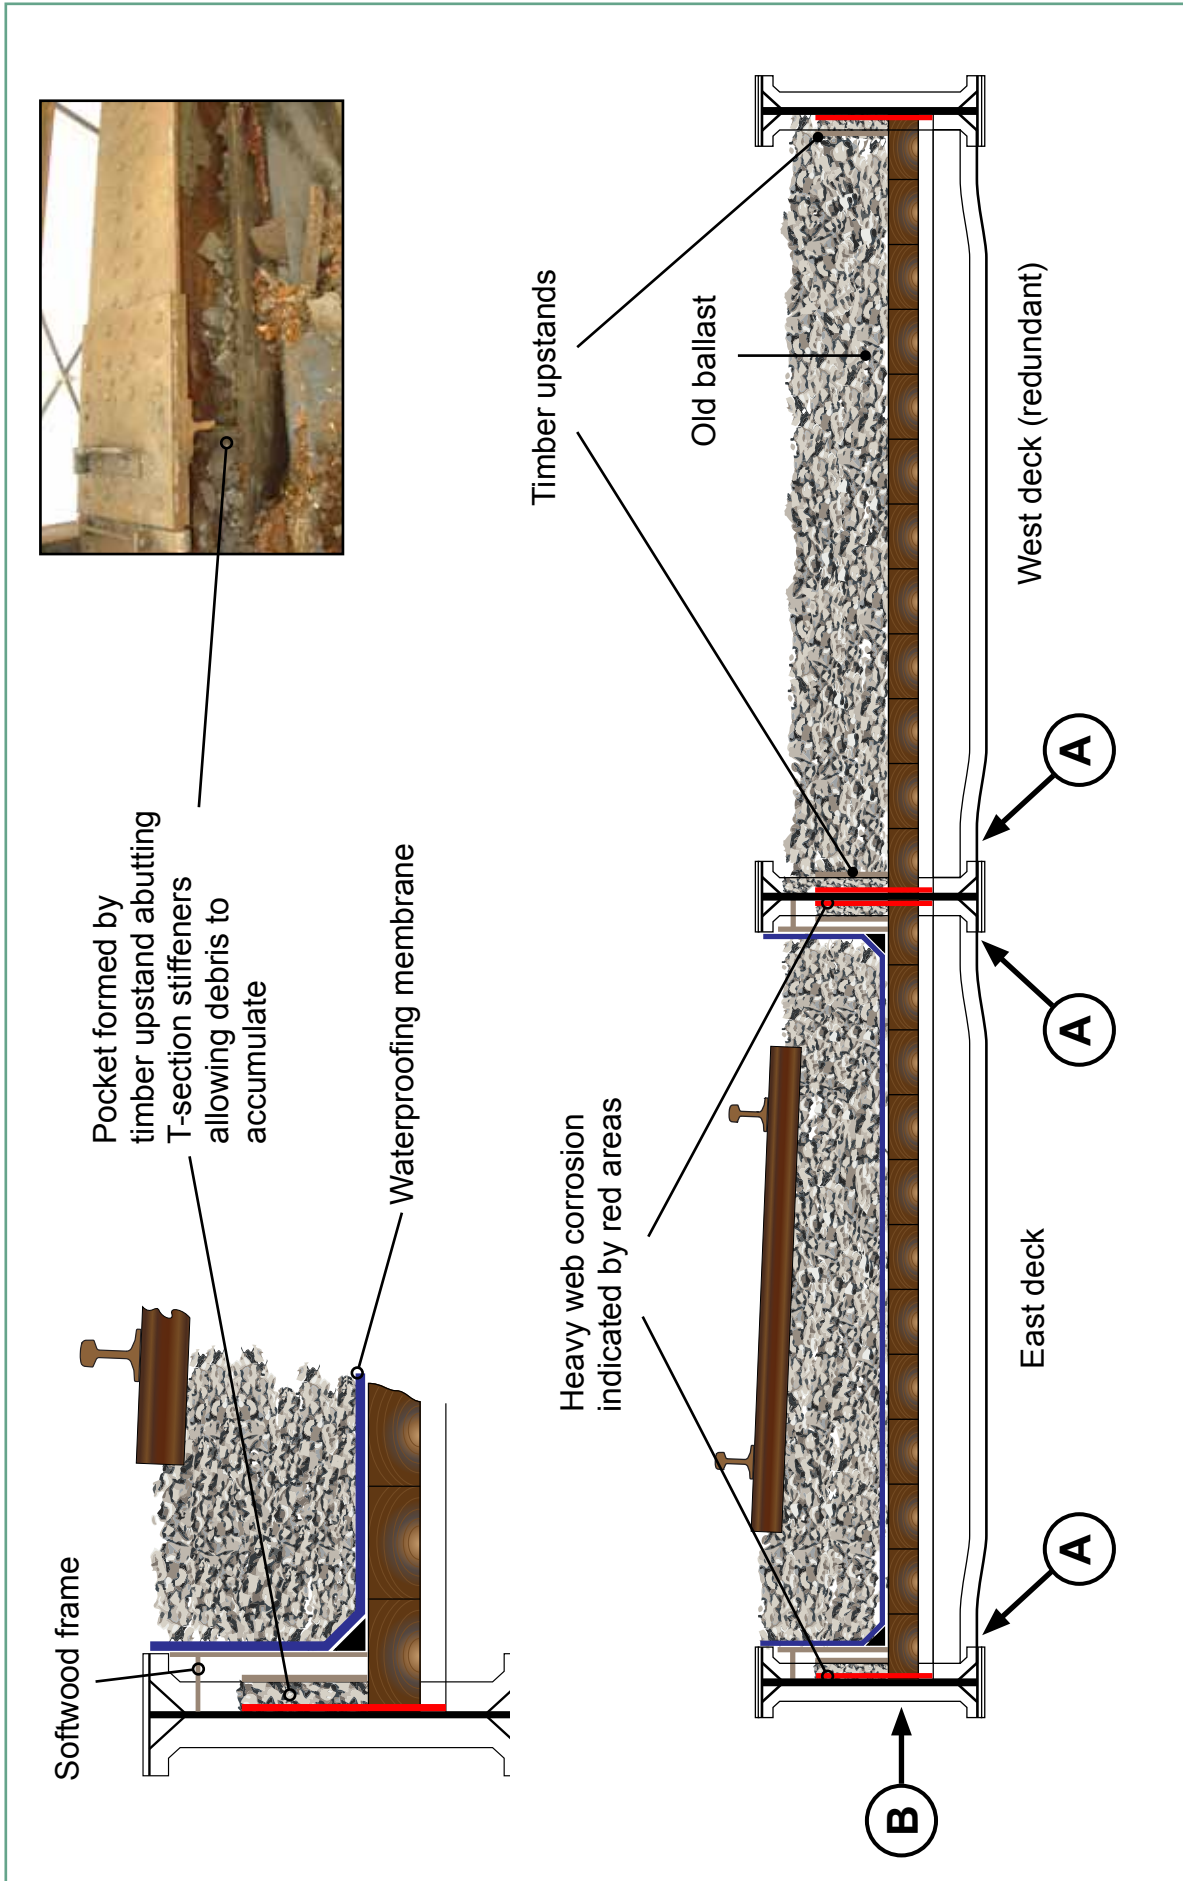
Figure 16: Cross-section of Bridge 88 showing areas of debris accumulation and heavy web corrosion

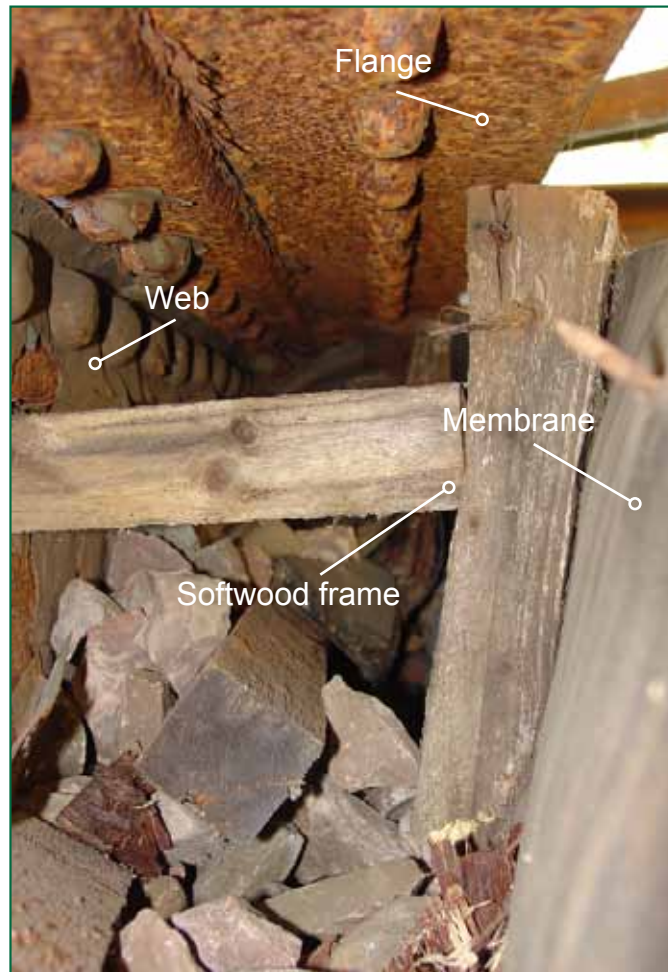
130 The membrane, therefore, effectively sealed in the LMSR timber upstands, the moist debris and the band of heavy corrosion. The photograph in figure 18, taken during dismantling, is a view behind the membrane fitted to the centre main girder – so much ballast had accumulated that the timber upstand is buried. There was no provision in the design or installation of the waterproofing arrangement to facilitate inspection of this critical area.

Figure 18: Accumulated ballast and debris found behind the waterproof membrane of the centre main girder

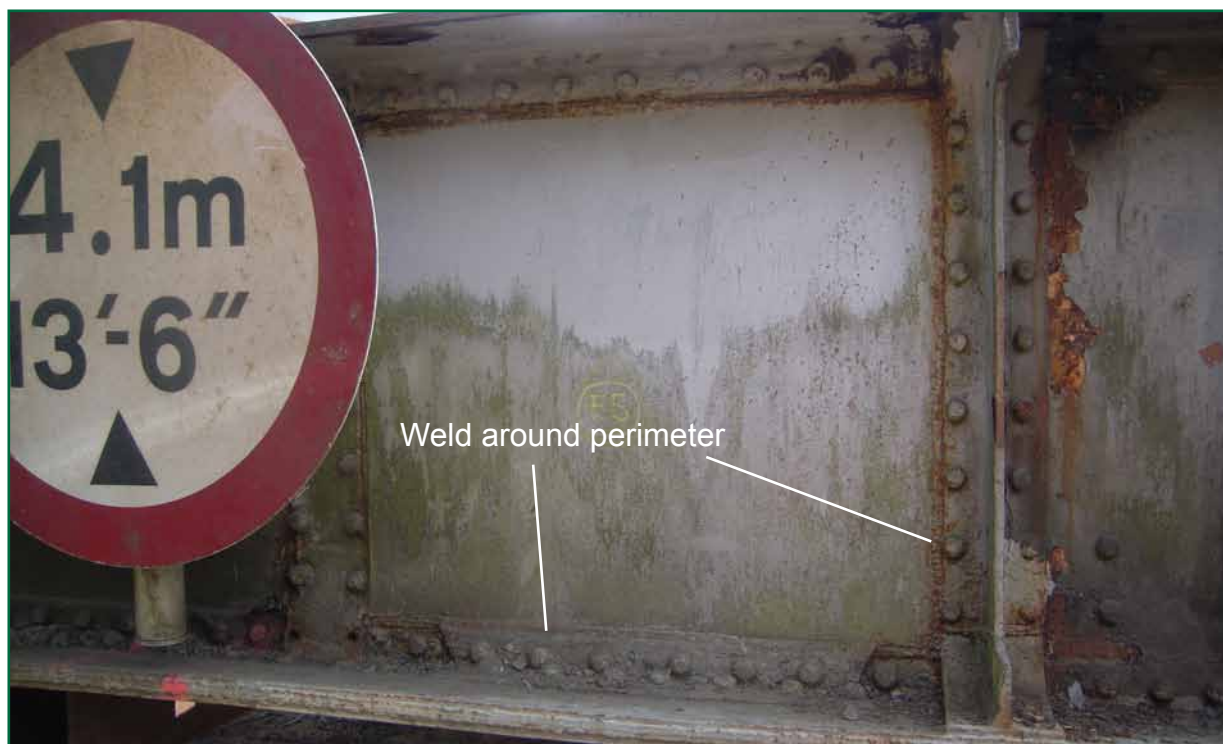
Figure 19: Repair plate welded to web panel 5 of the east main girder

147 The RAIB's survey of Bridge 88 found that web repairs had been considered necessary in the past. Web panels 1, 5, 10 and 12 of the east main girder all had steel repair plates welded to their external surface:

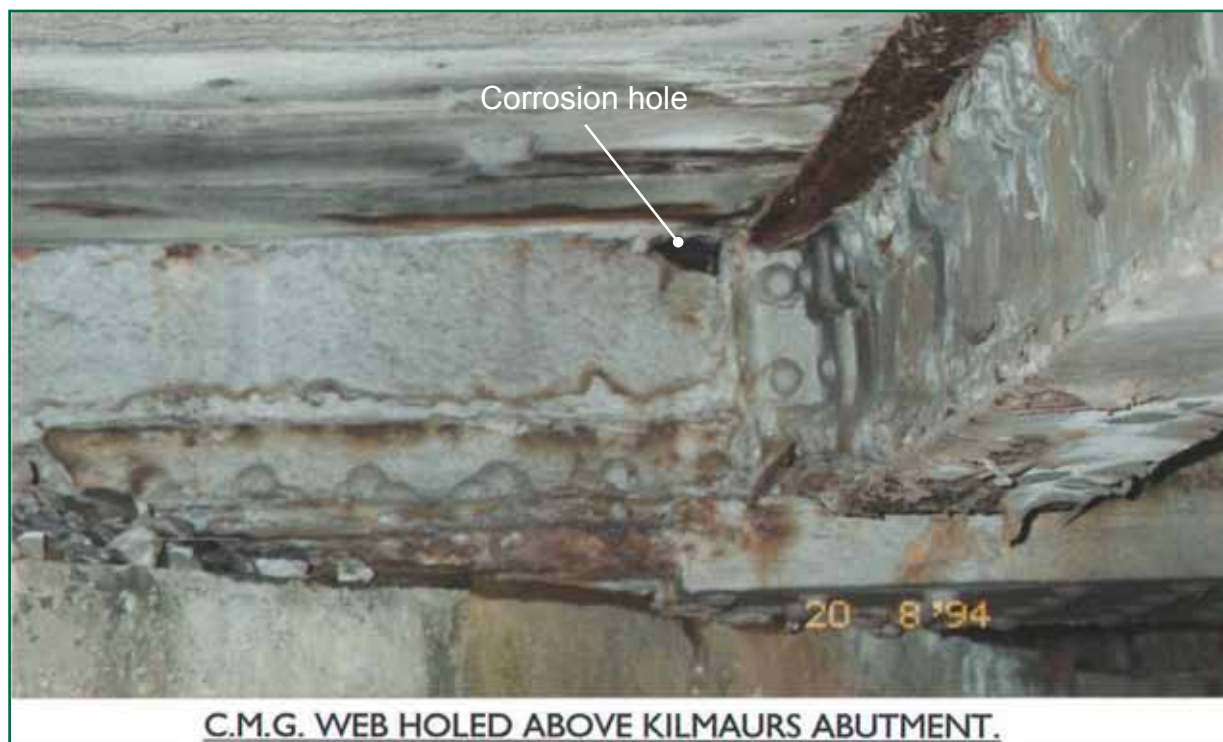
Figure 21: The web plate corrosion hole at the south end of the centre main girder that was illustrated in the 1994 Assessment report (photograph courtesy of Network Rail)

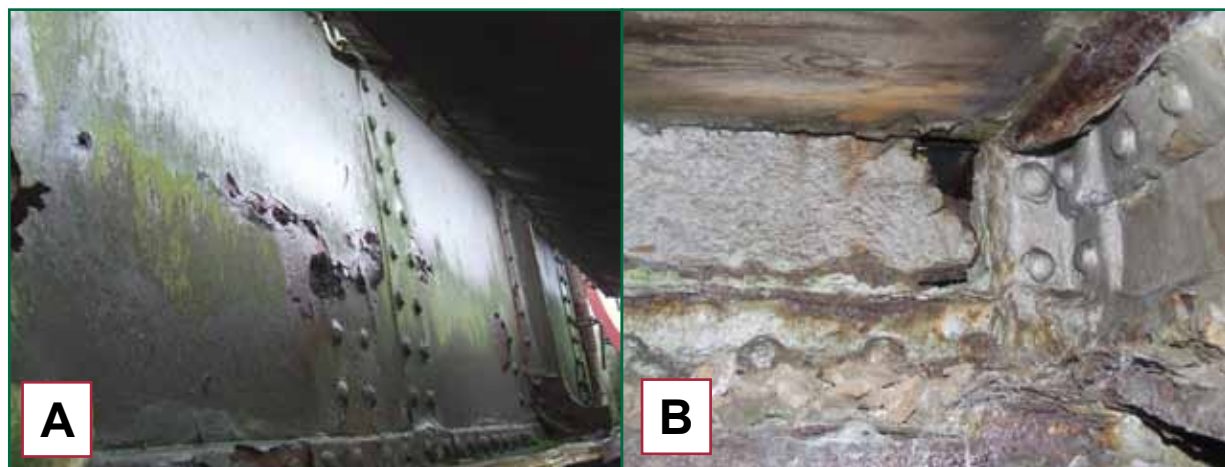
Figure 23: Photographs of web corrosion from the Inspection for Assessment undertaken 27 November 2007 (photographs courtesy of Network Rail)

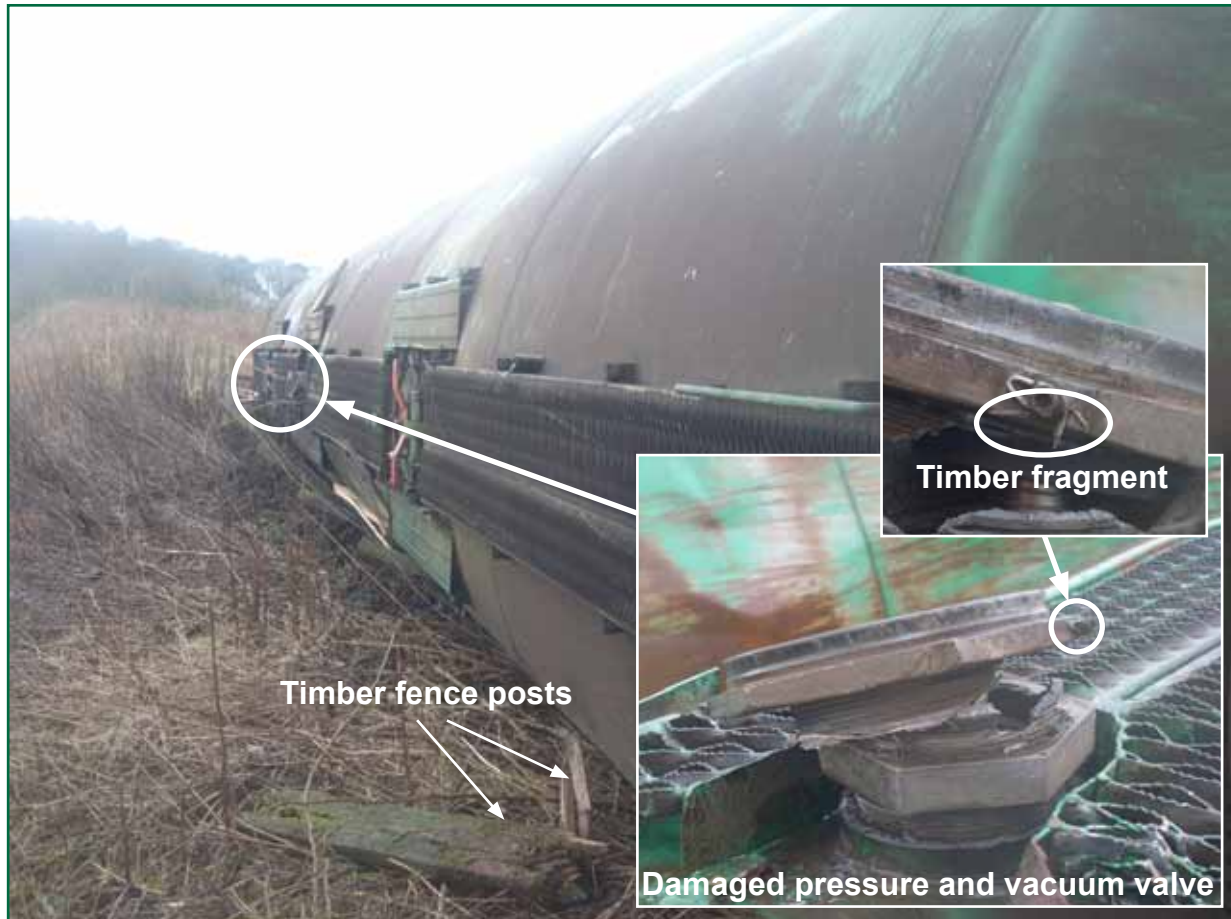
237 Two pressure and vacuum valves are mounted on the top of each wagon, and the rearmost valve on wagon 7, a TEB tank wagon, was severely damaged. The valve's head was pushed back causing the valve body to be torn open around its threaded section. There was evidence that it had struck a timber post from the railway boundary fence (figure 24). All of the fuel lost from wagon 7 leaked from the broken valve.

Figure 24: Damaged pressure and vacuum valve on wagon 7

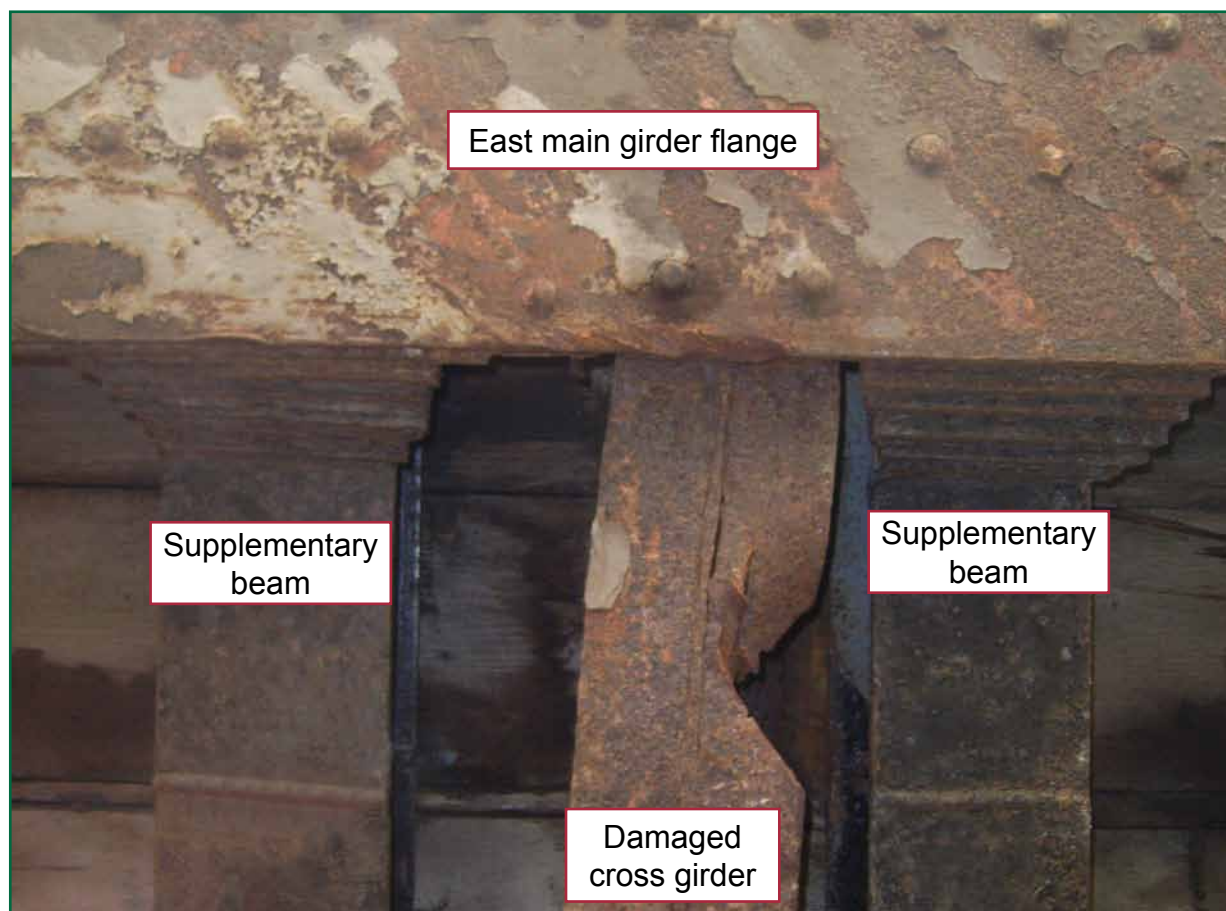
On the east side of the deck, one of the cross girders had been replaced in the past (date not recorded). Two other cross girders on the east side, whose bottom flanges were badly torn by a strike incident, had supplementary steel beams inserted each side of them. Records show the supplementary beams were installed in January 2004, probably in response to recommendations arising from the routine structures management process (paragraph 187) The RAIB found the repair work was intact when it surveyed the bridge (figure F1).

Figure F1: Repair done in 2004 to supplement cross girders damaged by vehicle strikes

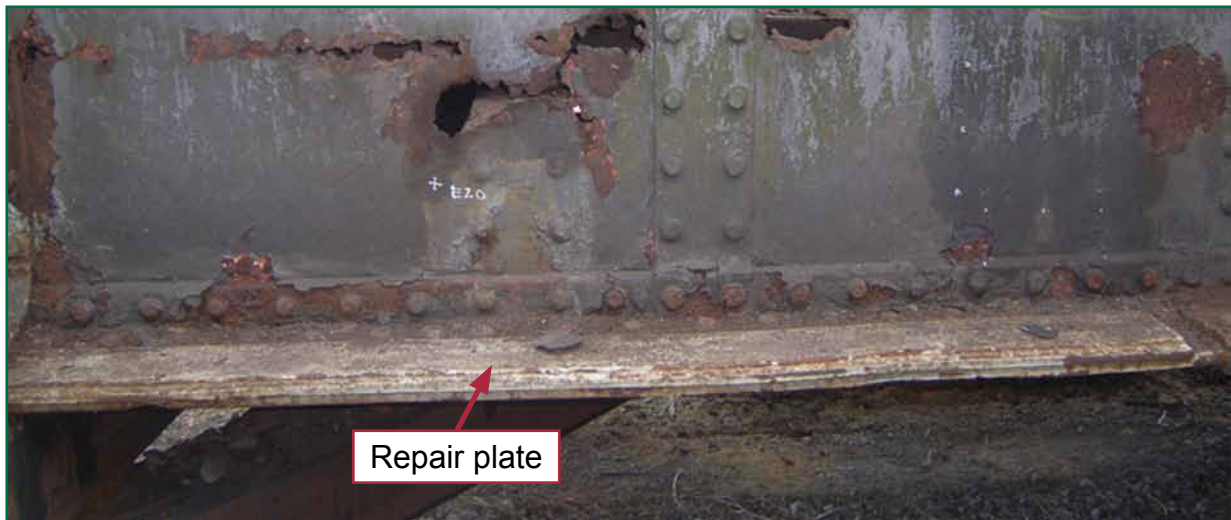
Figure F2: Repair to bottom flange of the east main girder

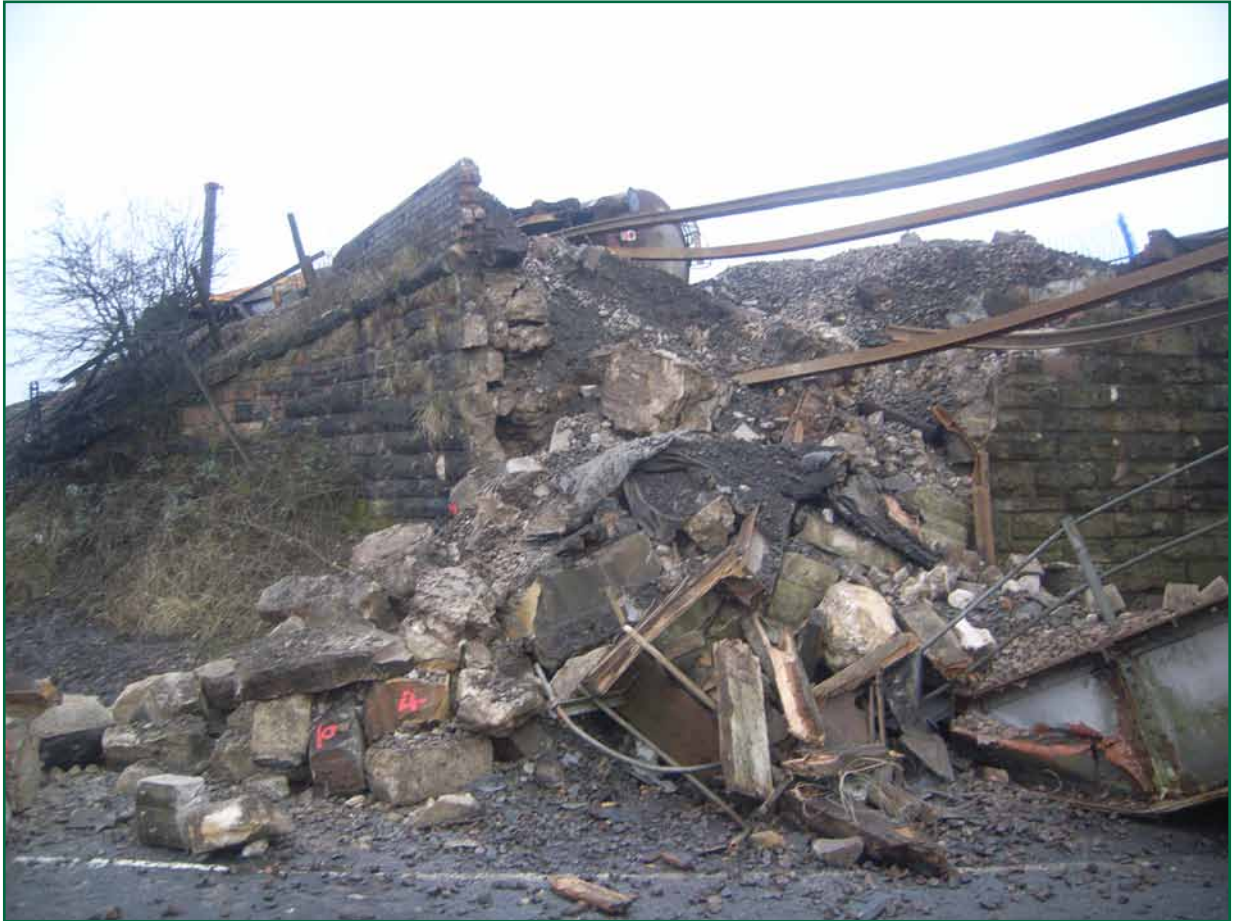
*Figure F4: Photograph of debris from failed south abutment*

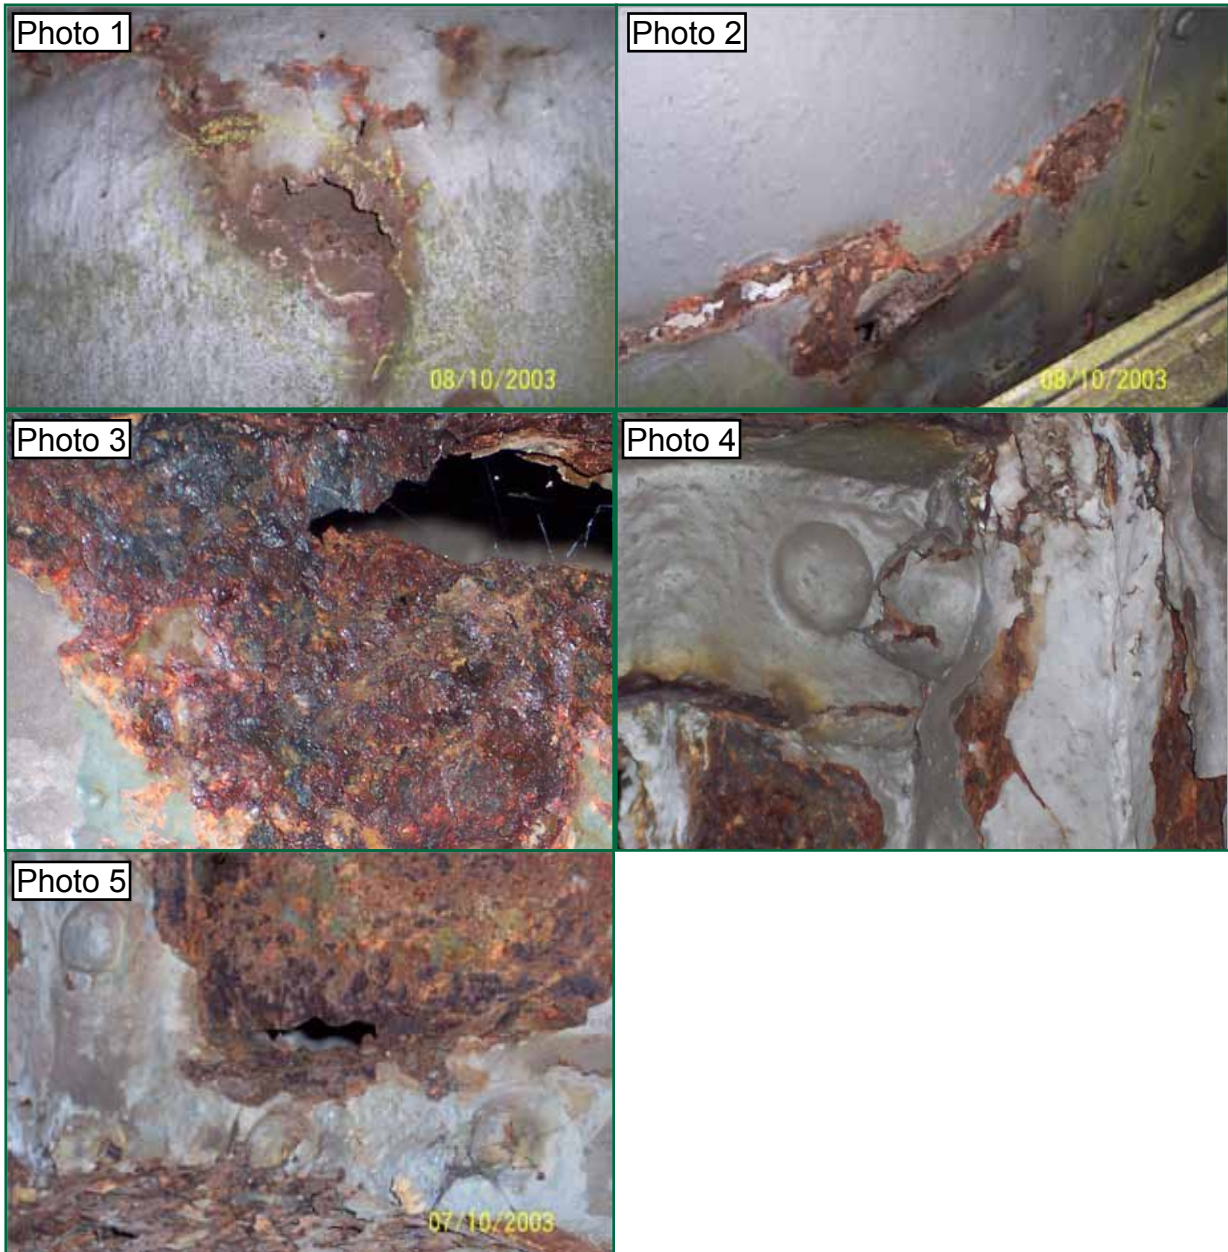
SEVERAL CROSS GIRDERS SHOW ISOLATED HOLES IN WEB AT ENDS NEXT TO CONNECTIONS TO MAIN GIRDERS. PHOTO 3 + 4 + 5.

Figure G1: Photographs from Atkins urgent defect report (photographs courtesy of Network Rail)
