Rail Accident Report

**Collision between an articulated tanker and a passenger train at Sewage Works Lane user worked crossing, near Sudbury, Suffolk
17 August 2010**

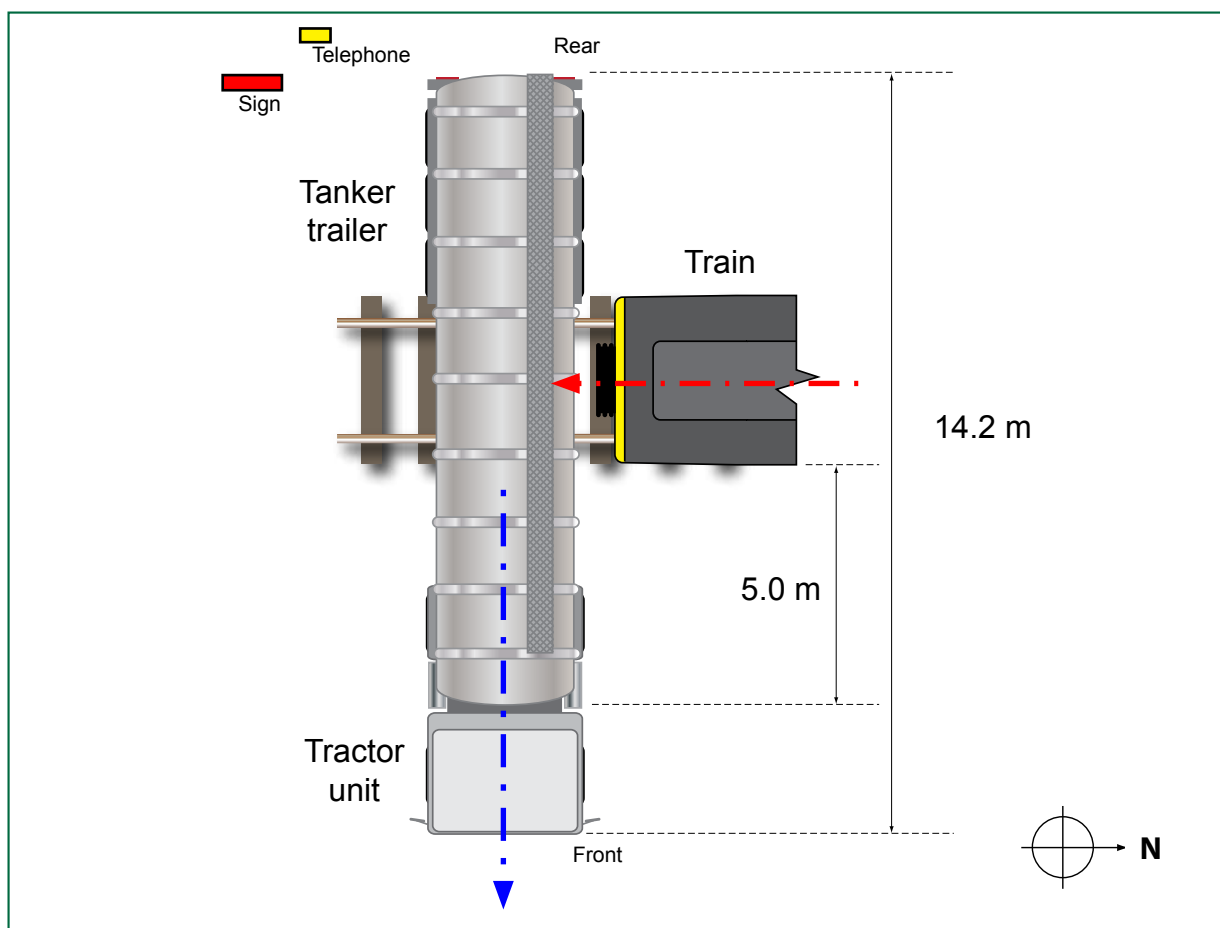
Figure 6: Diagram of point of impact.

- 36 The point of impact on the tanker was approximately 5 metres from the front of the tank and approximately 8.5 metres from the front of the tractor unit (figure 6). The tractor unit detached from the trailer as a result of the impact and the tank being conveyed on the trailer was breached, causing the contents to cascade over the train. The front of the leading coach of the train was severely damaged by the impact and the coach derailed, but remained upright at an angle, stopping approximately 35 metres beyond the crossing. The rear coach remained on the rails but suffered minor external damage. Both coaches had internal damage to doors, tables and fixings with some of the damage arising from passenger impact. The derailed coach damaged a short parapet alongside the track, with diesel fuel and effluent spilling into a pedestrian/cattle underpass (paragraph 16) below and onto the track.

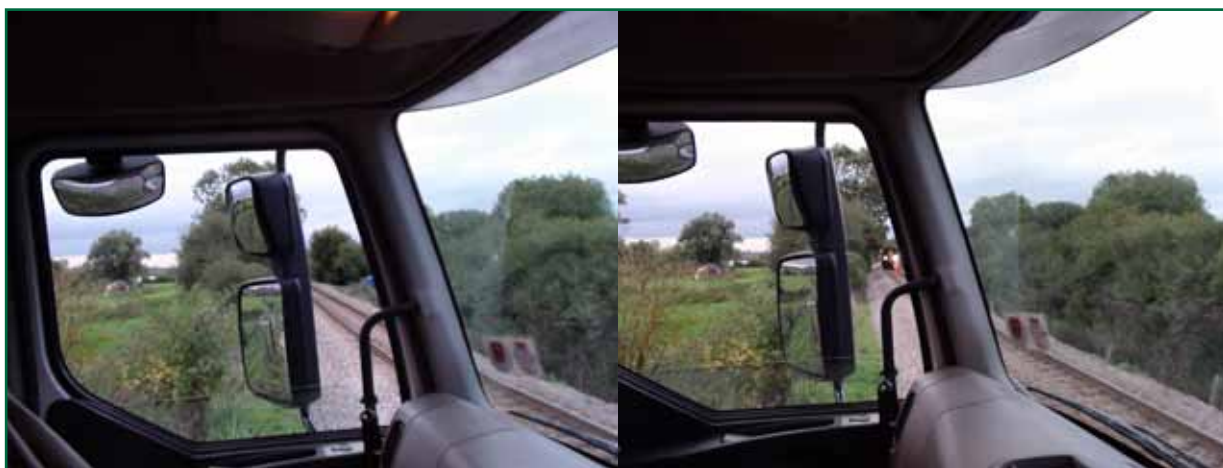
Figure 10: Effect on tanker driver's view of an approaching train caused by the mirror cluster on near-side of tanker (Photographs from the sighting tests on 3 October 2010)

- 89 The tanker driver said that he did not see the approaching train. The RAIB's tests on 3 October 2010 showed that it is possible that the array of mirrors located on the nearside of the tractor unit might obstruct the tanker driver's view of an approaching train (see figures 8 -10). However, the obstruction is easily overcome by the tanker driver moving his head backwards or forwards, an action that he would have been used to performing when joining or crossing a main road from a side road.

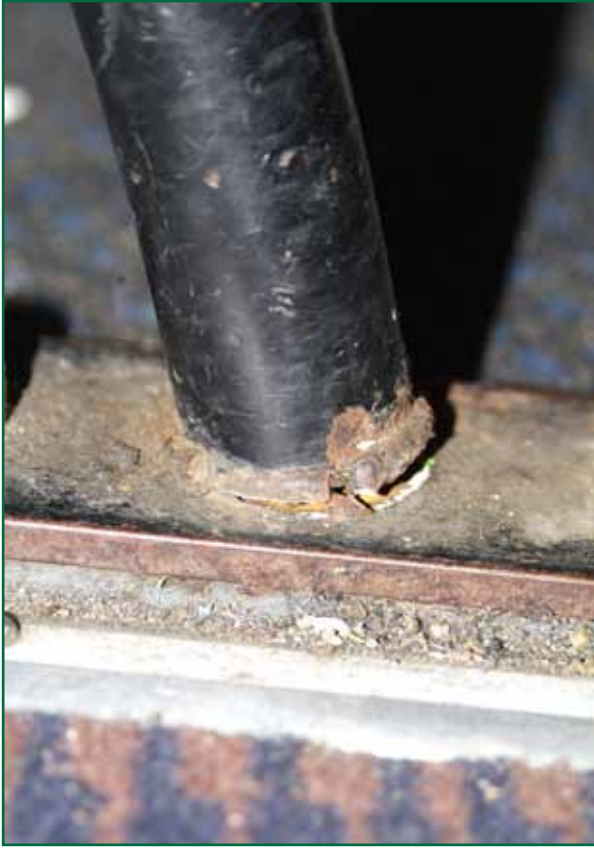
Figures 15 and 16: Damaged legs at base of interior tables within the vehicles

176 The front leg connection to the floor exhibited two types of deformation as shown in figures 15 and 16. In seven cases, the table leg bent and deformed plastically without material failure. In two cases, the table leg failed at the weld to the base plate. This meant that the table leg provided little or no energy absorption due to the inadequate weld strength.

177 Overall, the performance of the tables resulted in the potential for survival space to be compromised and the severity of the injuries to be increased.
