## **Derailment of a passenger train near Dryclough Junction, Halifax 5 February 2011**

Report 17/2011  
October 2011

# Derailment of a passenger train near Dryclough Junction, Halifax, 5 February 2011

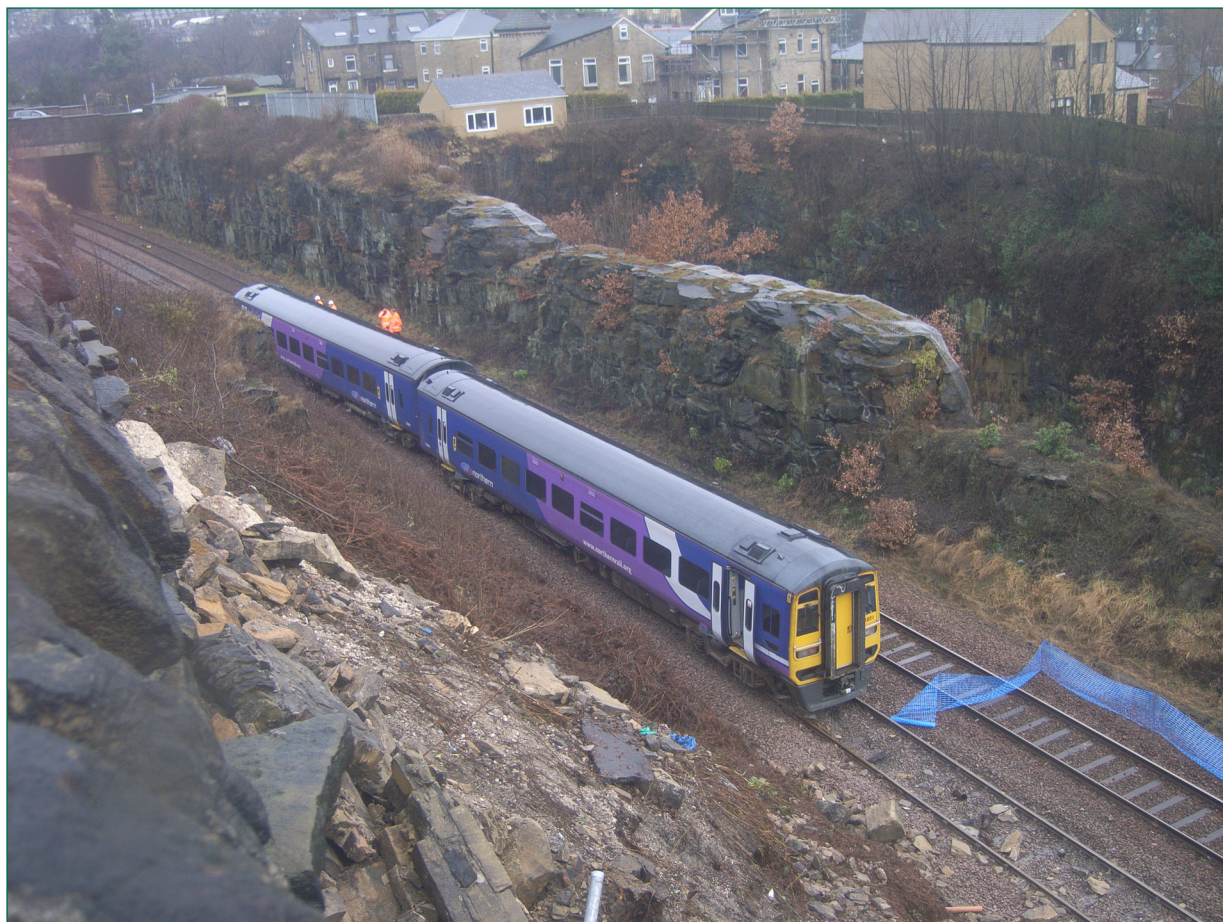
- 7 The train consisted of a two-car *diesel multiple unit* and both vehicles in the train were derailed by their leading *bogies*. The vehicles were derailed to the left and away from the other line.
- 8 There were eight passengers and two crew members on the train. Nobody was injured in the derailment.
- 9 There was extensive damage to equipment mounted on the underside of the train and to the bogies, wheels and axles. The track was also damaged over an 18 m length.

Figure 3: The derailed train

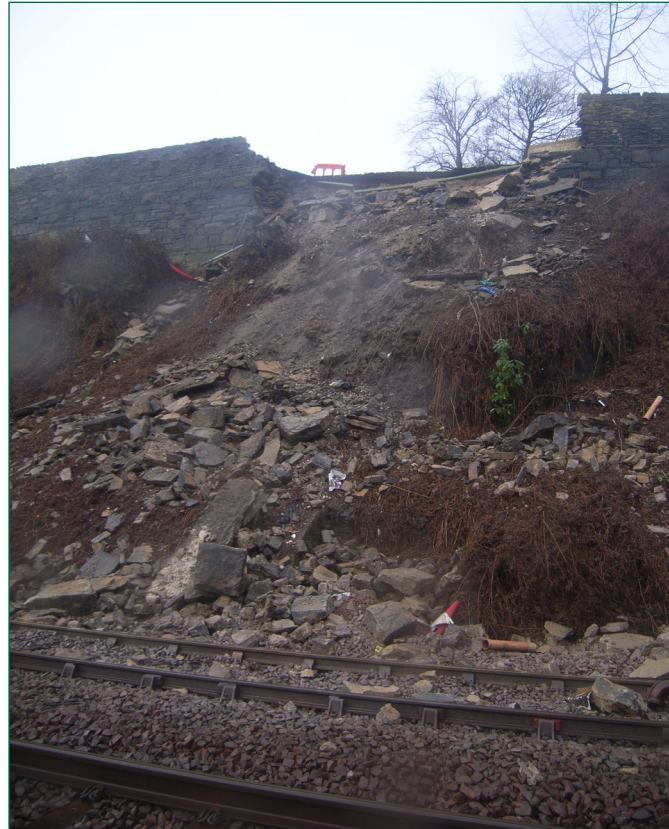
- 46 The derailment was caused by the train running into debris from the collapse of 13 m of retaining wall MRB/31A1 that had slid down the cutting slope onto the track (figure 4).

Figure 4: Collapsed section of the wall

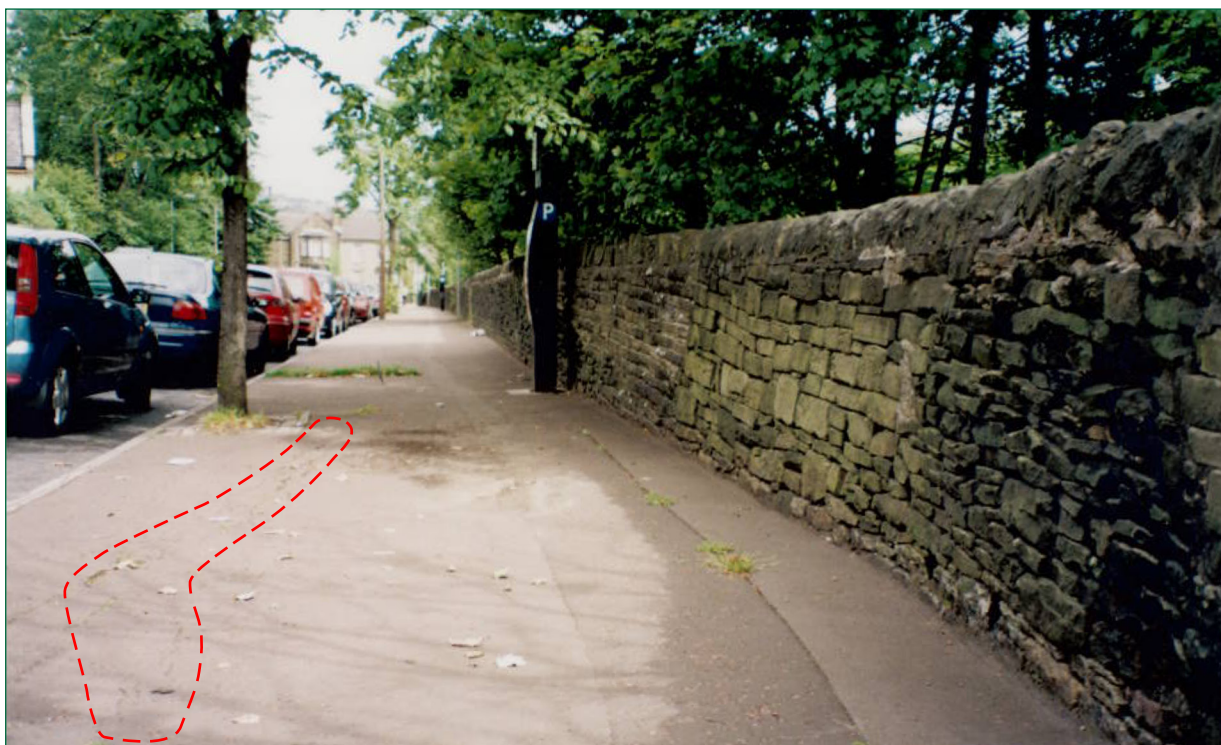
- 48 The detailed examination due in 2009 was not carried out. Its omission was a factor in this accident.
- 49 The most recent detailed examination prior to the accident was on 7 July 2003 and was carried out by an Owen Williams Railways structures examiner (examiner 1). The report of this examination was signed off by the Owen Williams Railways examining engineer on 30 July 2003 and the only work noted as being required were masonry repairs and removal of overhanging tree branches. Network Rail's structures management engineer wrote on the form that only the second item was to be done (removal of branches). Cracks in the pavement behind the wall were not mentioned by the examiner despite being visible in one of the photographs (figure 5). Such cracks show that there were movements in the material beneath the pavement and were an indication of a problem with the wall.

Figure 5: Pavement behind the wall in 2003 showing cracks (highlighted) from 2003 detailed exam report (courtesy of Network Rail)

- 56 The cracks in the pavement were not recorded in any of the reports from the visual examinations nor were they reported following the detailed examination report in 2003 even though they were visible in the photographs. The non reporting of cracks by the examiners was a factor in this accident.

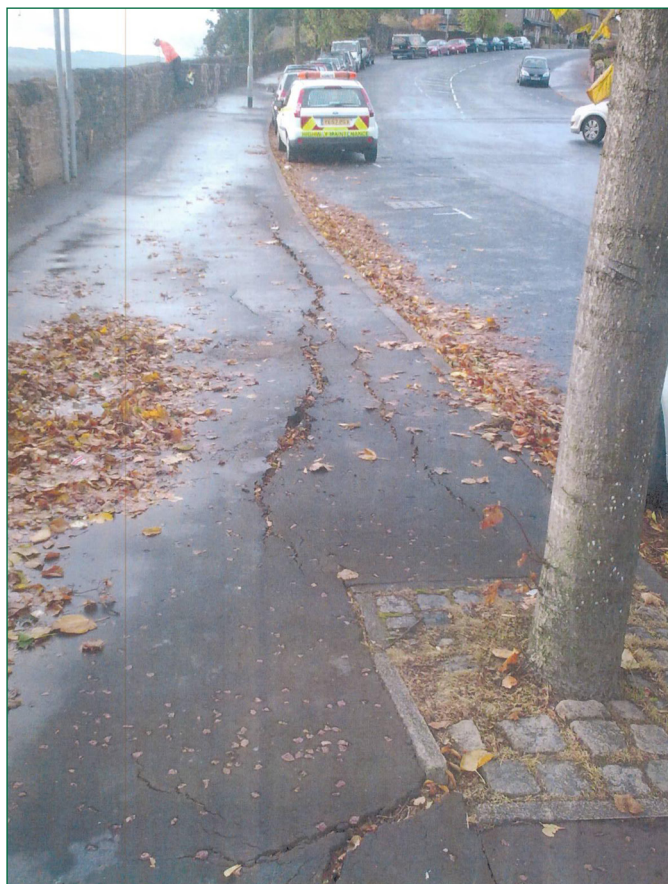
- 80 The contractor sealing the pavement cracks on 22 October 2010 found that they were much deeper than anticipated and contacted the highways inspector. He visited the site that day with his manager. They considered that the cracking was evidence of a significant structural problem and they arranged an urgent footpath closure. They noted that Amco were on site clearing vegetation from the wall at the same time. This was the vegetation clearance work ordered by Network Rail in June 2010 (paragraph 54).

Figure 6: Pavement behind the wall in October 2010 showing cracks (courtesy of Calderdale MBC)

103 The pavement cracks in figure 6 are in a similar position to those which appear in the 2003 detailed examination report photographs (figure 5 and paragraph 49). The cracks show that the wall has been moving, albeit very slowly, since at least 2003. Network Rail's regular examination process of the wall should have detected this, allowing investigation of the reason for the movement and the necessary repairs to be carried out. These repairs may have included repairing the leaking pipe. Although the Water Industries Act 1991 obliges sewerage undertakers to maintain the sewerage system, the RAIB has not investigated the ownership, maintenance or inspection of the road drainage. Whilst the leaking pipe may have contributed to the accident, the regular inspection process of the retaining wall should have detected the problem in time to allow effective repairs to take place.

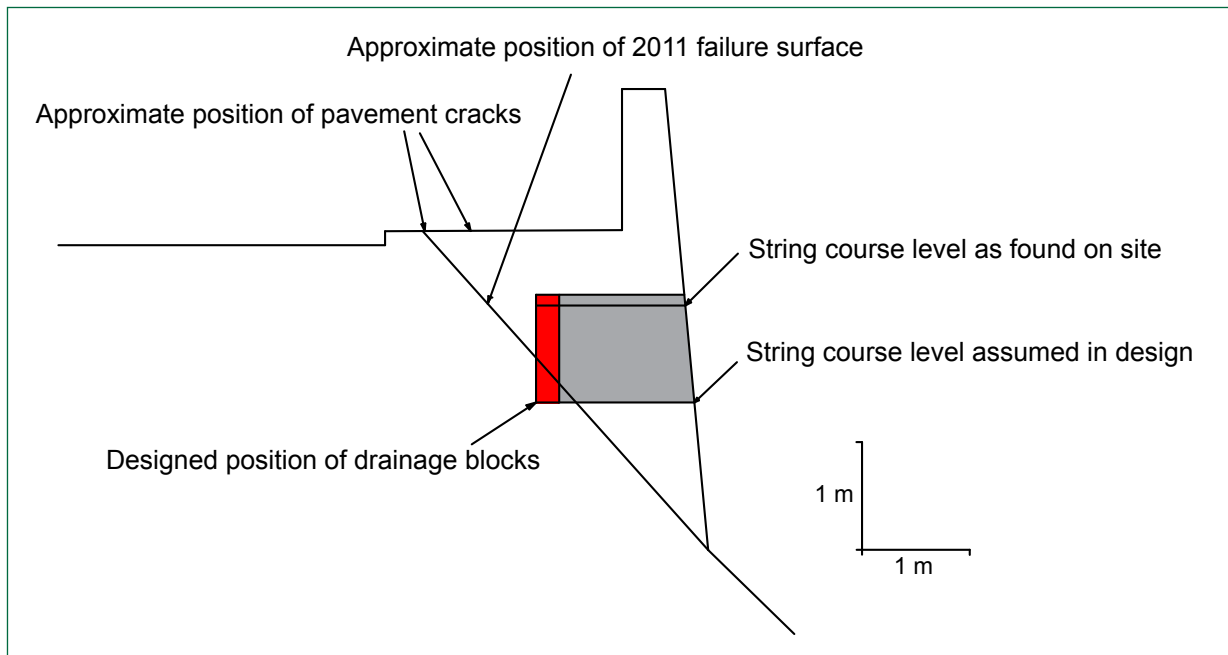
- 95 Amco began the repair work on site on 25 March 2006. When excavation started Amco discovered that the string course was much closer to the surface of the pavement than had been anticipated. Figure 7 presents a cross section of the wall with the original and revised extent of the repair, the position of the pavement cracks and the 2011 failure surface indicated. Amco asked Amey (Owen Williams Railways was acquired by Amey in February 2006) whether the design of the repair would still be satisfactory with a reduced depth of concrete above the string course. Witness evidence indicated that Amey's designer considered it would be satisfactory as the resulting new section of wall would not be so tall as originally designed and therefore would be more stable. The stability of the wall below the level of the repair was not considered, neither was consideration given to the matter of whether the repair was still appropriate given the reduced depth.

- 96 The contract for the repair of the wall was let by Network Rail's Major Projects and Investment (MP&I) organisation. MP&I had site construction engineers who visited sites where work was being carried out. One of the site construction engineers visited the retaining wall repair works every week during the work to check that the works were being carried out safely and in accordance with the design. His reports stated that the work was being carried out in accordance with the design and did not mention the omission of the drainage layer behind the wall.

Figure 7: Cross-section of the wall and pavement

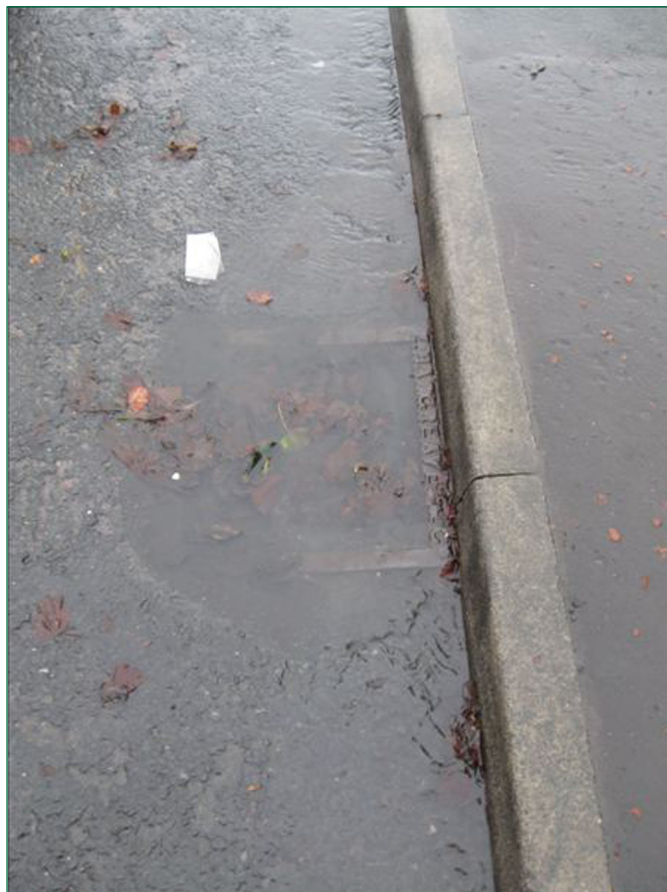
- 99 Heavy rain had fallen in the area during the 24 hours prior to the wall's failure. The pipe connecting the road drains behind the wall was broken in several places and was leaking. The presence of this additional water, either as a result of heavy rain or the broken pipe, was a probable factor to the accident occurring when it did.

101 After the accident Network Rail commissioned a CCTV survey of the pipe which connects the road drains on Dudwell Lane. This found that the pipe was extensively fractured from a point approximately 46 m upstream from the wall collapse to a point approximately 12 m upstream from the wall. The damage to the pipe would have reduced its capacity and led to water backing up and finding alternative drainage paths, possibly through the soil, at times of heavy rainfall. Figure 8 shows water flowing over a road drainage gully in Dudwell Lane shortly after the derailment, showing that it was unable to handle the flow of water. All of the gullies were able to handle the reduced flow of water after the rain had stopped falling later that day.

Figure 8: Road drain in Dudwell Lane shortly after the derailment (Courtesy of BTP)

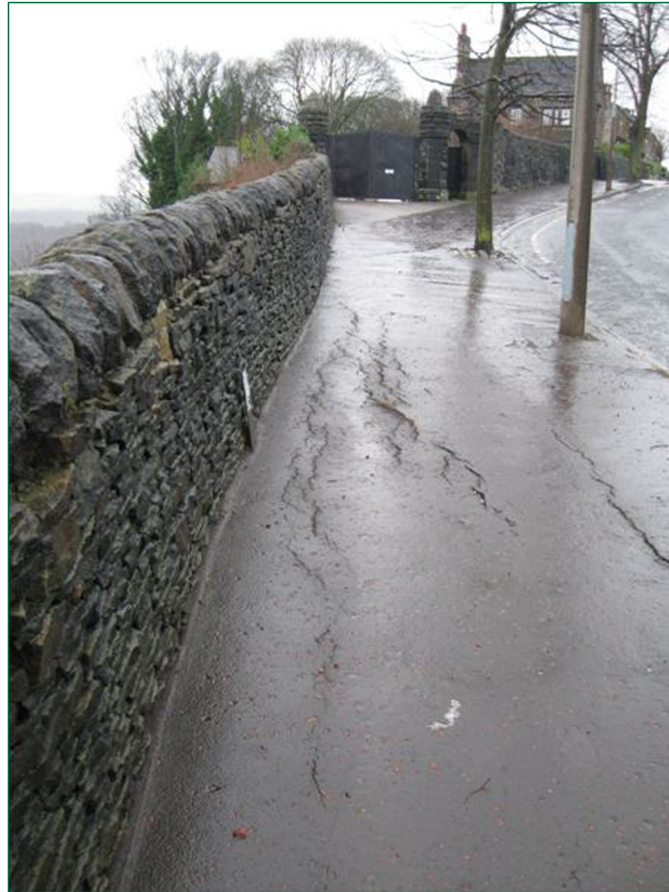
102 While the cracks in the pavement were most pronounced at the site of the failure, there were also cracks in the pavement at other places behind the wall (figure 9). After the accident Network Rail's geotechnical consultants calculated that the *factor of safety* of the wall was close to 1.0. A typical value for a retaining wall would be between 1.5 and 2.0<sup>3</sup>. The additional load caused by the soil behind the wall becoming more waterlogged after heavy rain may have been sufficient to overcome this small margin.

*Figure 9: Pavement cracks behind a different section of the wall after the derailment (courtesy of Network Rail)*
