# Rail Accident Report

**Pedestrian struck by a tram at Sandilands tram  
stop, Croydon  
16 May 2012**

Report 03/2013  
February 2013

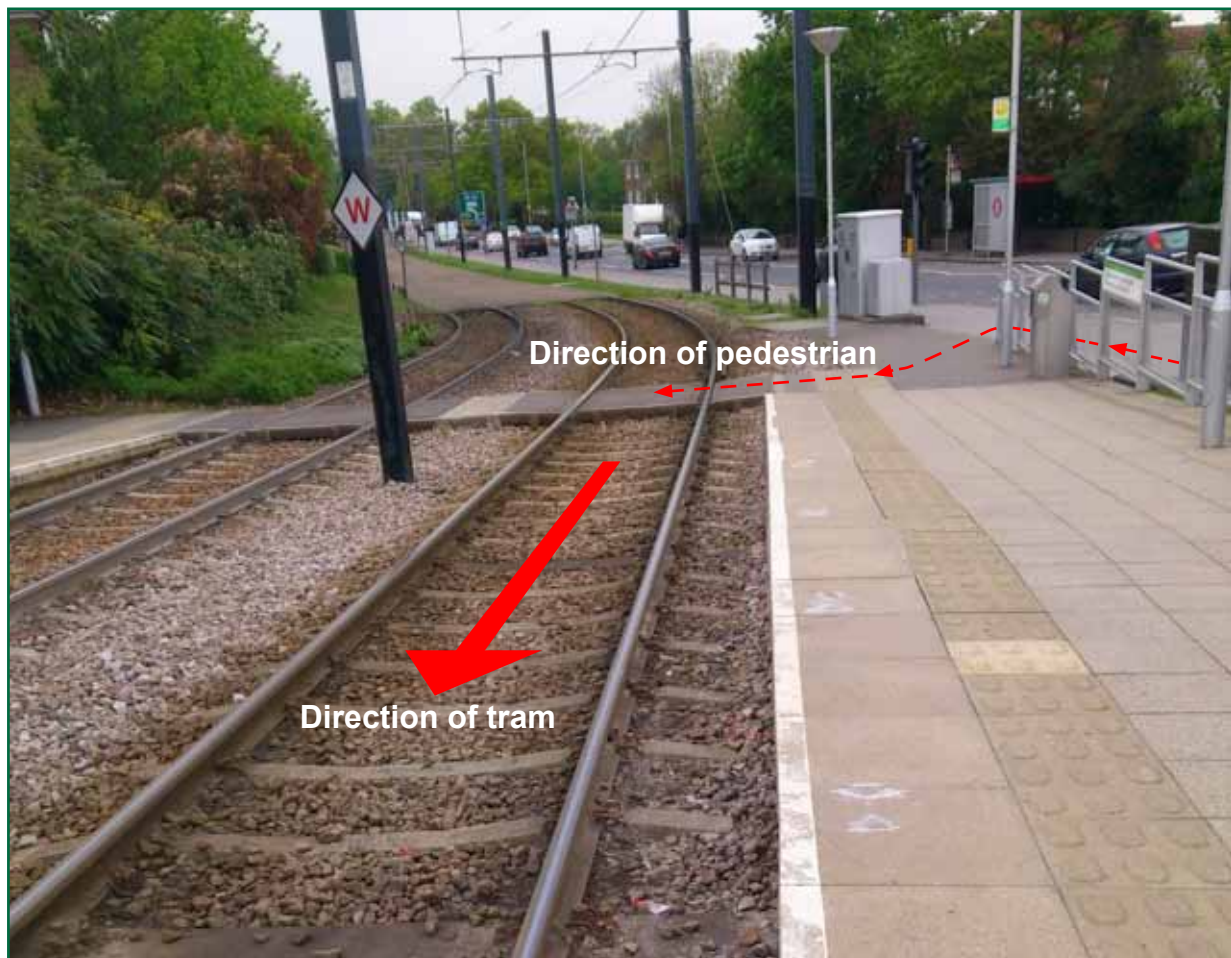
- 5 At approximately 09:44 hrs on Wednesday 16 May 2012, a pedestrian was struck by a tram as she crossed the tramway on a foot crossing at Sandilands tram stop in Croydon (figures 1 and 2).

Figure 2: Sandilands tram stop showing the crossing at the west end where the accident happened

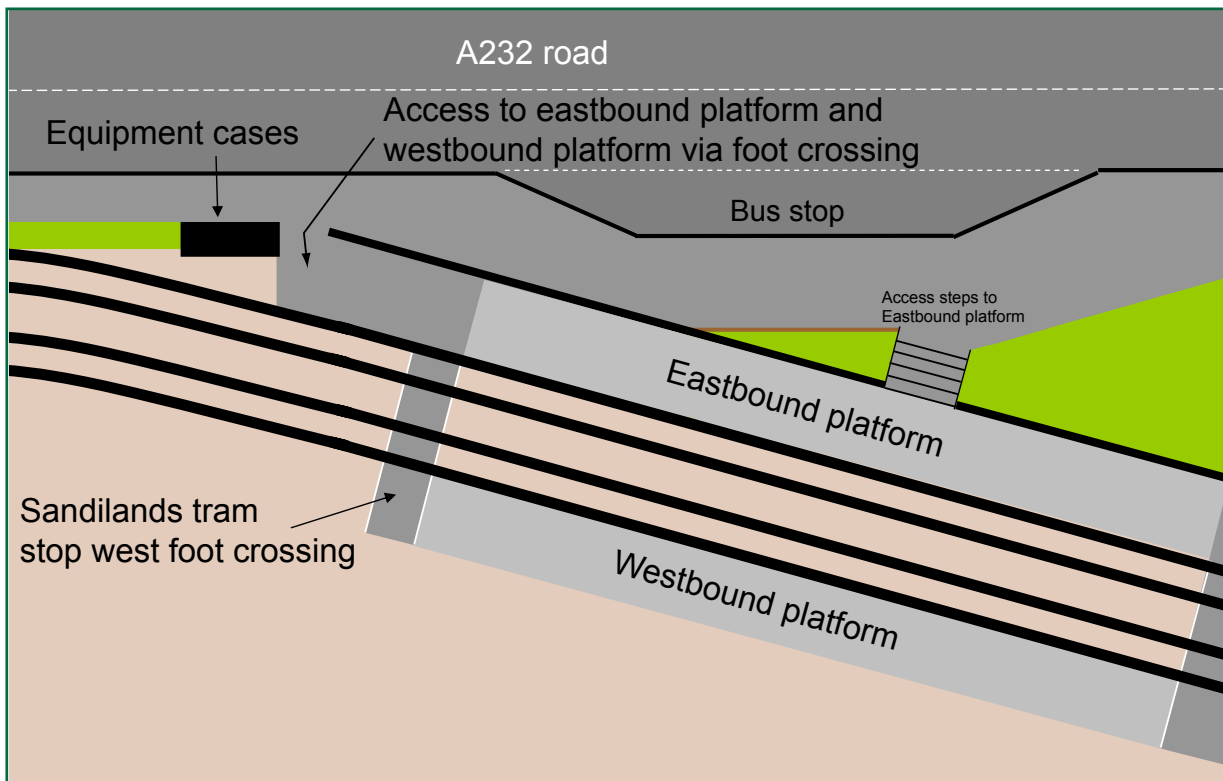
- 8 A fence separates the tram stop and the pavement, which are at different heights. Pedestrians going towards the platform and the foot crossing at the west end must walk a short distance on the pavement before reaching the entrance to the tram stop. At this point, it is necessary for them to turn back on themselves in order to reach the eastbound platform and the foot crossing to the westbound platform (figures 3 and 4).

Figure 3: Layout at Sandilands tram stop

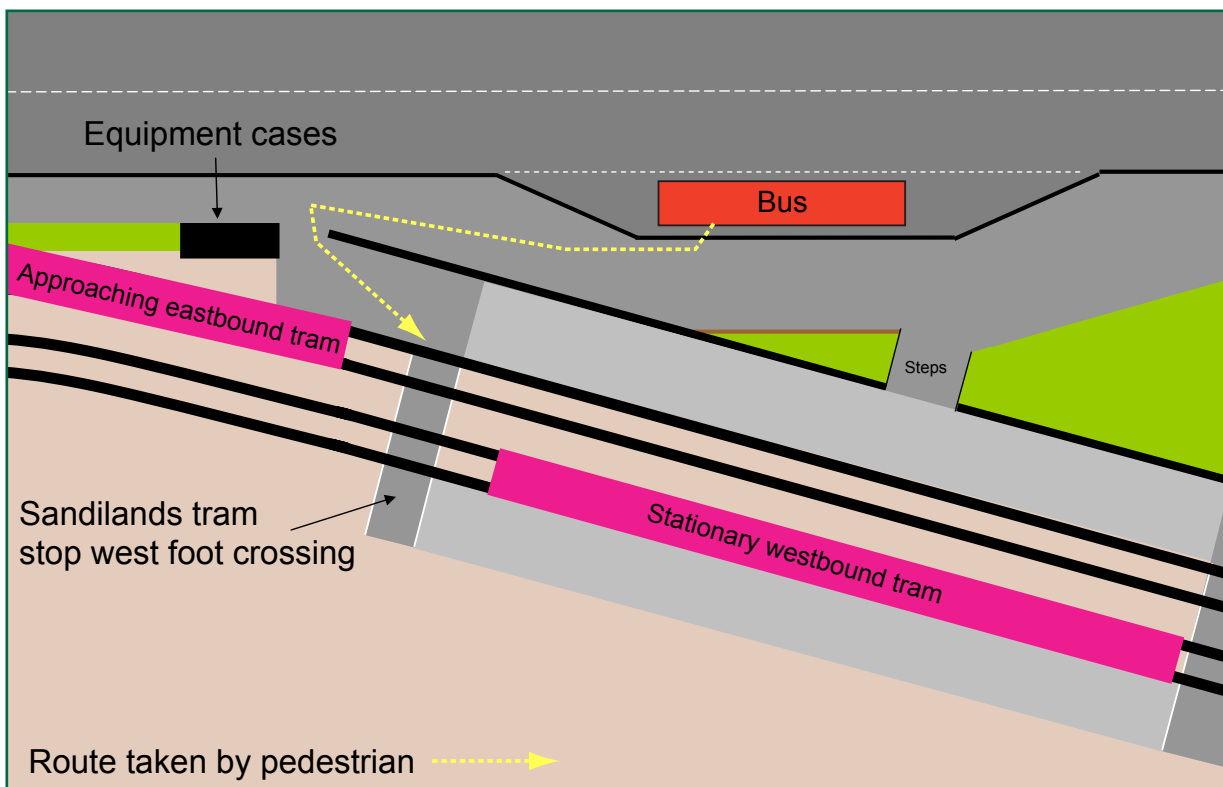
Figure 4: The pedestrian's route from a bus to the westbound platform at Sandilands

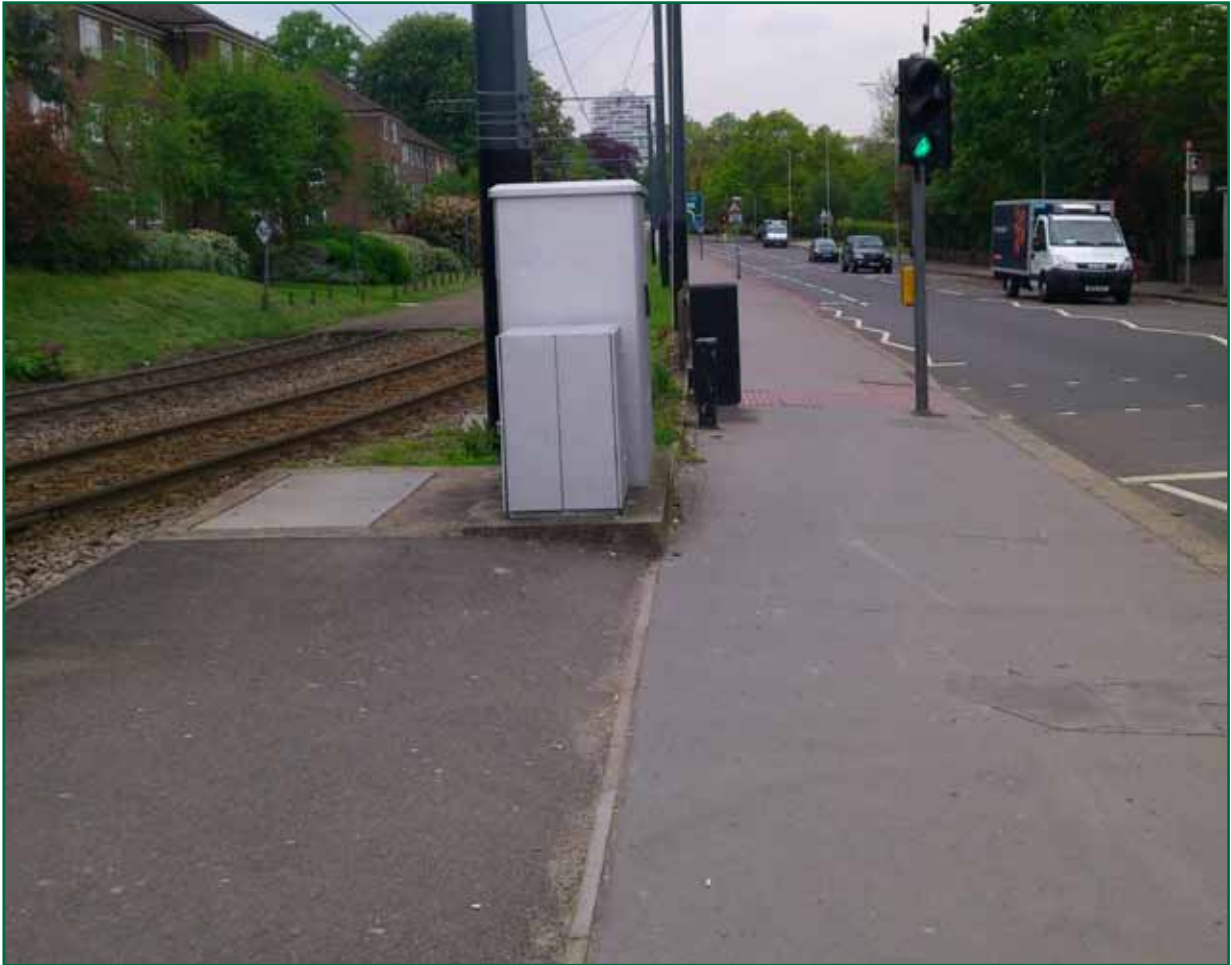
- 32 Paragraph 8 describes the route taken by pedestrians alighting from a bus to reach the entrance to the tram stop. As pedestrians walked towards the entrance, their view of approaching eastbound trams could be obscured by lineside equipment cabinets (figure 5), although this would not be the case if they walked close to the edge of the pavement. If they walked close to the fence separating the pavement from the platform, they were denied a view of approaching eastbound trams until they were approximately eight metres from the crossing. The RAIB has been unable to determine the exact position of the pedestrian as she walked along the pavement towards the entrance to the tram stop.

Figure 5: The obstruction to the pedestrian's view of approaching eastbound trams at Sandilands tram stop

- 87 London Tramlink did not identify the obstruction to a pedestrian's view of approaching trams that was caused by the equipment cases at the west end of Sandilands tram stop (paragraph 31), or the angle at which pedestrians could approach the foot crossing at the west end of the tram stop in relation to approaching eastbound trams.

- a. The pedestrian may not have been able to see the approaching tram as she walked from the bus stop to the entrance to the tram stop, because her view could have been obstructed by lineside equipment cabinets (**paragraph 31, Recommendations 2 and 3**).

- 2 *The intent of this recommendation is for London Tramlink to consider the need for removing the obstruction to pedestrians' view of approaching trams at Sandilands tram stop, to identify and take action as appropriate to deal with similar obstructions at other tram stops and to implement a process to prevent the installation of equipment in locations which are detrimental to pedestrian safety in the future.*

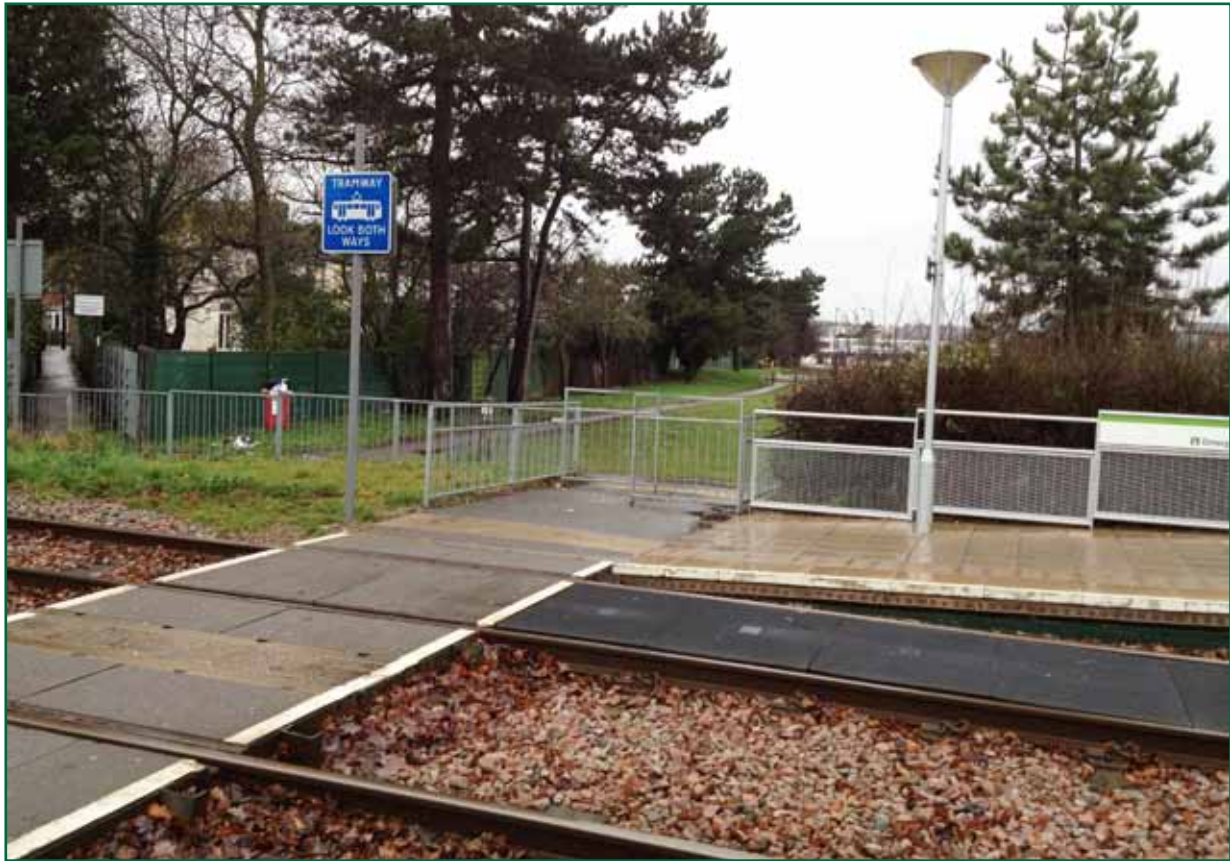
- 39 Following the accident at Arena, the concessionaire at the time, Tramtrack Croydon Ltd (paragraph 17), recognised the hazard of pedestrians approaching Arena tram stop with their backs to approaching trams and installed barriers which had the effect of encouraging pedestrians to approach the crossing at right angles, thereby making it easier for them to see trams approaching from either direction. Figure 6 shows the configuration of barriers that are currently in place at Arena tram stop; the barriers that were installed at Arena after the accident in August 2007 are shown in Figure 7 of the RAIB's investigation into another accident which occurred at Morden Hall Park footpath crossing in September 2008<sup>3</sup>.

- 40 Although Tramtrack Croydon Ltd recognised the specific hazard of the approach to the foot crossing at Arena tram stop, it did not carry out a review of other stops on the network where the same hazard existed, such as Sandilands, and similar mitigation was not applied elsewhere.

Figure 6: Barriers installed at Arena tram stop

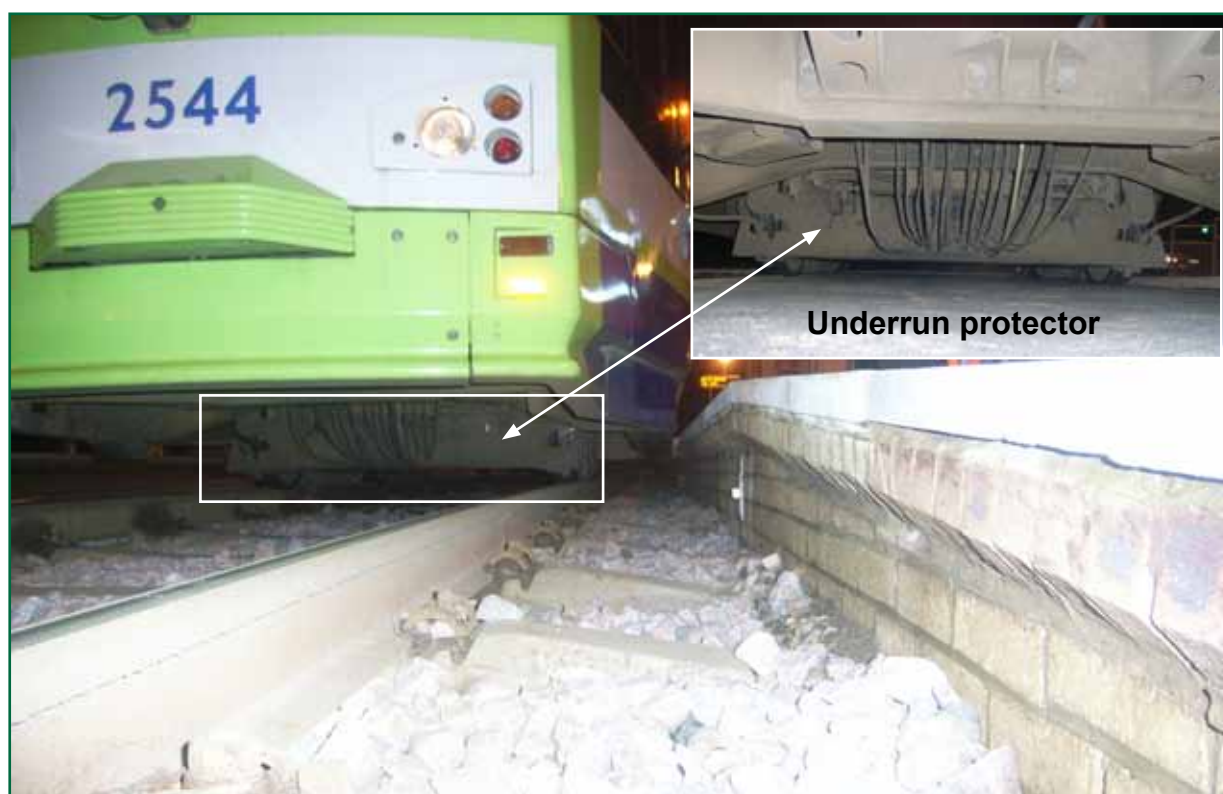
- 69 The underrun protector (figure 7) is a device located underneath the front of the tram that is intended to keep a pedestrian who has been struck by a tram from going underneath the wheels. For it to be effective, the clearance between the bottom of the underrun protector and the surface beneath it needs to be as small as possible, but allowing enough clearance to avoid it striking the ground in normal operation. Paving up to rail level at tram stops allows this clearance to be minimised; the use of ballast generally increases the clearance and thereby decreases the effectiveness of the underrun protector. At Sandilands, the clearance between the bottom of the underrun protector and the sleepers was 255 mm. Paving up to rail level would reduce it to around 105 mm, thereby increasing the likelihood of the underrun protector performing its function. The RAIB examined issues in relation to the design of tram underrun protectors in its investigation into a fatal accident at Piccadilly Gardens, Manchester on 5 June 2011<sup>10</sup> and recommended that research should be undertaken into the potential for the reduction of injuries to pedestrians involved in front end collisions with trams.

Figure 7: Front of tram showing underrun protector

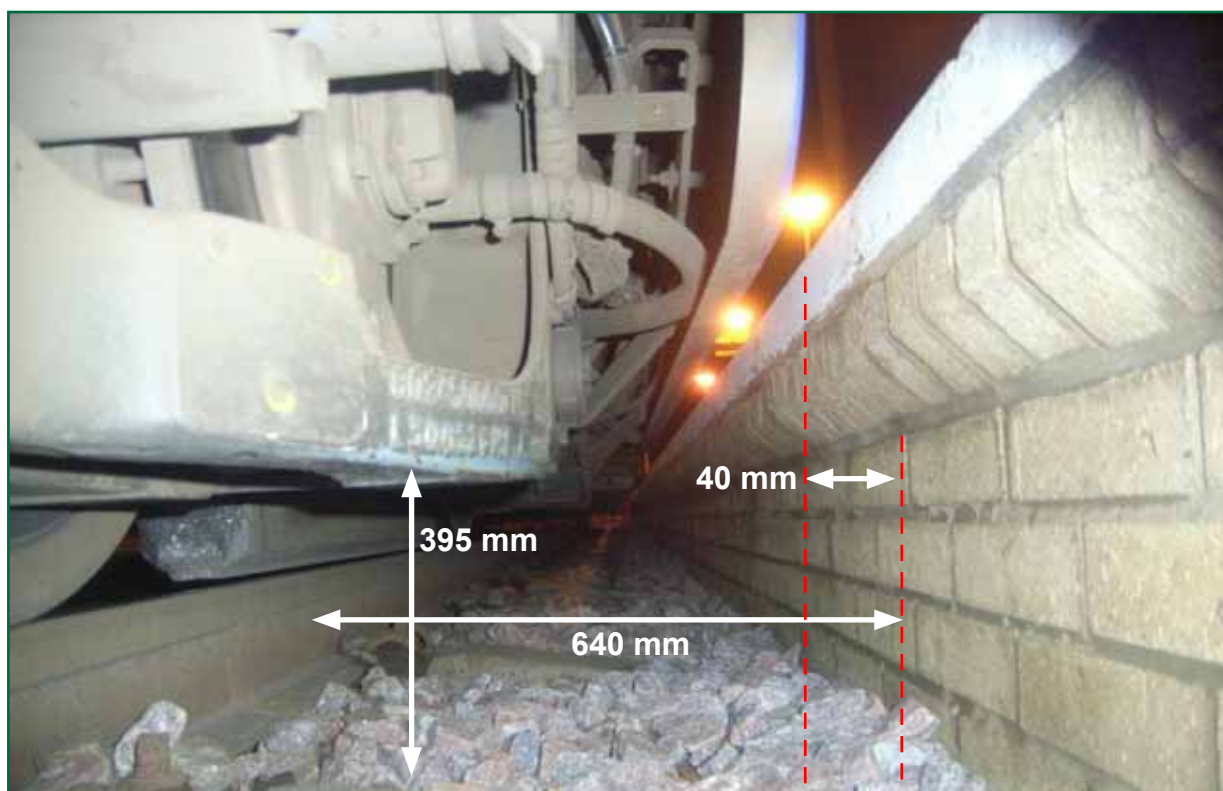
97 The size of the gap where the pedestrian was found after the tram had stopped is shown in figure 8. The limited space available meant that she was partly dragged by the tram, although the fact that she was only carried 17 metres beyond the crossing and not the full 40 metres traversed by the front of the tram, indicates either that the pedestrian was stationary for some of the time that the tram was moving or that she was being dragged at a slower rate than the tram was travelling.

Figure 8: Key dimensions in the gap between the platform face, platform-side rail and a tram

- 98 There are two reasons why the pedestrian survived the accident, both of which relate to the space available:
- The surface between the platform face and the rail comprised ballast which did not reach the height of the rail. Had the rails been set in slab up to rail height, the available vertical space would have been reduced by approximately 150 millimetres.
  - There was a recess under the platform, providing an additional 40 millimetres of horizontal clearance.
- 99 Paragraph 163 of ORR's guidance on the design of tram stops (paragraph 41) states:
- 'A recess below a platform coping is not required for tram platforms'.

- 3 *The intent of this recommendation is for ORR to re-evaluate its guidance to tram operators on optimising sight lines for pedestrians and tram drivers in the vicinity of foot crossings, physically guiding pedestrians as they approach foot crossings so that they are encouraged to look for approaching trams and the need or otherwise for recesses under tram stop platform and paving up to rail level through tram stops. The guidance should be amended in accordance with ORR's findings.*

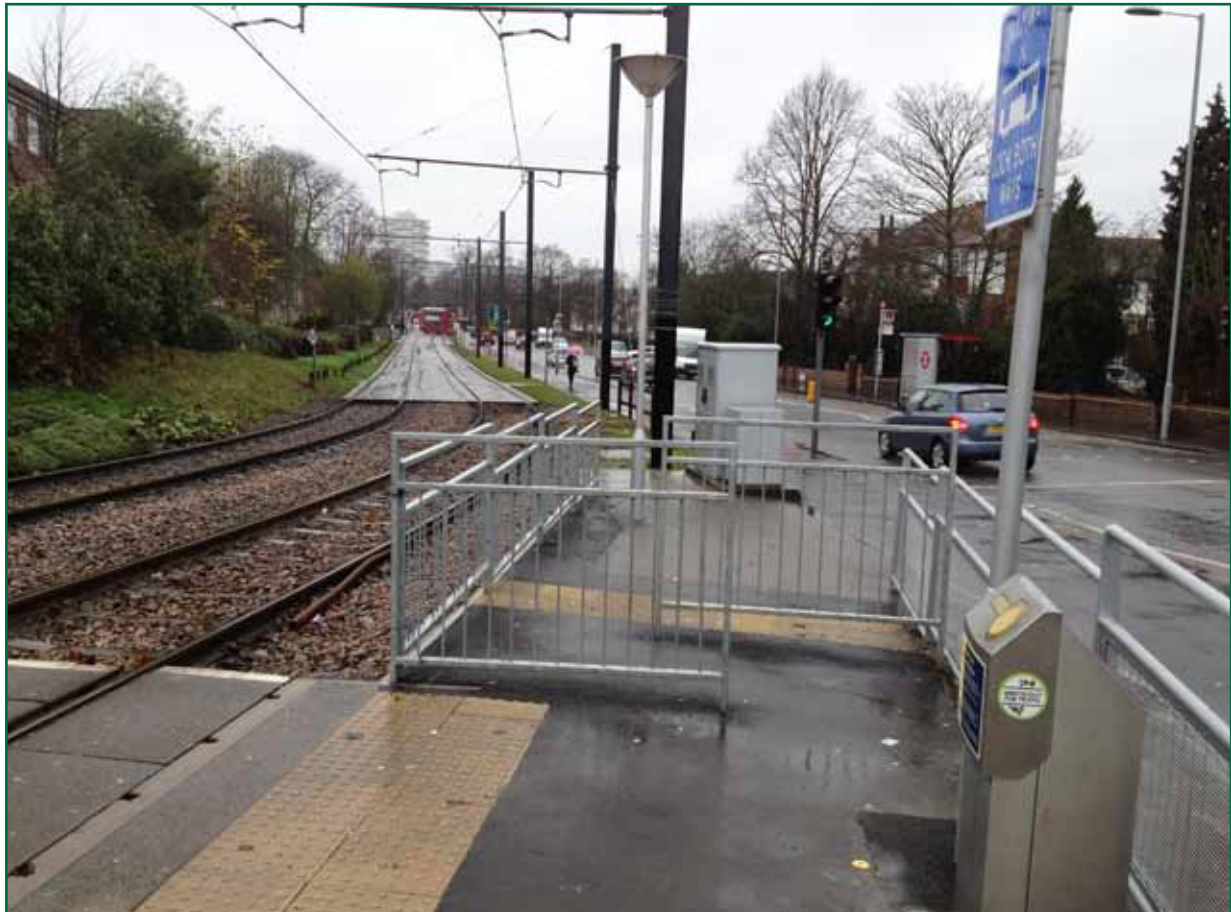
*Figure 9: Revised arrangements for pedestrians, including a chicane, at the west end of the eastbound platform at Sandilands tram stop*

- 121 A chicane has been installed at the Sandilands tram stop foot crossing, which has the effect of discouraging pedestrians from approaching the foot crossing diagonally and increases the likelihood that they will see a tram approaching from either direction (figure 9 and paragraph 115a).
