Rail Accident Investigation Branch

# Rail Accident Report

**Passenger trapped in a train door and dragged a short distance at Newcastle Central station  
5 June 2013**

Report 19/2014  
September 2014

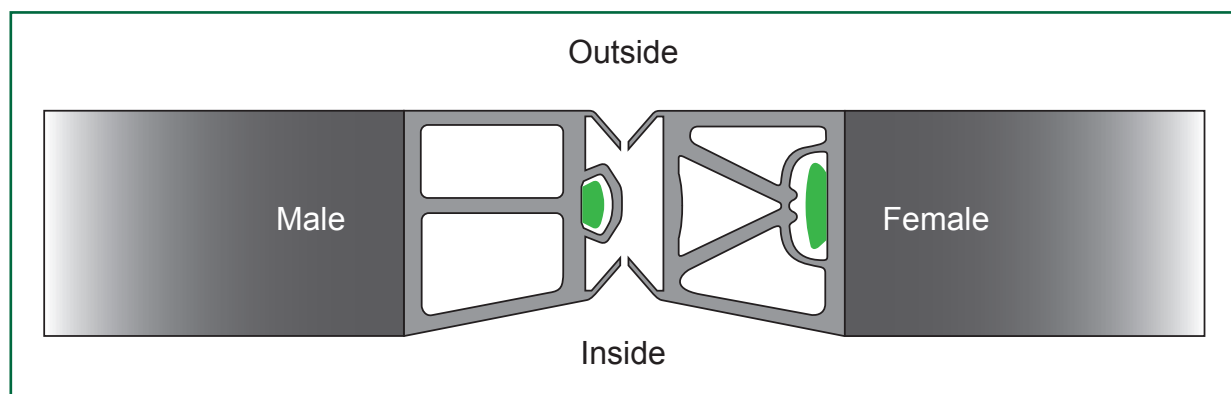
- 48 The electrical detection sensor in each door leaf runs from the top to the bottom of the door and is housed within the leaf's leading rubber edge (figure 9). The rubber edge of one of the door leaves is a 'male' edge and the other a 'female' edge. A feature of this design is that it is necessary to switch off the detection of the female sensitive edge shortly before the two leaves meet to prevent it sensing the opposite door leaf when they touch (which would cause the door to reopen). The male sensitive edge remains active until the door is detected to be closed and locked.

Figure 9: Cross-section through the sensitive door edges, showing the rubber sealing edge profiles housing the electrical sensing elements (shown in green)

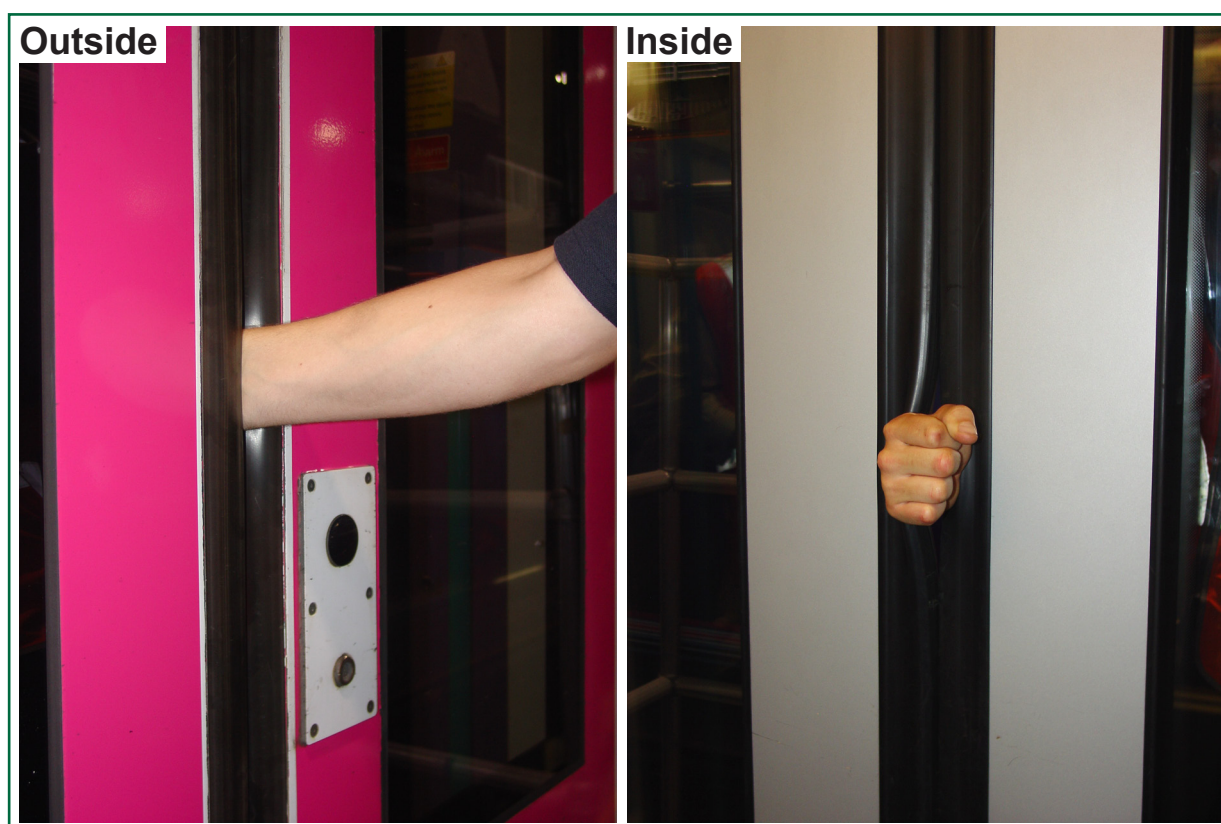
Figure 10: Adult male wrist (approximately 45 mm by 70 mm) trapped in a door detected as closed and locked

- 53 Siemens depot staff were then able to demonstrate to the RAIB how a correctly functioning door that met the design and maintenance test criteria could, nevertheless, trap an adult wrist and indicate to the train control system that the leaves were closed and locked (figure 10). This could be done by deflecting the male rubber edge inwards or outwards, ie away from the female rubber edge. This caused the male edge's sensing element to be moved away from the direction of the movement of the closing leaf and not detect the obstruction. By the time the leaves came together, the female sensitive edge had been switched off (paragraph 48). In this way it was possible, but not always easy, to trap the test pieces and also a reasonably large adult male wrist (figure 11).

- 54 With a stationary train, removal of a trapped wrist in these circumstances is possible but not easy. Following the Newcastle accident, FTPE undertook a risk assessment (paragraphs 104 to 110) within which it was recorded that a member of FTPE staff recreating the trapping of his wrist, reported that it was painful and difficult to remove. The view was also expressed that a trapped test piece (the size of which was not recorded) was difficult to remove, requiring a 'foot braced against the door' to achieve.

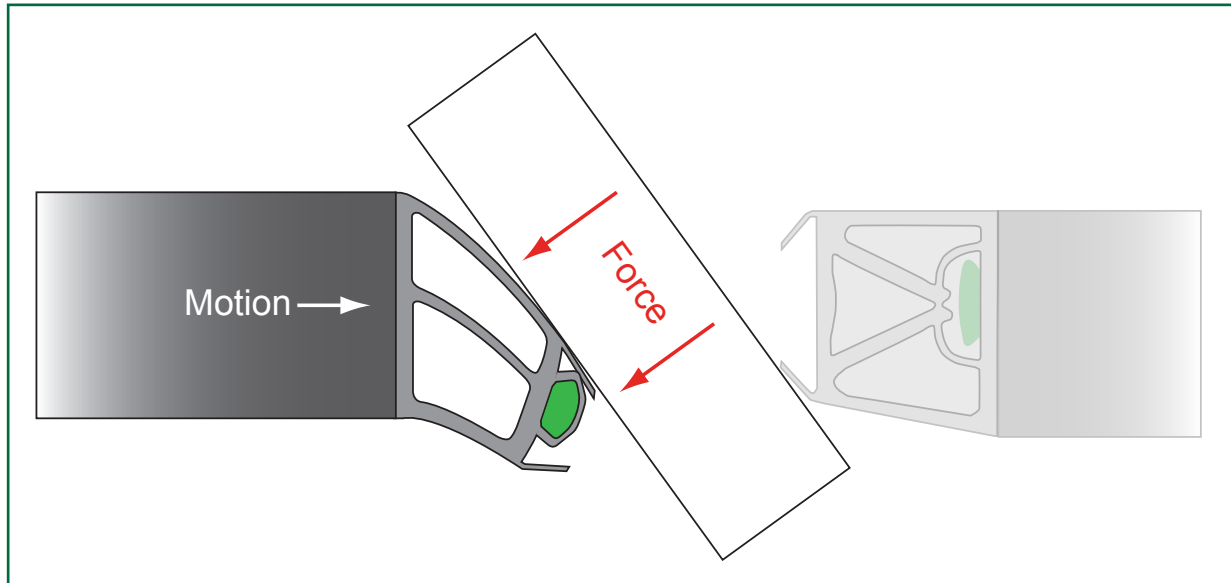
Figure 11: Cross-section through the sensitive door edges, showing the rubber sealing edge profiles and the deflected male edge

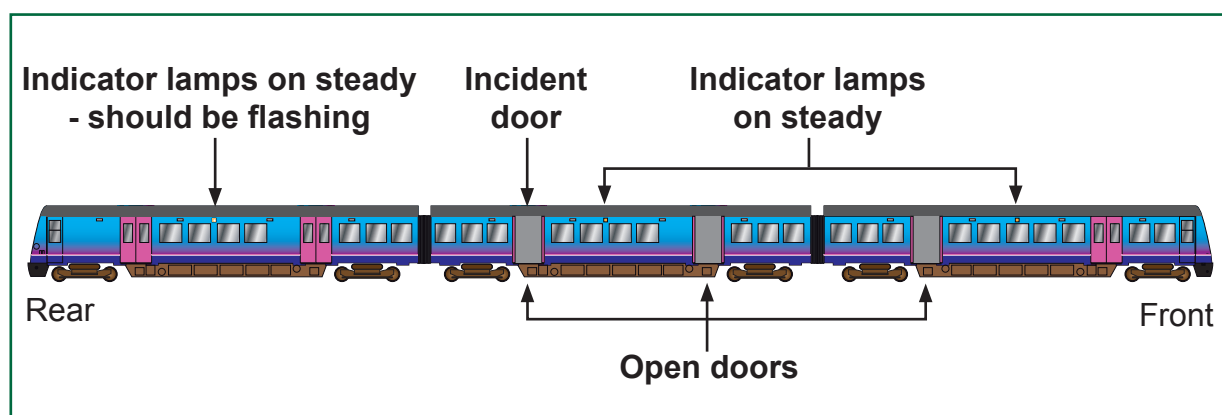
86 RAIB's analysis of the on-board CCTV recordings indicates that once he had turned the DKS on, the conductor's action of pressing the 'close doors' button closed three passenger doors which had not already closed automatically by 'auto-closing' (figure 12). One was the rear door of the front carriage and the other two were the front and rear doors of the centre carriage. The door at the front of the centre carriage had been open for over 2 minutes before the conductor closed it. The door at the front carriage and the rear door of the centre carriage (which trapped the passenger) had both been open since they were first opened more than 7 minutes earlier.

Figure 12: Condition of passenger doors and bodyside indicator lamps at the time the conductor reported that he was undertaking the train safety check
