Rail Accident Investigation Branch

Rail Accident Report

**Near miss involving a track worker at Tinsley
Green Junction
17 March 2007**

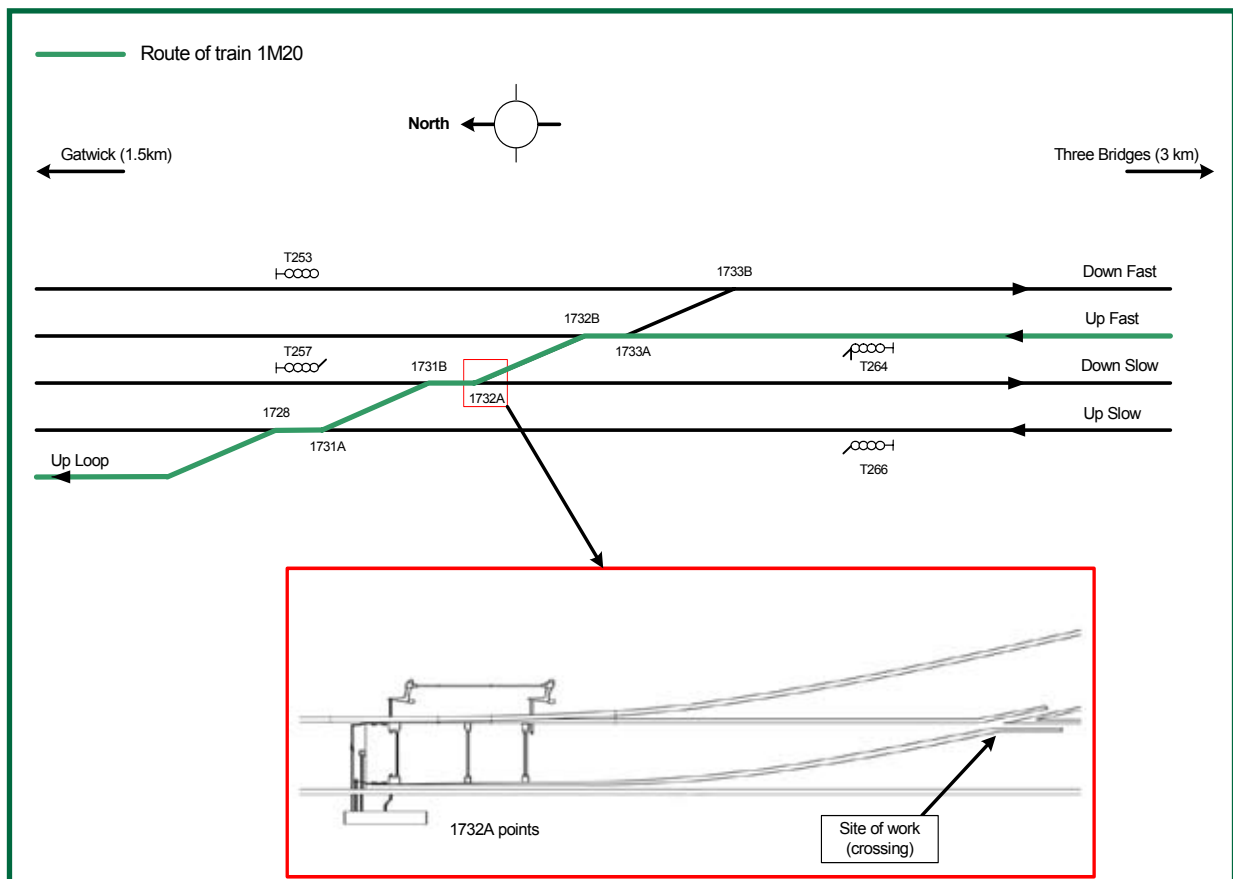
Figure 2: Track and signalling layout at Tinsley Green Junction, showing route of train 1M20

- 200 The direction of train movements over the crossovers at Tinsley Green Junction is missing from Table A of the Sectional Appendix. This has the potential to impede the safe planning of the task and the establishment of a safe system of work (paragraph 188 and Recommendation 8).

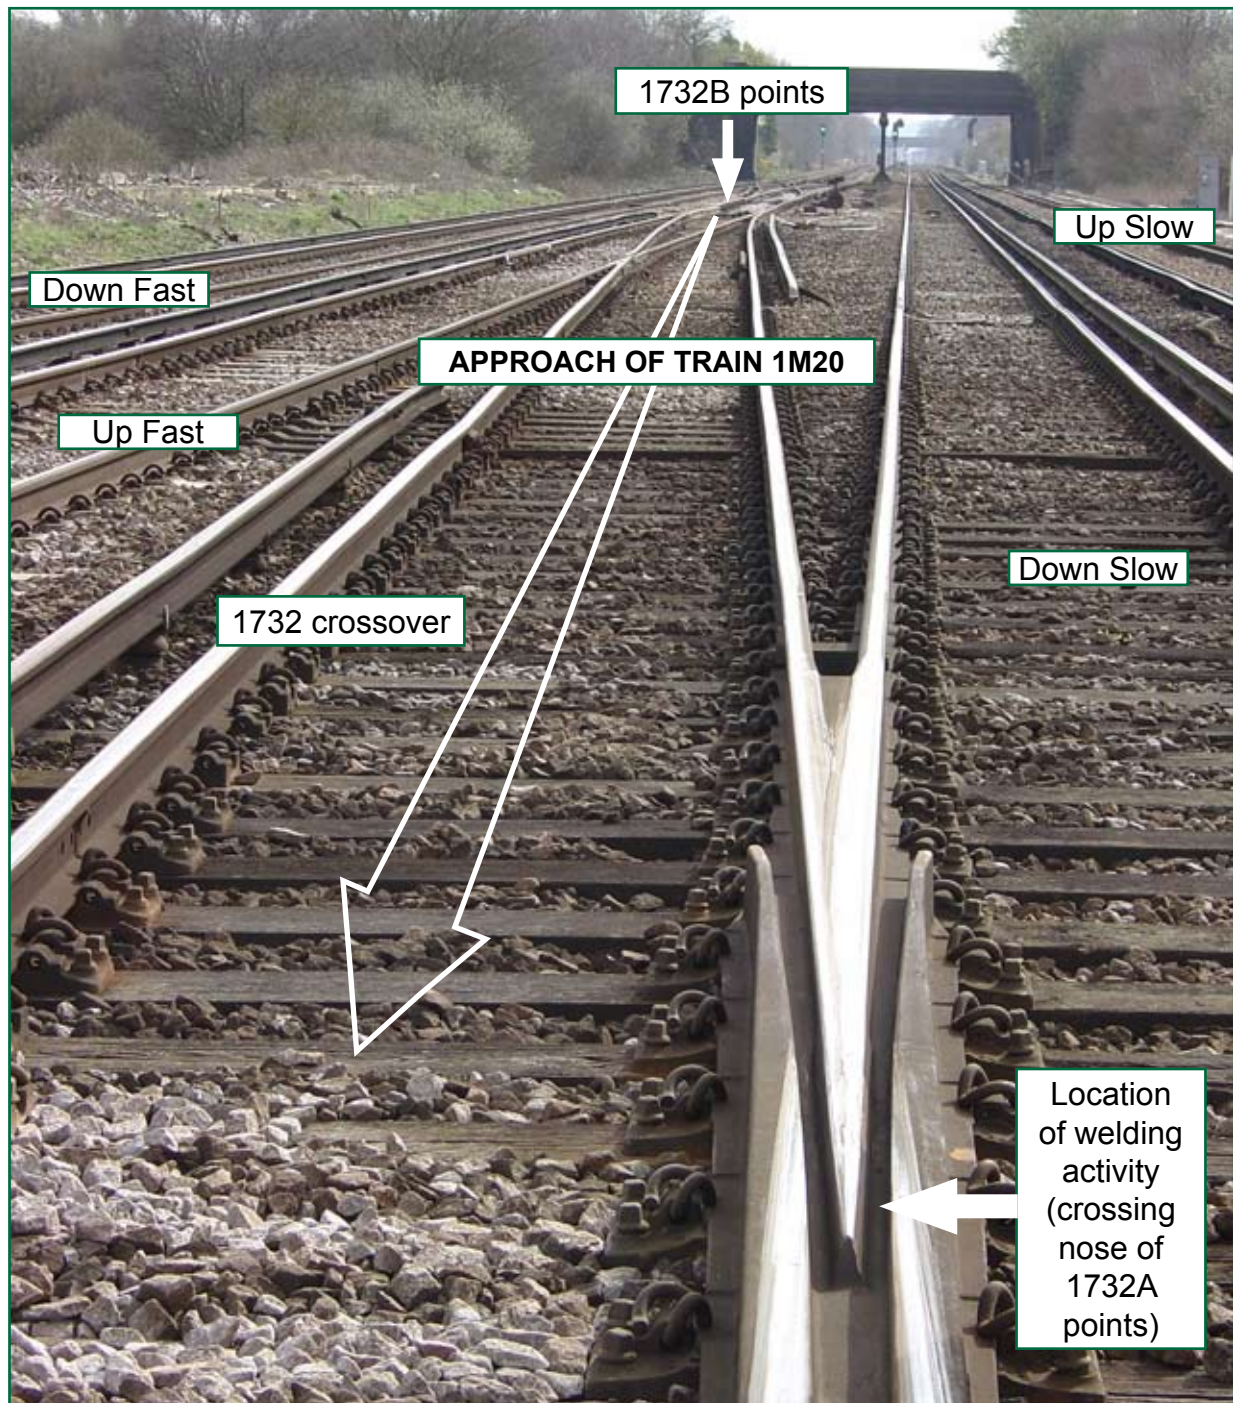
Figure 3: Tinsley Green Junction (looking south at the crossing of 1732A points)

- 176 Had the lookout tried to observe the points he would have found it difficult to discern the position of the 1732B switch toes at the southern end of the crossover. The 1732A switch toes were clearly visible.
