PRELIMINARY REPORT WITH IMMEDIATE SAFETY RECOMMENDATION

RAILWAY ACCIDENT ALNABRU - SJURSØYA 24 MARCH 2010

ISSUED 3 MAY 2010

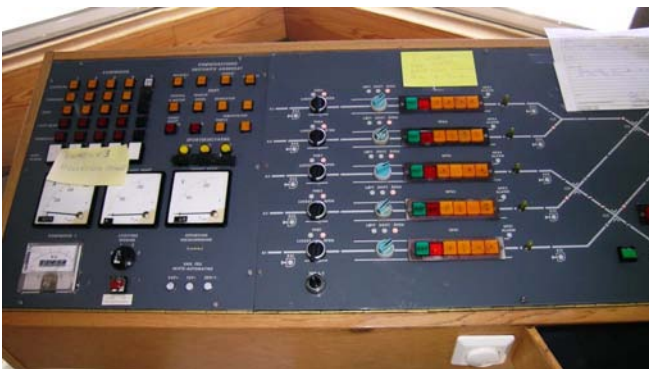
Figure 3: The control panel for the brakes.

Once it became clear that the wagons were in motion, the local traffic controller attempted to stop them by using the lowering brakes. The attempt was unsuccessful and the wagon set continued downwards through track G4. Tracks G4 and G5 are not equipped with diversion points or buffer stops and so there were no barriers to stop the wagons rolling out of Alnabru South. The wagon set passed the main dispatch signal at Alnabru at 13.07:07 at a speed of approximately 30 km/h. After leaving the Alnabru marshalling yard, there were no barriers to stop the wagons.

The brake systems in the marshalling yard are controlled from the slip signal control centre. At the time of the incident, the assistant local traffic controller had completed his tasks and left for the day. At this point in time, it was the local traffic controller who operated the slip signal control centre, including the station's brake systems.

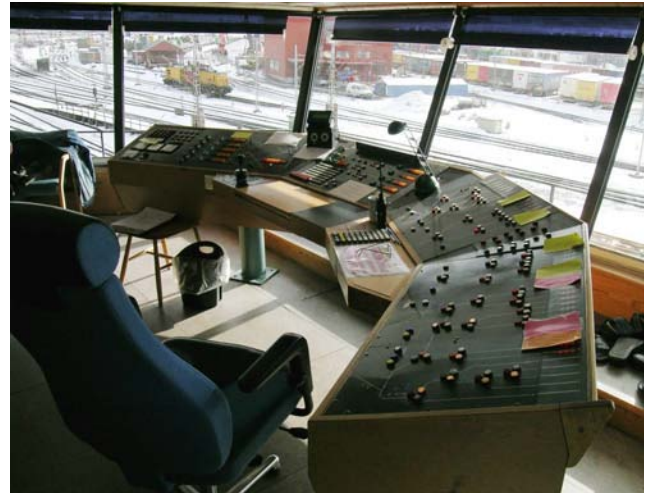
The workplace in the slip signal control centre. The control panel for the brakes on the left.

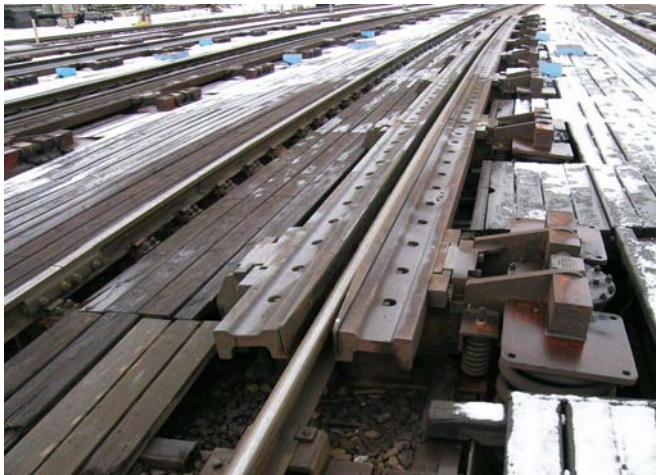
Figure 4: The mechanical brake is a beam brake that pinches against the rail car wheel.

Together with representatives from the Police, the AIBN inspected the mechanical brakes and lowering brakes on track A5 at Alnabru S on 24 March 2010. Following the inspection and documentation of the conditions, a simple function test was performed by applying and releasing the brakes. These inspections did not uncover anything to suggest technical failure in the brakes. Nor were there any marks to indicate that the wagons had 'climbed out of' the lowering brakes.

The mechanical brakes were also tested on the day after the accident, by applying them to a 'test train' with a corresponding number of wagons. The train's brakes were then released and it was noted that the train did not move despite the locomotive gently pulling on the wagons. A shunting route to G4, corresponding to the one on the day of the accident, was planned and the mechanical brake was released. The train started to roll by virtue of its own weight, and its speed was observed and the train was video-recorded

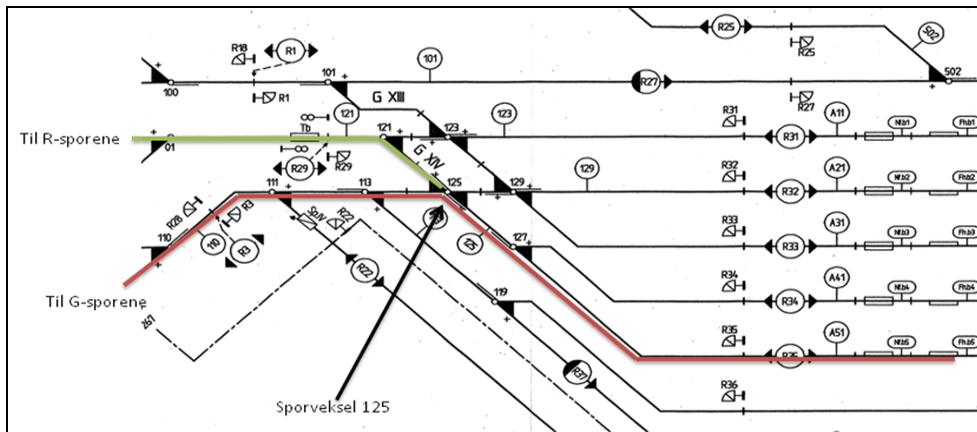
Figure 5: Schematic track plan section.

When leaving track A5, point no. 125 can be set to one of two routes: a) wagons can be directed towards the access break, or b) wagons can be directed towards tracks G2-G5 by passing the access breaks. Point no. 125 is controlled via the traffic control system so that it is normally set towards the access brakes, unless a set train route passes through it to the G tracks. In a normal situation, any runaway wagon will roll onto the directional tracks, collide with any rail car standing in its way and finally be caught by the end buffers at the southern end of the marshalling yard.

The fact that the set of wagons rolled towards the G tracks suggest that the shunting route towards the G tracks, which bypassed the access brakes, was set without the local traffic controller having ascertained whether the locomotive was in control of the rail cars. At this point in the investigation, the AIBN has not looked at the status of or practice relating to this procedure in any detail, but it has noted that this is a factor that requires further investigation.

The fact that the G2-G5 track system was constructed and equipped with a control system that lacked barriers capable of catching runaway wagons suggests that the track and safety systems were designed without adequate risk identification having been carried out beforehand. This track system was designed and established over a period (of some length) characterised by major and frequent reorganisation and replacement of personnel. Hence, critical competence relating to conditions at Alnabru S may have been lost, so that circumstances known to involve risk were neither taken into account during design and construction, nor passed on to the operating organisation when the construction was completed.

The barriers established to prevent rail cars without brakes from breaking loose and rolling away from Alnabru have proved insufficient. The Accident Investigation Board Norway recommends that the Norwegian Railway Inspectorate order the National Rail Administration to analyse the operational situation at Alnabru and to establish necessary barriers so that runaway rail cars cannot roll out of the station.
