REPUBLIC OF SERBIA
CENTER FOR INVESTIGATION OF ACCIDENTS IN TRANSPORT
SECTOR FOR INVESTIGATION OF ACCIDENTS IN RAILWAY TRAFFIC
AND INTERNATIONAL COOPERATION
Nemanjina 11, 11000 Belgrade

FINAL REPORT ON INCIDENT INVESTIGATION

Type of incident: Train decoupling
Train number: 8011
Place: Belgrade, area of junction and the stop Pančevački Most
Date: August 03, 2017
Time: 07:55

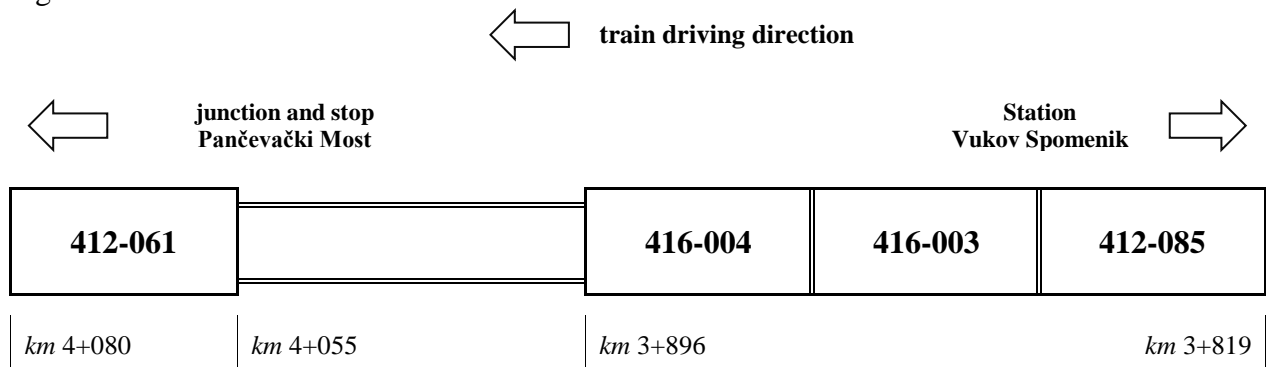
Picture 2.1.2.1: Position of the stopped units of the train No. 8011 after the decoupling

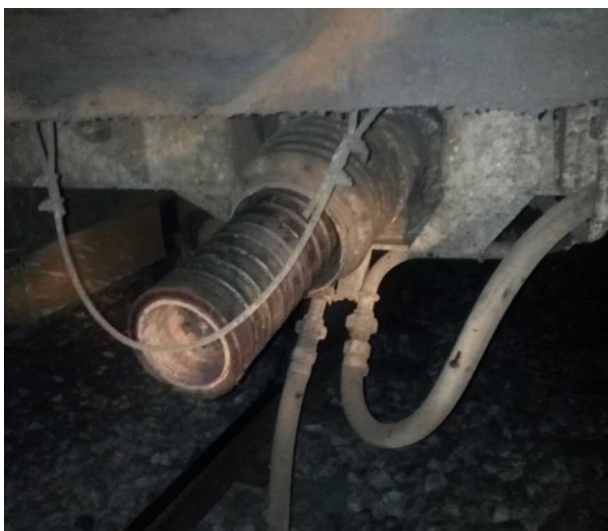
Figure 3.4.4.1: Appearance of a part of the decoupled coupling on the trailer 416-004

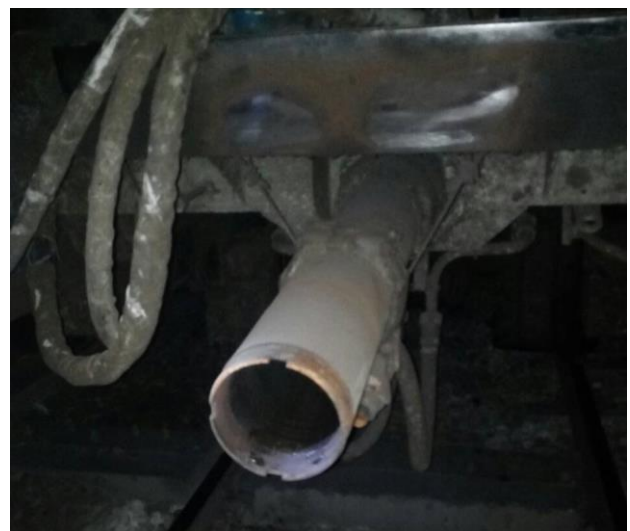
Figure 3.4.4.2: Appearance of a part of the decoupled coupling on the power car 412-061

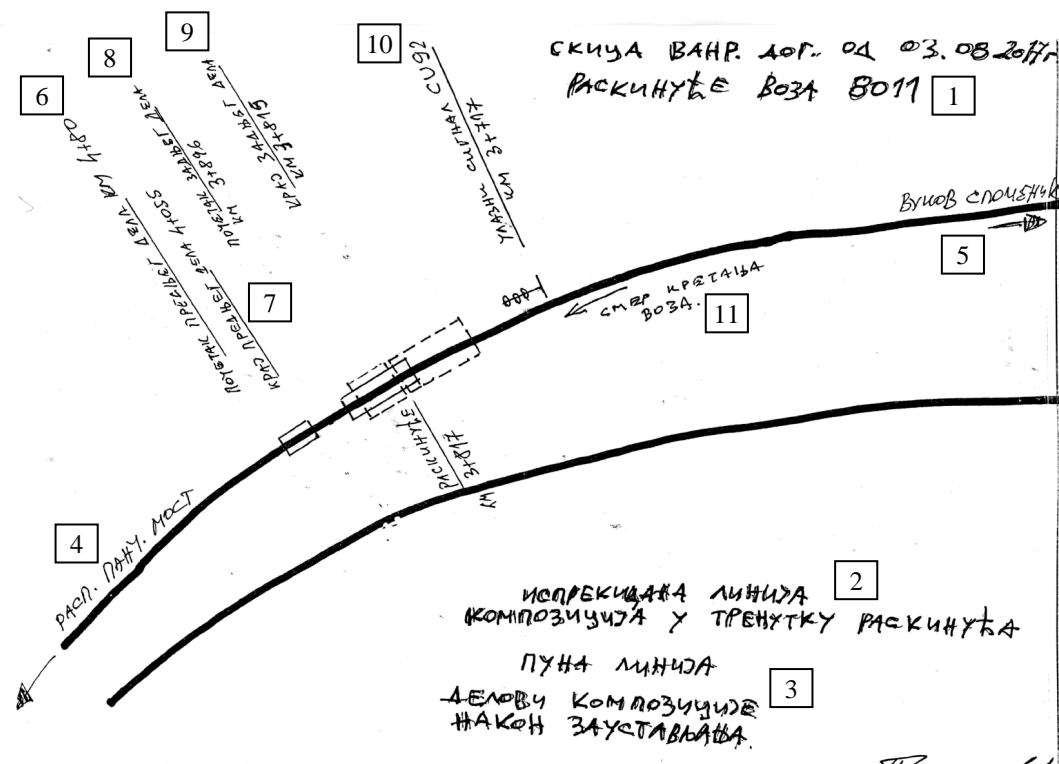
The decoupling occurred between the power car 412-061 and the trailer 416-004, when the air hoses broke and both parts of the train had to force brake due to the emptying of the main overhead line. The position of the decoupled train in which the train was found is shown in figure 4.1.1.

Figure 4.1.1: Sketch of the condition found at the place of the incident (source “IŽS“a.d.)

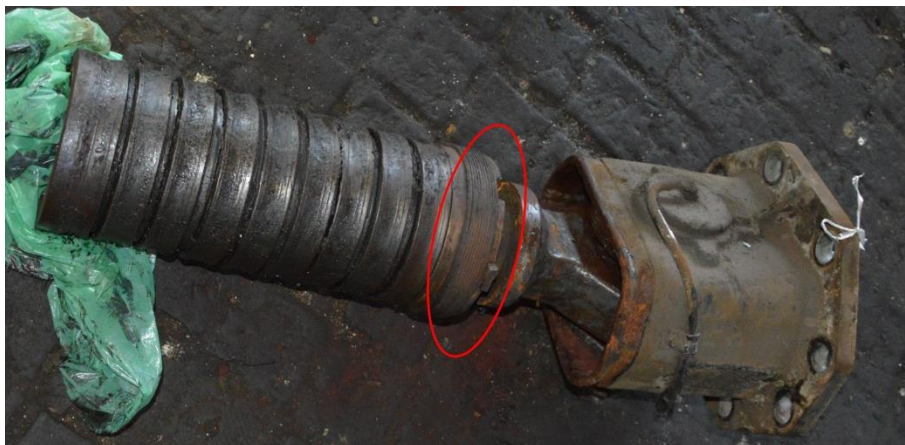
The immediate cause of the incident is wear of a threaded joint between set thread of draw bar and the short coupling box, due to which the threaded joint disconnected during driving.

After the incident, members of the working group have inspected the decoupled coupling, which belongs to the trailer 416-004, in the EMV Maintenance Depo in Zemun. It was determined that the entire set of the traction shaft with the nut onto which the external thread is placed, got out from the housing of the spring, in which the internal thread is fixed. Traces of deformation due to shear or other damage were not found on the internal and also not on the external thread (figures 4.2.3.1. and 4.2.3.2.).

Figure 4.2.3.1: Pulled out set of the draw bar (the thread part is encircled) demounted from the trailer 416-004

- SR_02/18** “Srbija Voz“a.d. should consider the possibility to make structural changes on the couplings between vehicles during regular repairs of EMV 412/416 in order to provide for a back-up alternative force transmission in case that the threaded connection is separated, or to apply other measures to reduce the risk of separation of the threaded joint (explained in item 4.2.3).

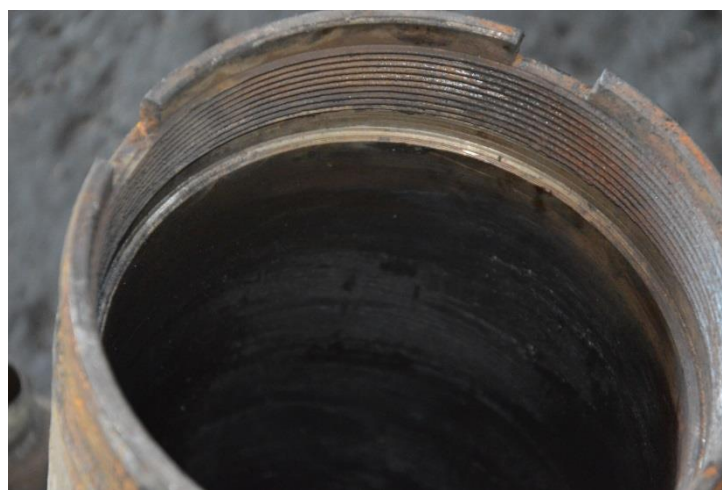
Figure 4.2.3.2: Thread of the housing of the coupling's spring from trailer 416-004

On the nut of the draw bar set, pins remained that serve to prevent self-unscrewing, which indicates that it did not unscrew itself. In the letter No. 19/2017 -1270 dated October 16, 2017, "Srbija Voz" a.d. submitted the Report on Determined Facts on the EMV 412/416-061/085. In the appendix to the records of the commission from the Sector For Rolling Stock Maintenance of "Srbija Voz" a.d, which was submitted to the working group, by performing measurements in four planes it was determined that the middle catch (wrap) of the threaded joint has a radius of less than 0.2 mm, which explains why traces of thread shear cannot be noticed.

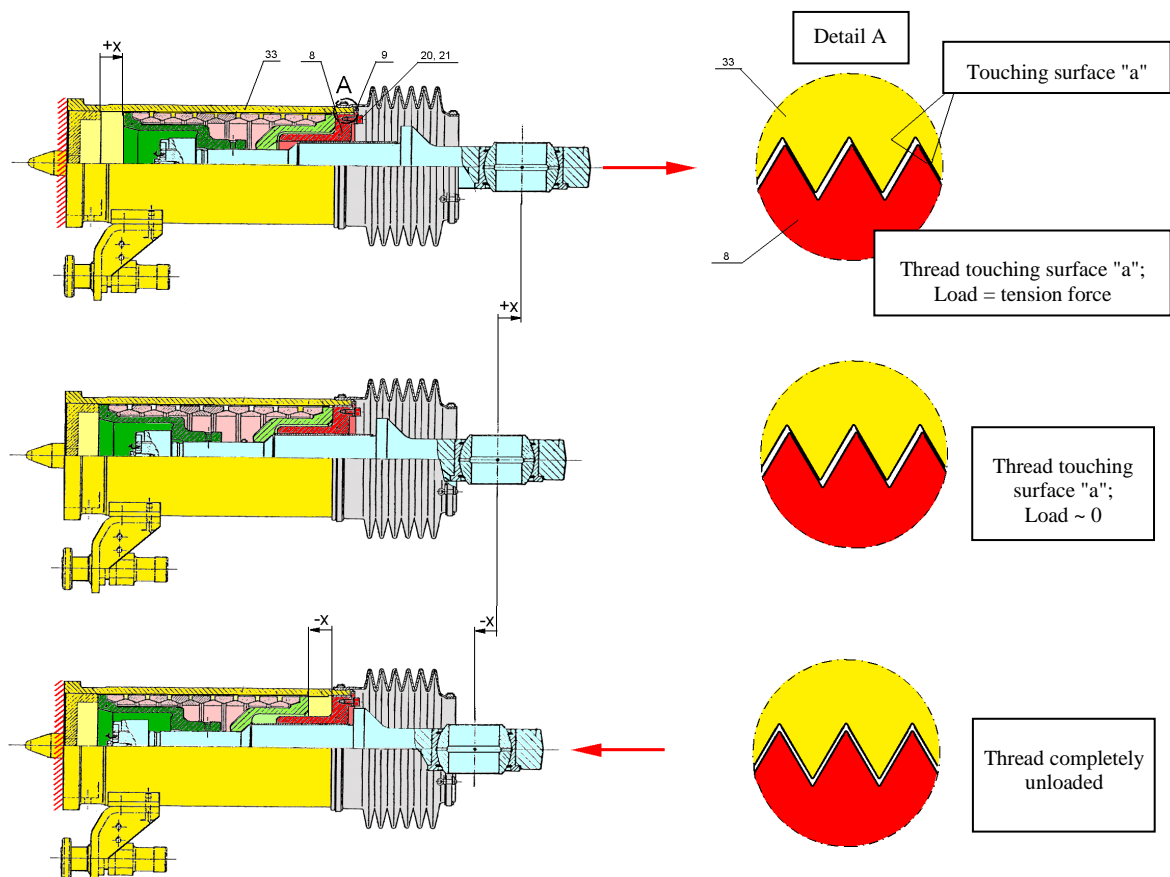
Figure 4.2.3.3: Operation of the threaded joint in use

In figure 4.2.3.3 the set of the tight coupling is shown. In the middle of the figure the correctly mounted coupling is shown in accordance with the Instructions for the Repair of Couplings Between Vehicles, which was prepared by the Institute "Kirilo Savić" in 2004, that is, such that the nut - 8 is tightened until the axial clearance of the draw bar with the spring in the housing of the spring -33 disappears. With the help of pins - 9 and screws - 20, 21 the nut -8 is protected from unscrewing itself.

Detail A shows the corresponding seating of the threaded joint, which is then practically unloaded or insignificantly loaded. If the set of the coupling during the train ride is exposed to the force of pressure, the nut - 8 is completely freed of load and is positioned anywhere in the space of the small mounting clearance (figure 4.2.3.3 down). If during motion the coupling is exposed to the tension force, the thread is touching the surface "a" and transfers the entire tension force (figure 4.2.3.3 up). Therefore, the threaded joint during its use is exposed to an unidirectional variable contact load that slowly causes its wear.

If with the passing of time the thread is so worn that it does not have sufficient catch (wrap) of the external and internal threaded part, the entire set of the draw bar with the nut -8 can get out of the housing -33.

The existing constructive solution has no alternative way to transfer force (disassembly delimiter, catcher, protective plugs and similar), so the separation of the threaded connection leads directly to the breaking loose of the EMV, as has happened in the observed case. The other theoretical possibility to prevent the wear of the thread would be to preload it with a counter-nut in order to prevent the periodical complete unloading of the threaded joint and to eliminate thus its wear. The potential increase of thread pitches could also be a measure to increase the catch of the thread and to reduce the risk to break the connection due to wear.
