REPUBLIC OF SERBIA
CENTER FOR INVESTIGATION OF ACCIDENTS IN TRANSPORT
SECTOR FOR INVESTIGATION OF ACCIDENTS IN RAILWAY TRAFFIC
AND INTERNATIONAL COOPERATION
Nemanjina 11, 11000 Belgrade

FINAL REPORT ON SERIOUS ACCIDENT INVESTIGATION

Type of accident: Serious accident at level crossing
Train No: 4905
Place: Brestovac, area of the swith block of station Brestovac
Date: 21 August 2017
Time: 19:38

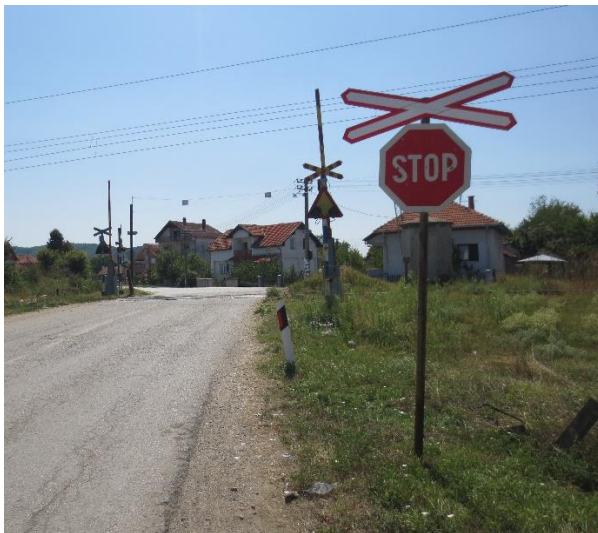
Fig. 2.2.3.1: The view of the crossing (from the direction Brestovac)

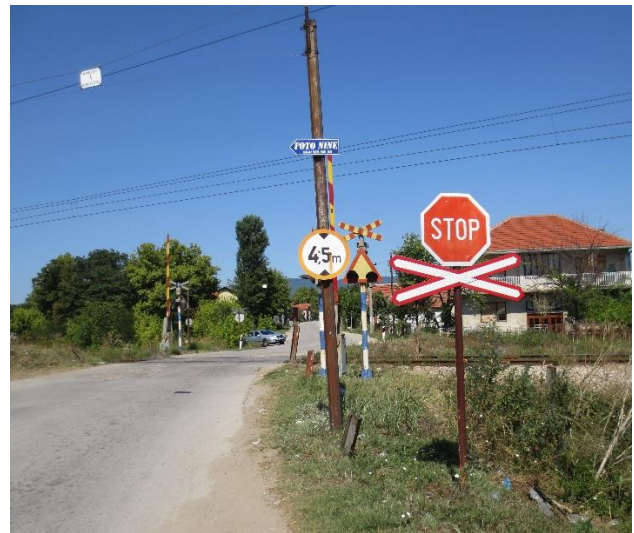
Fig. 2.2.3.2: The view of the crossing (from the direction Kutleš)

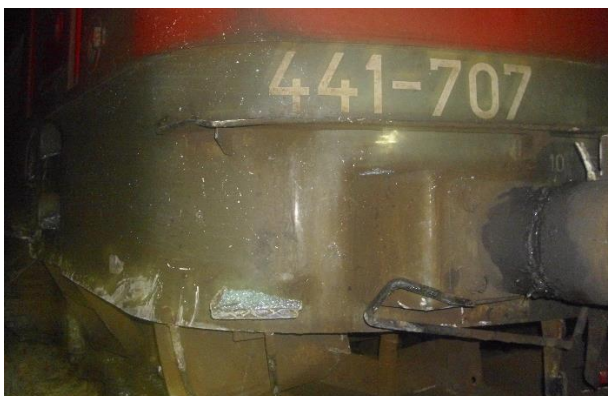
In the accident the railway vehicles (locomotive 441-707) and installations on infrastructure were damaged.

Concerning locomotive 441-707:	500 000,00	RSD
Concerning SS devices:	338 020,56	RSD
Total direct material damage:	838 020,56	RSD

Fig 3.4.4.1: Review of the damage on EMV 441-707

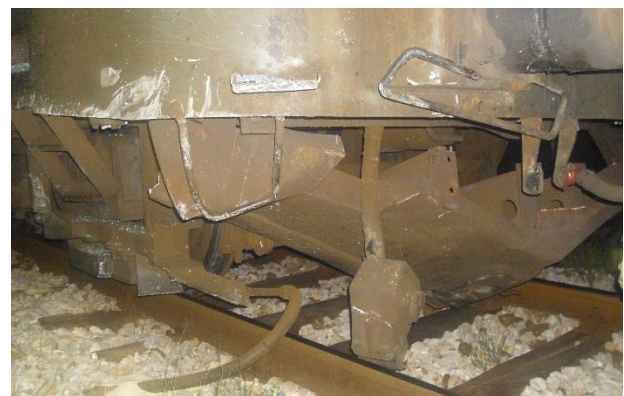
Fig. 3.4.4.2: Review of the damage on EMV 441-707

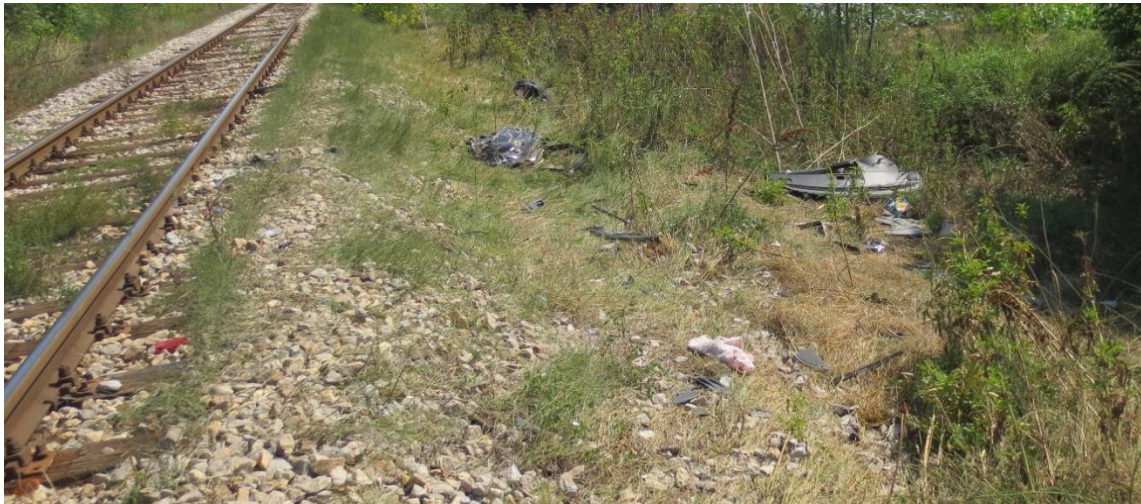
In this serious accident, one person died, two person were seriously injured, and two lightly. On the locomotive and SS devices (insulated section feeder head) there were some damages. The damage on the road vehicle is total.

Fig 4.1.1: The remains of the road vehicle that was a participant of the serious accident

The direct and immediate cause of a serious accident is that the road vehicle entered into the track just before the arrival of the train, thereby creating a dangerous situation of the occurrence of the serious accident. Hazardous situation has occurred due to the fact that the road vehicle toured half-barriers which have been suspended.
