REPUBLIC OF SERBIA
CENTER FOR INVESTIGATION OF ACCIDENTS IN TRANSPORT
SECTOR FOR INVESTIGATION OF ACCIDENTS IN RAILWAY TRAFFIC
Nemanjina 11, 11000 Belgrade

FINAL REPORT ON ACCIDENT INVESTIGATION

Accident type: Trains collision
Train No.: 2990 and 70922
Place: City of Belgrade, municipality Voždovac, settlement Ripanj,
open track between the stations Klenje and Ripanj Tunel
Date: 01.08.2018.
Time: 05:35

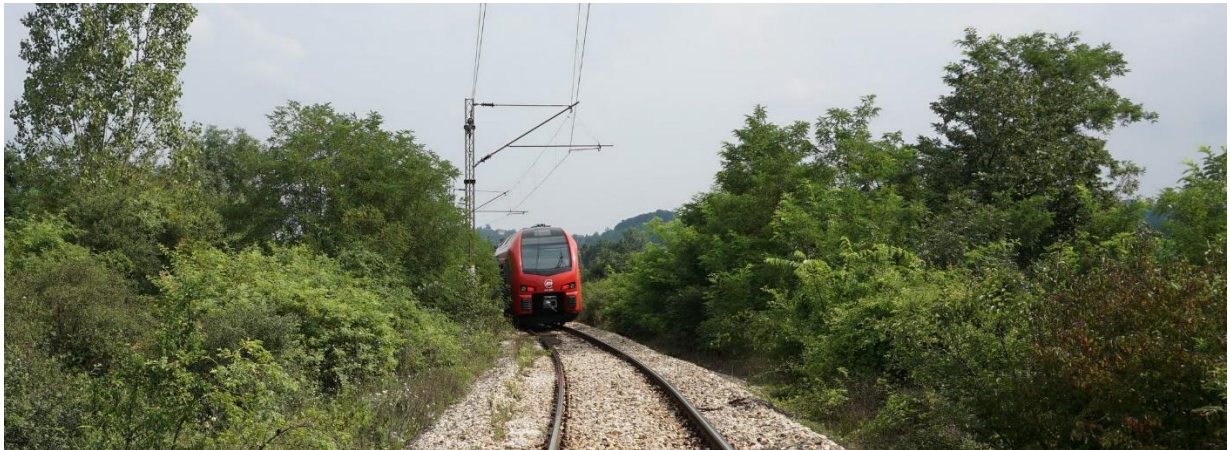
Figure 3.4.2.1: View of the back of the train No. 2990 after the respective accident

By on site investigation, the CINS Working Group, considering the place where the train No. 70922 was stopped (in the left curve, in the direction of movement the train) and on the vegetation present on the left side of the track (Figure 3.4.2.1), determined that from the perspective of the train driver of the train No. 2990, the possibility of detecting an obstacle on the track (stopped train No. 70922) was made difficult.

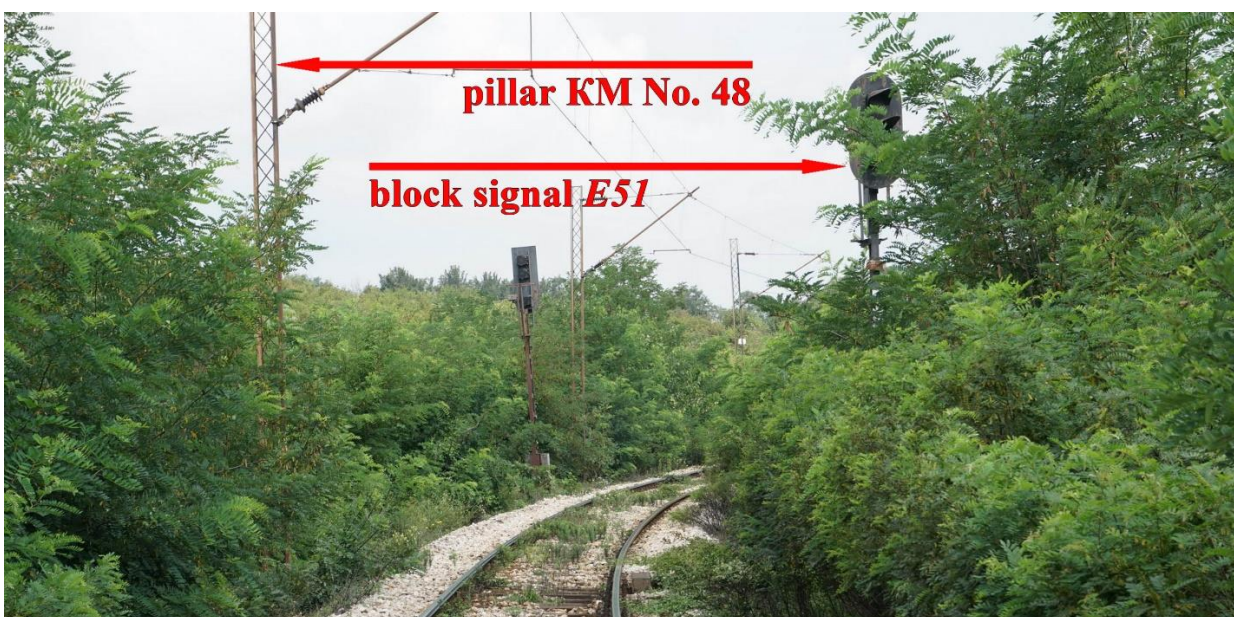
Figure 3.4.2.2: Position of the automatic block signal E 51 opposite the pillar KM No. 48

On-site inspection, the CINS Working Group has determined that the automatic block signal E 51 does not have the prescribed minimum distance of visibility.

Namely, the automatic block signal E 51 is, according to the mileage obtained from the Section for ETP Belgrade, TOJ for SS (Annex 1 of the letter No. 21/2018-1-4079 of 03.10.2018.), built in km 27+730. The automatic block signal E 51 is on the ground opposite the pillar KM No. 48 (Figure 3.4.2.2.). Pillar KM No. 48, according to the mileage obtained from the Section for ETP Belgrade, TOJ for KM (letter No. 21/2018-1-4074 dated 03.10.2018.) is located at km 27+714.

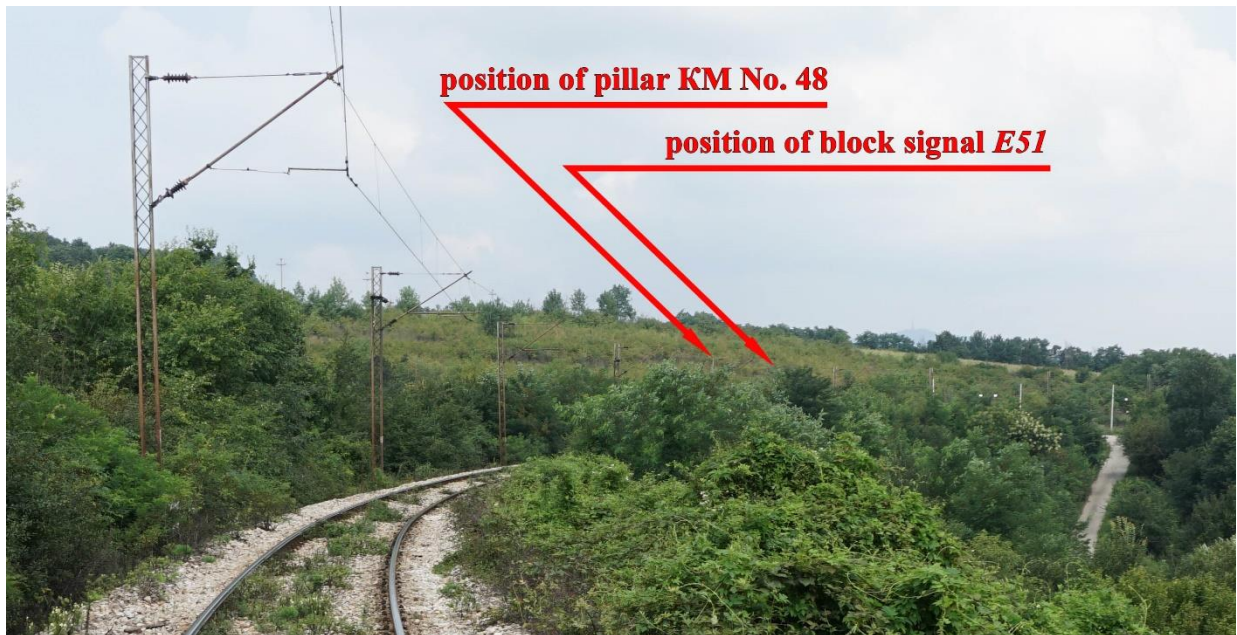
Figure 3.4.2.3: View from the point on the track next to pillar KM No. 53

Looking at the location on the track located: next to the pillar KM No. 53 (at km 27+869 at 155 m from the pillar KM No. 48; Fig. 3.4.2.3.), next to the pillar KM No. 52 (at km 27+839 to 125 m from the pillar KM No. 48; Figure 3.4.2.4.), and in addition to the pillar KM No. 51 (in km 27+804 at 90 m from the pillar KM No. 48; Fig. 3.4.2.5.), it is not possible to notice the automatic block signal E 51, and therefore and an aspect of a signal that the automatic block signal E 51 shows.

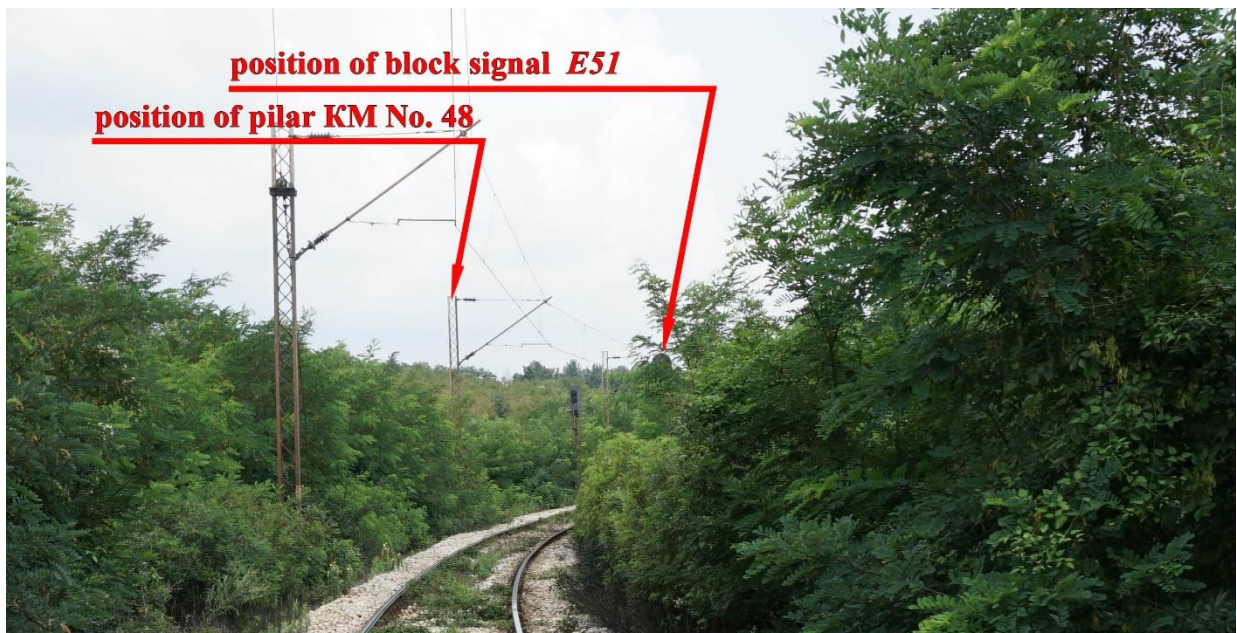
Figure 3.4.2.6: View from the point on the track next to pillar KM No. 50

Looking from the point on the track located: next to the pillar KM 50 (in km 27+74 at 60 m from the pillar KM No. 48; Fig. 3.4.2.6.) it is possible to spot the tip of the automatic block signal E 51, but it is not possible to notice the aspect of a signal which automatic block signal E 51 shows.

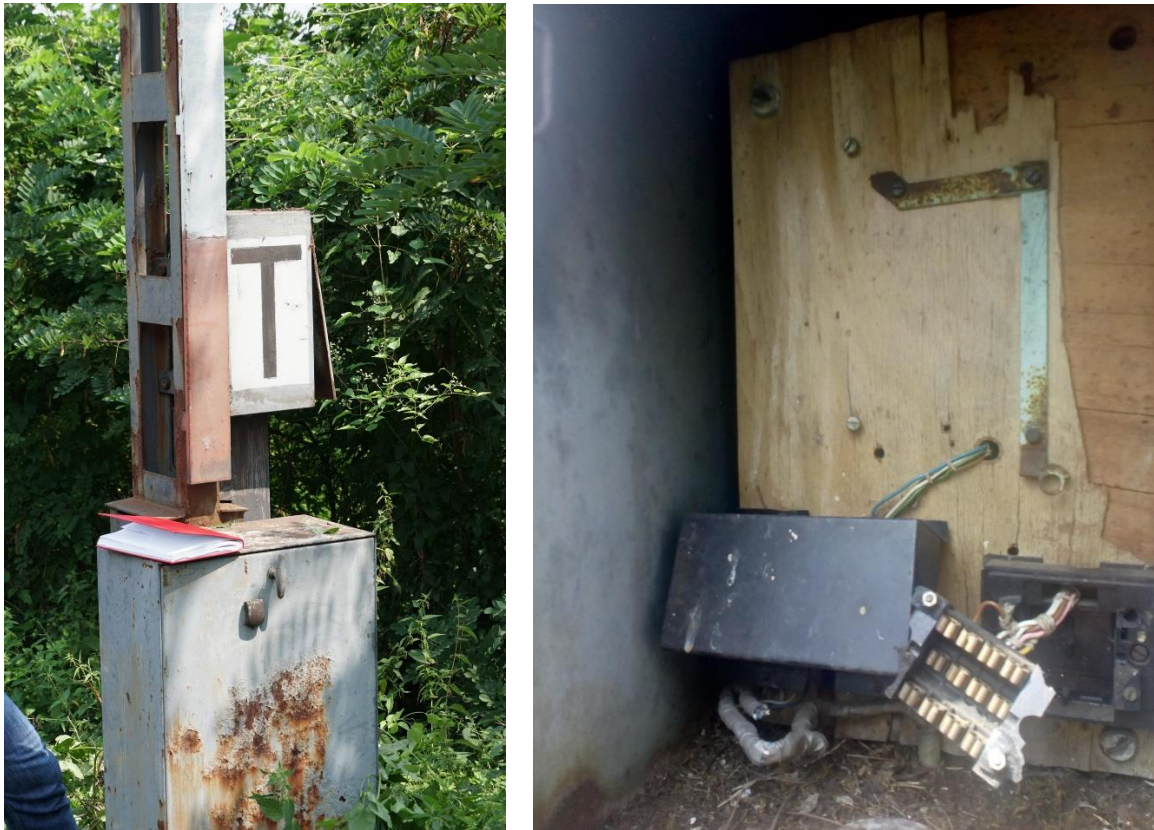
On-site investigation on 01.08.2018. the CINS Working Group established that TT cabinet was fastened to the pillar of automatic block signal E 51. The door of the cabinets was not closed and locked, and there is no phone in the cabinet (Figure 3.4.3.1.).

Figure 3.4.3.1: External and internal appearance of TT cabinet on the pillar of the automatic block signal E 51

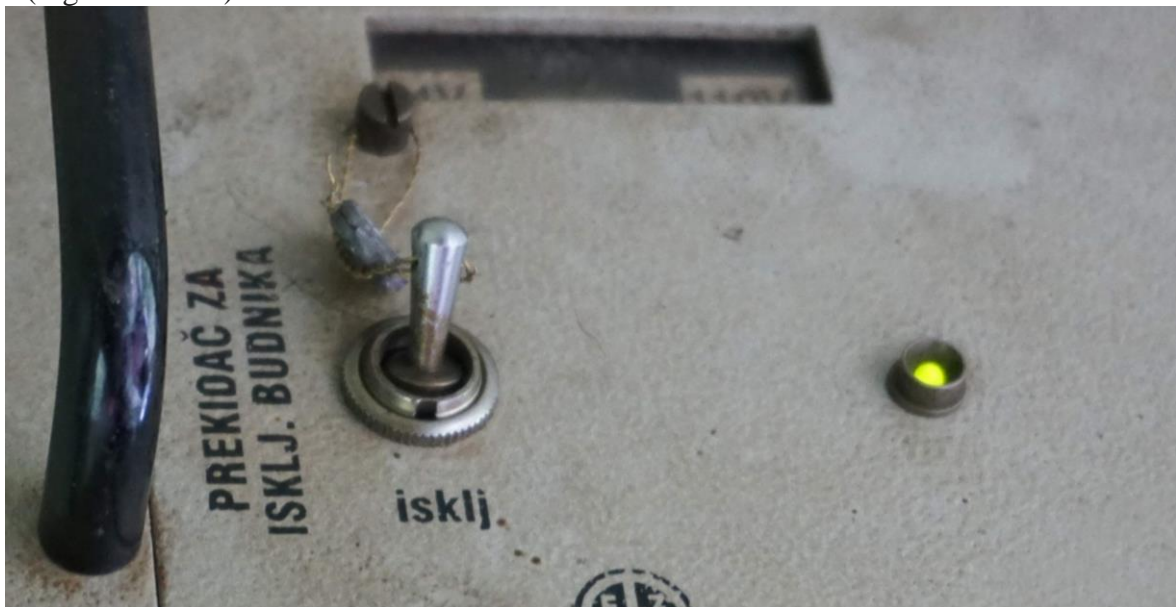
At the site of the respective accident, it was found that on the locomotive 661-162 the switch of the electronic part of the driver's safety device was in the "ON" position, but the state of the seal was such that it was possible to place the switch in the "OFF" position without damaging the seal (Figure 3.4.4.1.).

Figure 3.4.4.1: View of the switch of the electronic part of the driver's safety device on the locomotive. 661-162

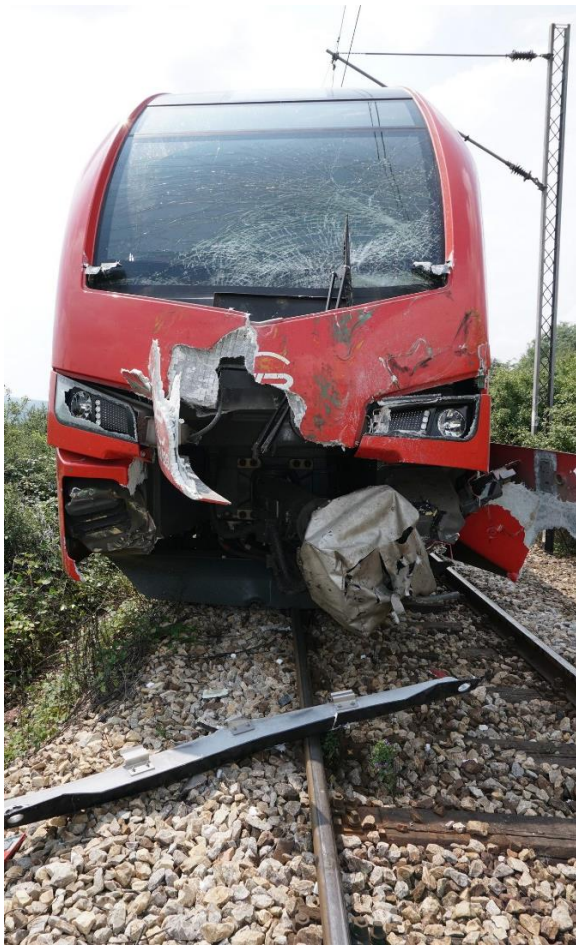
Figure 3.4.4.2: External part of the head of the train No. 2990

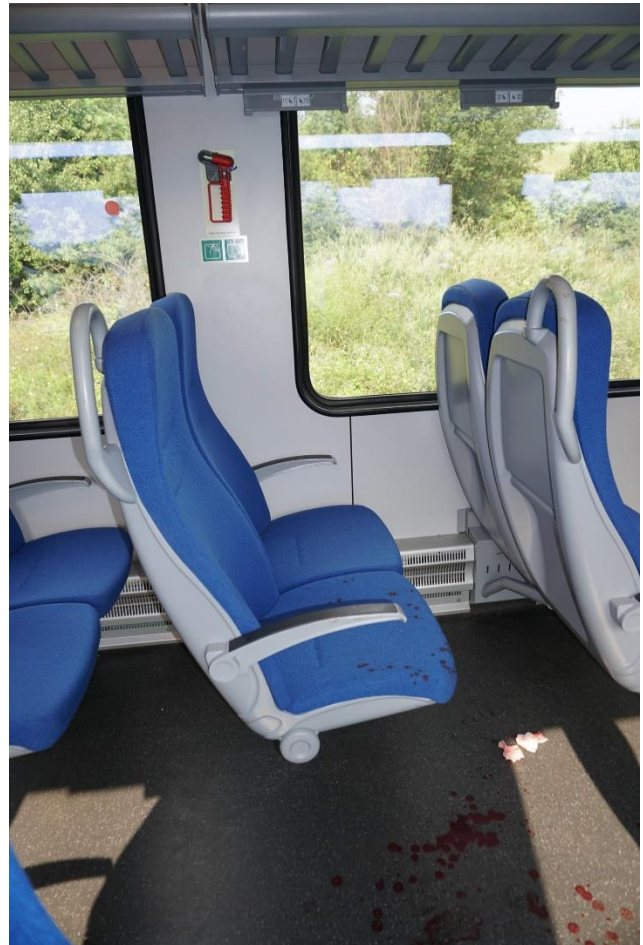
Figure 3.4.4.3: Appearance of the passenger compartment of the train No. 2990

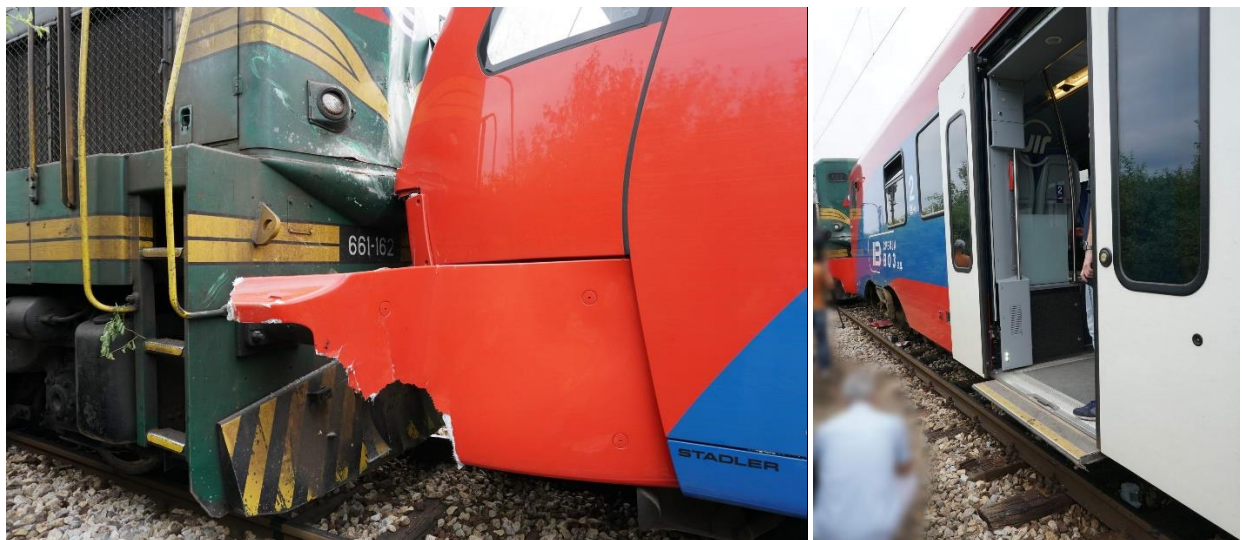
After the collision, the trains moved in the length of 19 m, after which they stopped. On that occasion, the EMV 413/417-033/034 from the train No. 2990 derailed with a single bogie (the first bogie in the direction of movement).

Figure 4.1.1: Appearance of the train collision

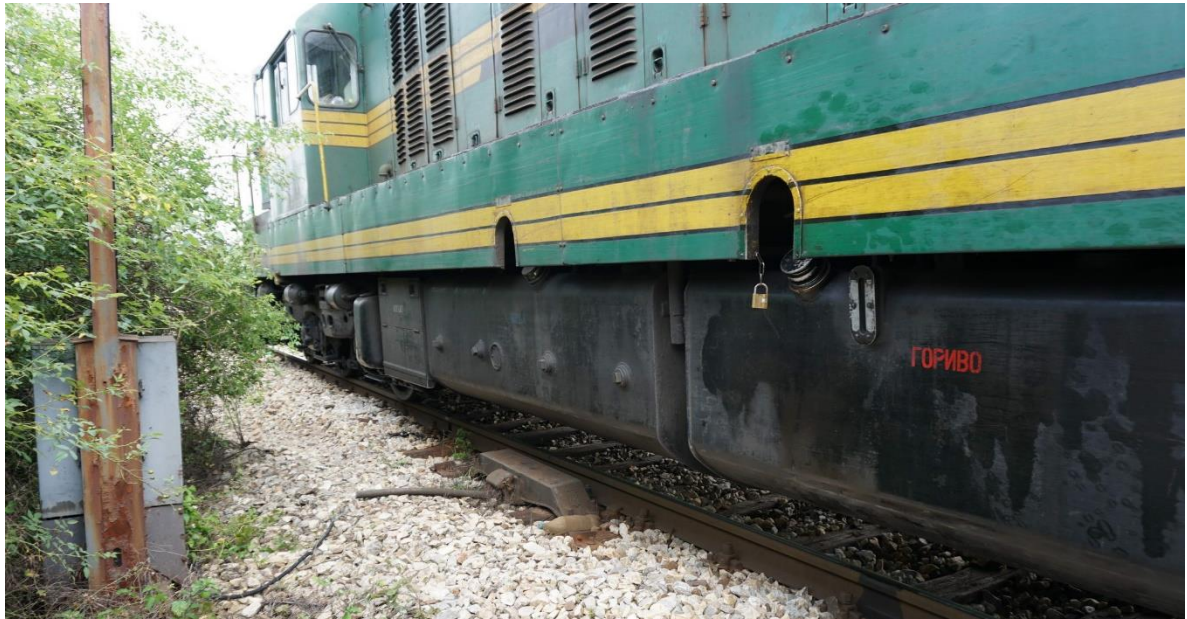
On the site, locomotive 661-162 was found, so that the center of the locomotive was opposite the automatic block signal E 42 (Figure 4.1.2.). All wheels of the locomotive were found on the track (they did not derail).

Figure 4.1.2: Appearance of the part of the locomotive 661-162

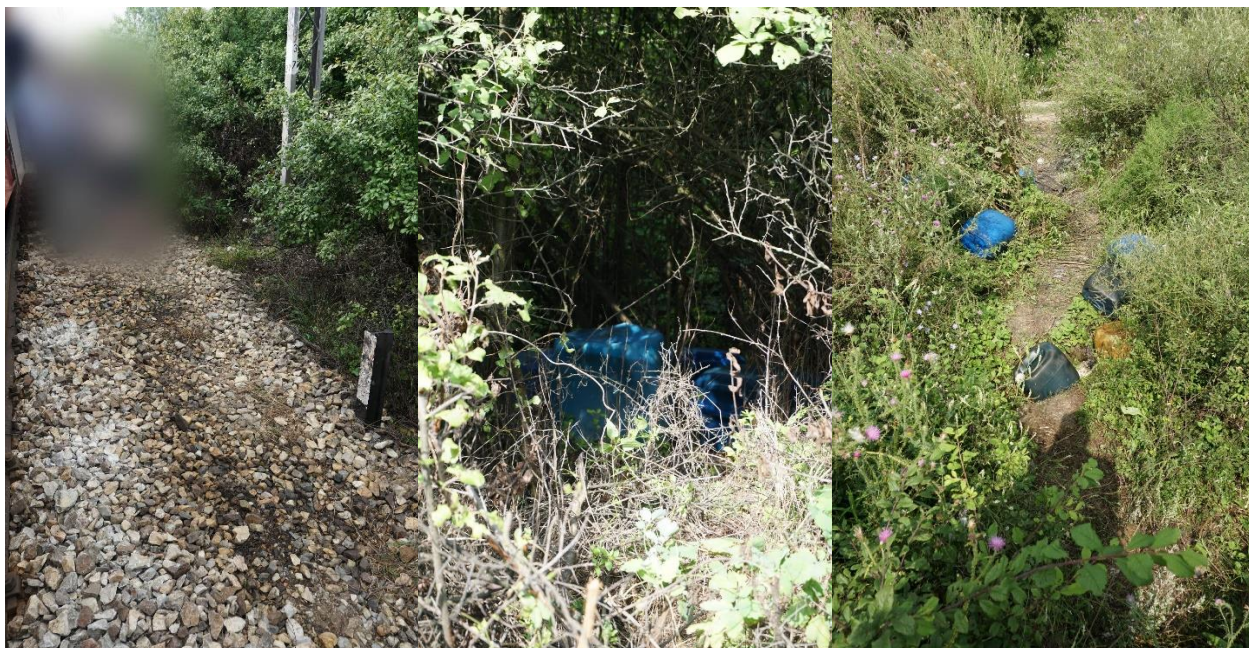
On the crushed stone next to the track, on the left side, in the direction of movement of the train, between the automatic block signal E 42 and the pillar KM No. 37, a grease stain was found smelling in a similar way like the smell of diesel fuel. Near the pillar KM No. 37 in the shrub near the railway and on the track that connects the track and the path that runs parallelly with the track, a large number of scattered plastic canisters was noted. (Figure 4.1.3.).

Figure 4.1.3: Appearance of the stain and plastic canisters spotted near the accident site

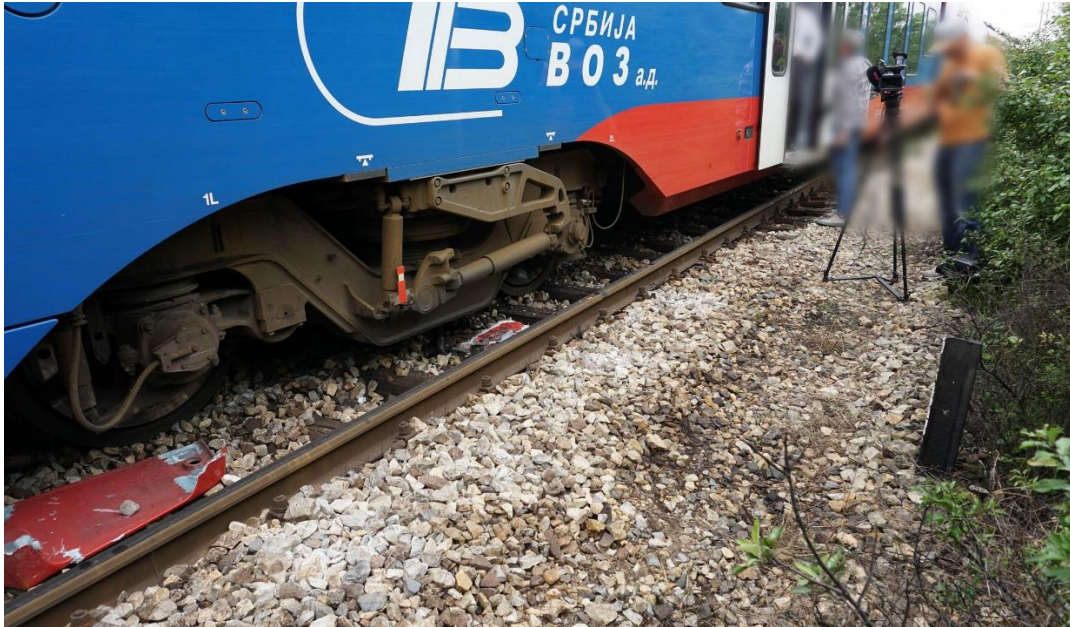
EMV 413/417-033/034 was found so that the forehead of motor wagon 413-033 was leaned on the end of the locomotive 661-162 (Figure 4.1.1.). The first bogie of the motor wagon 413-033 derailed to the right, looking in the direction of the train movement. Other EMV bogies were found on the track (Figure 4.1.4.)

Figure 4.1.4: Appearance of the derailed bogie EMV 413/417-033/034

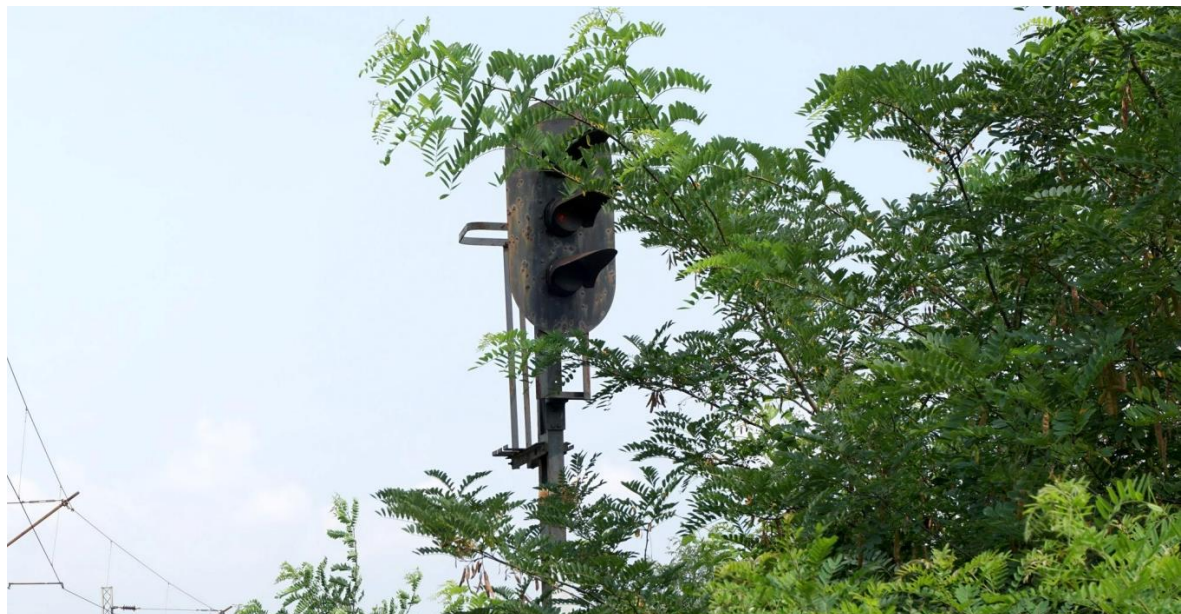
Fig. 4.1.5: Appearance of the automatic block signal E 51

Automatic block signal that the trains Nos. 70922 and 2990 past before the collision is E 51. After the collision, by the on site investigation of the Working Group of CINS, it was determined that the automatic block signal E 51 was showing the aspect of a signal 4:“Stop“ (Fig. 4.1.5.).

From the point where the CINS Working Group could spot an aspect of a signal that shows the E 51 automatic block signal, it was possible to spot it, but the intensity of the red light lantern was very weak. For the specified automatic block signal, the prescribed minimum distance of visibility is not provided (see point 3.4.2).

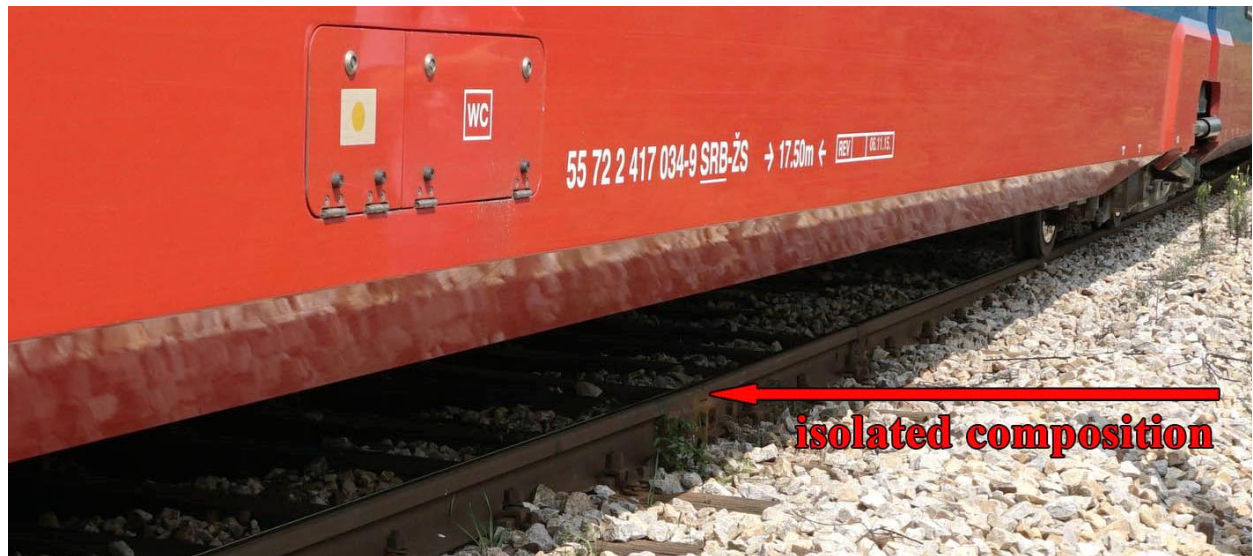
The isolated composition between the automatic block sections IpE3 and IpE4 is located below the trailer 417-034 (Figure 4.1.6.). Regarding the location of the collision and the length of the EMV, it was established with certainty that the locomotive 661-162 was located within the automatic block section IpE3 at the time of the occurrence of the respective accident.

Figure 4.1.6: Position of the isolated composition between the automatic block sections *IpE3* and *IpE4* relative to the EMV 413/417-033/034
