Rail Accident Investigation Branch

# Rail Accident Report

## Accident at Leatherhead 29 August 2007

Report 19/2008  
October 2008

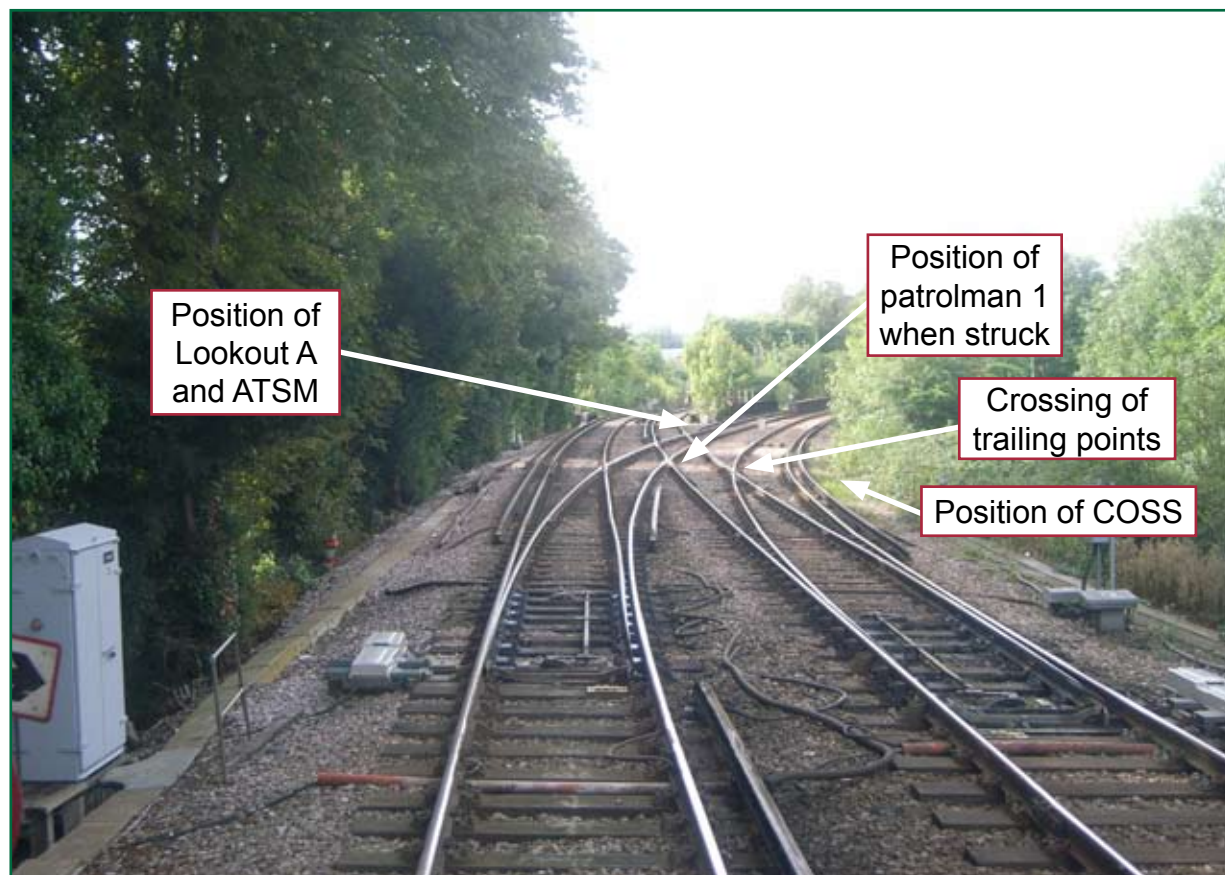
Figure 2: The site of the accident, from the front of a train going towards the Down Bookham line

- 18 At Leatherhead junction the double track line to Guildford via Bookham (the Bookham lines) diverges from the Portsmouth lines to the right (west) via a conventional *double junction* consisting of two sets of *points* and a fixed *diamond*. The radius of the curve on the Bookham lines is approximately 300 m.

- 19 Some 300 m beyond the junction both the Portsmouth and Bookham lines cross the river Mole on viaducts. There is dense tree cover on the embankments between the station and the river Mole, which restricts sighting distances around the curve on the Bookham lines.

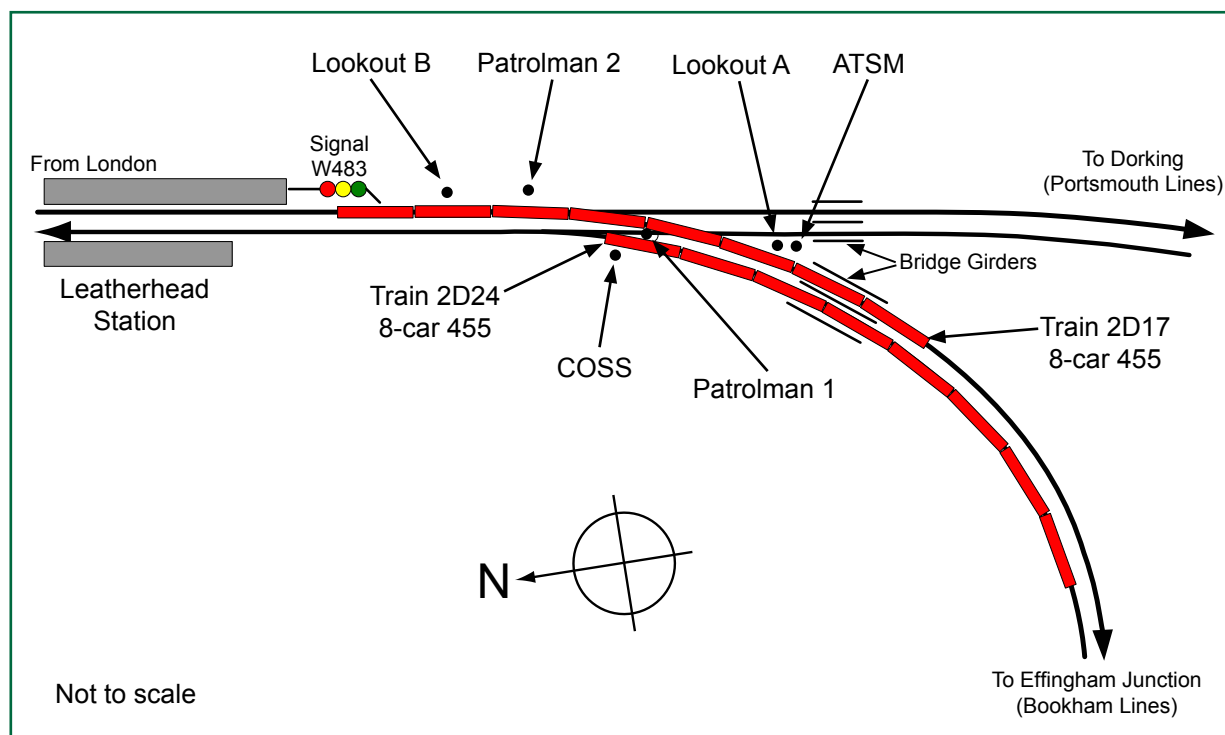
34 Patrolman 1 had received injuries to his head, back and legs. He was unconscious and was lying between the up and down Bookham lines, trapped under the current collection equipment of the train which had struck him. No-one else was injured, but the other members of the gang were severely shocked by what had happened.

Figure 3: Diagram showing the positions of people and trains immediately after the accident

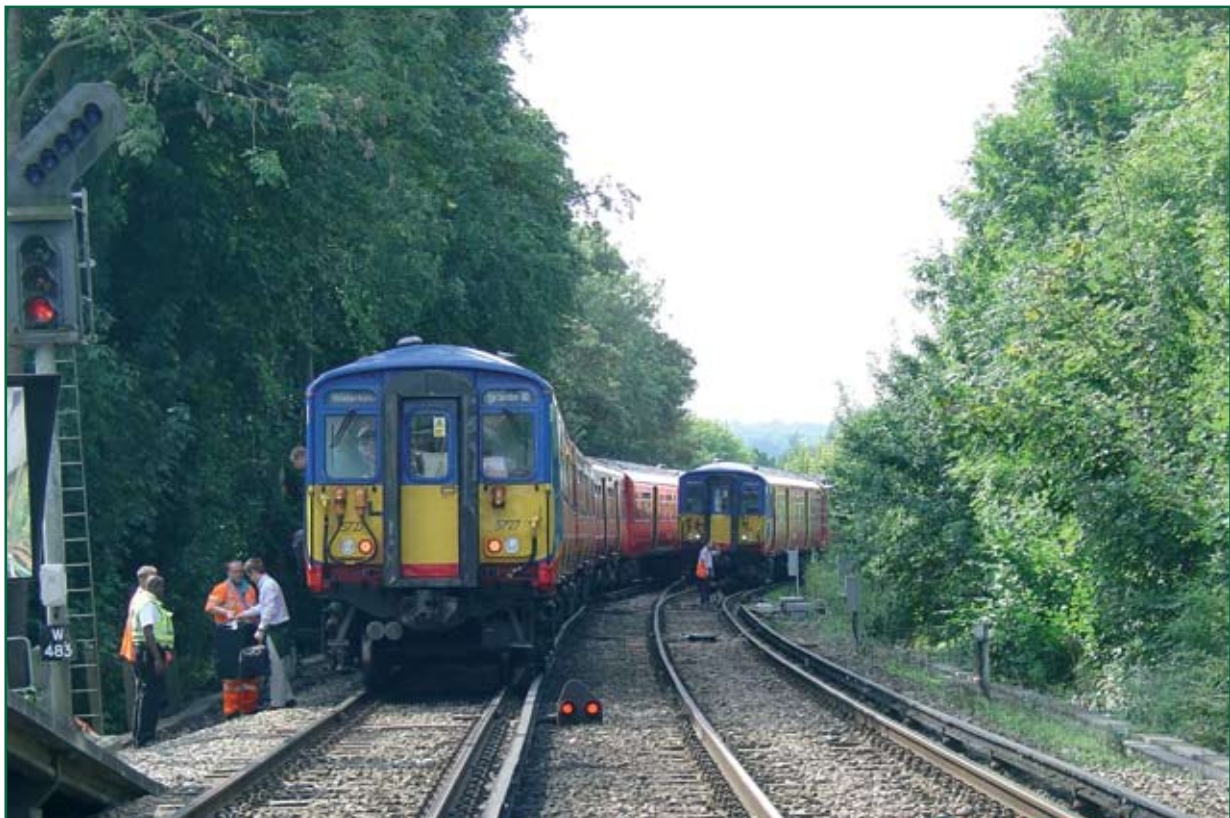
*Figure 4: The scene following the accident, showing trains 2D17 (left) and 2D24. Passengers are being escorted off 2D17*

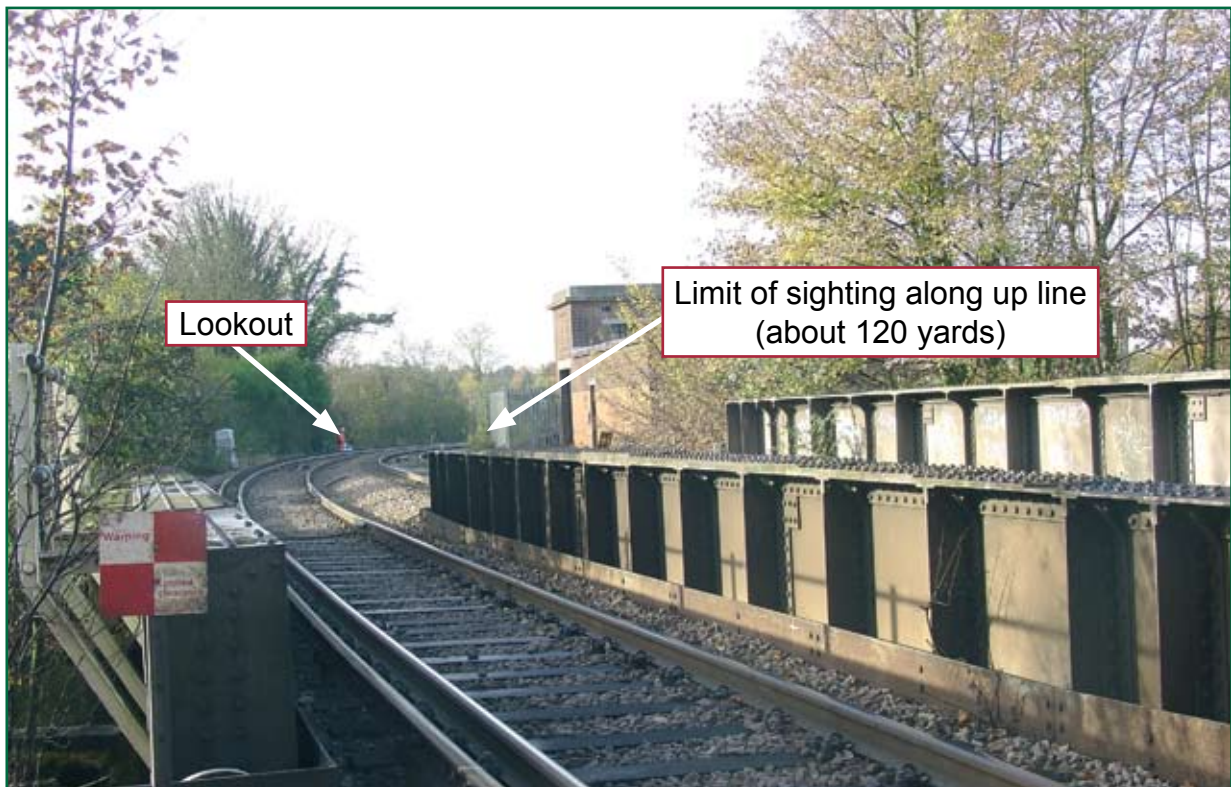
Table 1: Sighting distances and warning times

Figure 5: View along the Bookham lines from the position where Lookout A was standing in the vee of the junction

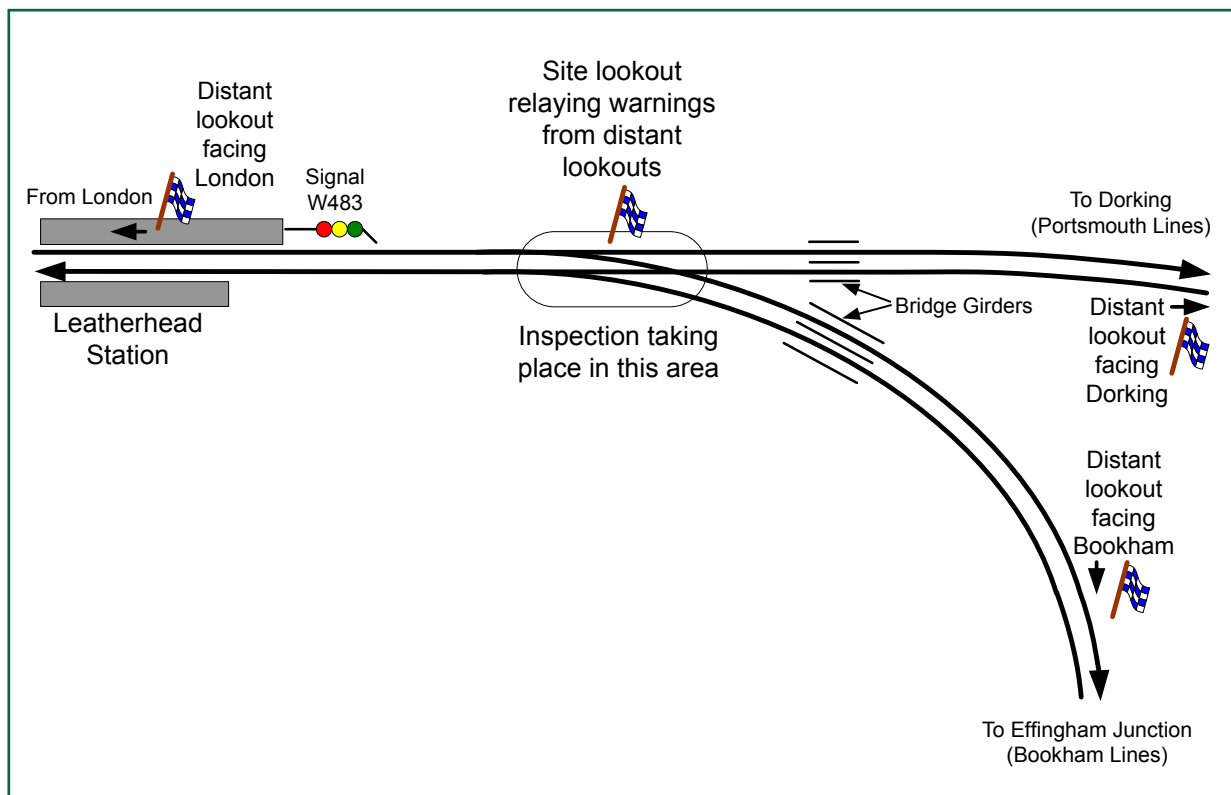
### The parties involved

Figure 6: Positioning of lookouts for giving adequate warning of trains approaching Leatherhead junction
