Safety Investigation Report

Derailment of a wagon of a freight train

Bressoux - 29/08/2022

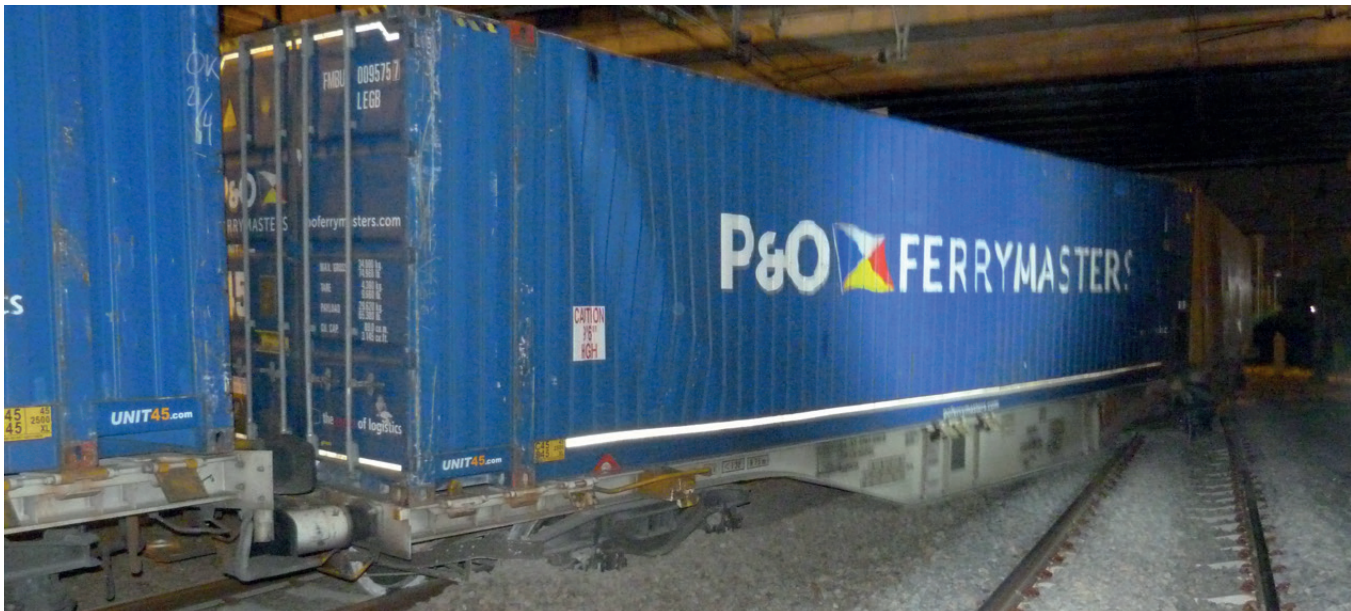
Approximately 2 kilometres after the Froidmont tunnel, at the entrance to the Bressoux station, the train runs over a switch: the first part of the train up to the sixth wagon continues its journey on track A of line 40, while the second part of the train (from the derailed wagon onwards) moves to the lead track of the Bressoux fan of sidings. The two parts of the train separate and the brake pipe ruptures. This rupture causes an emergency braking, bringing both parts of the train to stop.

There are no casualties, but the accident caused extensive damage::

- to the track over a distance of around 2 km
- to the sixth and seventh wagons.

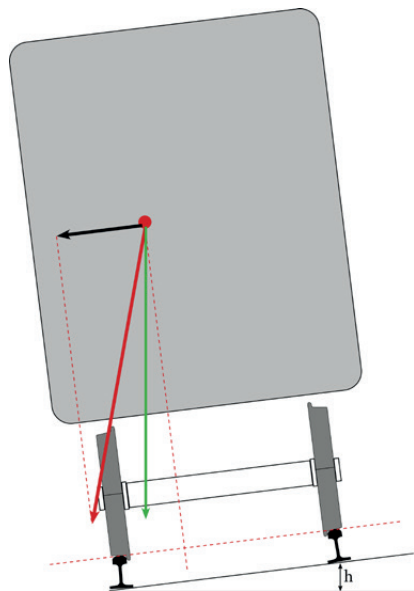
In a curve, a wagon is pushed by the centrifugal force towards the outside of the curve, causing an imbalance between the wheels on the inside of the curve and those on the outside. To counteract this, a curved track is generally laid at an angle that depends on the radius of curvature: the outer rail is raised sufficiently so that each rail supports approximately the same wheel load. The difference in level between the two rails is called the "cant". The cant is calculated for a specified design velocity.

In the Froidmont tunnel, the curved track was laid with a cant (h) calculated for a design velocity of 90 km/h.

When running at low speed with a load not centred laterally (the cellulose bales are positioned on the left against the wall of the container):

- centrifugal force is not as high
- the resultant of the forces involved is directed towards the inside of the curve.

It is assumed that the incorrect positioning of the load of cellulose bales in the container contributed to the centre of gravity moving towards the inside of the curve. Consequently, the resultant of the forces caused the offloading of the right-hand wheels on the first bogie of the wagon, lifting the wheels and causing them to derail.

The Investigation Unit recommends the National Safety Authority to ensure that all those involved in rail freight transport (infrastructure manager, railway undertakings, shippers, consignors, etc.) engage in a process of reflection and analysis in order to identify the risks associated with the transport of potentially wrongly loaded wagons/containers and implement measures to limit the risks identified.
