Rail Accident Investigation Branch

# Rail Accident Report

**Fatal accident at Tibberton No. 8 footpath  
crossing  
6 February 2019**

Report 13/2019  
October 2019

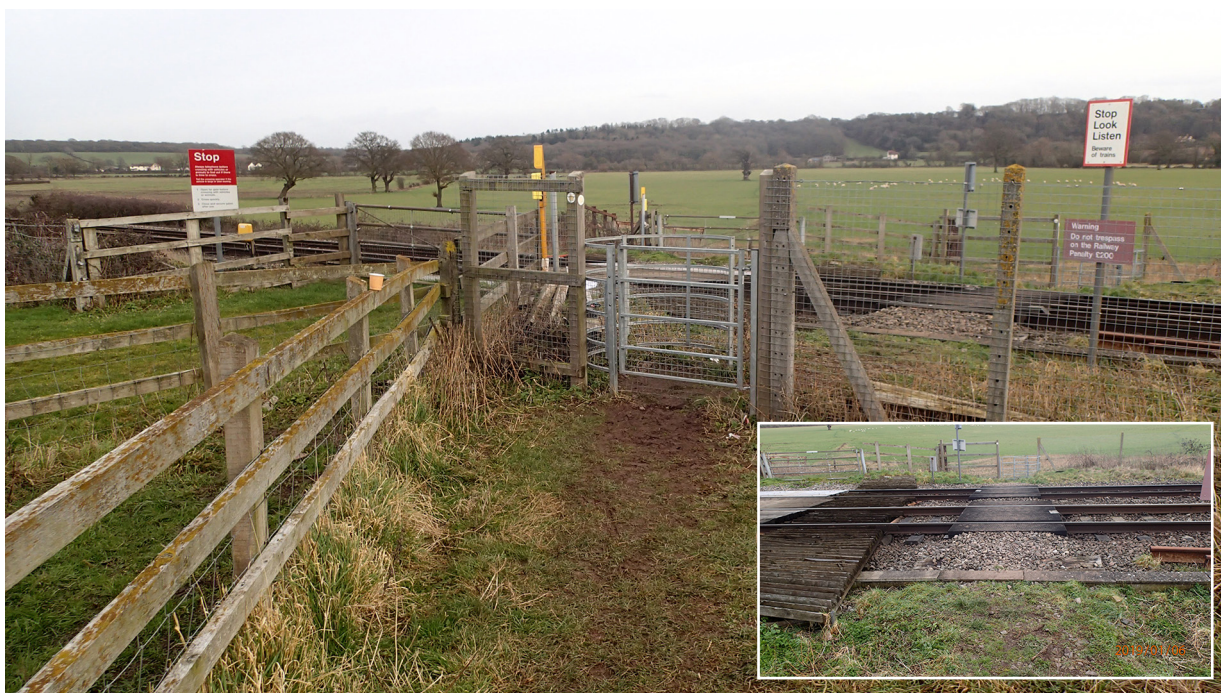
Figure 5: Significant features of Tibberton No. 8 footpath crossing when approaching from the west

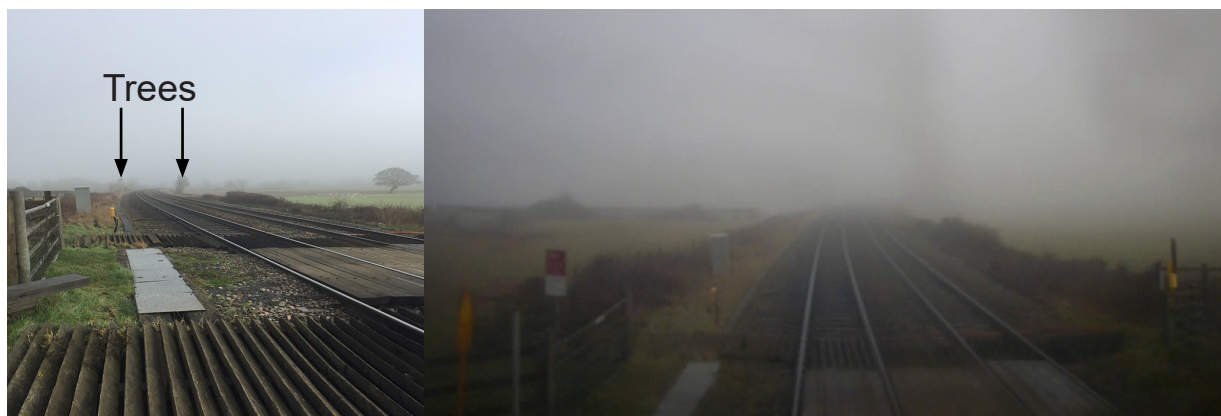
Figure 9: (left) Site conditions at 10:45 hrs and (right) FFCCTV from train 1M29 showing site conditions at 09:58 hrs (left image courtesy of Network Rail, right image courtesy of CrossCountry Trains)

- 64 The CCTV footage from train 1V05 shows how the fog progressively thickened as the train approached Tibberton No. 8 footpath crossing. Based on the footage, the RAIB calculated that the sighting time four kilometres north of Tibberton No. 8 crossing was approximately eight seconds. As the train approached the crossing, the visibility and hence the sighting time reduced to between three and four seconds.
- 65 Railway staff who attended the site took a photograph (figure 9) approximately 45 minutes after the accident (at around 10:45 hrs), at a time when the fog had started to lift. They indicated that at the time of their arrival on site (at around 10:20 hrs), the trees shown on the photograph were not visible.

- 66 A still image in the FFCCTV footage from train 1M29 which passed over the crossing approximately 20 seconds before the accident is shown in figure 9. The same trees cannot be seen on this footage. The trees are about 225 metres away from the crossing which, at a travelling speed of 100 mph (161 km/h), represents 5 seconds of warning time. A second later, the tree on the left-hand side starts to become visible.
- 67 At the time of the accident, the sighting time of a class 170 train<sup>21</sup> from the crossing was therefore between three and four seconds<sup>22</sup>. This is significantly less than the minimum required warning time of 7.6 seconds calculated in the narrative risk assessment.

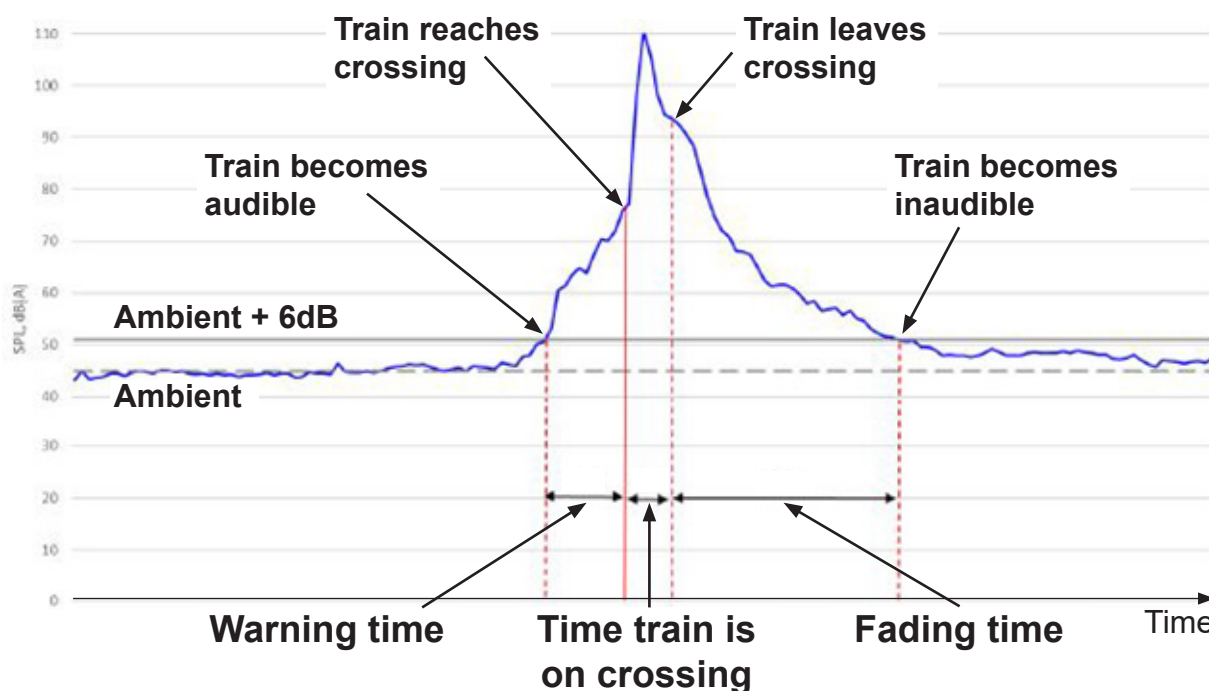
Figure 10: Typical sound trace recorded at Tibberton No. 8 footpath crossing

- 70 Measurements of background sound pressure levels (SPL) were carried out and found to be between 34 and 46 dB, depending on the time of day. The acoustic specialist advised the RAIB that there was no existing standard or research which defined the required difference in sound pressure level to make the general noise caused by an approaching train audible above the ambient noise<sup>23</sup>. Based on his experience, he suggested that a 6 dB difference represented a 'just audible' condition<sup>24</sup> (this being double the sound pressure). A typical sound trace of a train passing the crossing is shown in figure 10.

- 73 Table 1 shows that, depending on the background sound level, the time from a train becoming 'just audible' to the front of it arriving at the crossing varied between three and eight seconds. The time for it to become 'just inaudible' was longer, between eight and seventeen seconds.
- 74 The time from the train becoming 'just audible' to the front of the train reaching the crossing is the audible warning time. Therefore a user standing at the crossing is provided with three to eight seconds of audible warning time for the types of train considered (class 170 and class 220/221), from either direction. For a class 170 train approaching on the down line, as was the case during the accident, the audible warning time was between three and four seconds.
- 75 This is significantly less than the minimum required warning time of 7.6 seconds calculated in the narrative risk assessment.

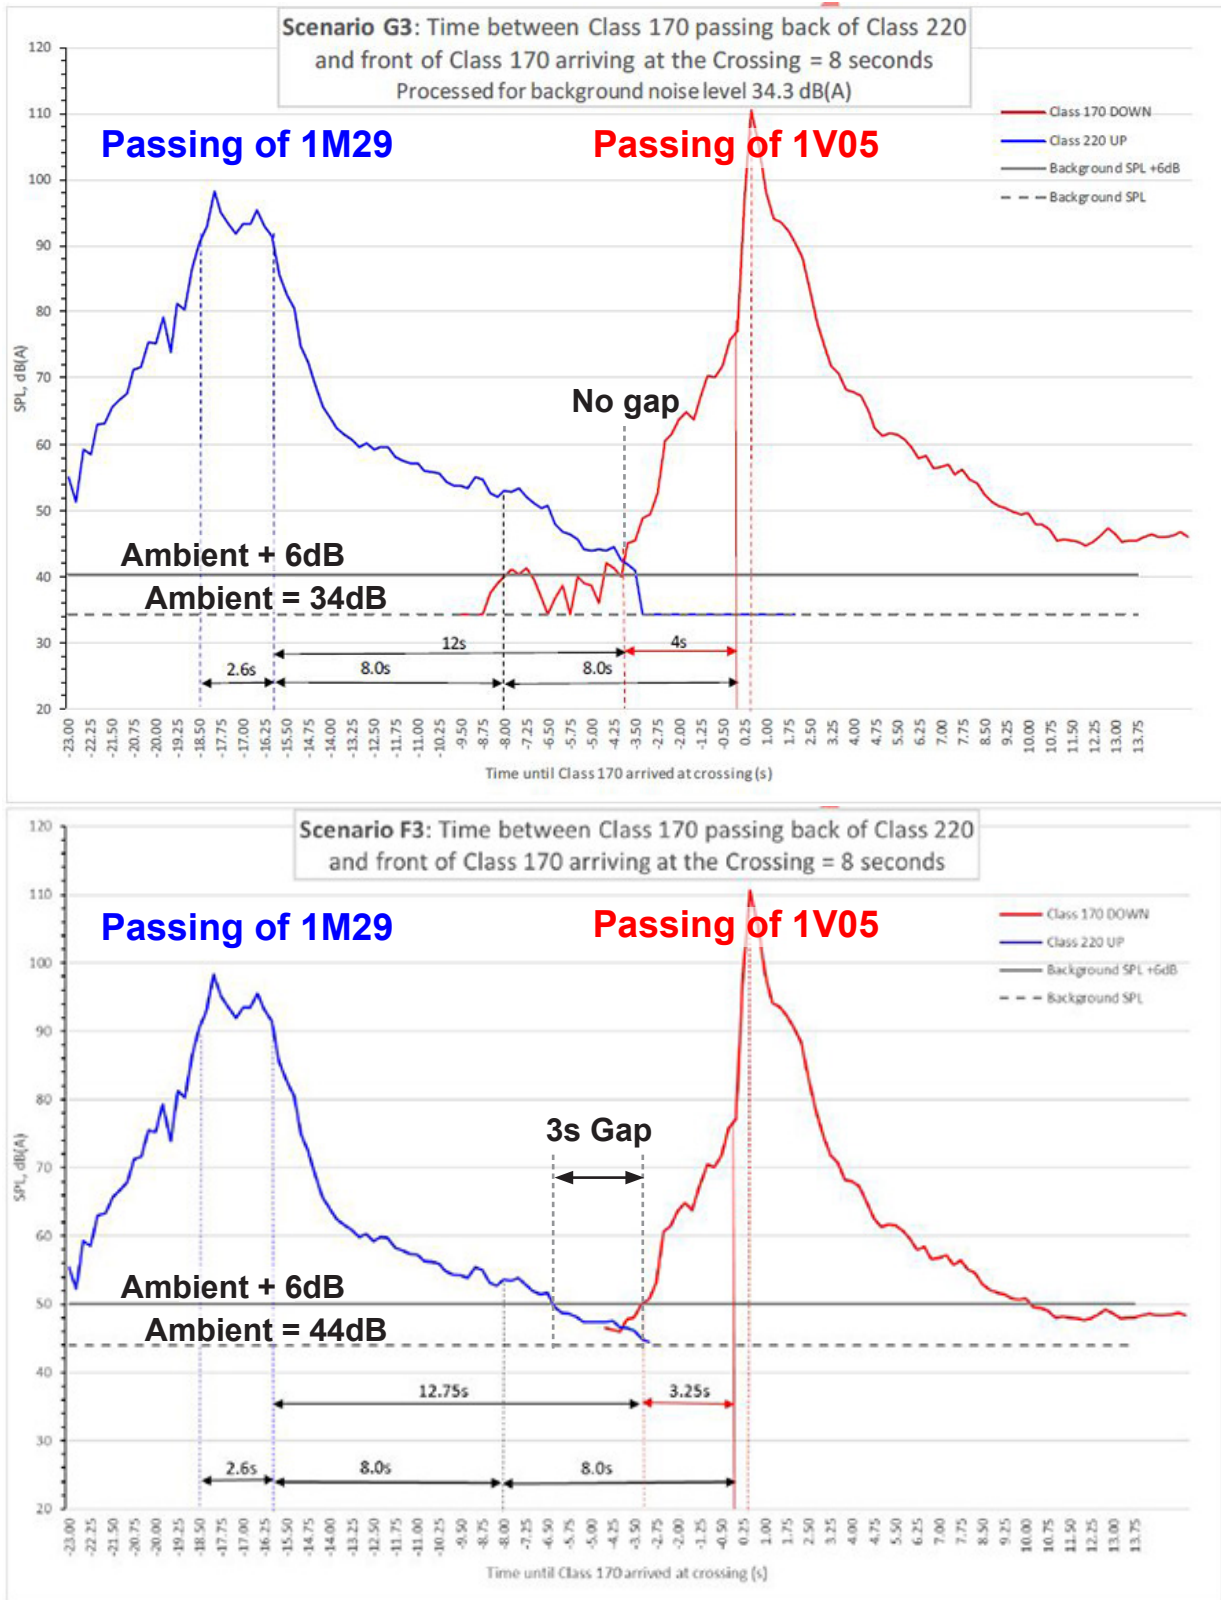
Figure 11: Passing of the two trains (low/high ambient)

- 76 The acoustic study also considered whether the passing of the first train (1M29) audibly masked the approach of train 1V05. The precise sequence of events on the day could not be replicated during the tests. However, using the sound measurement results for a class 170 train travelling on the down line and a class 220/221 train travelling on the up line, the accident scenario was recreated. The sound measurement results were aligned as if the front end of the class 170 train passed the back end of the class 221 train eight seconds before the class 170 train reached the crossing (paragraph 23).
- 77 Figure 11 shows the effect of the ambient sound level on the audibility of the trains for a user standing at the crossing in the scenario on the day of the accident.

- 78 Figure 11 shows that, for a low ambient sound level at 34 dB, the sound of the passing train (1M29) reached the inaudible level just as the sound of the approaching train (1V05) became audible. Figure 11 also shows that, for a higher ambient sound level at 44 dB<sup>26</sup>, the sound from the passing train (1M29) had been inaudible for approximately three seconds before the sound of the approaching train (1V05) became audible.

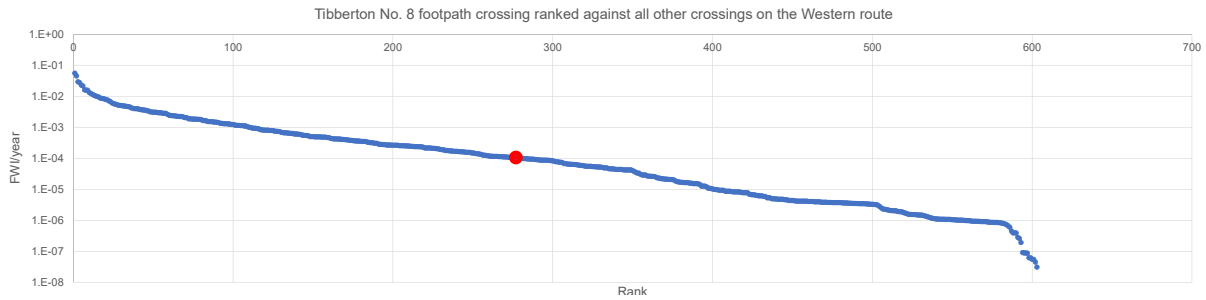
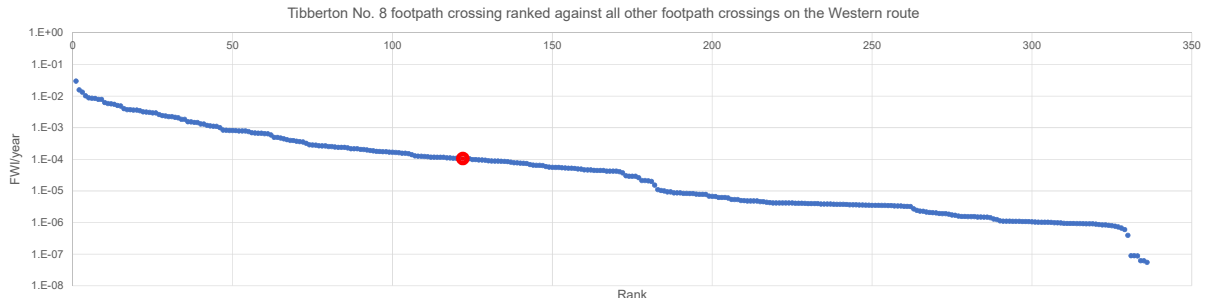
Figure 12a: Tibberton No. 8 footpath crossing ranked against all other crossings on the Western route

Figure 12b: Tibberton No. 8 footpath crossing ranked against all other footpath crossings on the Western route

- 93 Data provided by the Western Route indicates that fog was mentioned in the ALCRM input script for 48 of the 340 footpath crossings, that is one in seven crossings. Tibberton No. 8 footpath crossing was ranked 16 out of 48 footpath crossings for which fog had been identified as a potential risk factor in ALCRM.
- 94 Had fog been coded in the algorithms underpinning ALCRM, those crossings at which it had been identified would have sat higher in the risk ranking. This may have made crossings like Tibberton No. 8 footpath crossing more likely to be considered for investment opportunities.

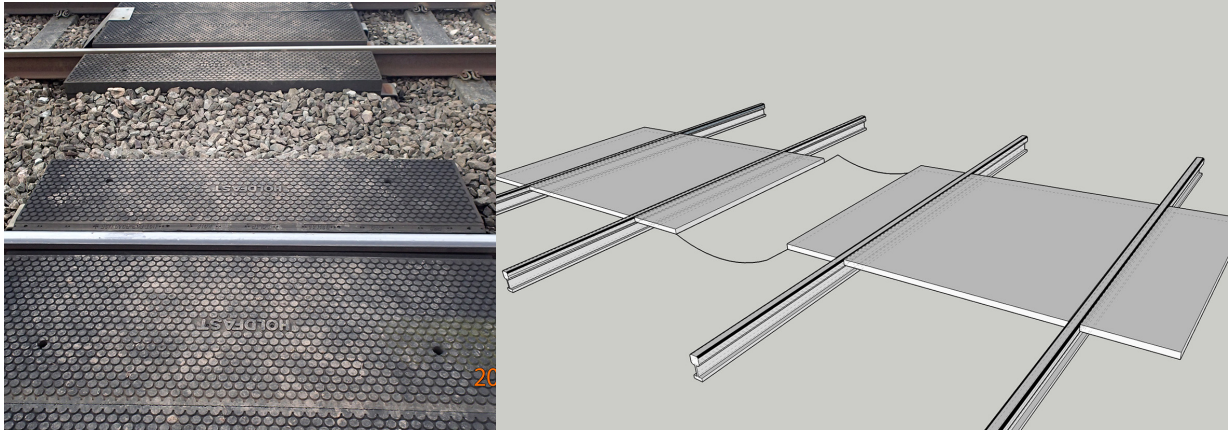
Figure 13: Crossing surface

103 The crossing surface at Tibberton No. 8 footpath crossing was made of two rubberised crossing decks with a gap in the six-foot (figure 13). The gap was approximately 840 mm wide and the ballast at this location was up to 100 mm lower than the crossing surface itself. As such, the crossing surface did not comply with the requirements of NR/L2/SIG/30015.

104 Although the gap and drop in ballast height may have slightly increased the pedestrian's traverse time and directed his attention to the ground, there is no evidence to suggest that this was a factor in this accident.

- 1 Level crossing designers and level crossing managers are reminded that, in accordance with Network Rail's standard NR/L2/SIG/30015, crossing surfaces should be level with the head of the rail, without tripping hazards and gaps greater than 10 mm and constructed from a single type (where track layout permits) (paragraph 116a).
