## TRAIN COLLISION MAASVLAKTE (13 APRIL 2012)

### SUMMARY

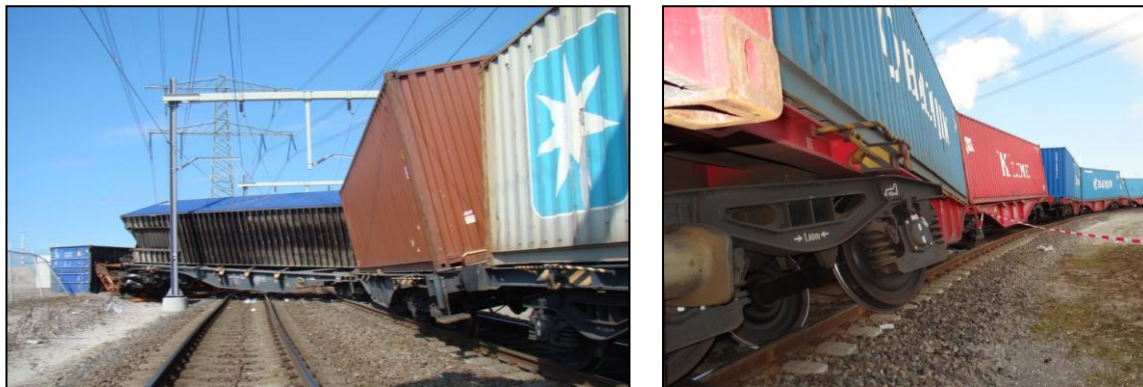
Two of the three train drivers sustained mild injuries as a result of the collision. Both locomotives and some of the wagons/containers also sustained damage, some of which was serious. One of the locomotives and twelve (of the 48) wagons were derailed. The railway infrastructure was also damaged over a stretch of some six hundred metres. According to a global estimate, the direct damage to the rolling stock and railway infrastructure totalled between five and ten million euro's. No hazardous substances were released.

Figure 1: These two photos show some of the derailed wagons.

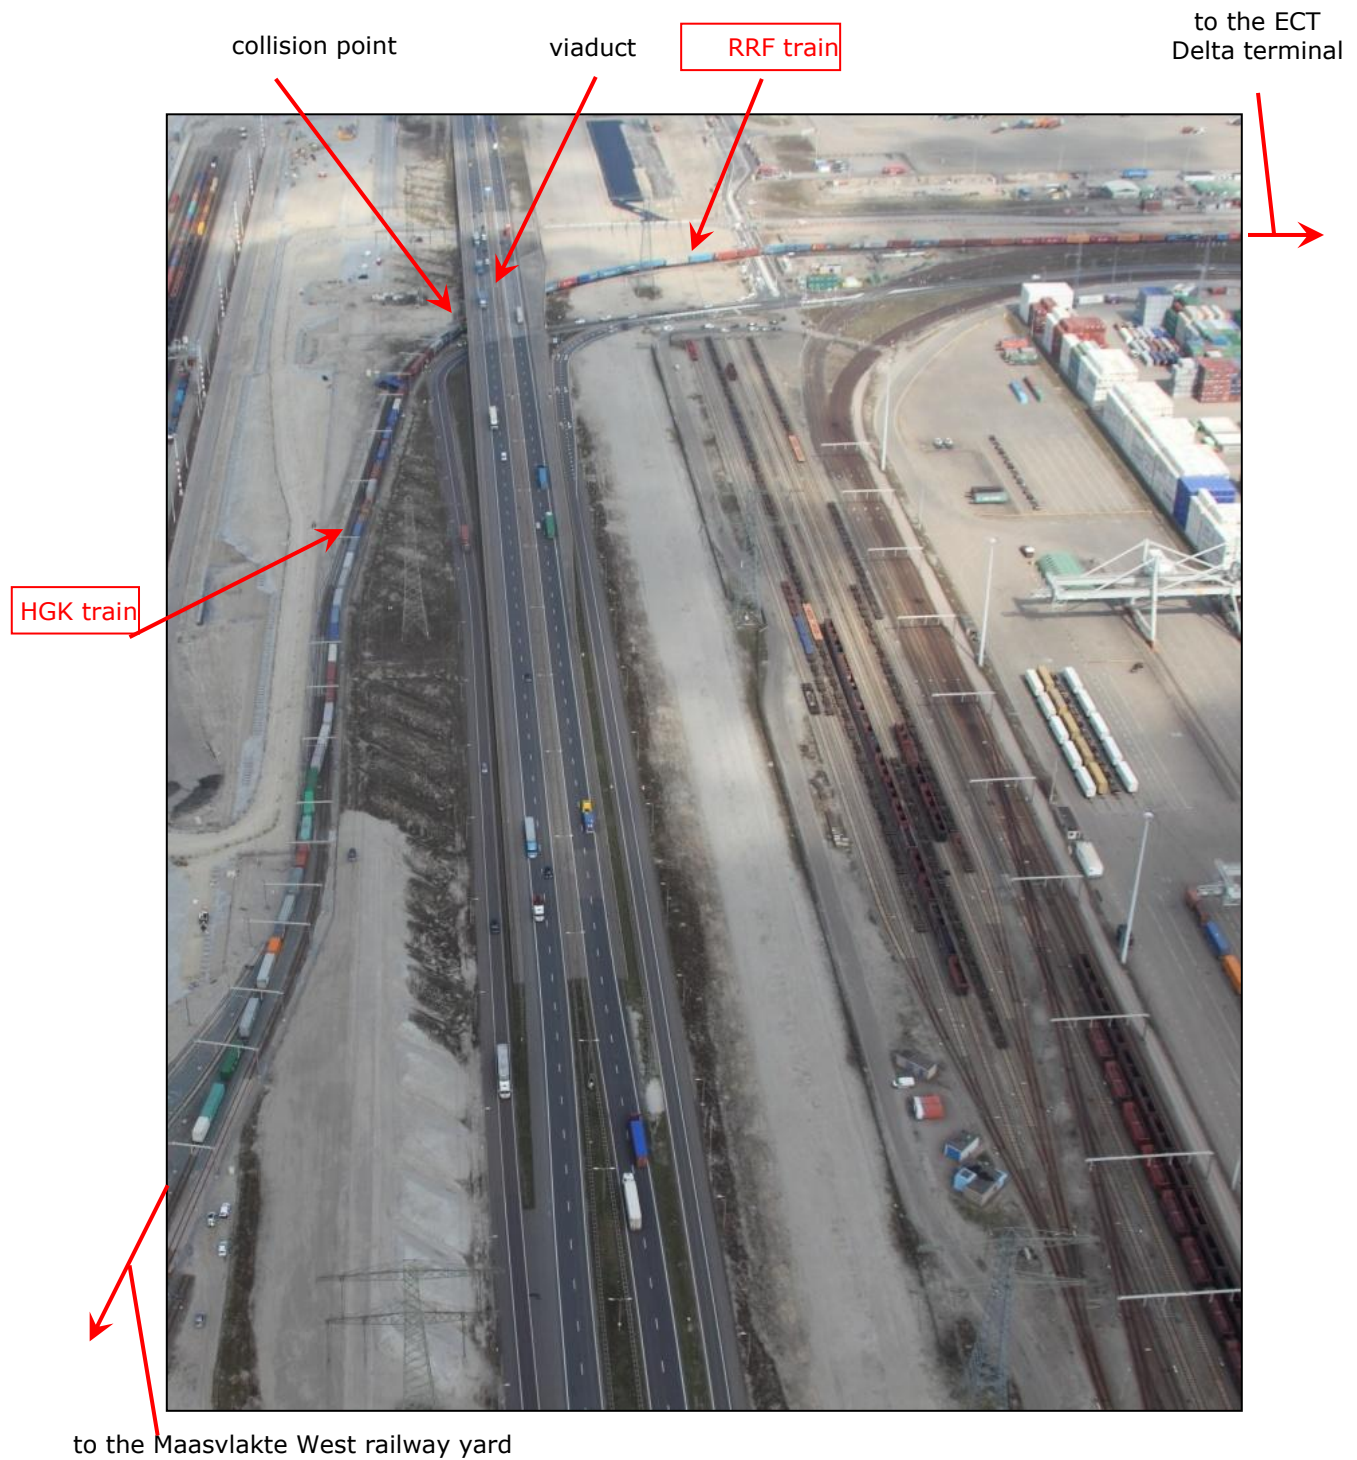
The collision took place on the route section between the Maasvlakte West railway yard and ECT Delta terminal. This route section consists of two tracks (891 and 892), the collision took place on track 891. At the site of the location of the accident, these tracks bend and pass under a viaduct (N15). As a result, local visibility was limited to less than one hundred metres. The maximum line speed is 30 km/hour. At the time of the accident, there was still daylight and it was not raining;

Figure 2: This photo shows the course of the railway tracks and the final positions of both trains.

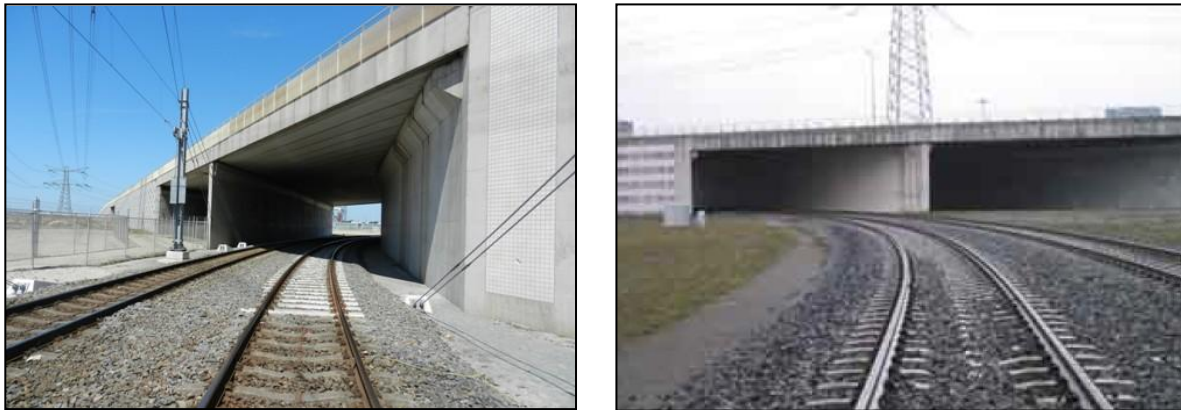
Figure 3: These photos show the visibility limitations near the bend and viaduct (from both directions).

- The train drivers could not see the other approaching train until the very last minute because the track at the site of the accident is sharply curved and passes under a viaduct.
- Despite the lack of an active train protection system and limited visibility at the viaduct, the two connecting tracks were ordinarily used in both directions. The use of two-way traffic (instead of 'driving on the right side only') was attributable to the fact that part of the ECT Delta terminal is more easily accessible if trains use the 'left' connecting track.

- a) ProRail has determined that route section permissions for these connecting tracks (891 and 892) must be limited to trains driving on the 'right side', with the exception of specific cases<sup>8</sup>. ProRail has also determined that the train traffic controller responsible for the Maasvlakte (which is charged with controlling the connecting tracks) must monitor all route section permissions for the Non-Centrally-Controlled-Zone in the Rail Management System. This means the train traffic controller must mark all previously issued route section permissions on one of his monitors by activating a yellow highlight over the relevant track number; the train traffic controller may not remove this highlight until he has received a report that the train has left the track. These two procedural measures were implemented briefly after the accident.
