Rail Accident Report

Near miss between a train and a level crossing user at Dock Lane, Melton, Suffolk 14 June 2016

Report 08/2017
May 2017

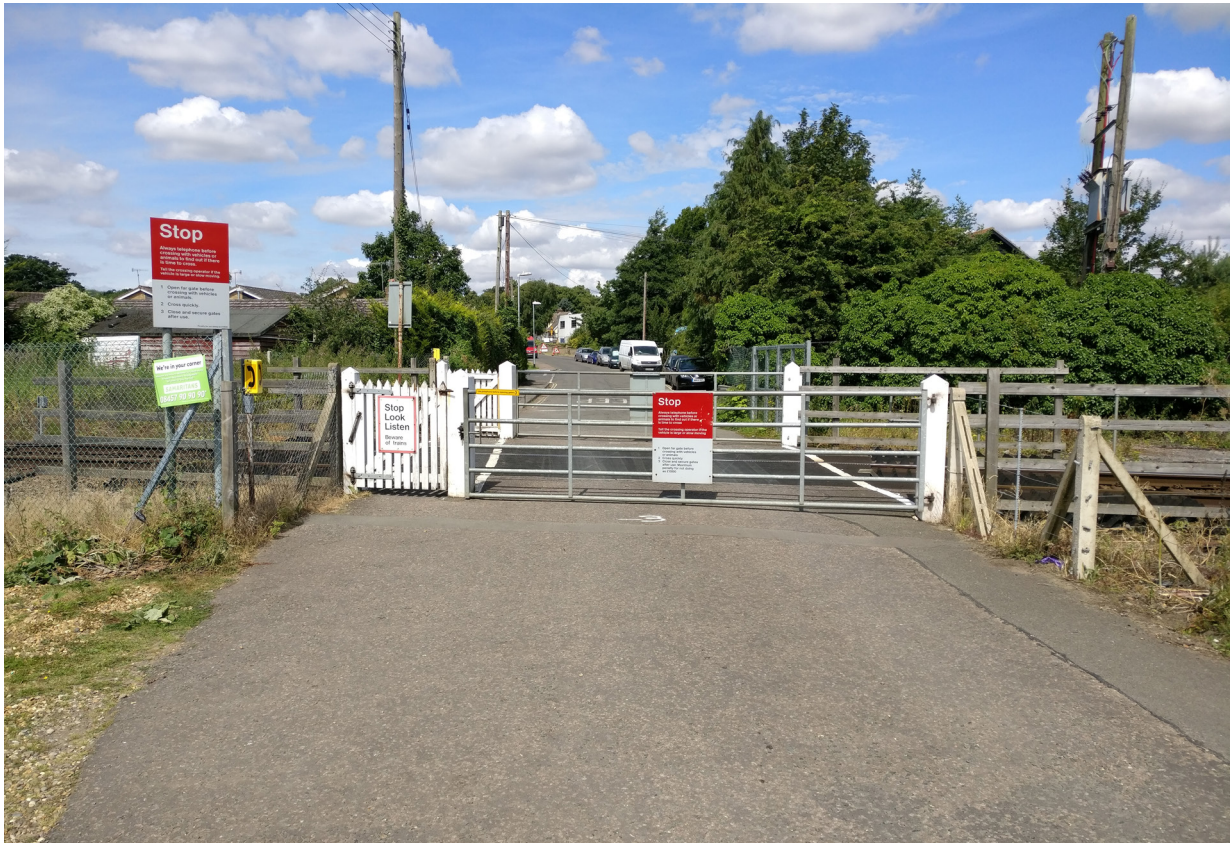
Figure 4: Dock Lane user worked crossing, viewed from river (east) side of railway

- 14 Dock Lane level crossing is classified as a user worked crossing with telephones (UWC-T) and is intended for use by road vehicles belonging to, or having business with, a defined set of authorised users. The operator of the boatyard that the vehicle occupants had been visiting, was an authorised user. The UWC-T is fitted with a metal vehicle gate on each side of the railway which the road user is required to open and close on foot. There is a parallel footpath crossing, provided with a wooden pedestrian wicket gate adjacent to each vehicle gate (figure 4).

- 15 Telephones are provided at the crossing for vehicle users to contact the signaller to gain permission to cross, due to the insufficient sighting time of trains for vehicle users (paragraph 33). The signaller is located at Saxmundham signal box, which is approximately 10 miles (16 km) to the north-east of Dock Lane level crossing.

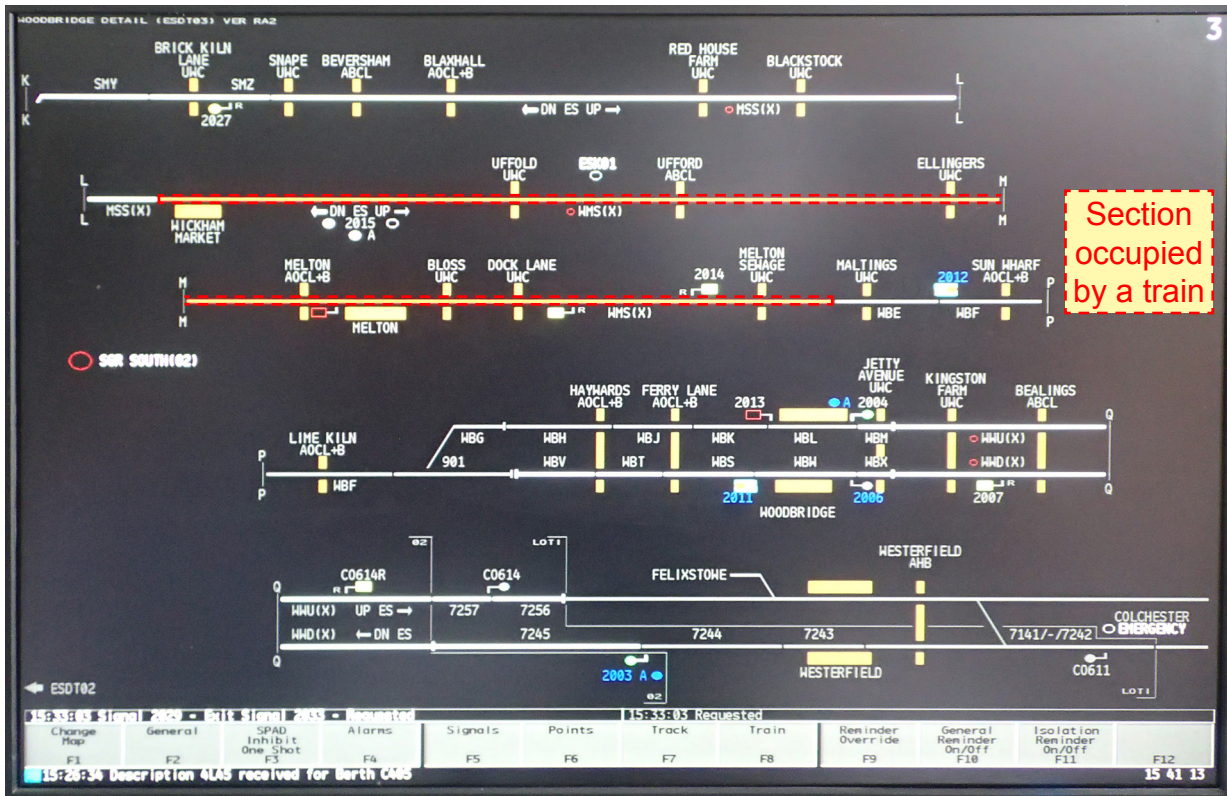
Figure 6: Saxmundham signalling display, showing long track section occupied by a train

- 89 The signaller’s displays at Saxmundham highlight which track sections are occupied by a train in red (figure 6). Some of these track sections are long and it can take the train considerable time to traverse them. As an example, the track section covering both Bloss and Dock Lane crossings (highlighted in figure 6) extends for a distance of approximately 5 miles (8 km) and includes both Wickham Market and Melton stations; trains take around 10 minutes to traverse it.

- 90 Although signallers at Saxmundham are able to tell when a train is occupying a track section, they are unable to observe a train’s position within it. If a signaller was to refuse users permission to cross the line at crossings within, or near to the exit of, occupied long track sections, some users would have to wait for extended periods before getting permission to cross. This introduces the risk of impatient users either ignoring the refusal or not seeking permission to cross the line, and thus increasing the likelihood of accidents or near misses.
