# Rail Accident Report

## **Collision between two trams at Shalesmoor, Sheffield 22 October 2015**

Report 17/2016  
August 2016

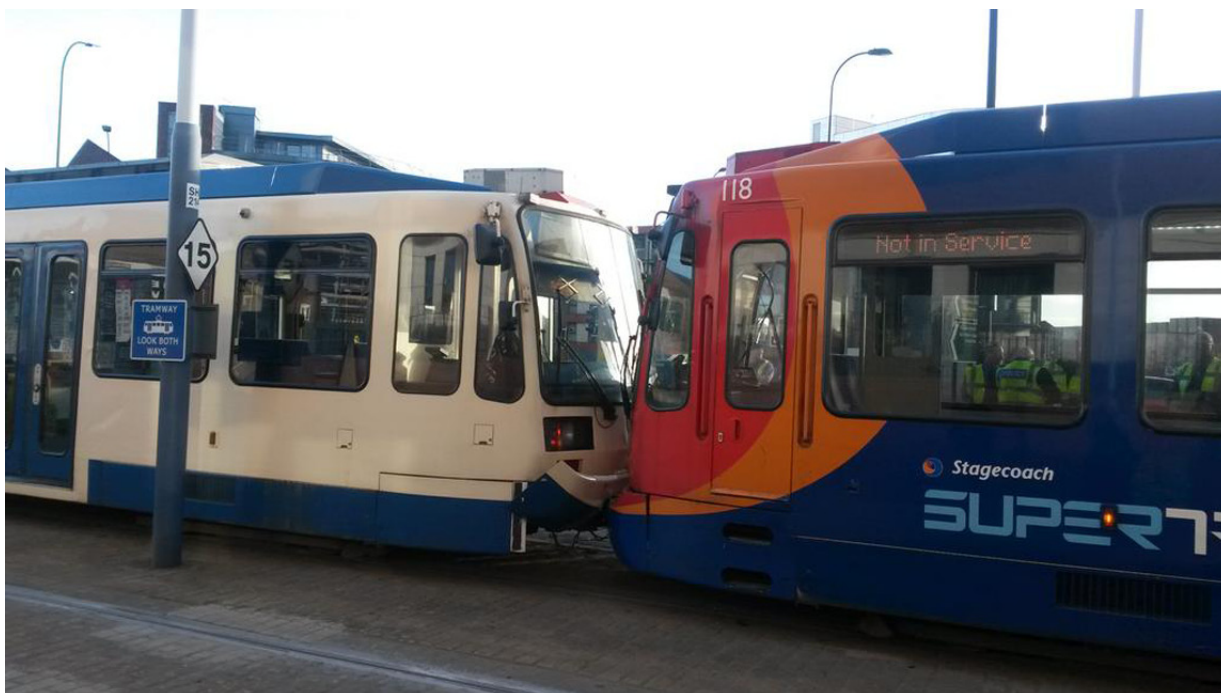
Figure 3: The two trams immediately after the collision (photo courtesy of Sheffield Star)

- 4 A member of Stagecoach Supertram staff and fifteen passengers received minor injuries as a consequence of the collision. Both trams were seriously damaged, and the tramway through Shalesmoor was closed for the remainder of the day while recovery of the damaged trams took place.

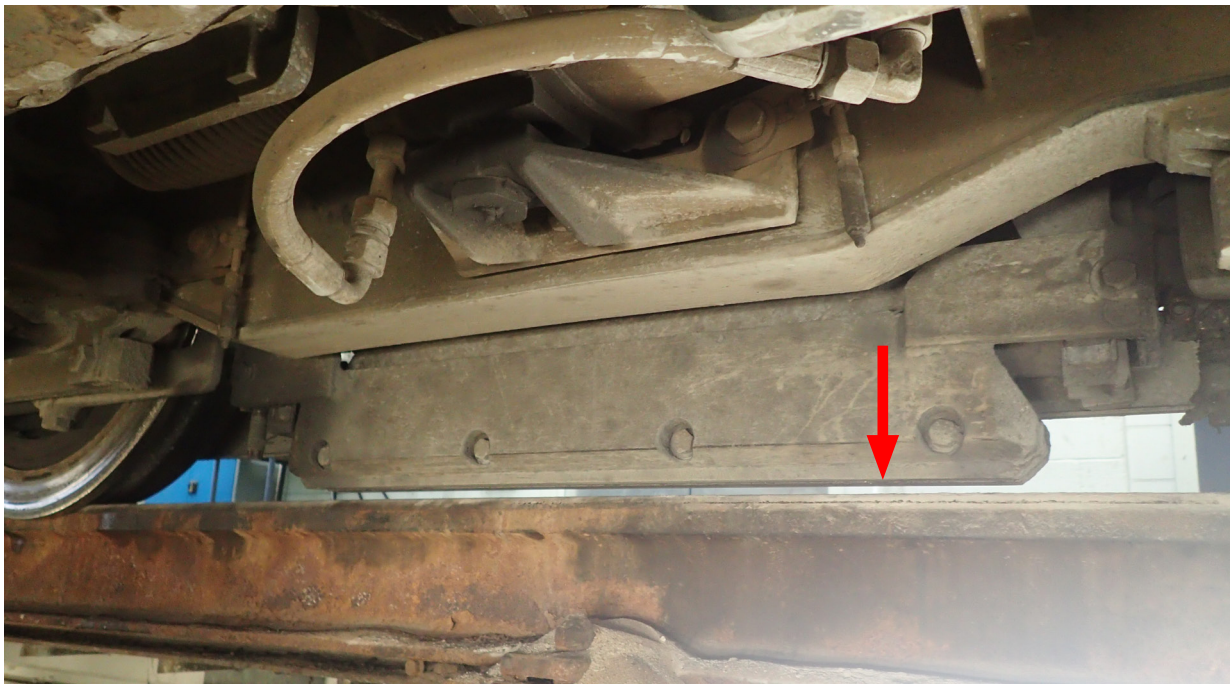
Figure 6: A magnetic track brake shoe as fitted to a Sheffield tram; arrow indicates direction of movement of magnetic track brake when energised

- 62 The tests confirmed that braking distances in low adhesion conditions, using both the service brake and the hazard brake, are significantly extended compared to normal dry rail conditions. The tests also confirmed that magnetic track brakes are adversely affected by a low coefficient of friction between the magnetic track brake shoe and the rail head<sup>5</sup>.

- 1 This accident demonstrates that the performance of friction-type magnetic track brakes can be adversely affected by rail head contamination in a similar way to the friction brakes on the wheels. Tram drivers should therefore adopt a defensive driving style in low adhesion conditions that does not place undue emphasis on the added braking effort provided by the track brakes.

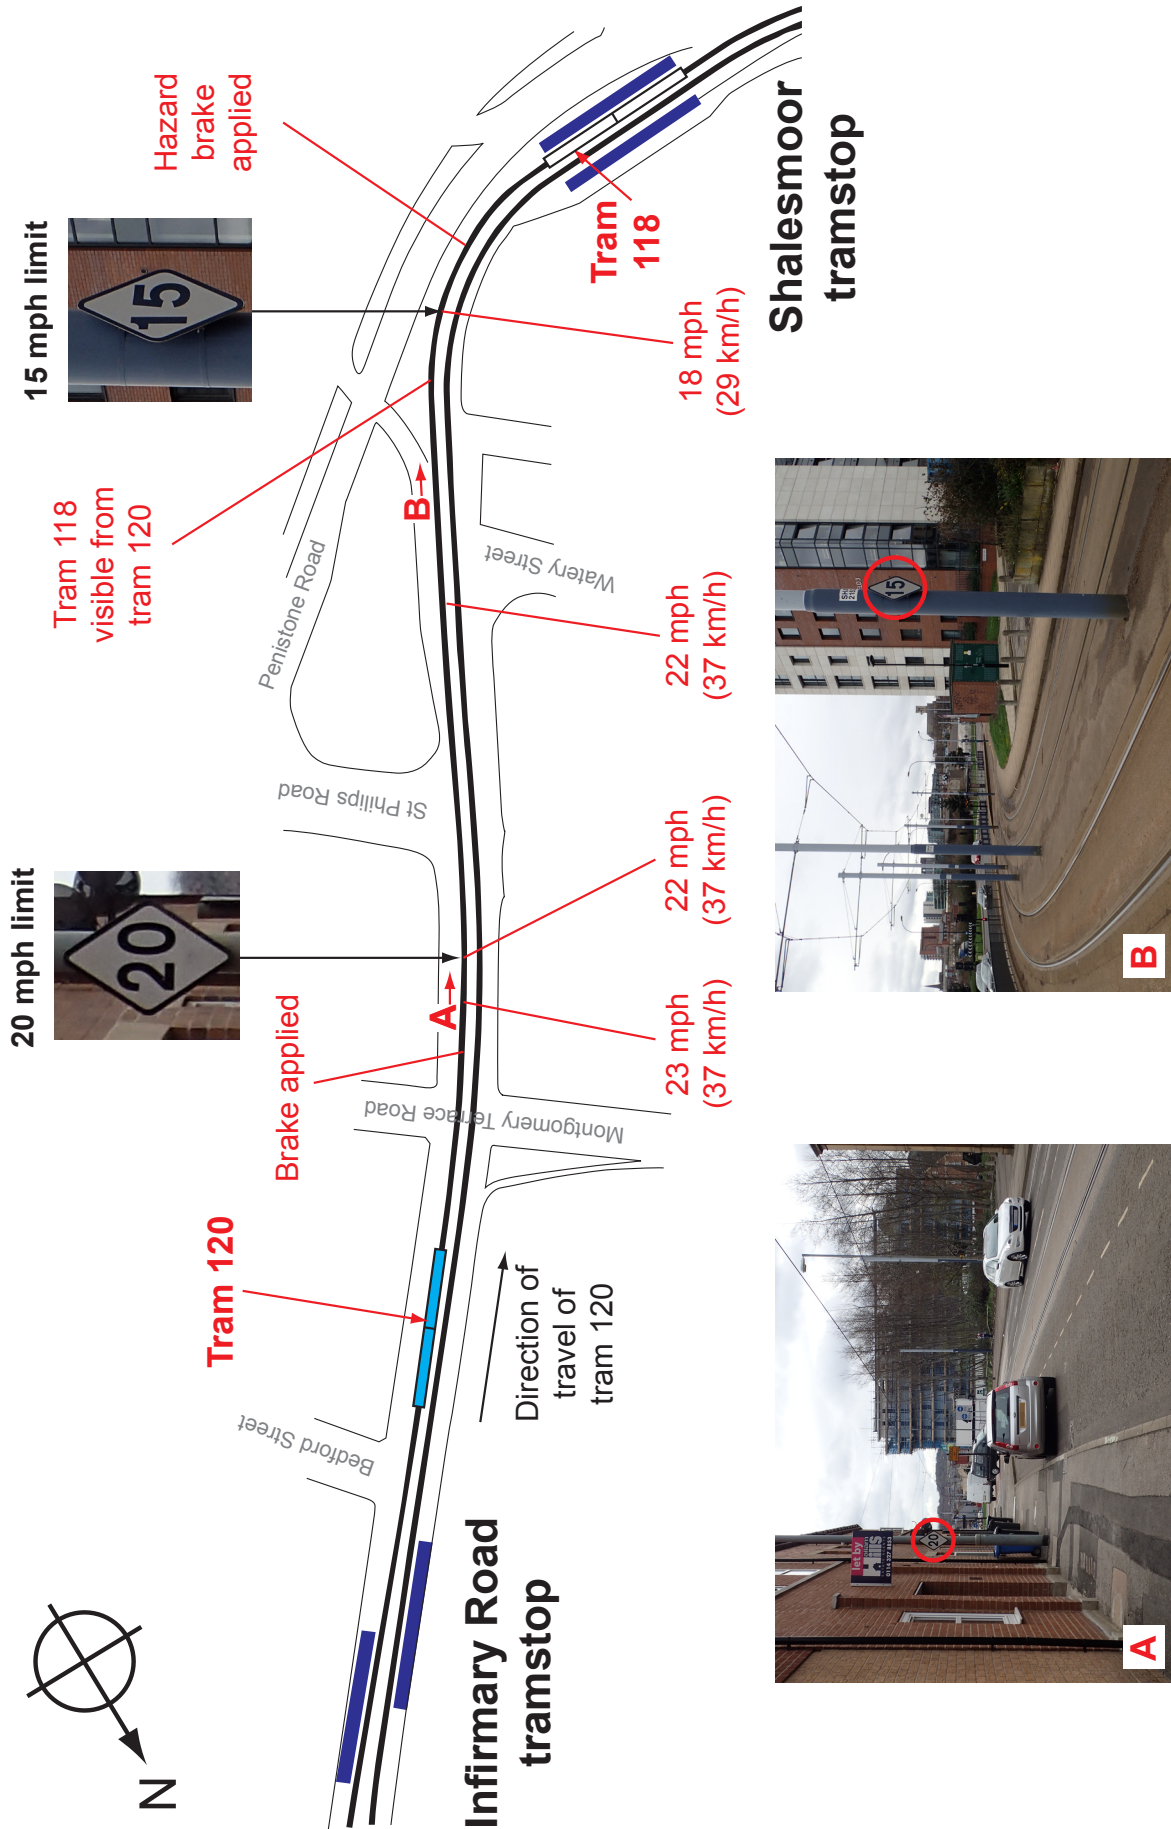
- 44 As the driver of tram 120 proceeded towards Hillsborough from Malin Bridge, he encountered a 'stop' indication from the traffic signal system. This indicated to him that another tram had approached Hillsborough from the Middlewood route, and was a short distance in front. However, tram 118 had departed from Hillsborough tram stop by the time that tram 120 arrived. Tram 120 proceeded towards Shalesmoor, stopping at all three intermediate tram stops. Tram 118 was occasionally visible in the distance. Tram 120 had commenced braking for the tram stop at Shalesmoor from a speed of 23 mph (37 km/h) approximately 230 metres before the point of collision. The tram was still moving at 22 mph (25 km/h) when it passed the 20 mph (32 km/h) speed limit board near St Phillips's Road (paragraph 6 and figure 8). Thereafter, stationary tram 118 would have become visible to the driver of tram 120 approximately 70 metres before the collision (figure 8). Tram 120 was travelling at 18 mph (29 km/h) at the 15 mph (24 km/h) limit (paragraph 6 and figure 8) on the final approach to Shalesmoor tram stop.

- 45 The data recorder on tram 120 showed that the driver deployed the hazard brake 25 metres before the collision, when the tram speed was 14 mph (23 km/h). Had there been normal levels of rail head adhesion, this distance should have been sufficient for tram 120 to stop before colliding with tram 118. However, the low level of rail head adhesion present at Shalesmoor (paragraphs 55 to 58) meant that the hazard brake was significantly less effective than would normally be expected.

Figure 8: Map showing start of braking, 20 and 15 mph signs, point of deployment of hazard brake and point of impact

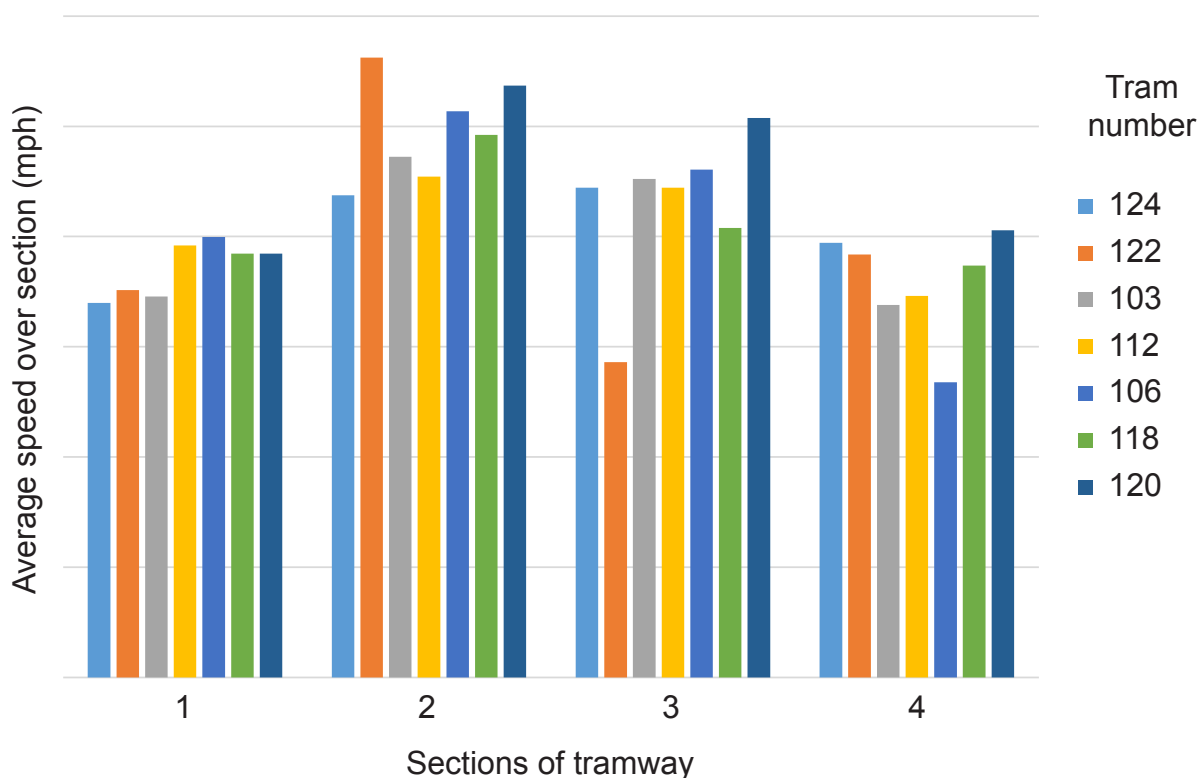
- 46 The RAIB carried out an analysis of tram speeds between Hillsborough and Shalesmoor on the morning of 22 October 2015 before the accident using data from the VIS loop system for four sections of the route. The sections were chosen to minimise, as far as possible, the effect of traffic lights and road congestion. The average speed for each of seven trams on each of the four sections was calculated. This data is shown in figure 9. Tram 120 recorded the highest average speed on two of the four sections, and was above the median for the other two sections.

Figure 9: Comparison of average speeds (mph) of seven trams on four sections of track between Hillsborough and Shalesmoor on 22 October 2015

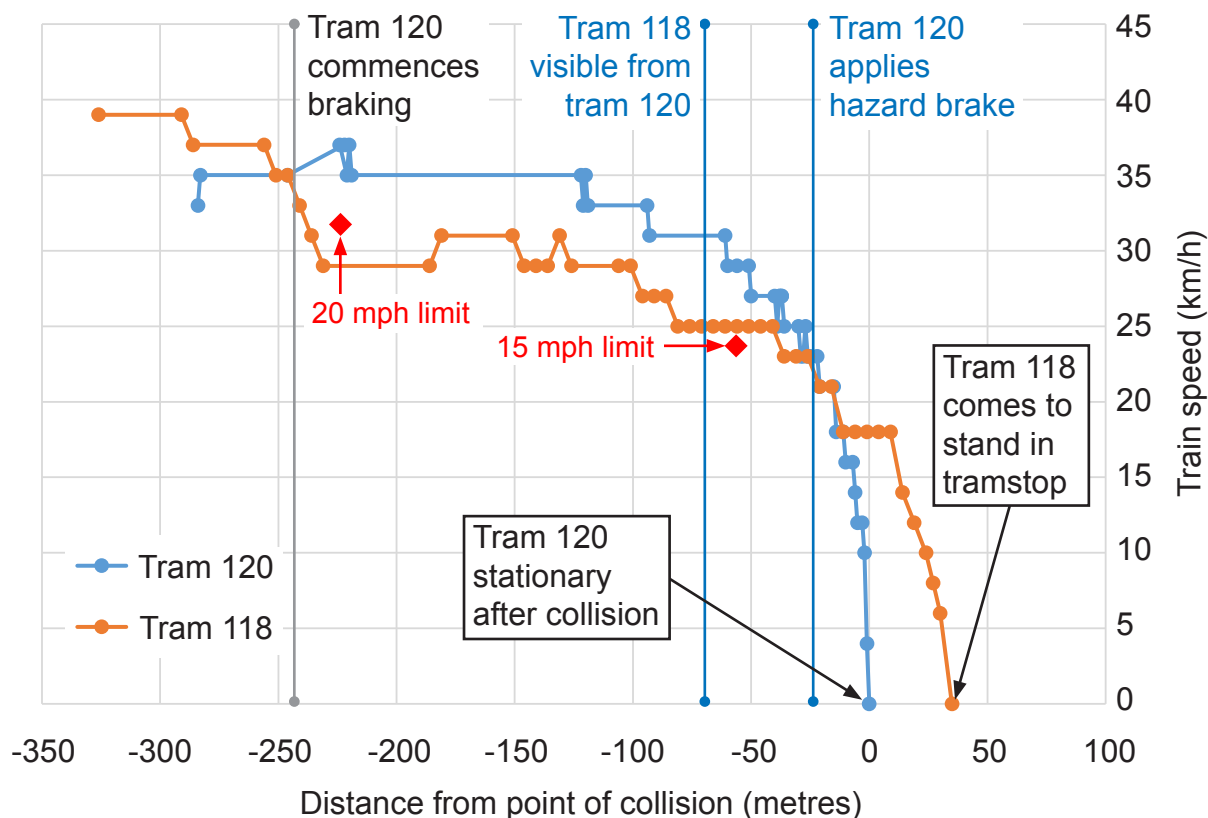
- 47 Using evidence from the On-Tram Data Recorder (OTDR) and Closed-Circuit Television (CCTV) systems fitted to trams 118 and 120, the RAIB compared the speed profile of the two trams on the approach to Shalesmoor tram stop. This data is plotted in figure 10, and indicates that, although the deceleration rates of the two trams are similar (before the application of the hazard brake by tram 120), tram 120 was unable to stop in time because of a combination of its higher initial speed at the 20 mph (32 km/h) speed limit board and the ineffectiveness of the braking systems due to low adhesion conditions.

Figure 10: Comparison of speeds of trams 118 and 120 on approach to Shalesmoor tram stop. The point of collision between the trams was approximately one metre before the point at which they came to a final stop. Note that the stopping points are the front of each of the trams. The difference in stopping points is therefore equal to the length of tram 118.

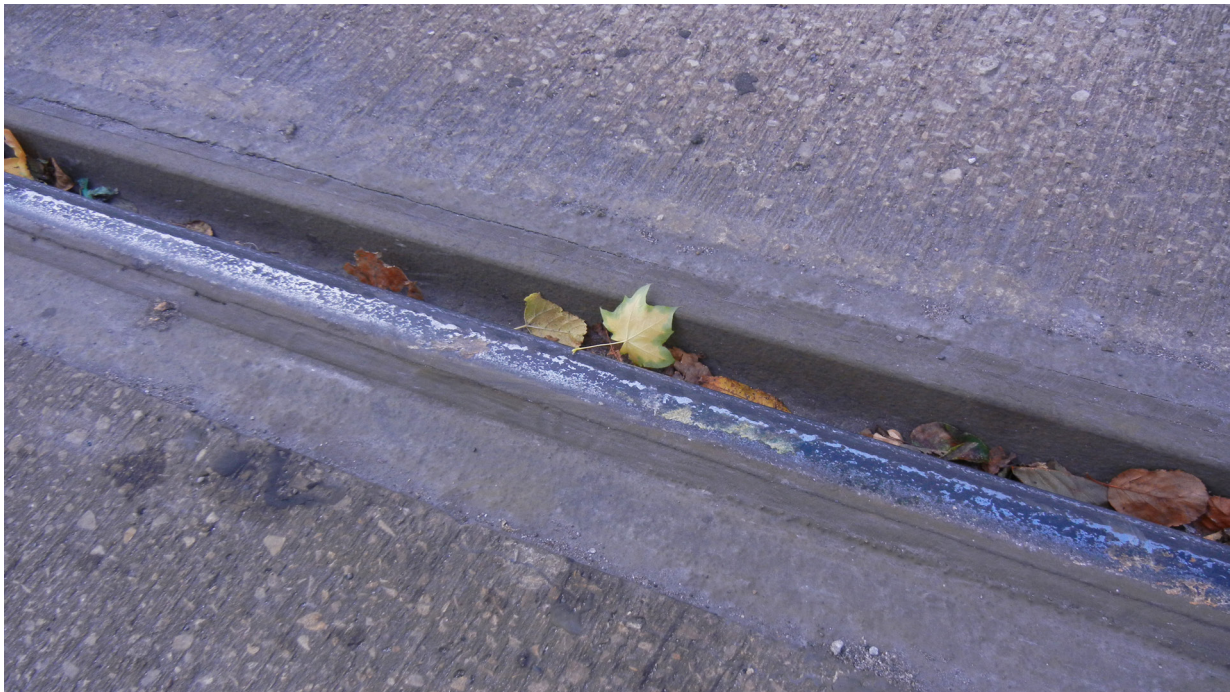
- 55 The area of Shalesmoor is known to be an area at high risk of rail head contamination in autumn and is identified in Stagecoach Supertram's procedure ST0057 Issue 1 Rev b ('Slip Slide – Cleaning and prevention of contaminated rails'). The primary source of this contamination is from fallen leaves.
- 56 It is well established<sup>2</sup> in the railway industry that rail head contamination by leaf detritus can lead to a significant loss of adhesion. Such contamination is generally black in colour and is difficult to remove by scraping. Photographs taken immediately after the accident (figure 11) indicate the presence of such contamination. Analysis of rail head swabs taken by the RAIB on 11 November 2015 revealed the presence of organic contamination which appeared similar to that photographed on the day of the accident.

Figure 11: Photograph of rail head at Shalesmoor, taken immediately after accident. Note that rail head is black in colour and the presence of fallen leaves

- 57 The effect of the rail head contamination from crushed leaves, combined with the probable presence of moisture from dew, lowered the available adhesion at Shalesmoor. Dew is caused by condensation of atmospheric moisture onto cold surfaces; changing atmospheric humidity around sunrise increases the likelihood of dew forming<sup>3</sup>. Calculations by the RAIB based on OTDR<sup>4</sup> data indicate that the effective coefficient of friction ( $\mu$ ) at Shalesmoor on 22 October 2015 was between 0.05 and 0.04, which represents a very low level of adhesion. However, even lower levels of adhesion have been identified as a factor in previous investigations.

- 58 The low rail head adhesion on the approach to Shalesmoor tram stop reduced the effectiveness of the braking systems on tram 120. Evidence obtained from the control systems on the tram indicates that the WSP system on the vehicle was operating correctly. It should be noted, however, that as with any vehicle, a WSP system can only optimise the use of the available adhesion and cannot stop a tram more quickly than adhesion levels allow (ie braking distance increases as adhesion levels fall).

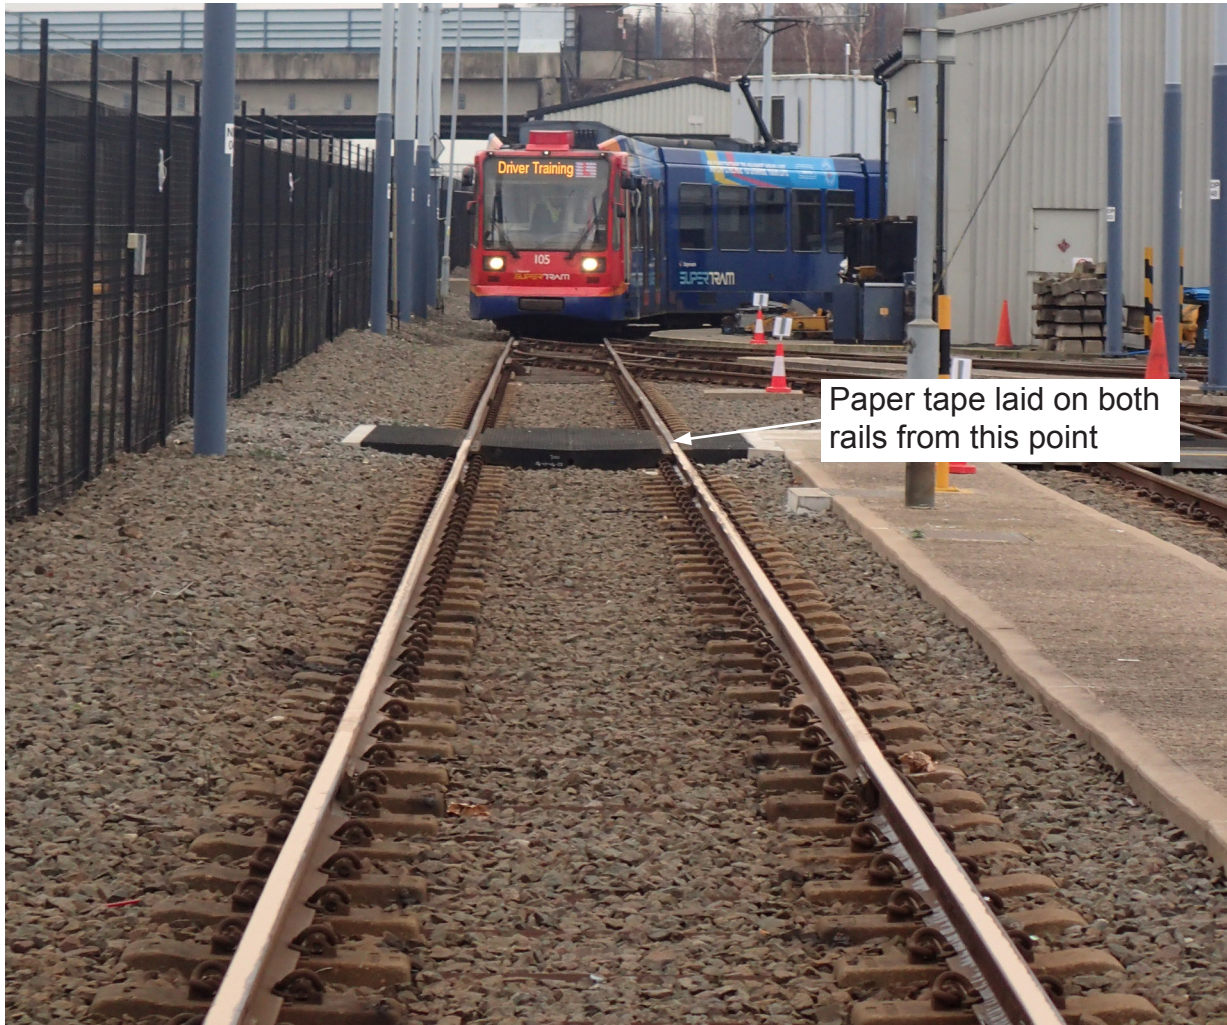
- 60 Low adhesion conditions were created by applying moistened paper tape to the rail head and rolling it onto the surface while spraying water. The paper tape was then run over by multiple passes of a tram. This method of artificially creating low rail head adhesion conditions has been used extensively in the railway industry to generate low adhesion conditions for brake testing and driver training. The paper tape was prone to being scrubbed from the rail head by the tram's magnetic track brakes, and therefore multiple applications of the tape was required to consistently maintain low rail head adhesion conditions. It should be noted that the leaf contamination at Shalesmoor (paragraph 56) is unlikely to have been so easily scrubbed from the rail head by the magnetic track brakes.

- 61 In the tests the stopping distance was found to increase from around 12 metres on dry uncontaminated rail to around 35 metres in the simulated low adhesion conditions, when using the full service brake. When the hazard brake was used (and sanding was automatically activated), the braking distance was found to increase from around 8 metres to around 19 metres.

Figure 12: Testing in simulated low adhesion conditions at Nunnery Depot . The tram is moving towards the viewer. Paper tape has been applied to the railhead from the crossing onwards

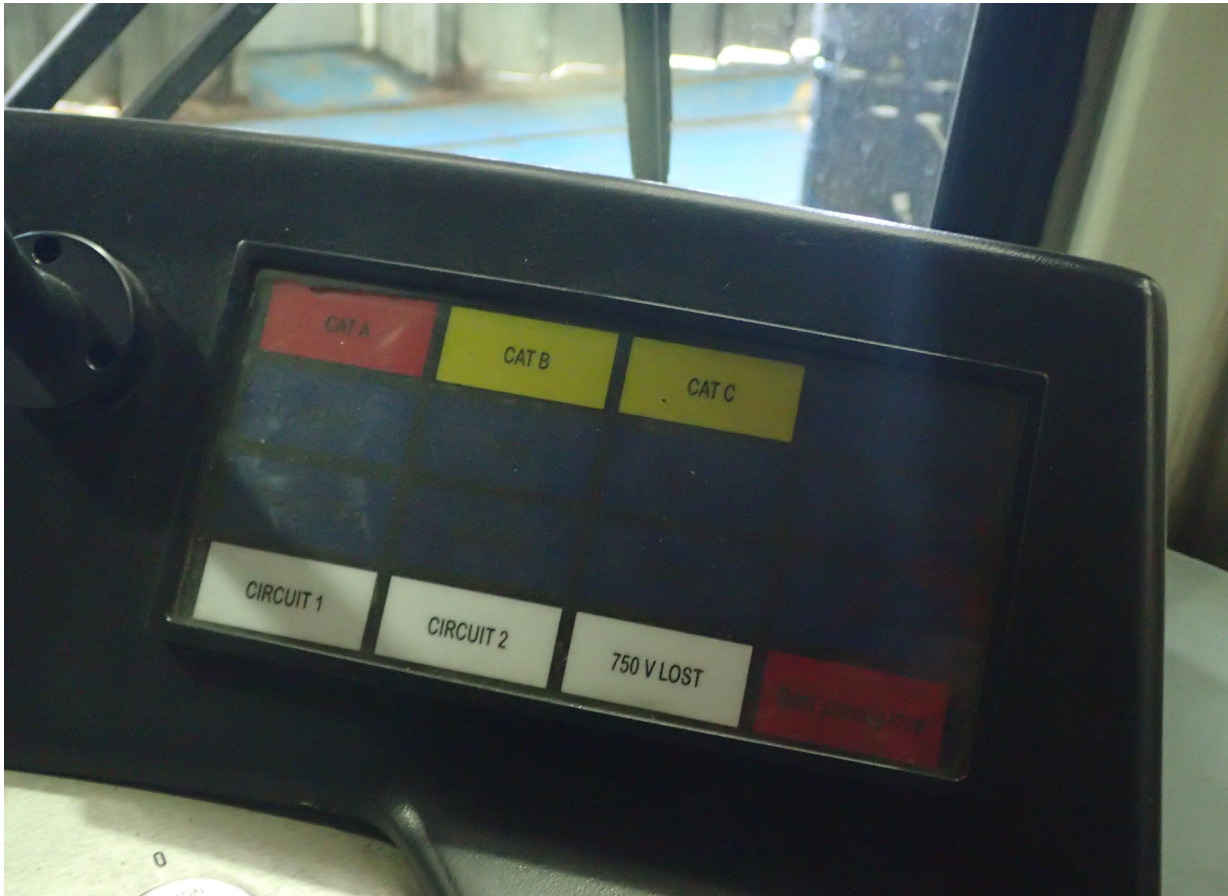
- 69 Evidence obtained by the RAIB indicates that tram drivers tended to only report low adhesion incidents to the OCC when indications appeared on the annunciator panel. However, the annunciator panel cannot be relied on to indicate all wheel slide events. This is because the software system controlling the annunciator panel uses an internal event counter. Cat A, B, C faults are indicated once the counter has reached set thresholds. However, the counter is reset when the driver changes ends (as happened at Malin Bridge when tram 120 commenced its journey). Following the accident at Shalesmoor, the driver reported that the annunciator panel did not indicate wheel slide on tram 120.

- 70 A consequence of this dependence on the annunciator panel as the primary indication of low adhesion conditions was that there was a significant under-reporting of low adhesion events by tram drivers to the OCC.

Figure 13: The cab annunciator panel
