Rail Accident Report

Track worker near miss incidents at Camden Junction South, London 28 February 2017

Report 16/2017
November 2017

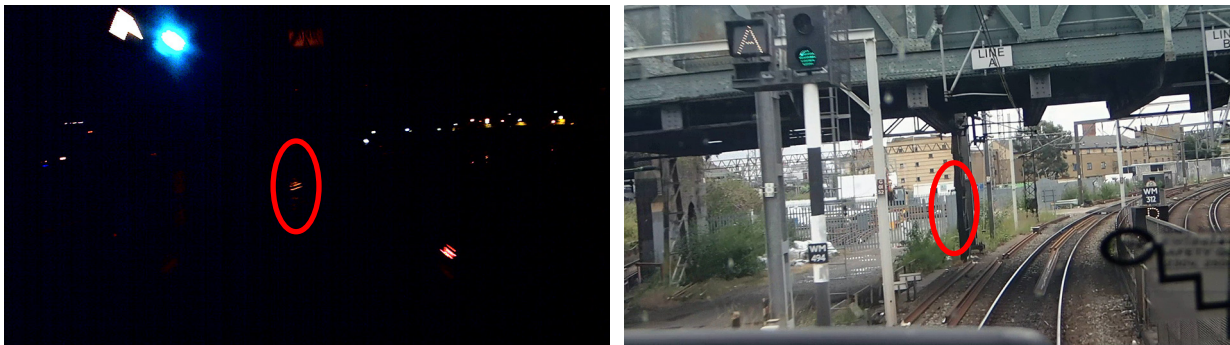
- 30 Just before 01:03 hrs, the train passed signal WM494 and, immediately afterwards, approached PS1, who had been in the process of placing a *possession limit board* on the track. PS1 heard and then saw the train approaching, and so took the possession limit board and walked off the track to a position of safety to the left of the track (in the direction of travel). The train driver saw PS1 walking off the track, sounded the train's horn and then started braking. PS1 reached the position of safety just before the train passed (figure 4). The train stopped about 25 seconds later, having travelled about 264 metres past the signal (ie all except the last carriage of the train had passed the point where PS1 had been standing). The train driver and PS1 did not have any further interaction.

Figure 4: Image of the first near miss from the train's forward-facing CCTV (left, courtesy Virgin Trains) and comparable daytime view (right) highlighting the approximate position of PS1
