FINAL REPORT ON SERIOUS ACCIDENT INVESTIGATION

Serious accident type: Train derailment

Train No.: 45010

Place: City of Pirot, outskirts of the village of Sopot, open track
between the Staničenje crossing point and the Pirot station

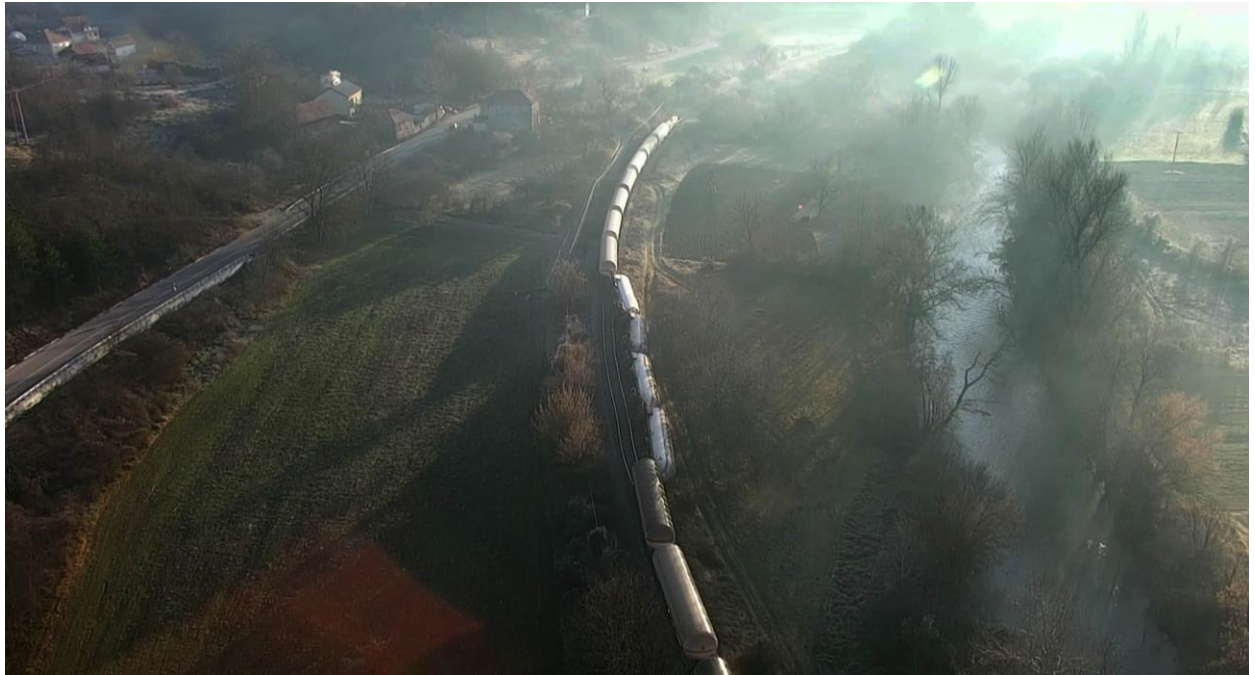
Figure 2.1.2.1: The appearance of the serious accident site (source: MUP, Sector for Emergency Situations)

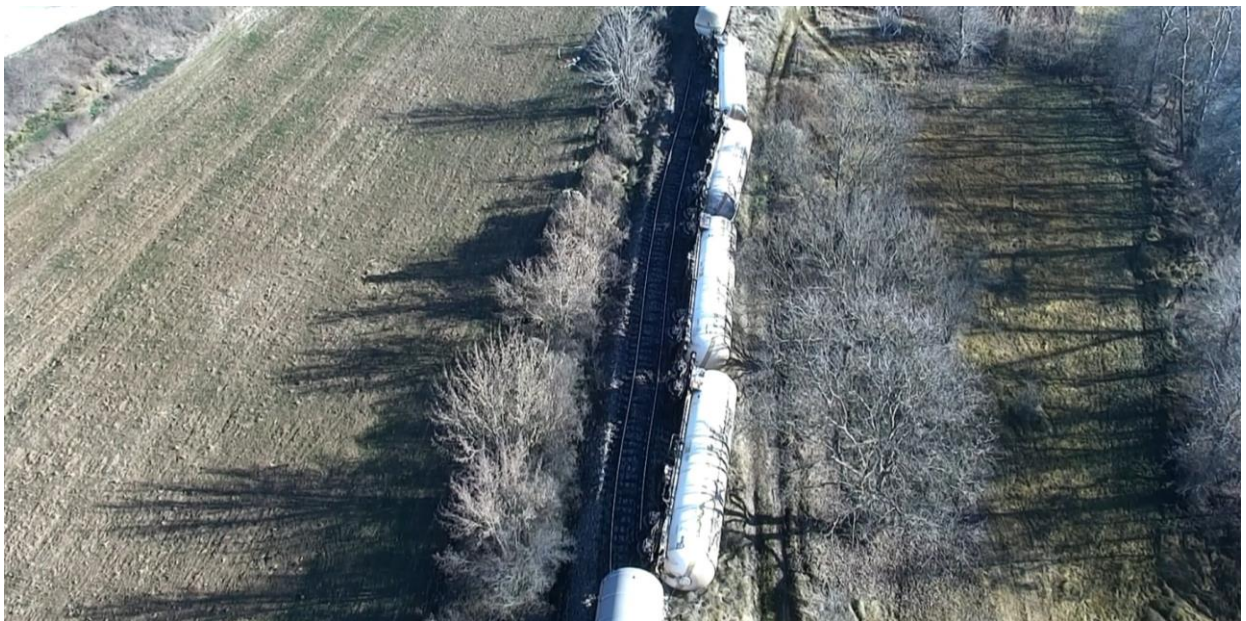
Figure 2.1.2.2: The appearance of the point of overturning of the wagon-tanks
(source: MUP, Sector for Emergency Situations)

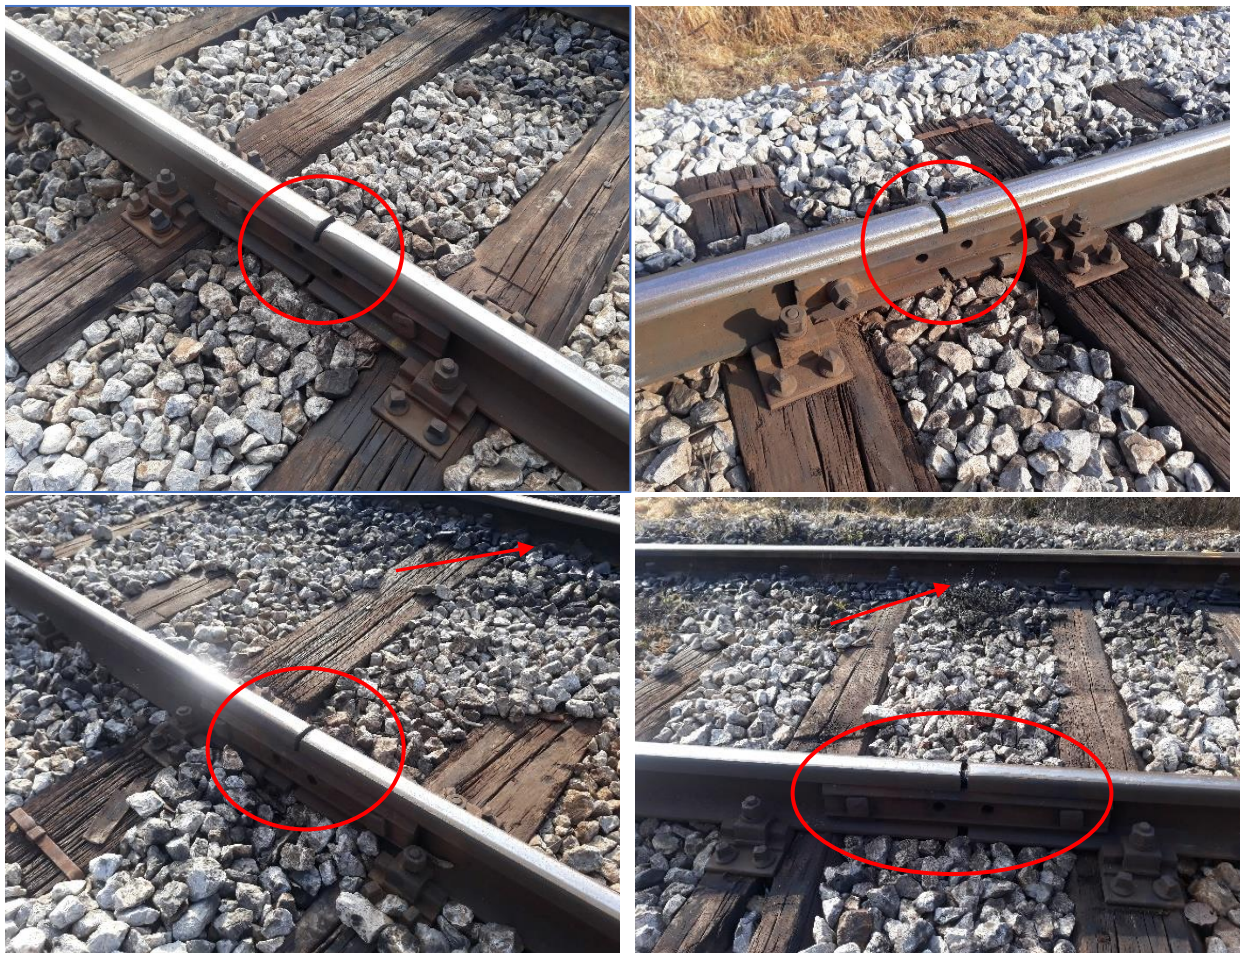
In the broader area of the serious accident site, several non-aligned floating rail joints have been observed. The appearance of these rail joints is shown in Figure 3.4.2.2.

Figure 3.4.2.2: Appearance of rail joints (source: "IŽS" a.d.)

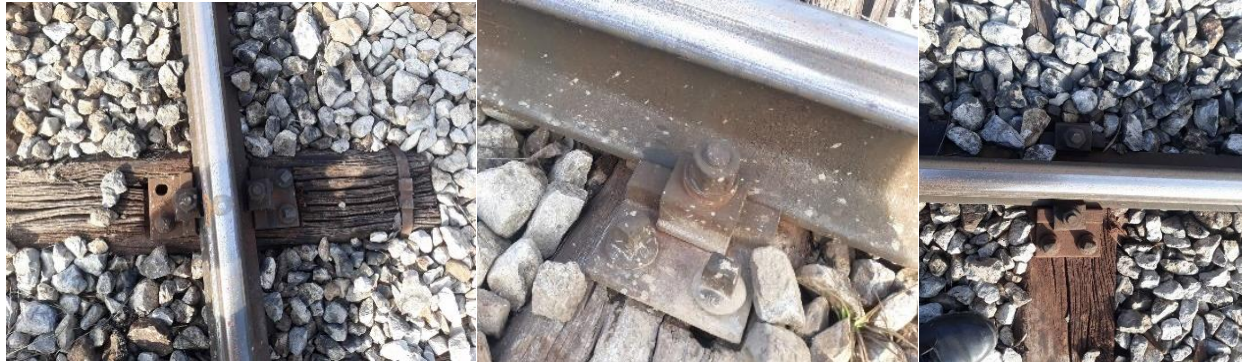
Between the Staničenje crossing point and the Pirot station, from km 63+800 to km 72+900, wooden sleepers have been installed at a distance of 60 cm with fastening equipment of type “K”. The appearance of the sleepers and the fastening equipment is shown in Figure 3.4.2.3.

Figure 3.4.2.3: Appearance of track fastening equipment (source: “IŽS” a.d.)

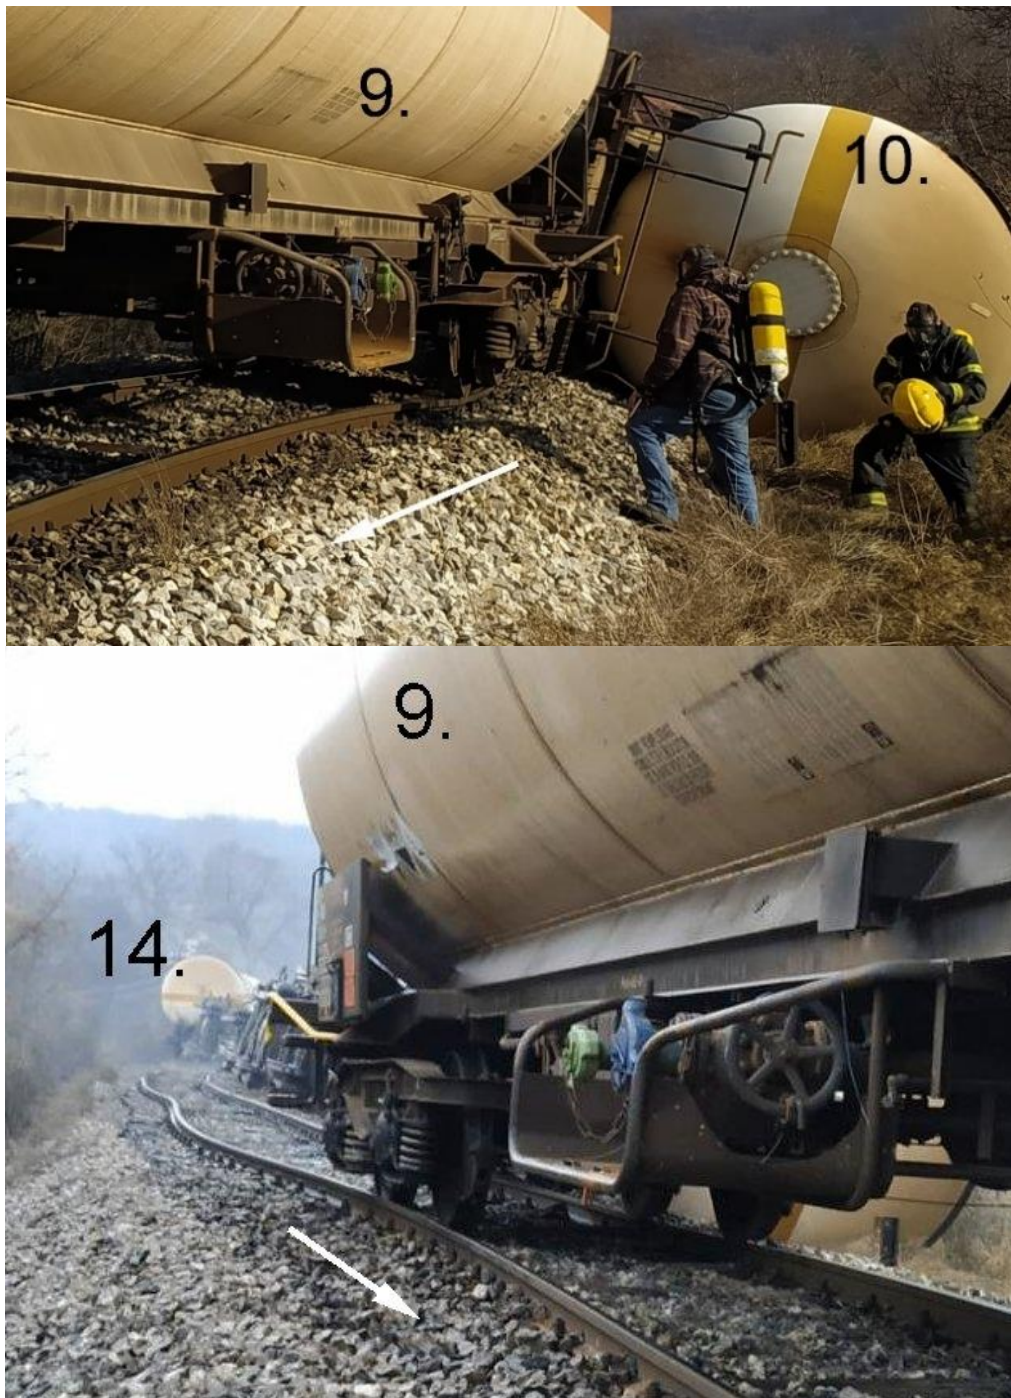
The locomotive No. 661-249 and the first eight wagons were located on the track. The front bogie of the ninth wagon No. 33 87 7813 563-6 was standing on the track. The rear bogie had both left wheels (when viewed in the direction of movement) on a rail that was transversely deformed towards the inside of the curve (image 4.2.1.2.). Due to this deformation, the two right wheels of the rear bogie pedestal became trapped in the track. Based on the shape of the deformed couplings and the coupling guides between the ninth and tenth wagons No. 33 87 7813 580-0, as well as their relative position, it can be concluded that the track deformation occurred due to the pulling of the rear end of the ninth wagon by the tenth wagon during their overturning.

Figure 4.2.1.2: Position of the ninth wagon rear bogie

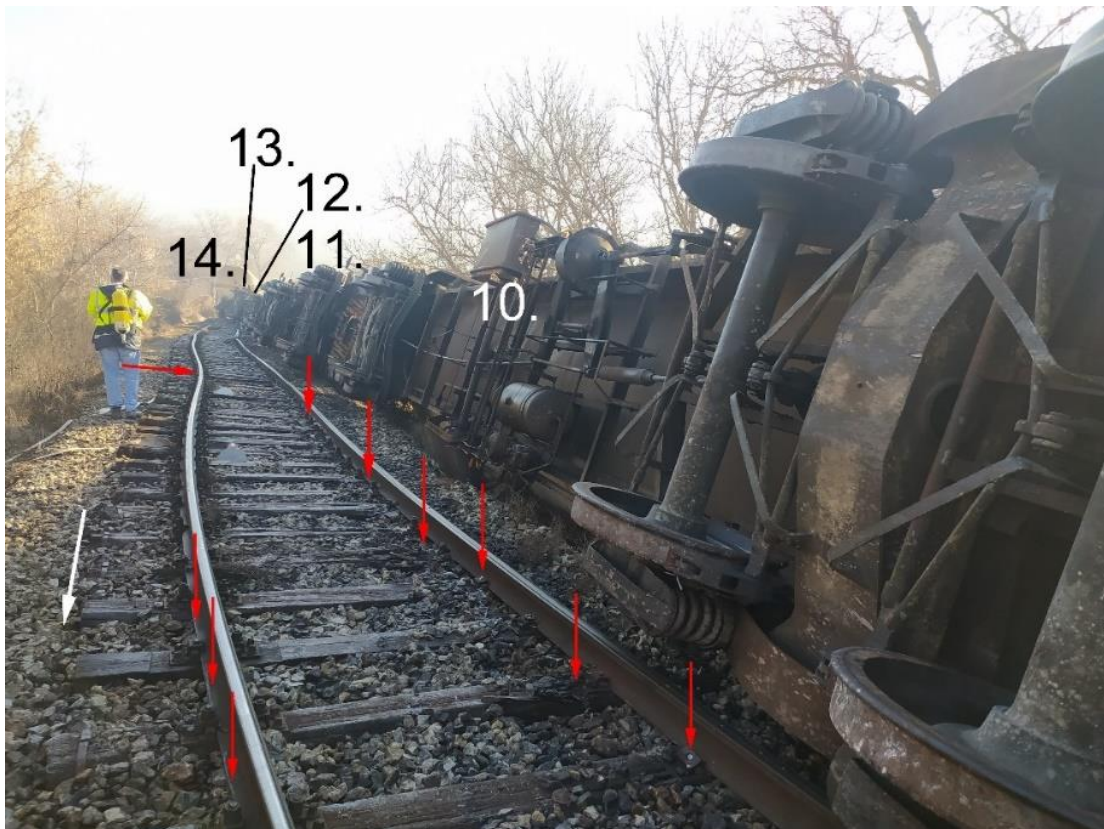
The tenth wagon No. 33 87 7813 580-0, eleventh wagon No. 33 87 7813 586-7, twelfth wagon No. 33 80 7922 029-3, and thirteenth wagon No. 33 80 7818 081-1 overturned on their left side, towards the inside of the curve (image 4.2.1.3). Traces of movement of the derailed wheels can be seen on the track extending up to the front axle of the tenth wagon (indicated on the image by vertical red arrows).

Figure 4.2.1.3: Appearance of the derailed wagon from tenth to thirteen

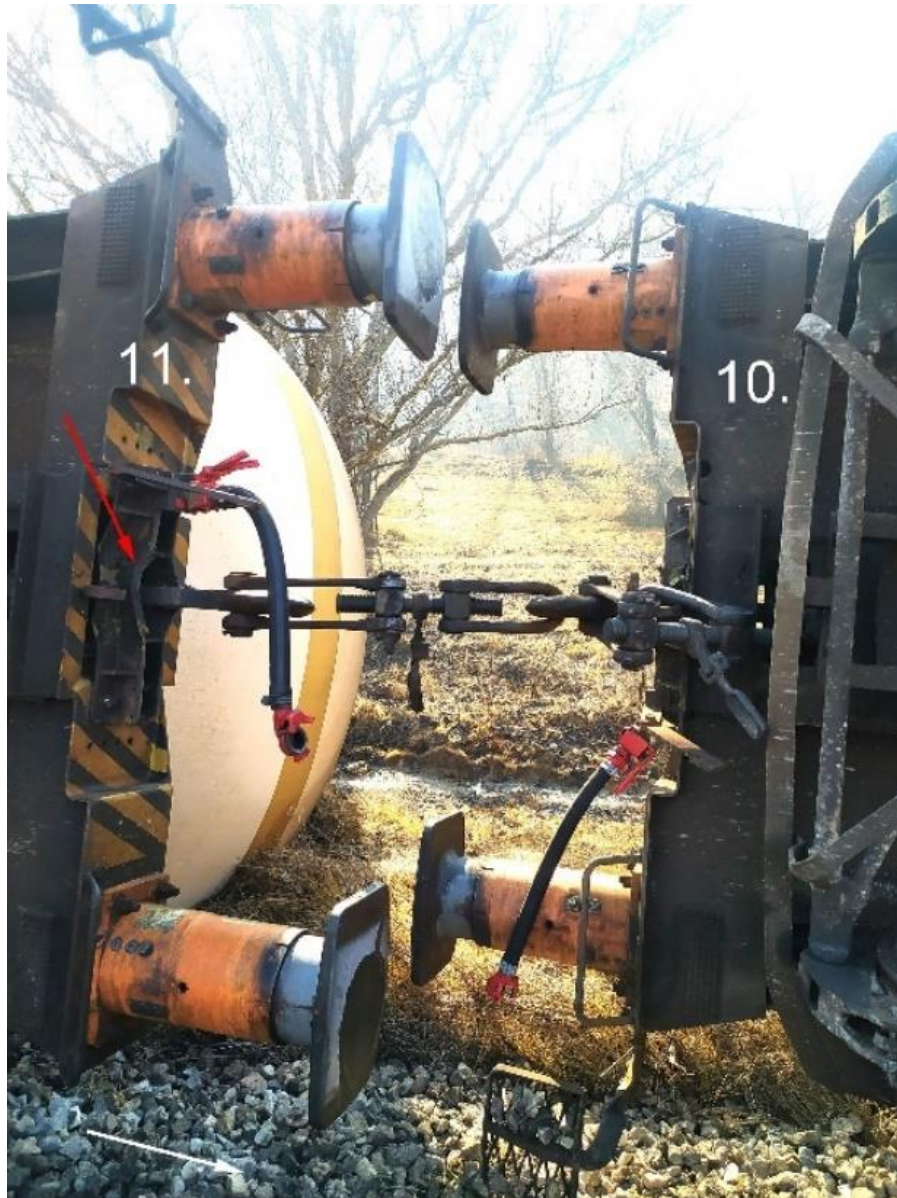
In the zone of the rear bogie of the tenth wagon, the track is transversely deformed towards the inside of the curve. Based on this, as well as on the basis of the deformations of the traction devices and the guides of the traction devices between the tenth and eleventh wheels (Figure 4.2.1.4.), it can be concluded that the eleventh wheels pulled the tenth wheels to the side during the overturning, caused the deformation of the track, and then the overturning of ten wagons.

Figure 4.2.1.4: Joint position of the overturned tenth and eleventh wagon

In Figure 4.2.1.4., it is observed that the brake couplings are disconnected, which indicates a strong tightening in the connecting hoses during the relative rotation of the tenth and eleventh wagon during overturning.

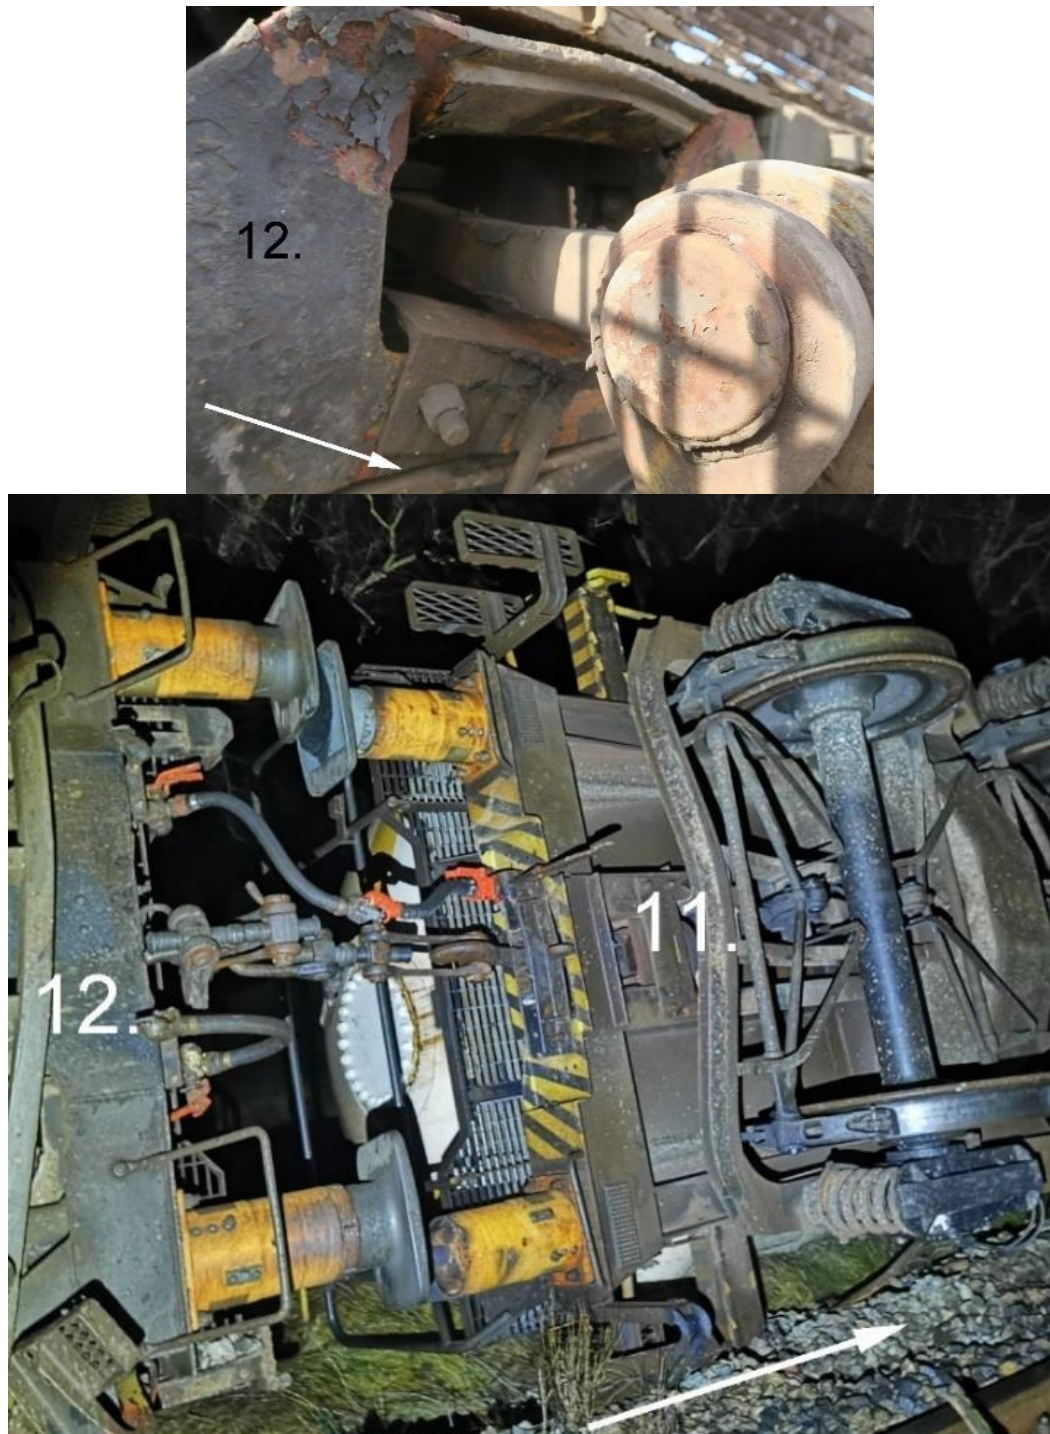
Figure 4.2.1.5: Draw devices of the eleventh and twelfth wagon

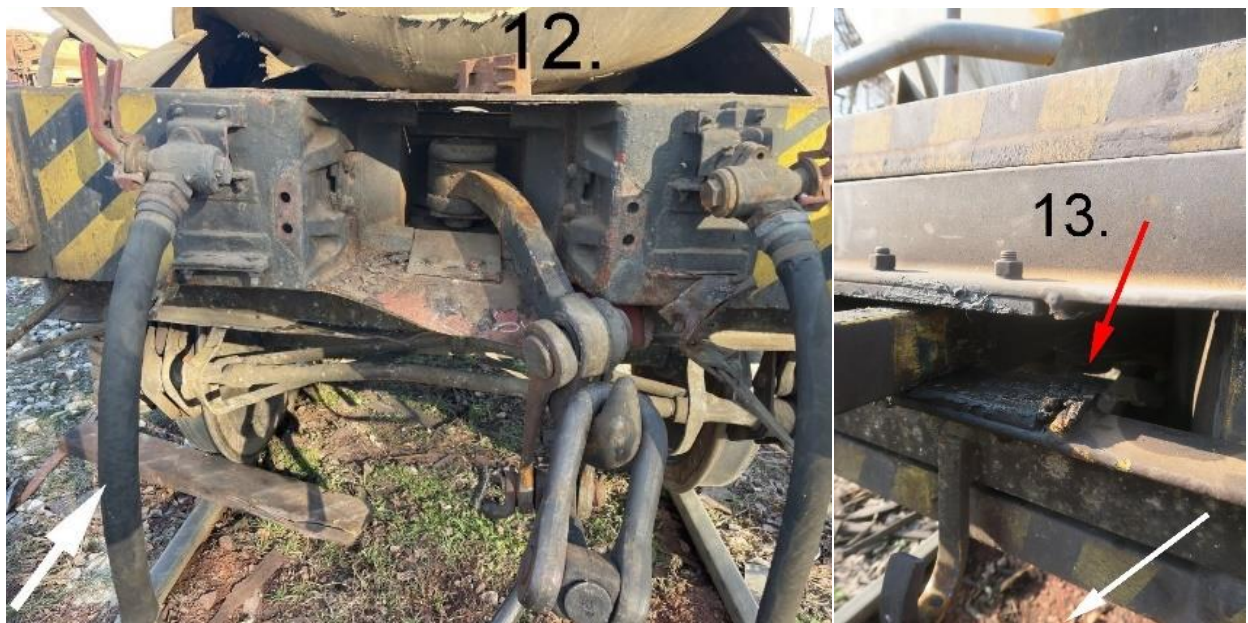
Figure 4.2.1.6. shows deformed hooks and their guides between the twelfth and thirteenth wagon. The neck of the twelfth wagon hook is strongly bent downwards and to the right relative to the direction of movement. The left (in relation to the direction of movement) boundary of the thirteenth car's hook is detached, and the neck of the hook is slightly deformed on that side. These deformations indicate that the twelfth wagon strongly pulled the thirteenth wagon to the side during overturning, after which the thirteenth wagon also overturned.

Figure 4.2.1.6: Deformed hooks and guides between the twelfth and thirteenth wagon

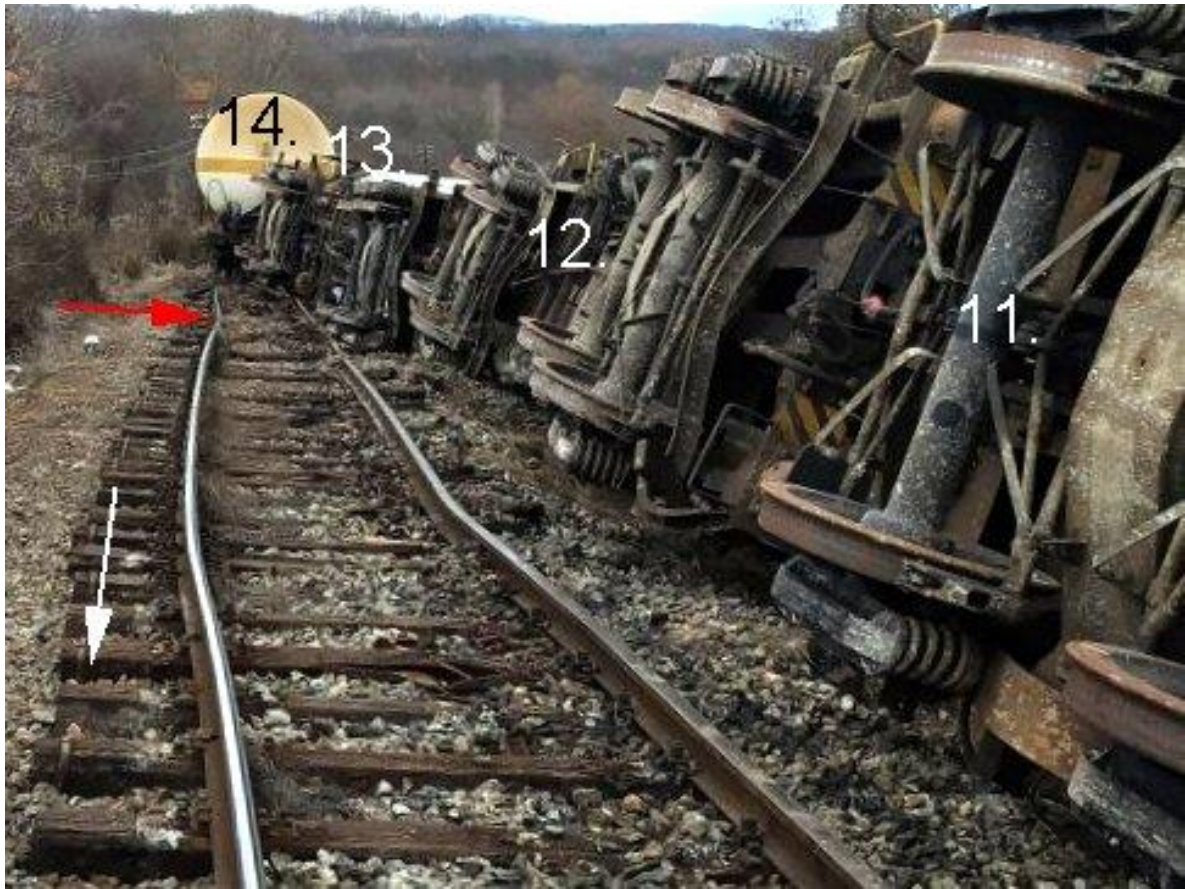
Figure 4.2.1.7. shows the transverse deformation of the rails (indicated by the red arrow) in the area of the front bogie of the thirteenth wagon, which indicates a strong pulling of that end of the wagon to the side before their overturning.

Figure 4.2.1.7: Track deformation in the zone of the front thirteen wagon bogie

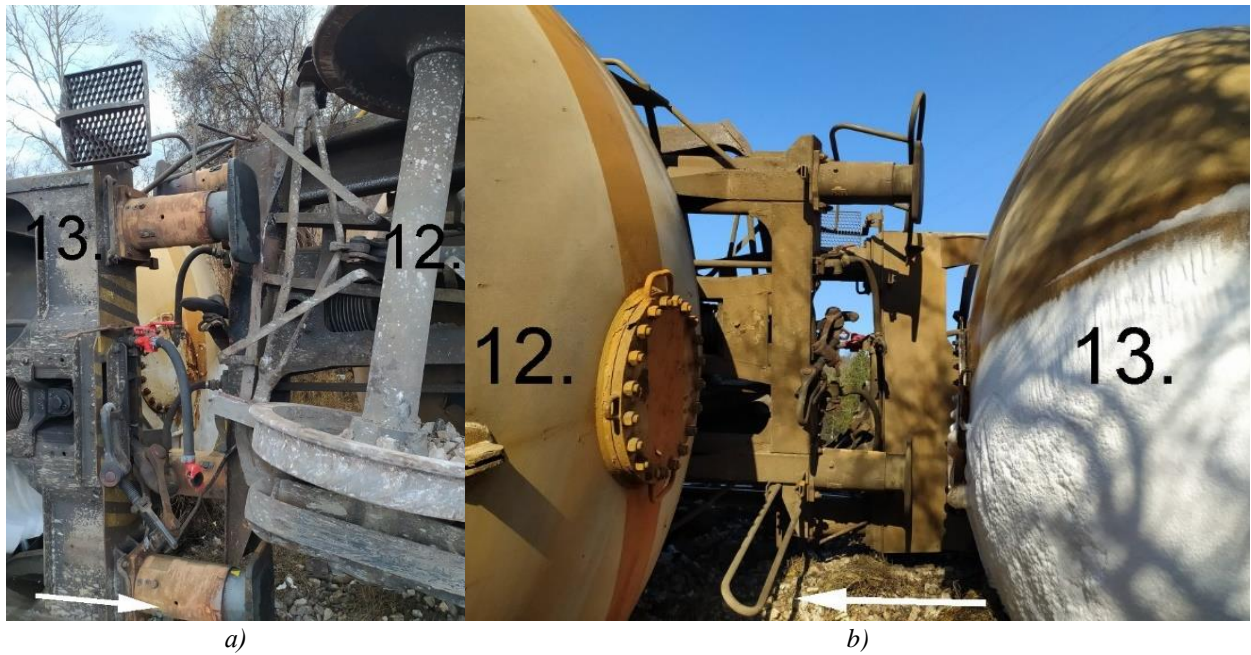
The brake couplings also disconnected during the overturning, due to the strong tightening in the connecting hoses.

Figure 4.2.1.8: Condition found between the twelfth and thirteenth wagon

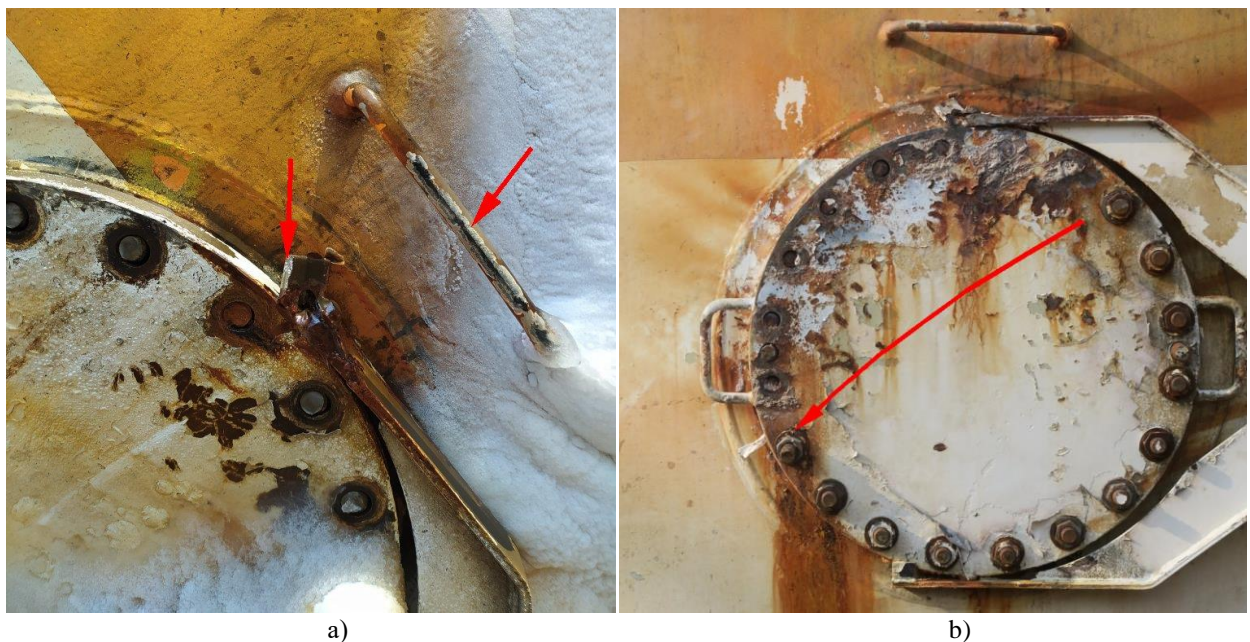
There has been a leak of ammonia under the inspection hole cover of the thirteenth wagon. In image 4.2.1.9. a), taken at the scene, the cover is shown with detached screws, as well as traces of scratched paint on the handle above the inspection hole and on the cover holder. Eight out of twenty screws have been detached, and the contact marks can still be seen on one screw in front and one screw behind the group of detached ones. In image 4.2.1.9. b), which was taken during a subsequent inspection of the wagon at the “Inter-mehanika”d.o.o. Skorenovac workshop in Smederevo on 08.02.2023, it can be observed that all the detached screws in the cover openings have been shifted in the direction indicated by the arrow. This suggests that they were detached by sliding in the same direction.

Figure 4.2.1.9: Damages on the inspection hole cover of the thirteenth wagon

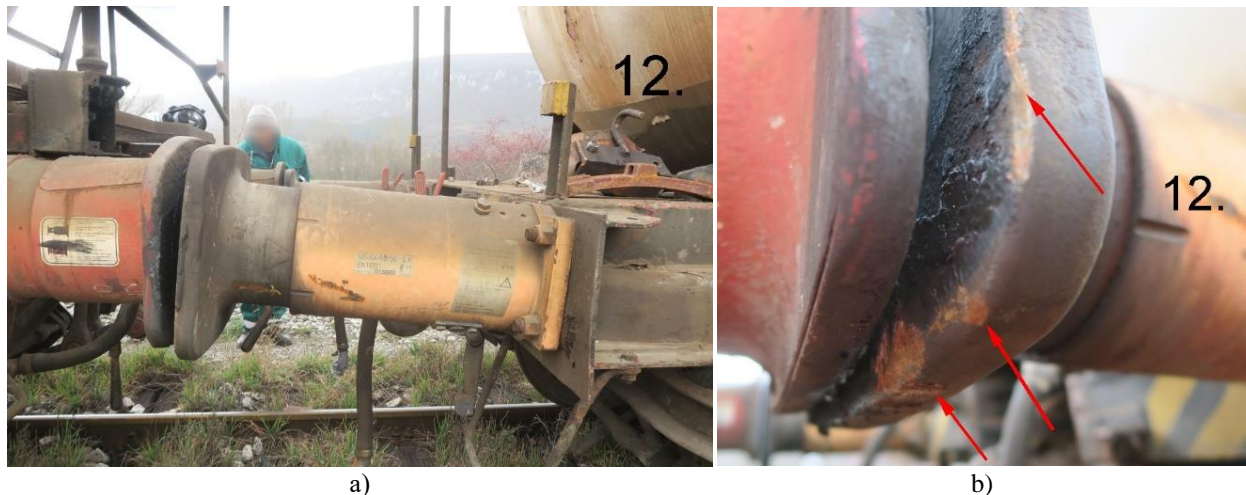
In Fig.4.2.1.10. the rear right buffer of the twelfth wagon is shown after lifting the wagon for inspection on 19.01.2023. The buffer is tilted upwards with deformation of the attachment plane on the chest beam (see image 4.2.1.10. a)). On the lower and right side of the buffer plate, there are surface traces of damage (see image 4.2.1.10. b)).

Figure 4.2.1.10: Bent buffer and traces on the buffer plate of the twelfth wagon

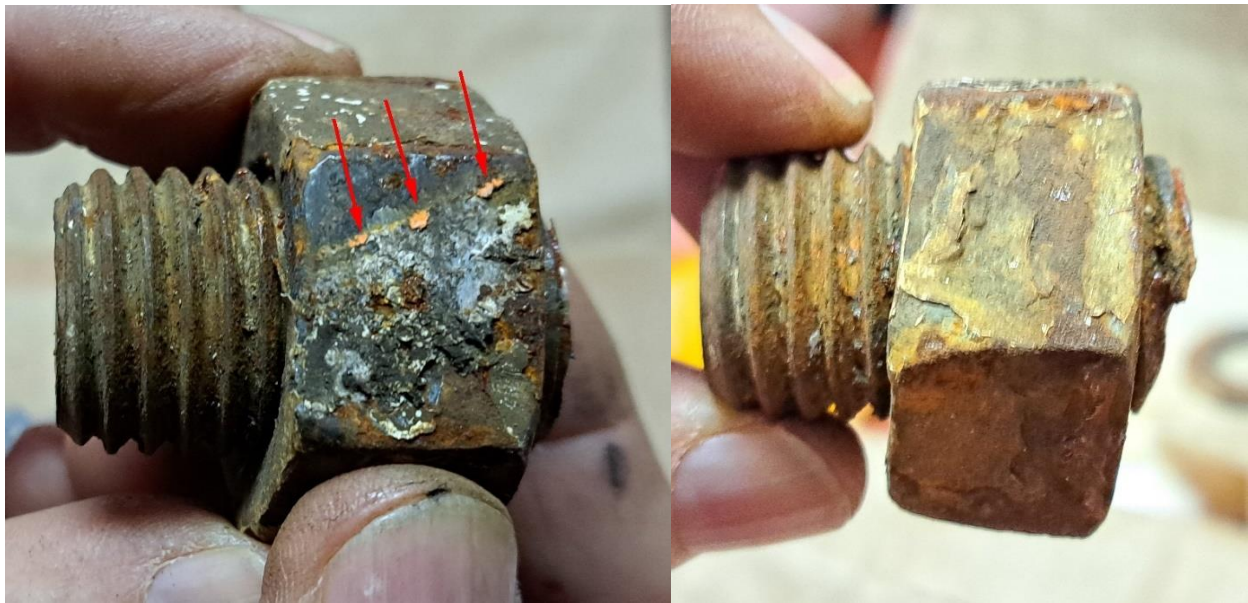
On one side of nut 1 (Figure 4.2.1.11. a)), a gray area is visible, which differs from the rusty appearance of the other sides. Traces of paint, which could come from an impact with the buffer plate shown in Figure 4.2.1.10. b)), are also observed. Nut 2 (Figure 4.2.1.11. b)) is deformed from the received lateral impact.

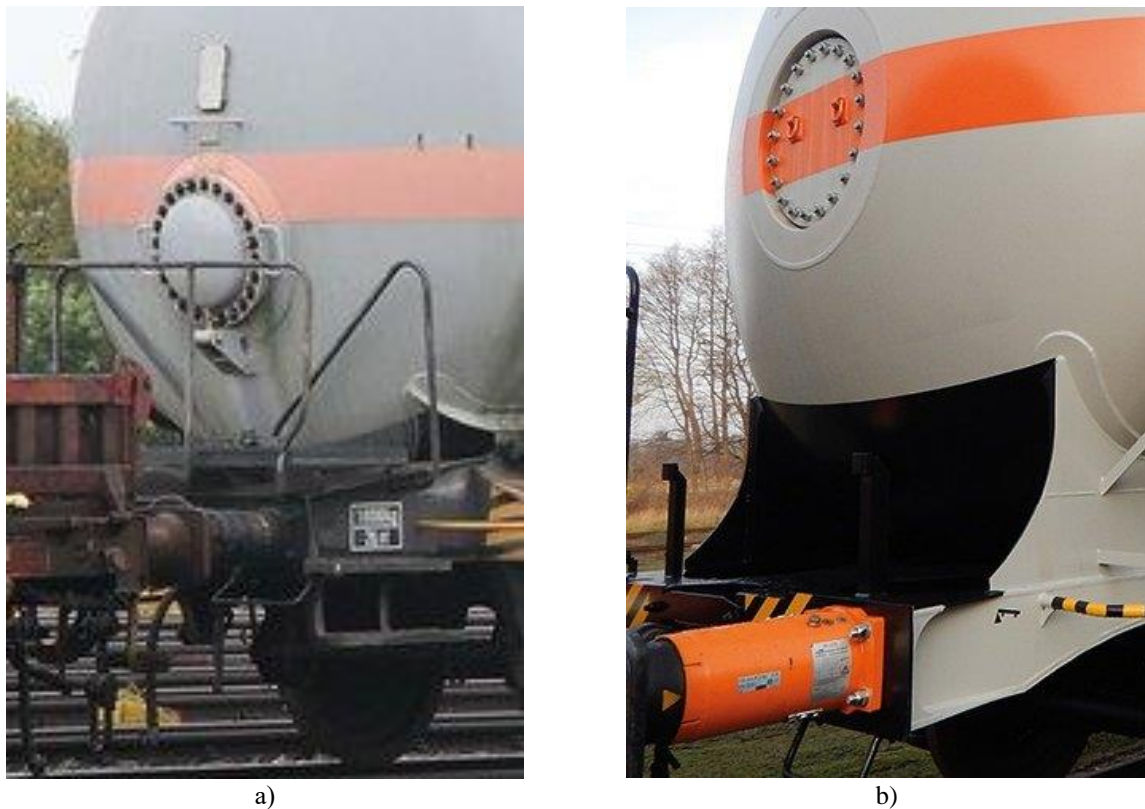
Figure 4.2.1.12: Appearance of structural variations of the inspection hole cover

An even better solution is shown in Figure 4.2.1.12. b), with a recessed inspection hole, which would probably avoid screw severing and gas leakage in such accidents. Additionally, the recessed inspection hole is positioned in the center of the beam, which reduces the likelihood of contact with neighboring buffers in accidents similar to this one.

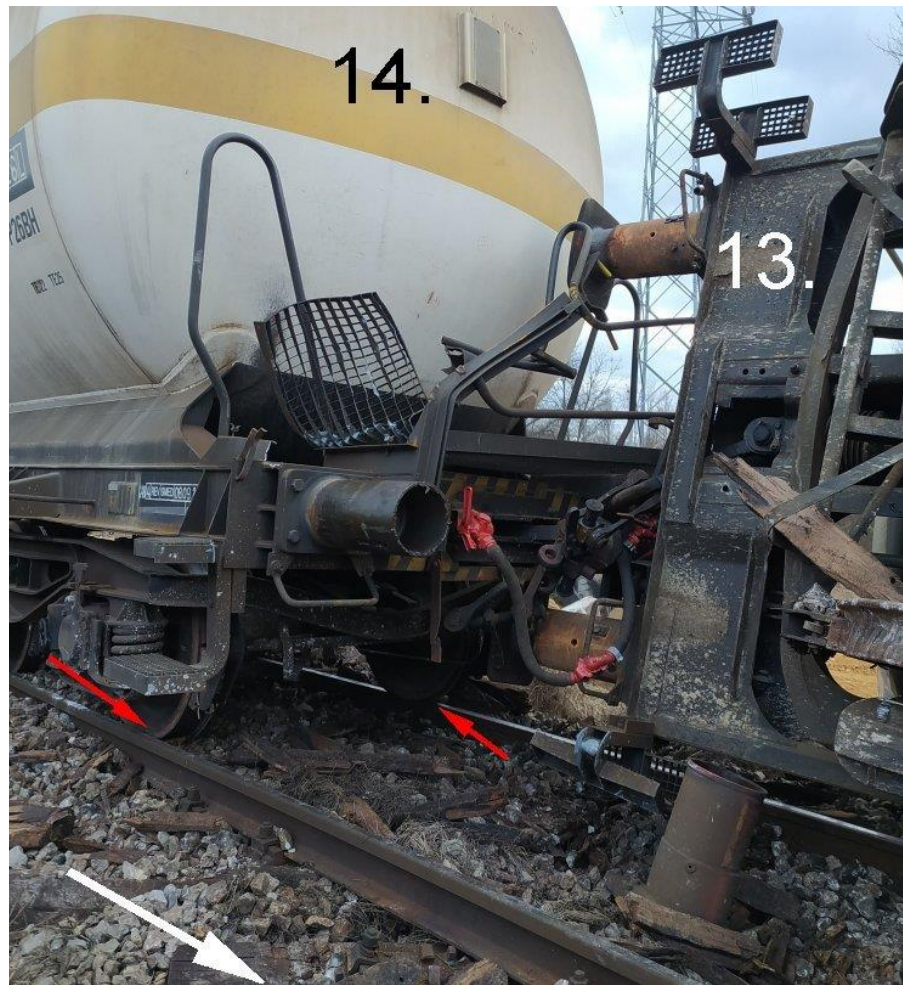
The buffer sleeve on the front right buffer of the fourteenth wagon fell off.

Figure 4.2.1.13: The condition found between the thirteenth and the fourteenth wagon

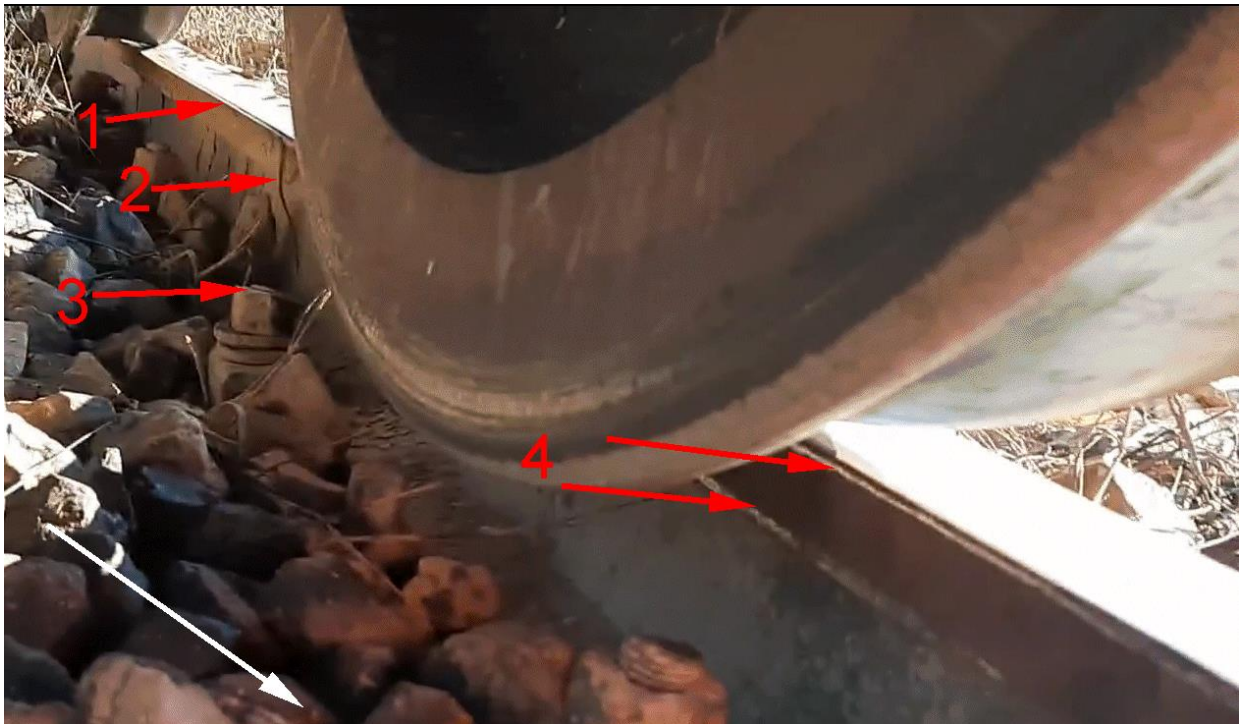
On the outer, right rail in the direction of movement, there are no signs of derailment.

Figure 4.2.1.14: Trace of the first fall of the wheel into the track

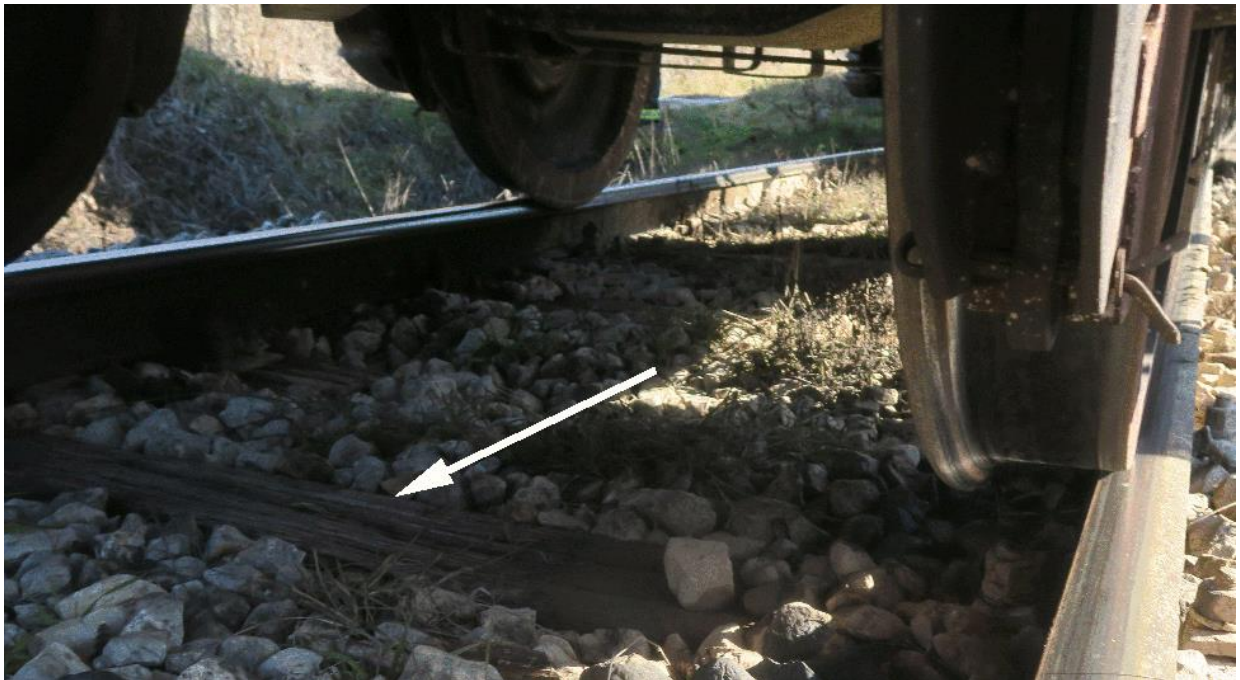
Figure 4.2.1.15. shows the observed position of the inner point of the third axle of the seventeenth wagon No. 33 80 7814 612-7, which is the closest to the point of impact. Under the weight of the wagon, in a stationary state, the wheel rests on the rail with a width of approximately 15 mm. At the scene, under the weight of the train in front of the third axle of the seventeenth wagon, the width of the railway track was measured using the “Geismar” measuring instrument owned by “IŽS” a.d. The width of the railway track was beyond the measurement range of the instrument (1475 mm), and it was estimated to be approximately 1490 mm. Towards the front part of the seventeenth wagon, the width was even greater, meaning further outside the scale of the measuring instrument. Nevertheless, the rear part of the fourteenth, fifteenth, sixteenth, and seventeenth wagons crossed the widened railway track and remained with their wheels on both rails.

Figure 4.2.1.15: Position on the rail of the third axle of the seventeenth wagon's left wheel

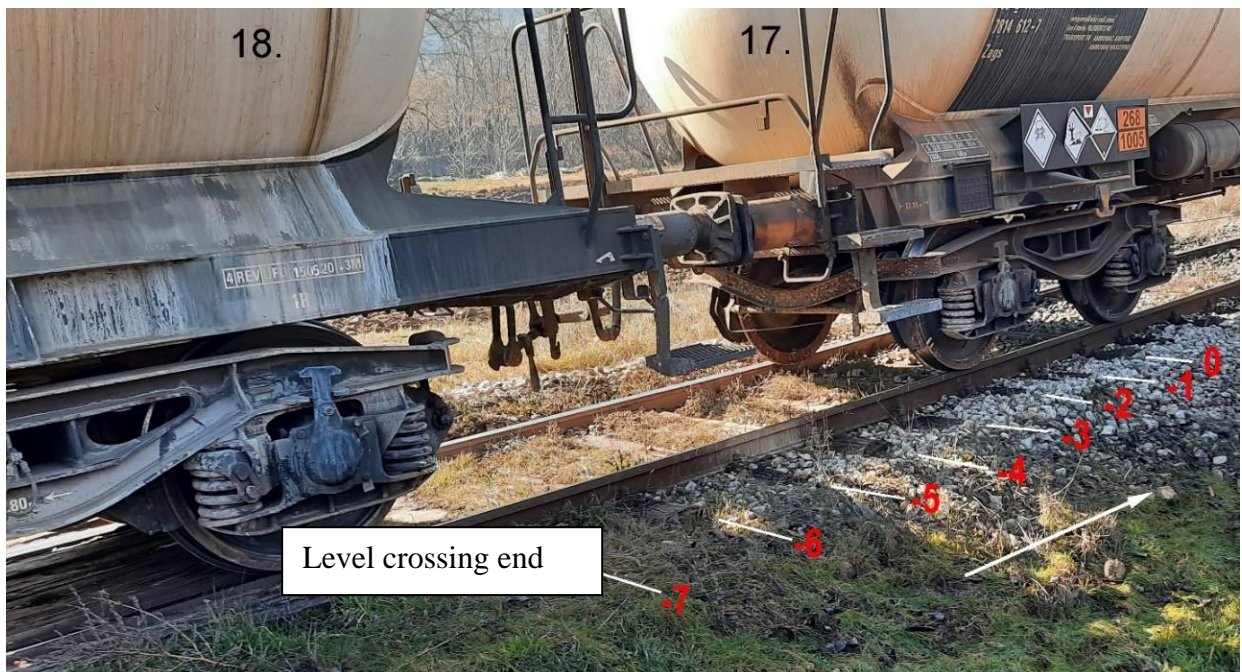
Figure 4.2.1.16. shows the sleeper where the first deformation on the top of the screw caused by the wheel's impact was found, marked as the zero sleeper. Sleepers in front of the impact site are marked with negative numbers, while sleepers after the impact site are marked with positive numbers (see Figure 4.2.1.19.).

Figure 4.2.1.16: Point of the falling of the wheel into the track (zero sleeper)

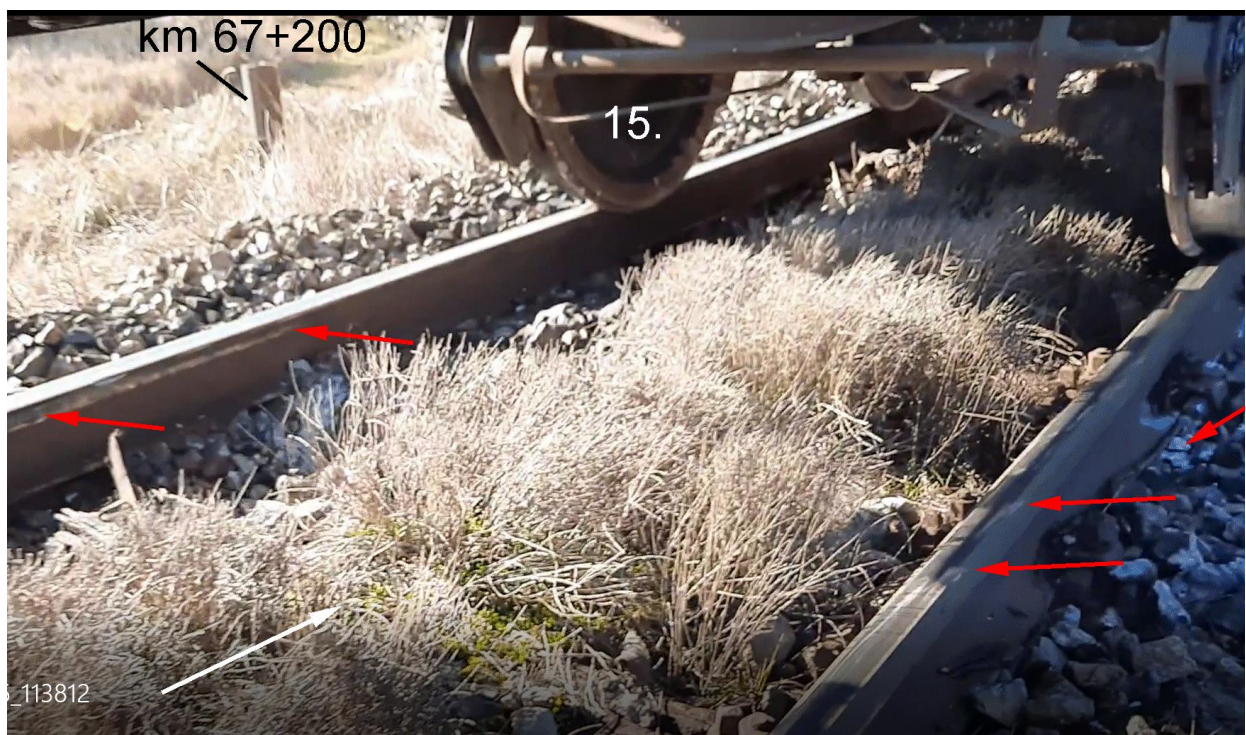
Based on this, it can be assumed that only one wheel, most likely from the front axle, fell onto the railway track, and therefore, the bogie had support along the other diagonal all the way to km 67+203. At that location, there are traces of derailment on the outer side of the right rail, and the trace of scraping from the fallen point on the left rail ceases (Figure 4.2.1.17.).

Figure 4.2.1.17: Trace of derailment on the right rail

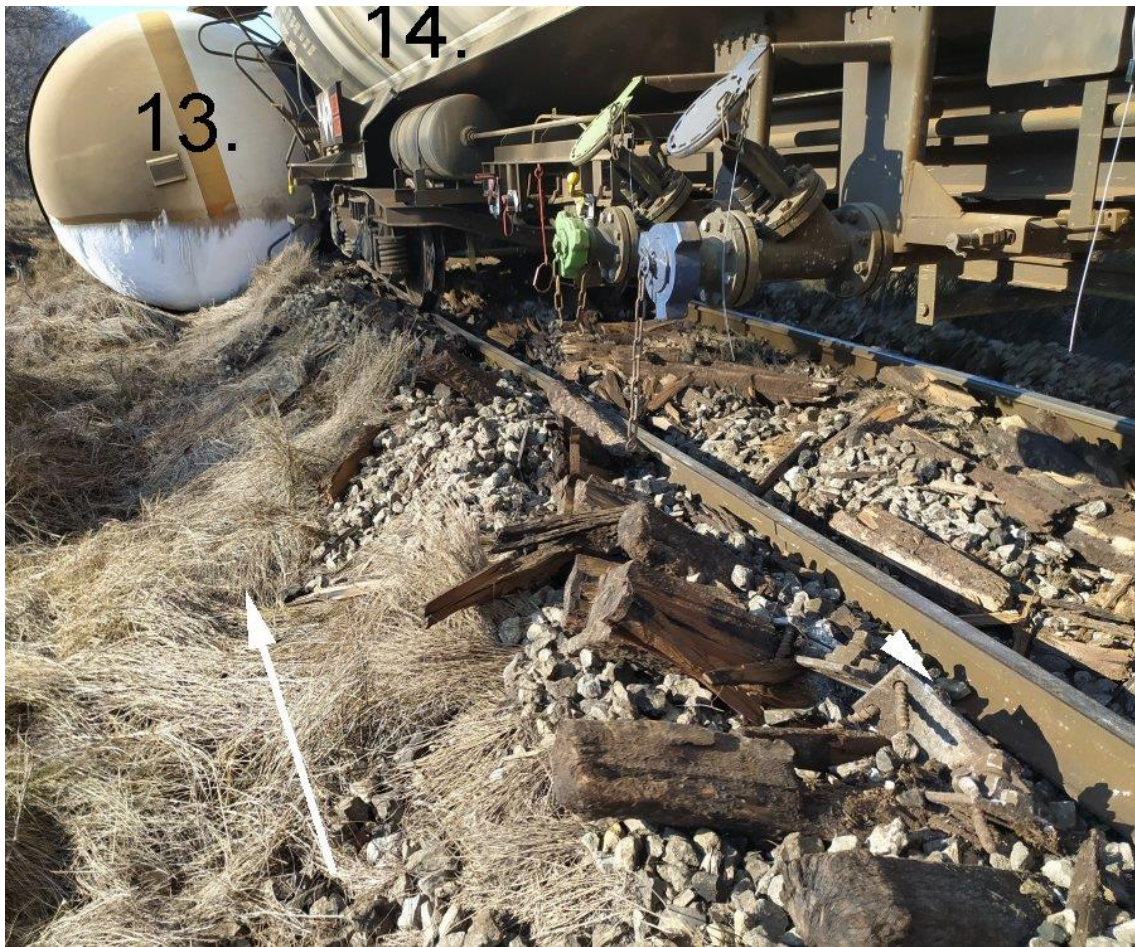
Over the next twenty meters, the railway track is severely damaged with torn-up sleepers, leading to the point where four wagon-tanks were overturned (Figure 4.2.1.18.). It was not possible to determine how many axles in total derailed before the wagon-tanks overturned. However, it is confirmed that the traces of derailment extend all the way to the first axle of the tenth wagon (Figure 4.2.1.3.), so there is a probability that this axle was the first to derail.

Figure 4.2.1.18: Severely damaged track in the fourteenth wagon area
