FINAL REPORT ON SERIOUS ACCIDENT INVESTIGATION

Serious accident type: Train derailment

Train No.: 45010

Place: City of Pirot, outskirts of the village of Sopot, open track
between the Staničenje crossing point and the Pirot station

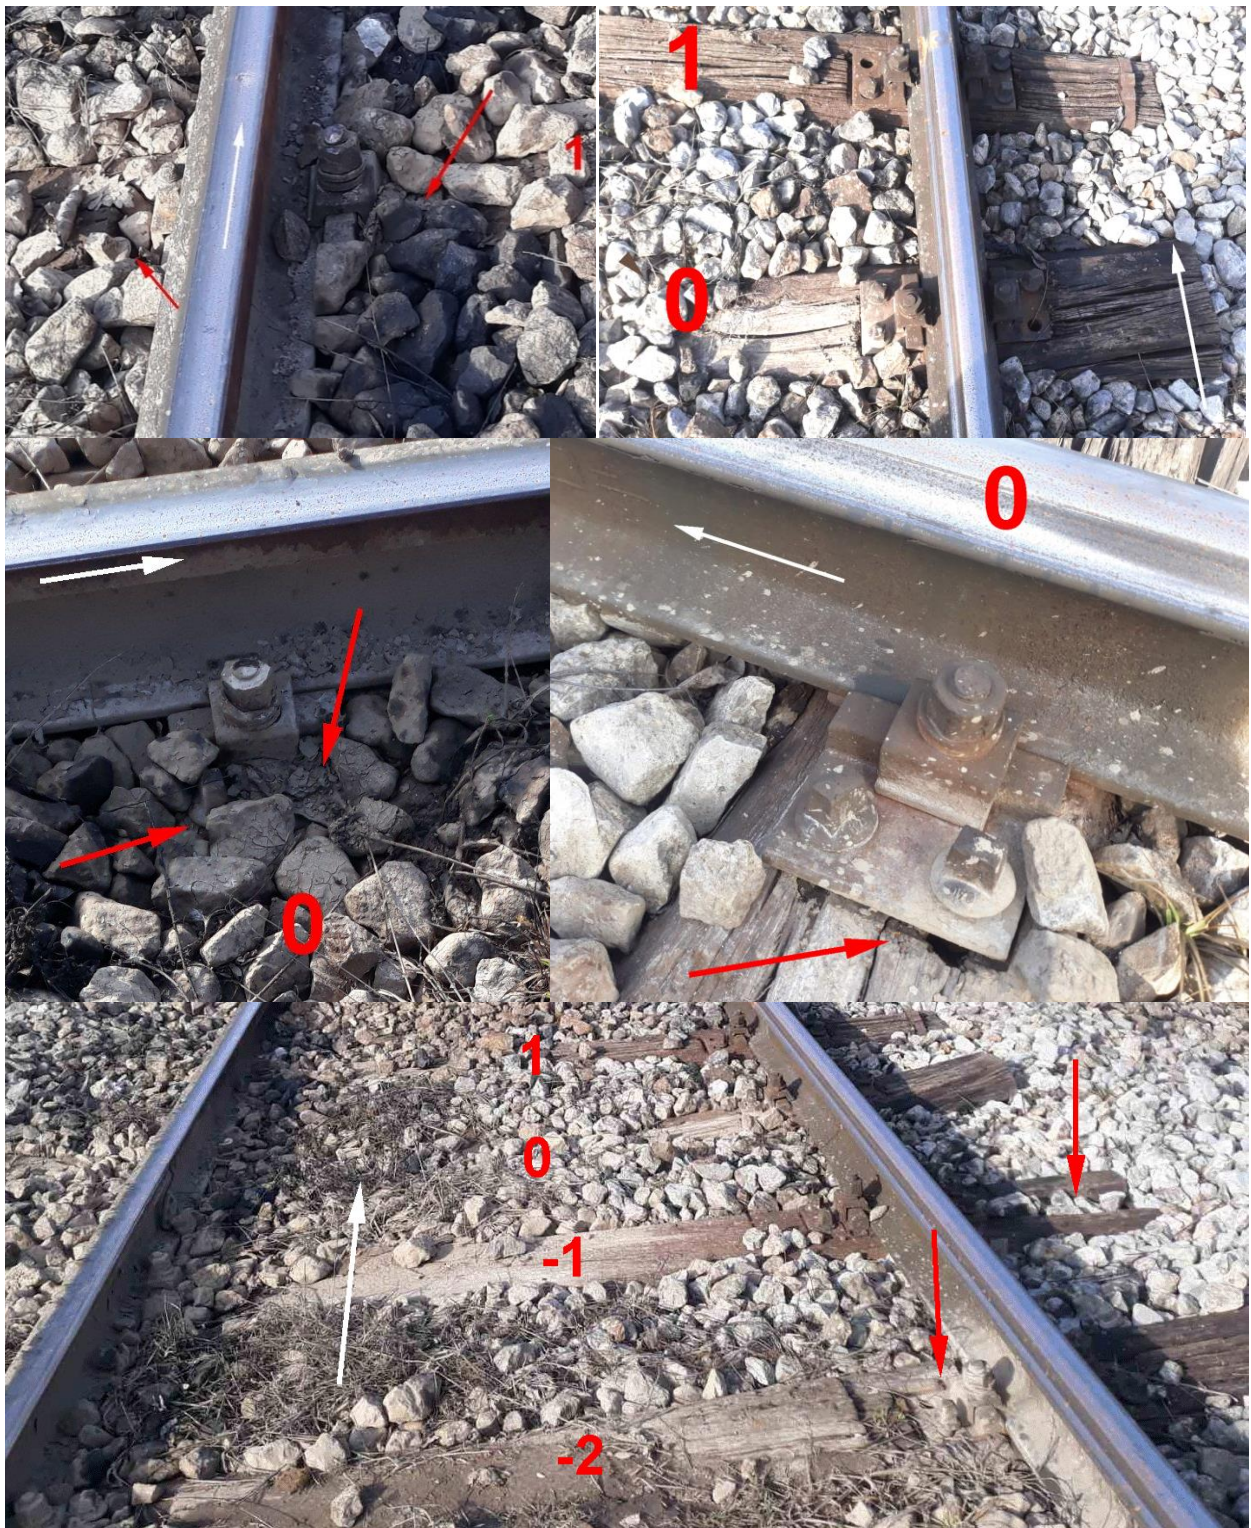
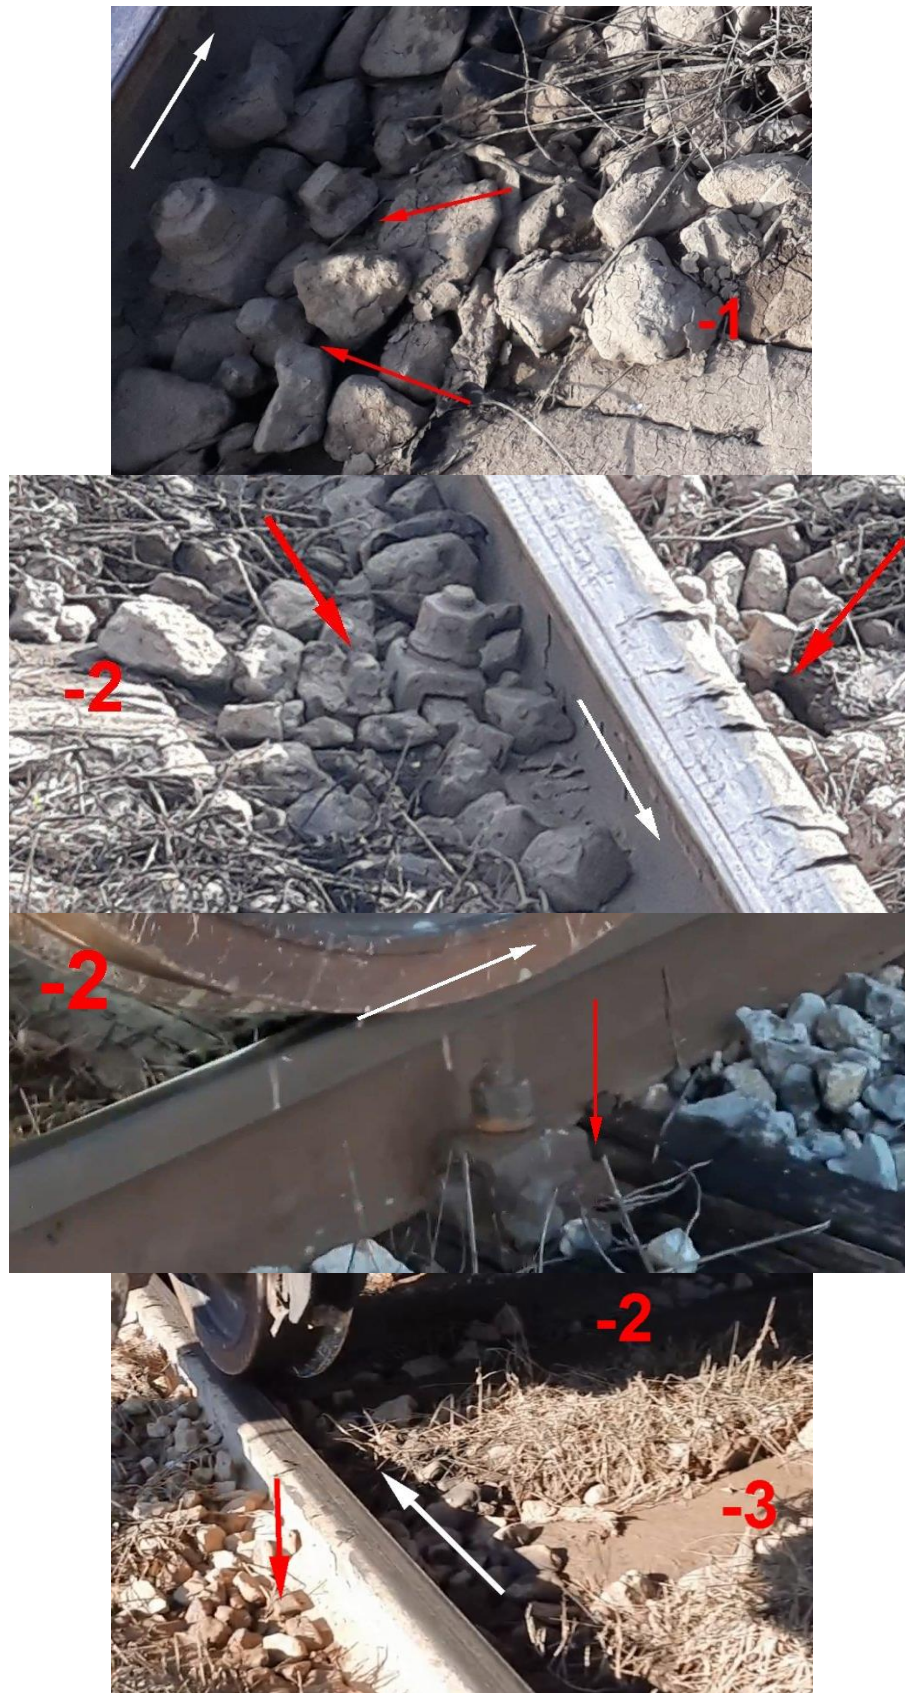
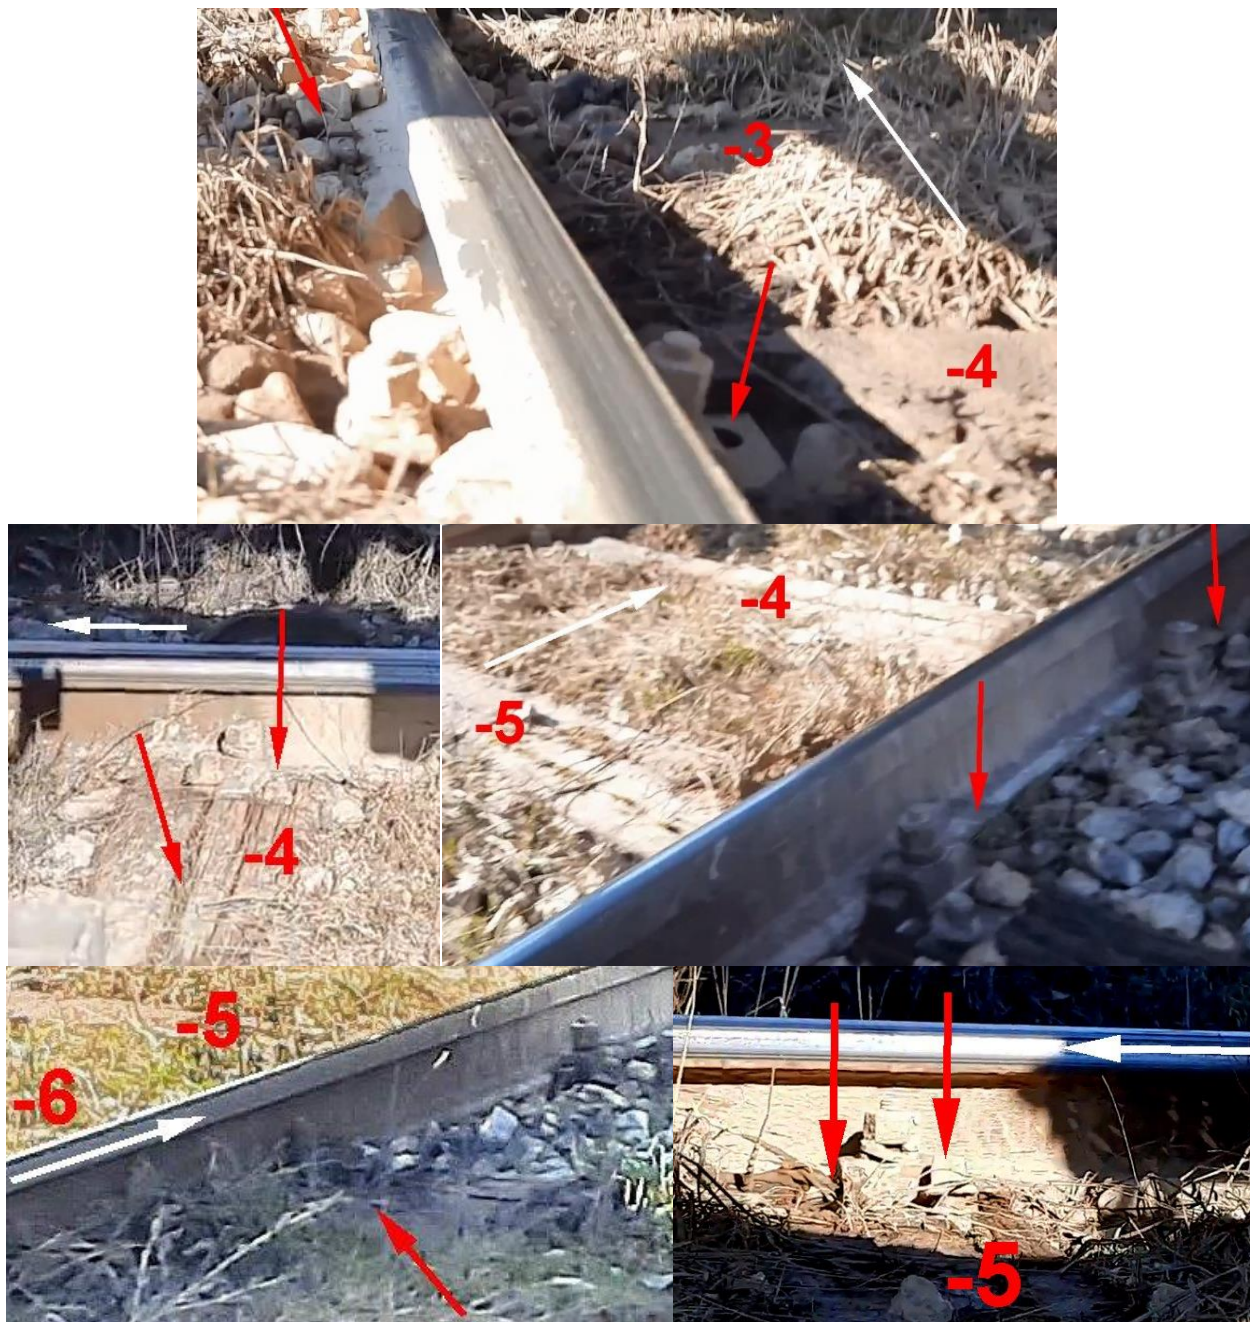
Figures from 4.2.1.19. to 4.2.1.21. show examples of the condition of the fastening equipment in the area of the first wheel derailing. Given that the expansion of the railway track required for the wheels derailing occurred during approximately one rotation of the wheel, the available images of the fastening equipment cover approximately 3 m before the point of derailing. A similar condition of the fastening equipment exists in the broader area around that location. On all sleepers, there is evidence of cracking, with some sleepers showing direct alignment with the tyrphons. Multiple tyrphons are missing, and the remaining ones are partially pulled out or loose. The ballast is soiled and partially muddy.

Figure 4.2.1.19: Condition of the fastening equipment in the area of the first wheel derailment

Figure 4.2.1.20: Condition of the fastening equipment in the zone of the first wheel derailment

Figure 4.2.1.21: Condition of the fastening equipment in the zone of the first wheel derailment

- SR_06/23** “IŽS” a.d. is required to, considering the inadequate maintenance and condition of the track, sleepers, and fastening equipment, conduct a risk assessment for train traffic on the main arterial line No.106: Niš - Dimitrovgrad - state border - (Dragoman) and take measures to reduce the risks to an acceptable level. Based on this, they should conduct a professional assessment of the minimum necessary resources (materials, machinery, workforce) for track maintenance (see points 4.2.1, 4.2.6, 4.2.7, 4.2.9, 4.3.1, and 4.3.2.).

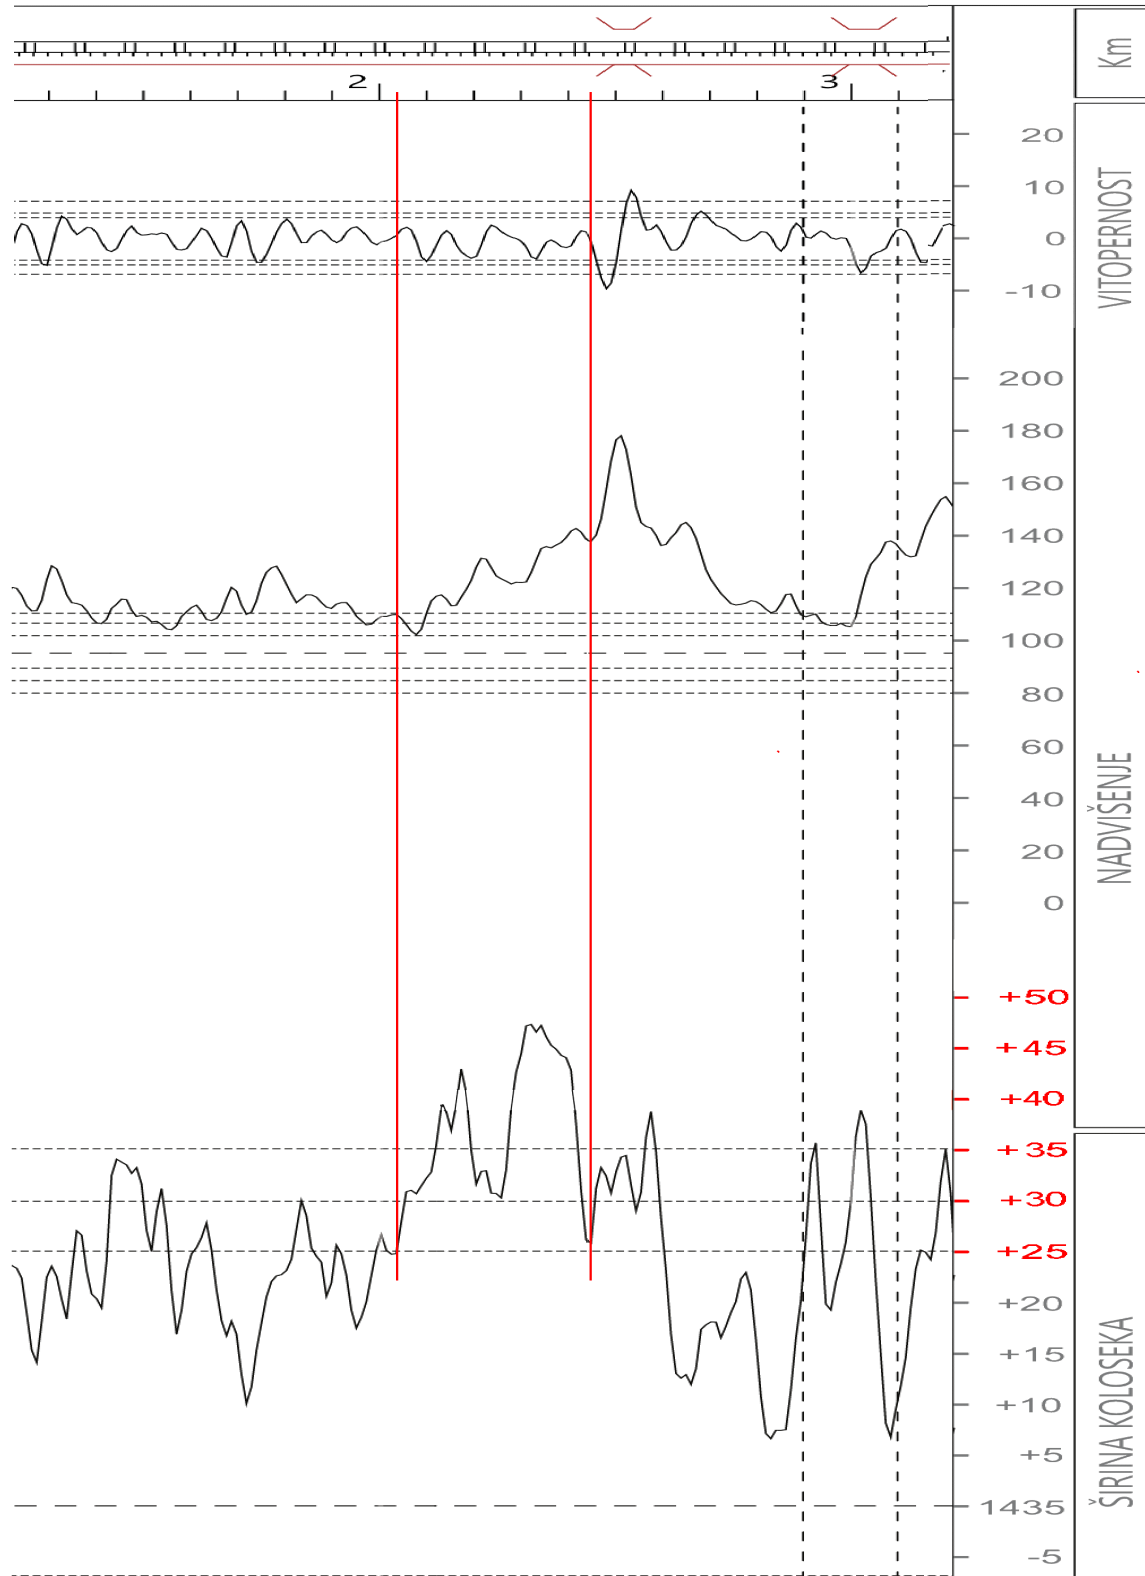
The data provided indicate that due to the large excess of cross level, the vertical load on the inner (left in the direction of movement) wheels was increased. At the same time, the change in twist between two values above the current intervention boundary further triggered oscillations around the longitudinal axis, resulting in even greater amplitude load on the inner wheels. In combination with the lateral guiding force in the curve, the very poor condition of the fastening equipment and sleepers led to the spreading of the rail heads and the derailment of the inner point into the railway track. This has occurred on the axle where at a given moment a critical combination of a number of the mentioned parameters simultaneously happened, some of which have a random oscillatory character.

Figure 4.2.1.22: The geometric condition of the railway track in the zone of the wheel's derailment

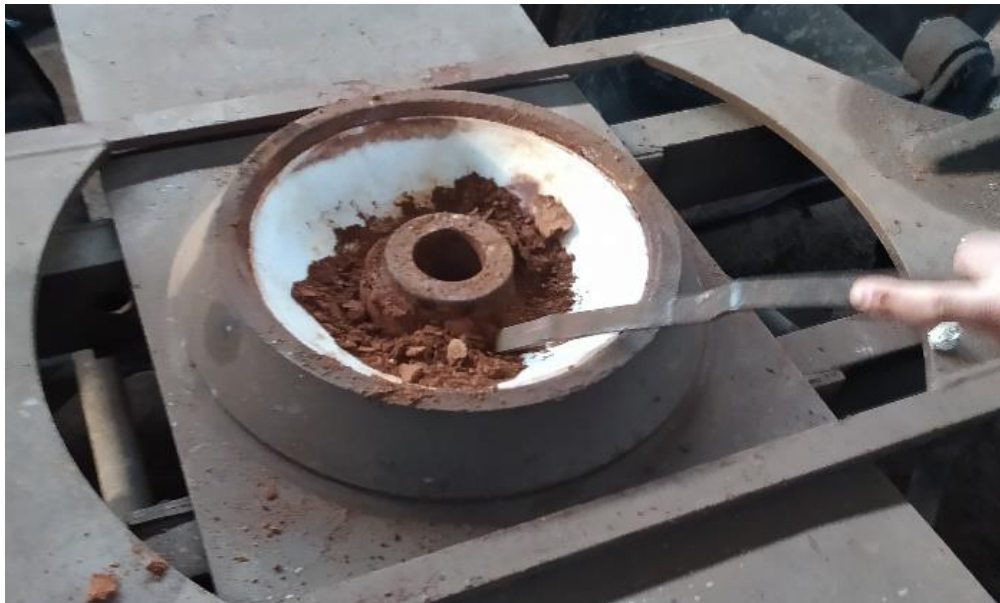
Figure 4.2.2.1. shows the center bowl with foreign material from the tenth wagon (which was provided with the complaint from the representative of “IŽS” a.d.).

Figure 4.2.2.1: Center bowl with the foreign material of the tenth wagon

Although there is red soil present in the wider area of the serious accident, similar to the one in Figure 4.2.2.1, photographs from the scene of the serious accident show that the overturning of the tenth wagon occurred on the ballast without visible traces of excavated red soil. Therefore, it is unlikely that the soil entered the center bowl during the serious accident. On the other hand, the probability of this happening during normal operation is even lower, especially since similar occurrences were not observed in the other center bowl. The third possibility is that soil entered the center bowl during the unfastening of the bogies in some workshop, which is also unlikely since the previous revision was performed only three months before the serious accident (on 26.9.2022) in Smederevo, and according to the provided data, there was no extraordinary maintenance from that time until the serious accident.

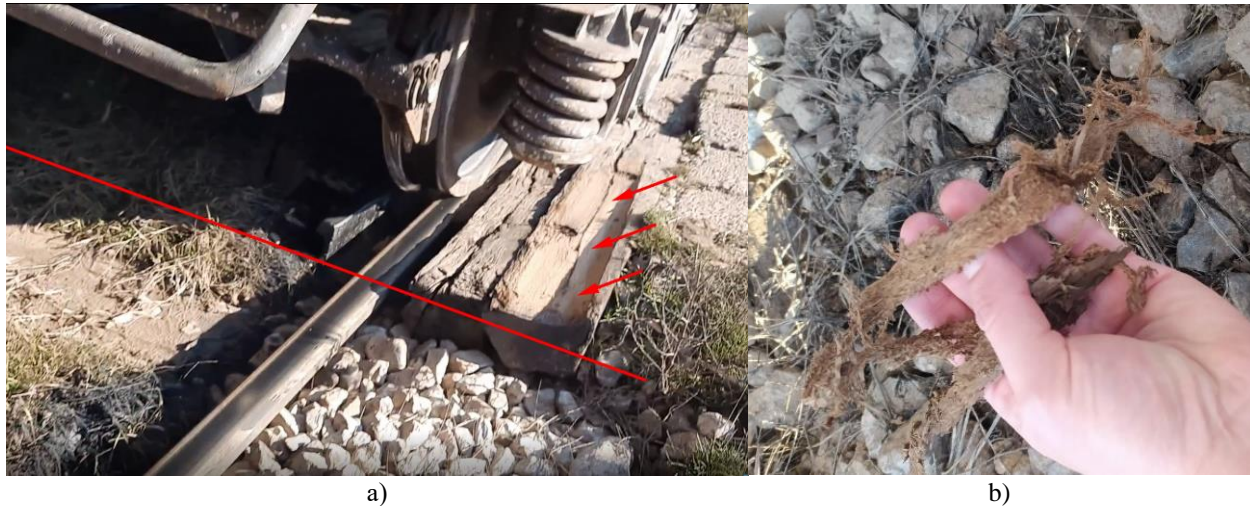
In addition to the level crossing, metal shavings or debris were found (see figure 4.2.5.1.1. b)), most likely originating from the damage.

Figure 4.2.5.1.1: Hollowed part of the wooden roadway structure at the level crossing

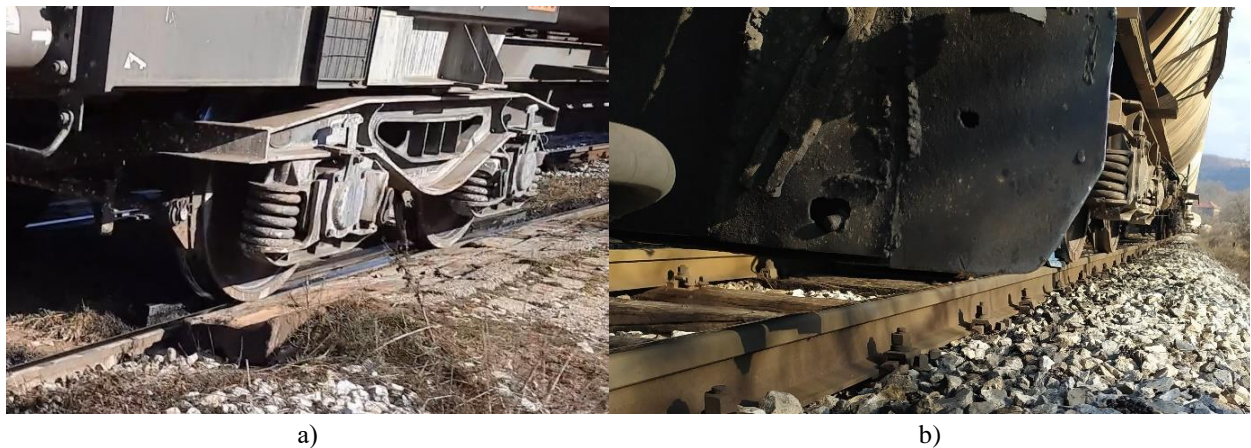
During the on-site inspection and later examinations, no parts that could be so low were found on any of the vehicles in the train. In the picture 4.2.5.1.2. a), taken at the scene, you can see that on the wagon-tanks, the lowest parts of the pedestal housings have their lower surfaces, at approximately 200 mm above the GIŠ, at medium wheel wear. In picture 4.2.5.1.2. b), also taken at the scene, you can see the rear rail cleaner of locomotive 661-249 and the low parts of the wagon-tanks. The rail cleaner, when the wheel are most worn and the springs are at their maximum deflection, can be as low as 80 mm above the GIŠ, but it is normally higher than that.

Figure 4.2.5.1.2: Position of the lower parts of the vehicle

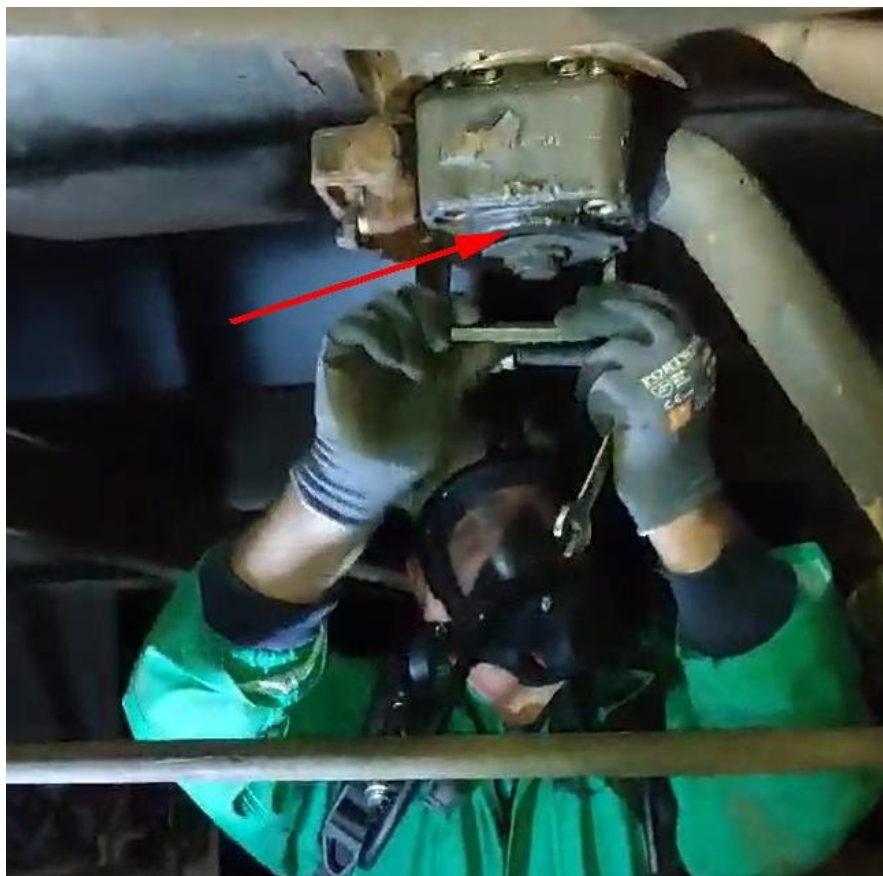
Figure 4.2.5.2.1: The point of ammonia leakage on the seventh wagon-tank No. 33 87 7813 561-0

- SR_10/23** Atir-Rail SA, is to, when receiving a vehicle from a regular repair, perform additional monitoring of the condition of the valves for filling and emptying the cistern, considering that on some cisterns, only a few months after the regular repair, leaks appear on the valves (see point 4.2.5.2.).

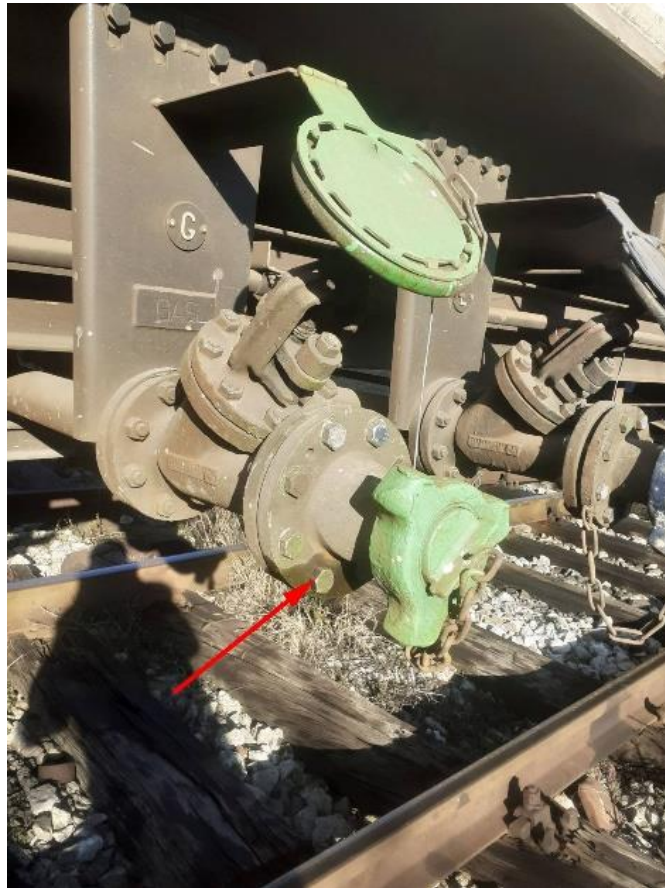
Figure 4.2.5.2.2: The point of ammonia leakage on the eighth wagon-tank No. 33 80 7818 092-8

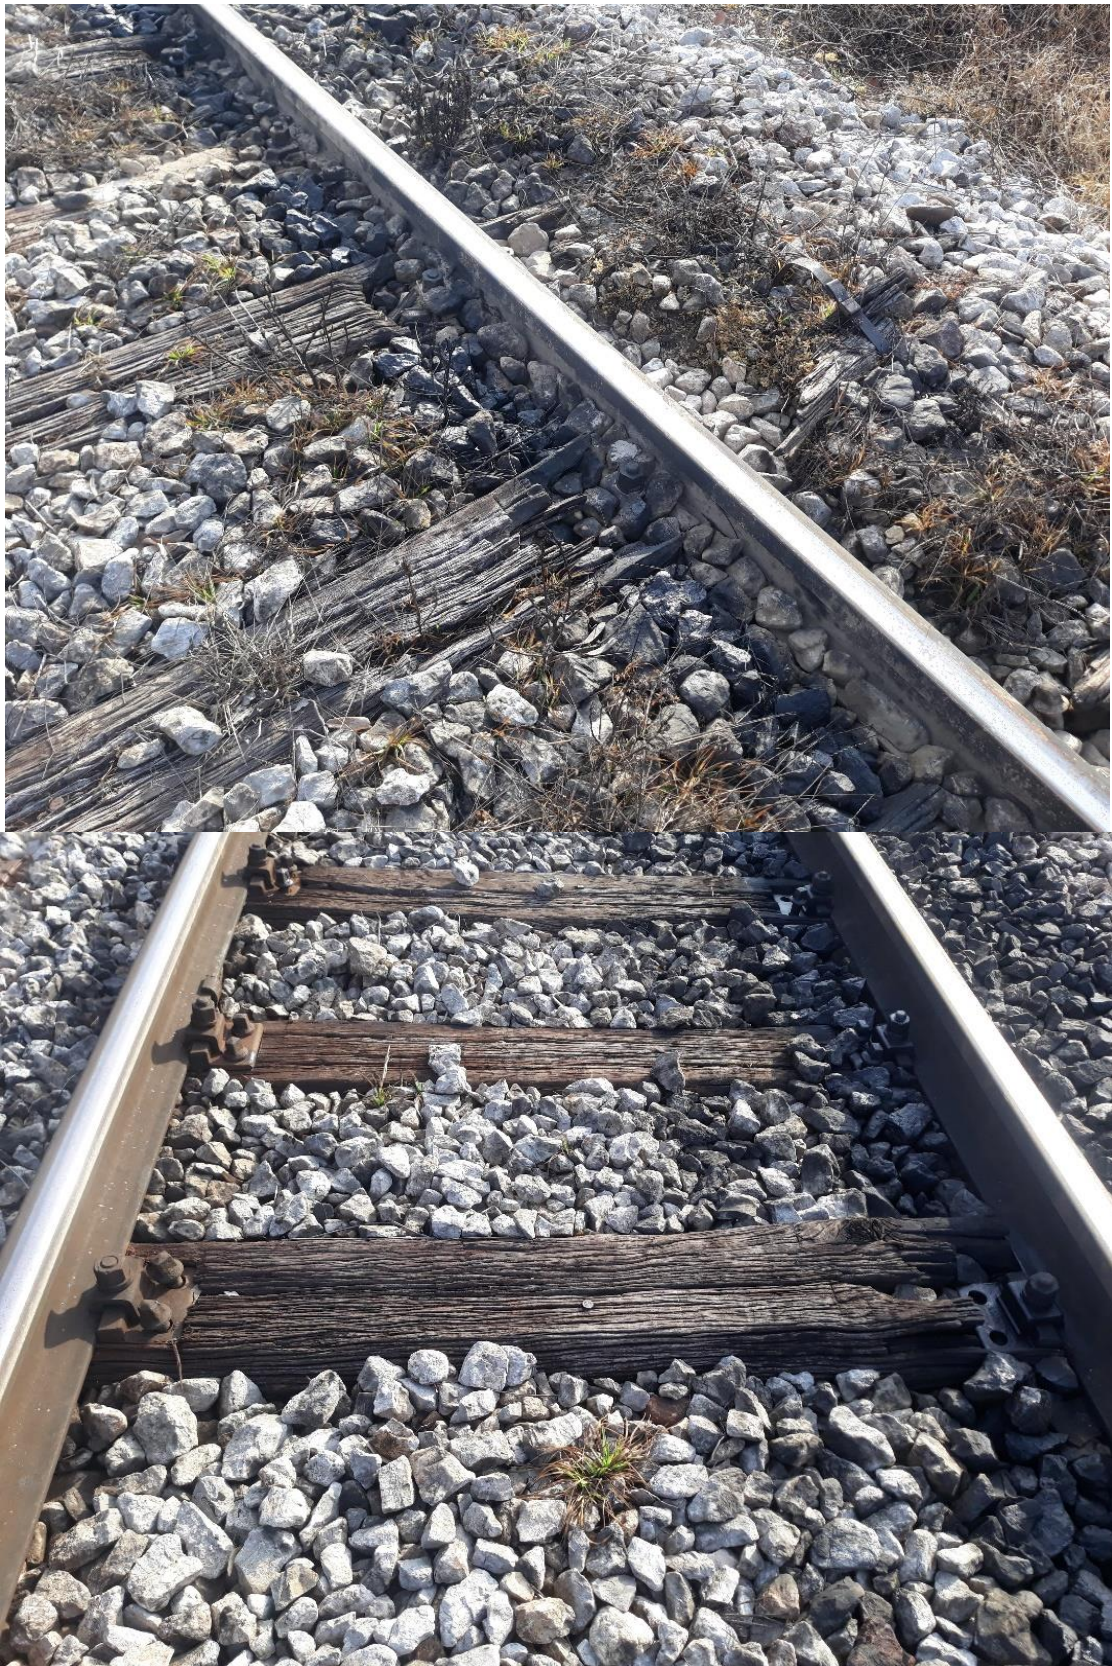
Figure 4.2.6.1: Appearance of the wooden sleepers in the serious accident zone (source: "IŽS" a.d.)

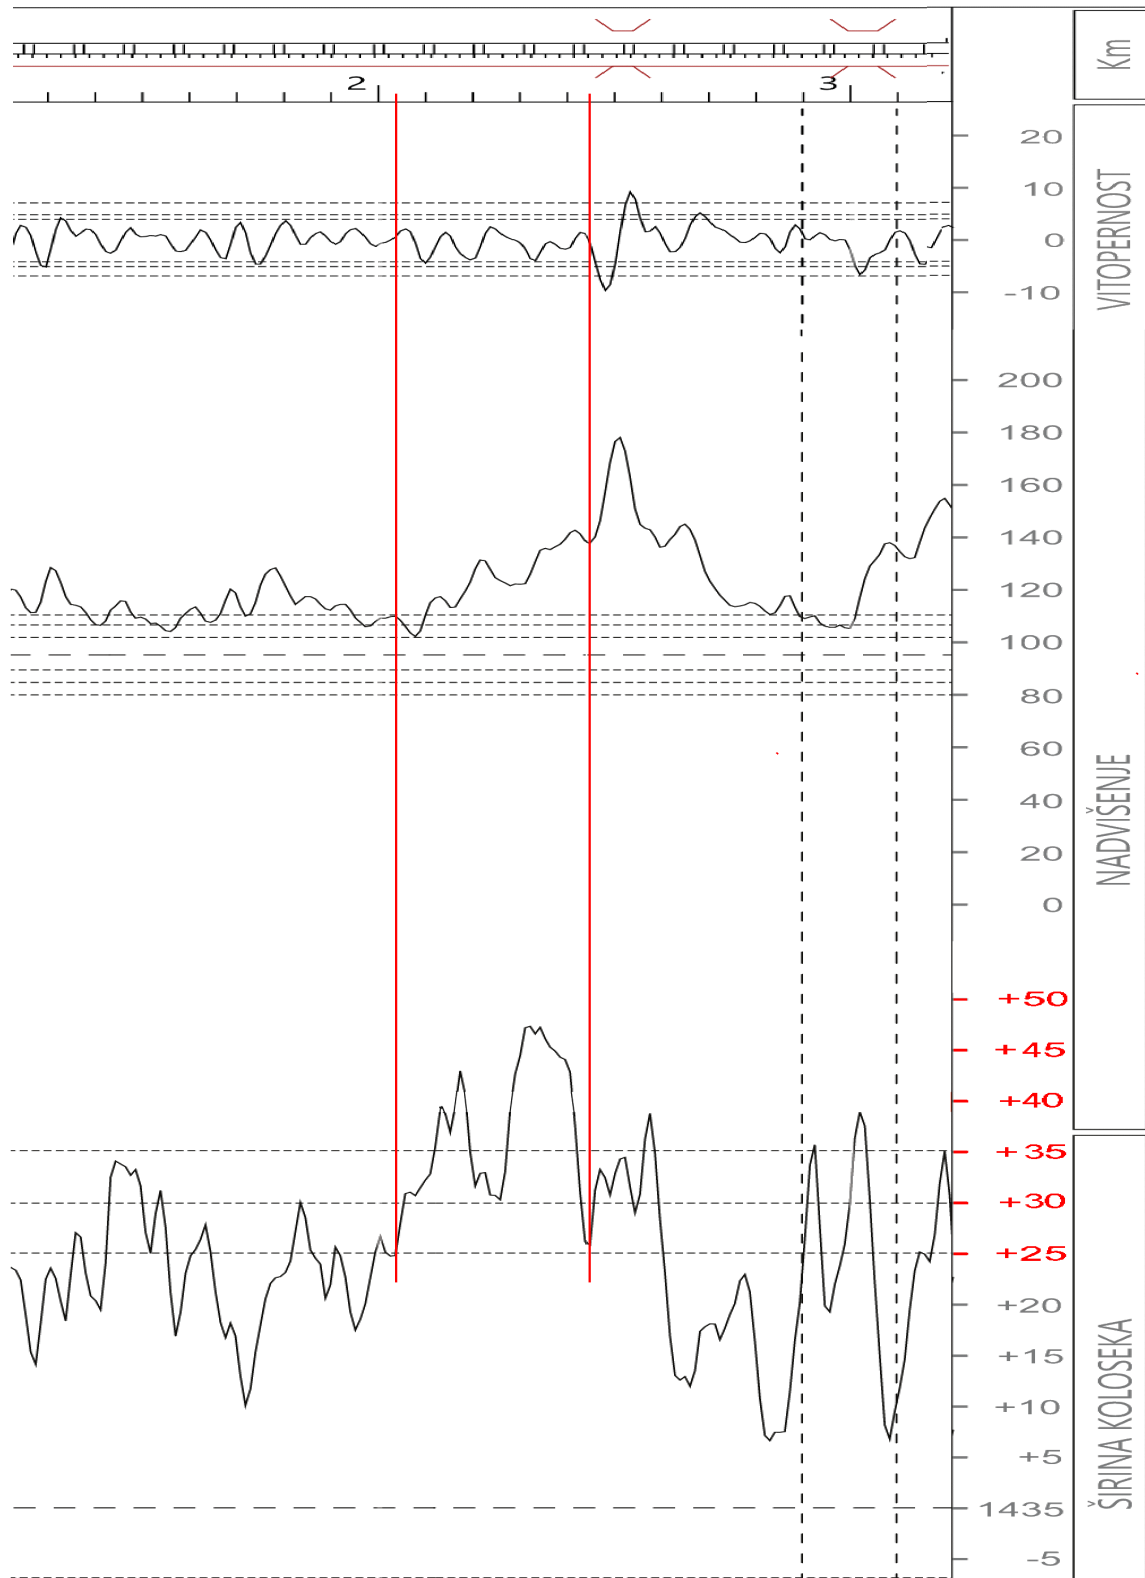
Figure 4.2.7.2: Excerpt from the graphical record of measuring devices from 20.10.2022.

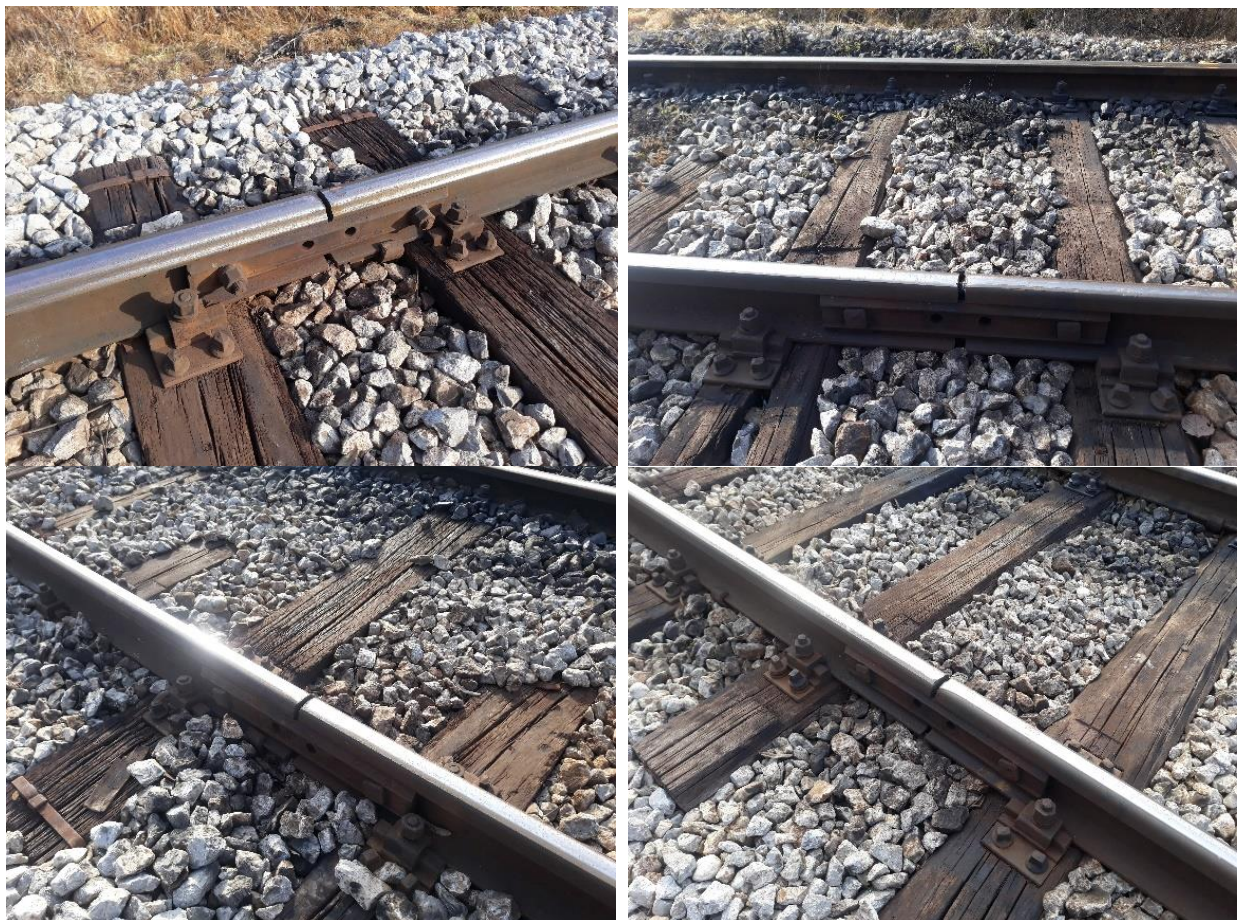
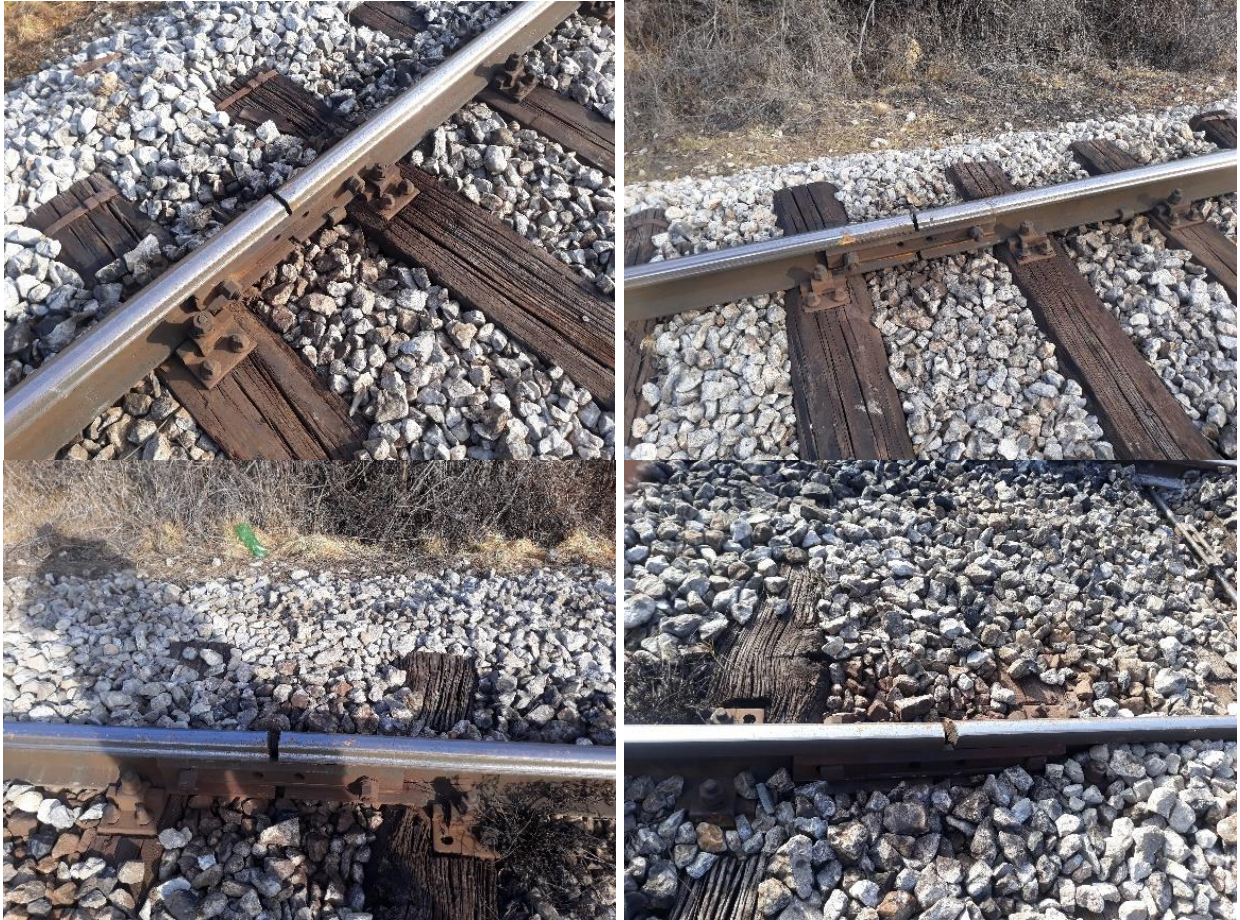
Figure 4.2.9.6: The appearance of railway joints in the broader area of the serious accident (floating unbalanced joints)

Figure 4.2.9.7: The appearance of railway joints in the broader area of the serious accident (floating unbalanced joints)
