STATE COMMISSION ON RAILWAY ACCIDENT INVESTIGATION
Ministry of Interior and Administration

REPORT No. PKBWK 03/2023

**on the investigation of the railway accident
that occurred on November 3, 2022 at 18:45
at Krzcięcice passenger stop on track no. 2, at km 244.636
railway line no. 8 Warszawa Zachodnia - Kraków Główny
area of the infrastructure manager PKP PLK S.A. Railway Line Department in Kielce**

WARSAW, September 7, 2023.

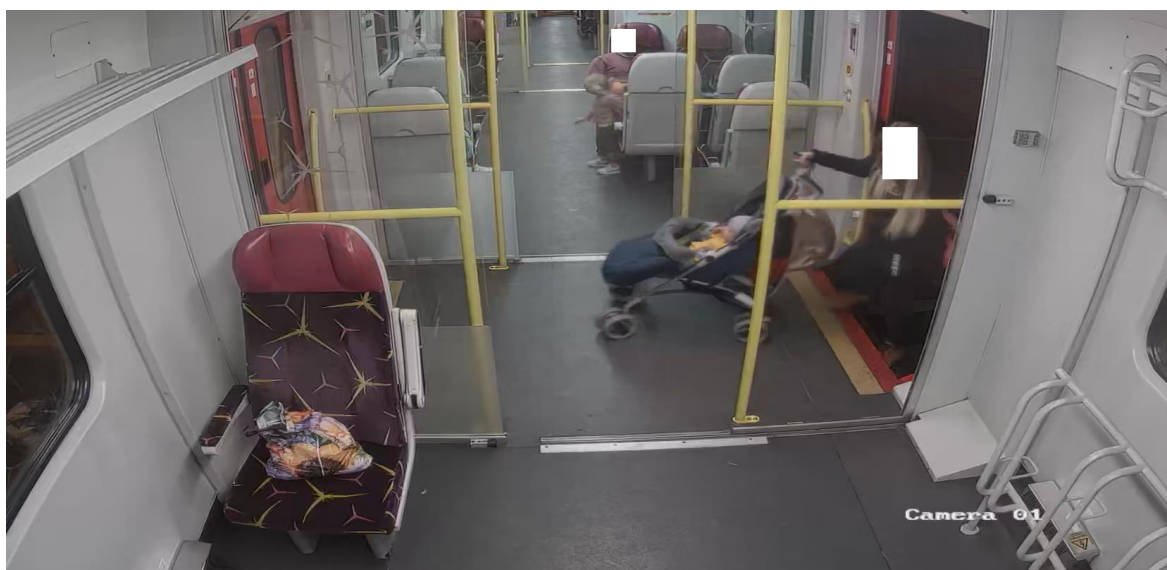
Photo 6 - Recorded image of a traveler getting off the train (vehicle monitoring)

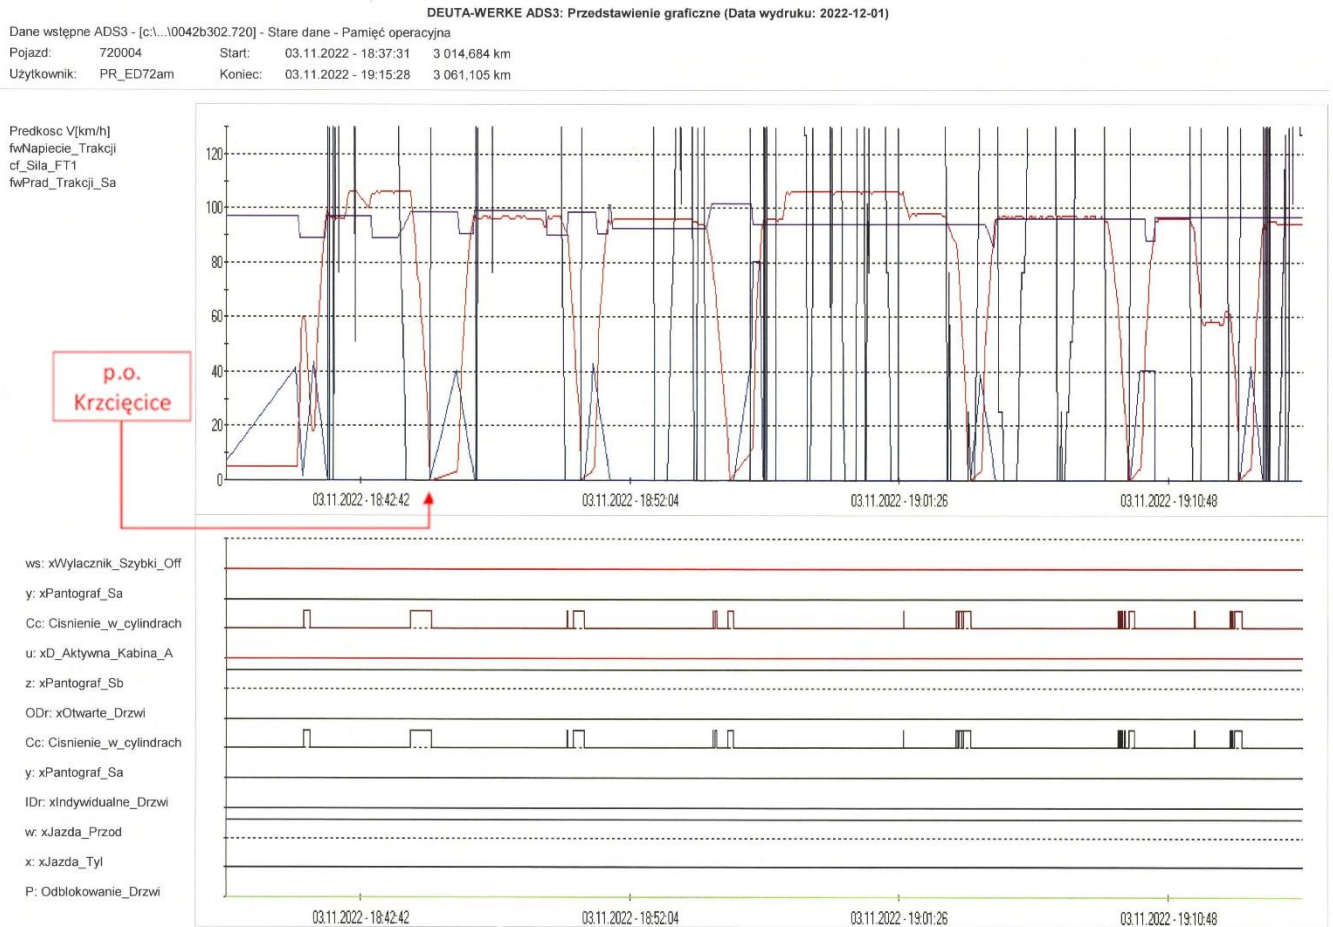
Figure 3 - Graph of driving parameters of the ED72Aa-004 locomotive as a function of time

- 18:40:27 at the departure of the train from Sędziszów station, there was a gradual increase in speed to V-60 km/h,
- 18:40:40 registered pressure in brake cylinders with simultaneous decrease of speed to V-26 km/h,
- After that, the speed was gradually increased to 106 km/h, and the train continued to run at the set speed until 18:44:24, at which time electrodynamic braking was recorded with a decrease in speed to a complete stop, i.e., 18:45:03,
- Stop from 18:45:03 to 18:46:02. The distance covered by the train from Sędziszów station corresponds to the stopping point at Krzcięcice station. The length of the platform edge is 199.5 m. The front of the train stops at km 244.549, occupying 69 m of the initial part of the platform.

During the operation of the train, the driver's reactions to the operation of the ABP (Automated Train Safety) equipment - correct. The planned speed of the train on this section is up to 110 km/h. The ED72Aa-004 electric multiple unit is equipped with a system of centralized opening of the doors by the driver. In this system, the passenger opens the door individually after the train stops. Each entrance door of the ED72Aa-004 train is equipped with an intercom system for voice communication with the driver. The device was not used on the day of the occurrence.

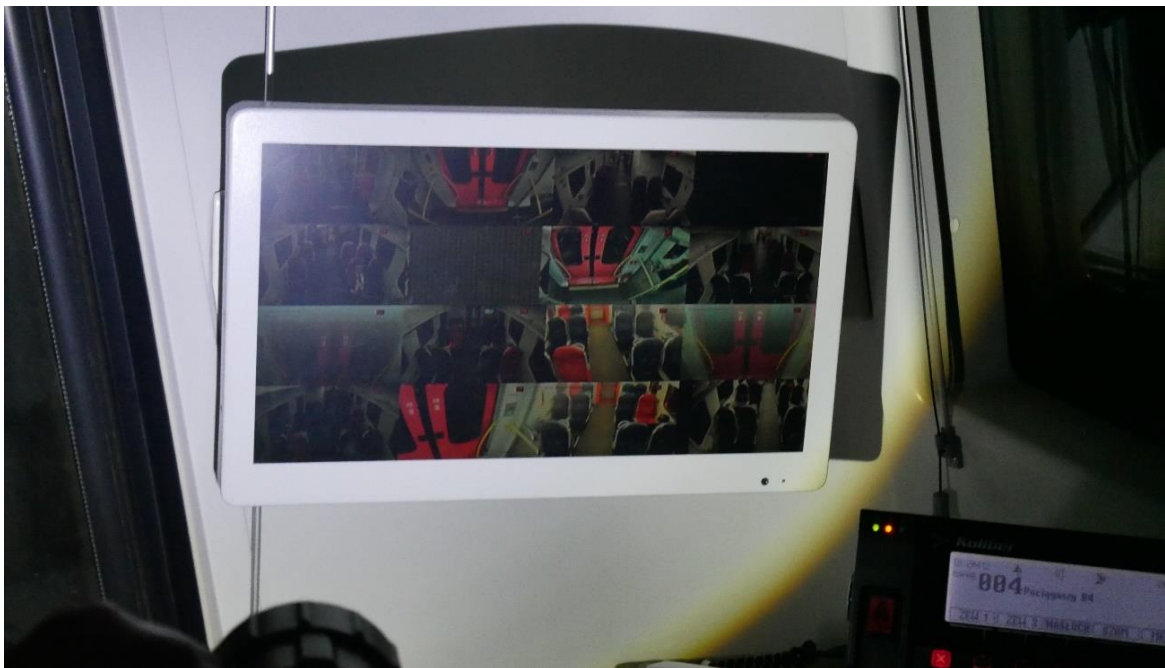
In the driver's cab of the ED72Aa-004 train, an LCD monitor with a split of 16 images from surveillance cameras is installed for real-time viewing and recording of events inside the train. The Investigation Team found that the driver could not assess the location of the stop and the occurrence that occurred at the Krzcięcice passenger stop based on the view from the cameras installed inside the train.

Photo 8 - Driver's cab equipped with CCTV viewing (PKBWK's own material).

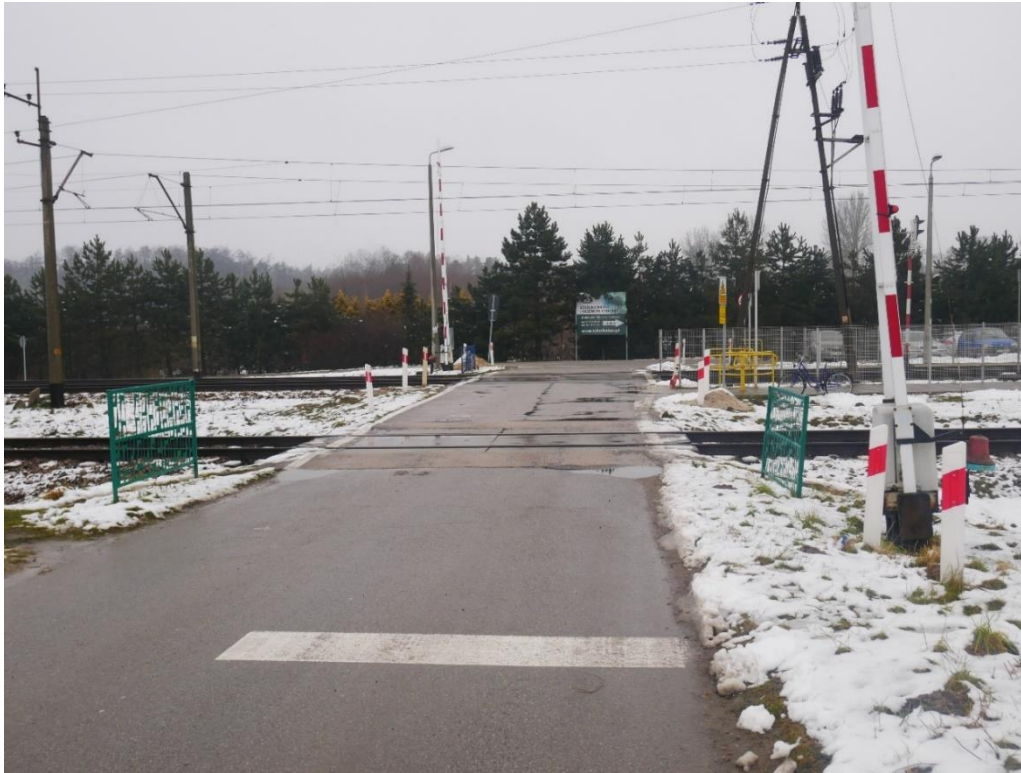
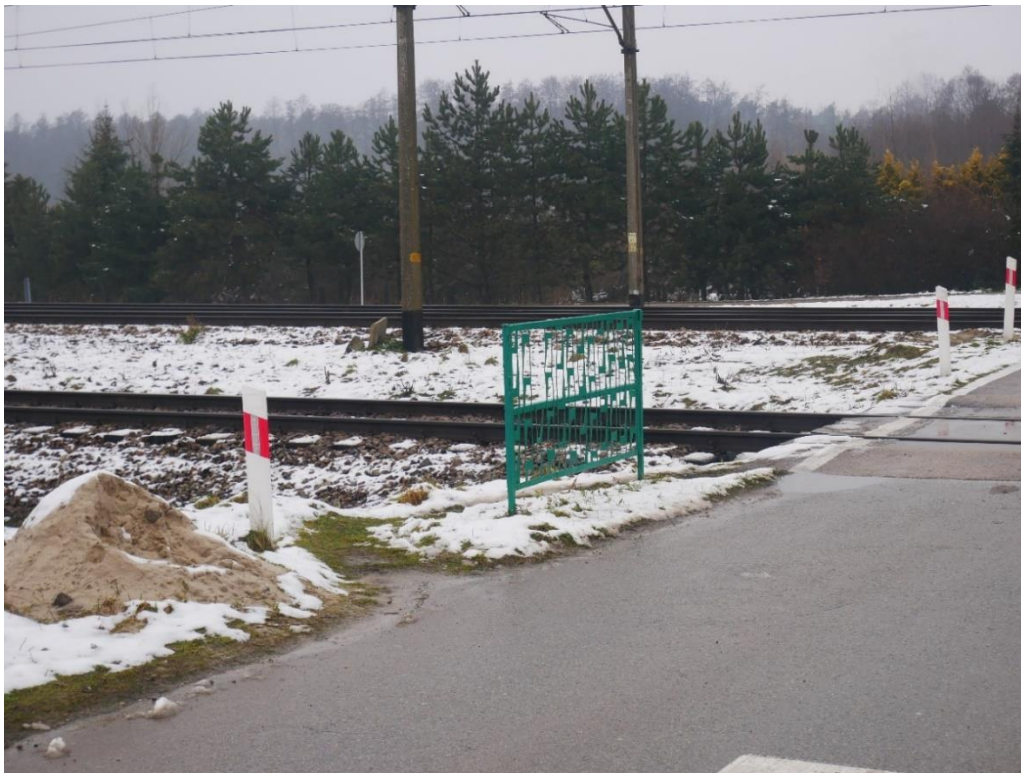
1. *At a cat. A level crossing with a length of 33 m, which crosses two railroads: no. 8 (double-track) at km 244.630 and no. 65 (single-track) at km 311.347; two light points are installed, which is not in accordance with § Article 88 of the Regulation of the Minister of Infrastructure and Development of October 20, 2015, on the technical conditions to be met by crossings of railway lines and railway sidings with roads and their location (Journal of Laws, No. 1744), which states "The number of lighting points shall be determined depending on the length and width of the railway crossing or road crossing, taking into account the values of illuminance and uniformity of illumination in accordance with PN-EN 12464-2 Light and Illumination".*

2. *Unnecessary absolute stop lines P12 at the Cat A crossing at km 244.630.*
3. *The fencing of the cat. A crossing km 244.630 inconsistent with Regulation of the Minister of Infrastructure and Development of October 20, 2015, on the technical conditions to be met by intersections of railway lines and railway sidings with roads and their location (Journal of Laws, item 1744), which states The sections between the track and the horns shall be separated by handrails preventing access to the track bypassing the horns, if the location of the horns allows it. The ends of the handrails closest to the track shall be located 3 m from the outermost rail.*

Photo 9 - View of the Cat A crossing km 244.630 with fencing (PKBWK's own material).

Photo 10 - View of the Cat A crossing km 244.630 with fencing (PKBWK's own material).

The above anomalies affect the safety of passengers using the platform and the safety of users of the crossing. These irregularities may contribute to the occurrence of occurrences and accidents involving travelers. The study team sees the need to eliminate them.
