**STATE COMMISSION ON RAILWAY ACCIDENT INVESTIGATION**  
**Ministry of the Interior and Administration**

**REPORT No. PKBWK 03/2024**

**on the investigation of a railway accident  
that occurred on 19 May 2023 at 09:51 hrs  
on the Komorów – Podkowa Leśna Główna route,  
track no. 1, Category D level crossing, at km 18.805  
of railway line no. 47 Warszawa Śródmieście WKD – Grodzisk Mazowiecki Radońska  
the area of the infrastructure manager Warszawska Kolej Dojazdowa sp. z o. o.**

**Warsaw, 1 February 2024**

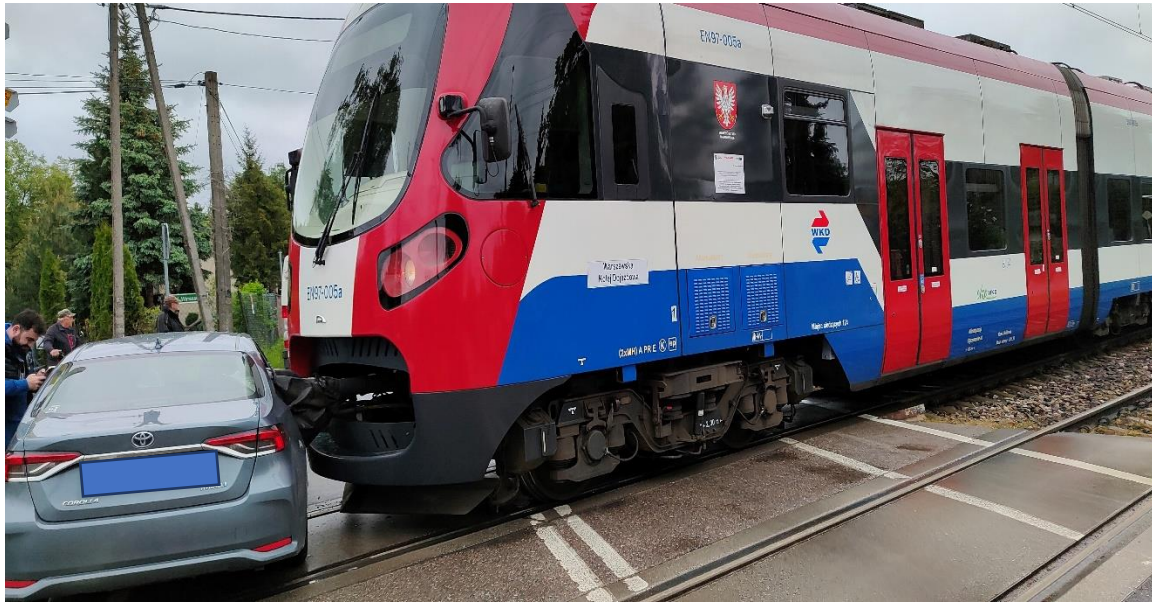
**Consequences of the occurrence:** No person was injured in the occurrence. There was damage to the Toyota Corolla passenger car and EN97-005 electric multiple unit.

**Photograph 1 - Effects of the occurrence (source: documentation of the railway commission)**

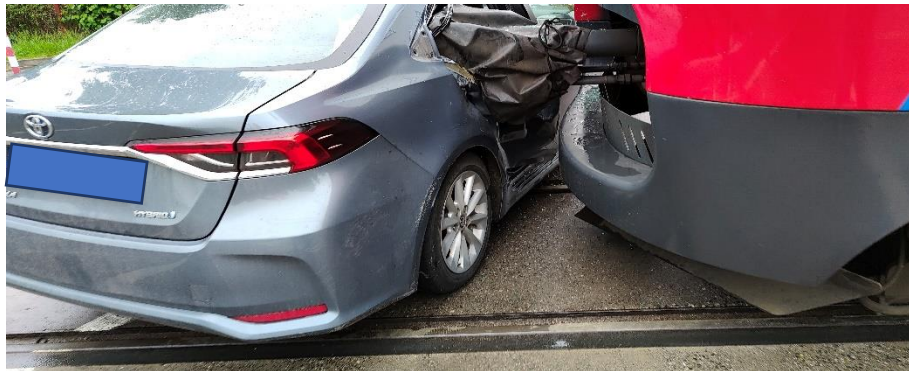
**Photograph 2 - Effects of the occurrence (source: documentation of the railway commission)**

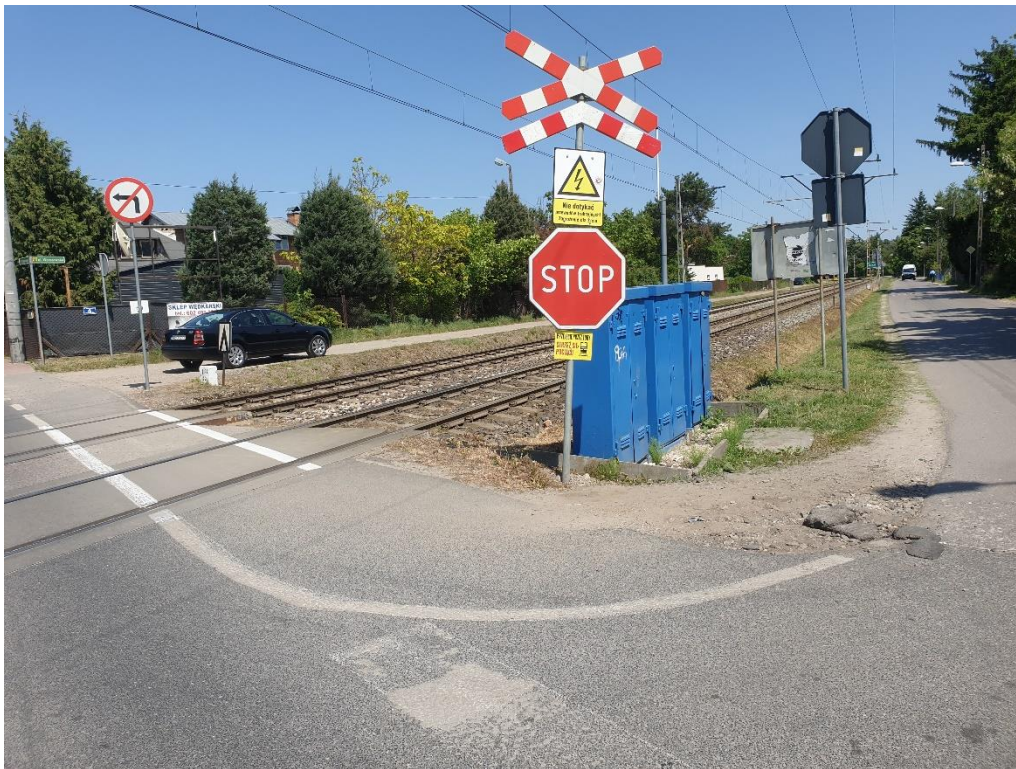
On the left side of the level crossing, from the driving direction of the car, the visibility of the head of trains from 5 m to the right (from the driving direction of the train) was hindered by apparatus cabinets positioned along track no. 2 and road signs positioned at Warszawska Street.

**Photograph 4 - Visibility from 5 m from the left side of the level crossing to the right - situation as during the accident (source: PKBWK documentation)**

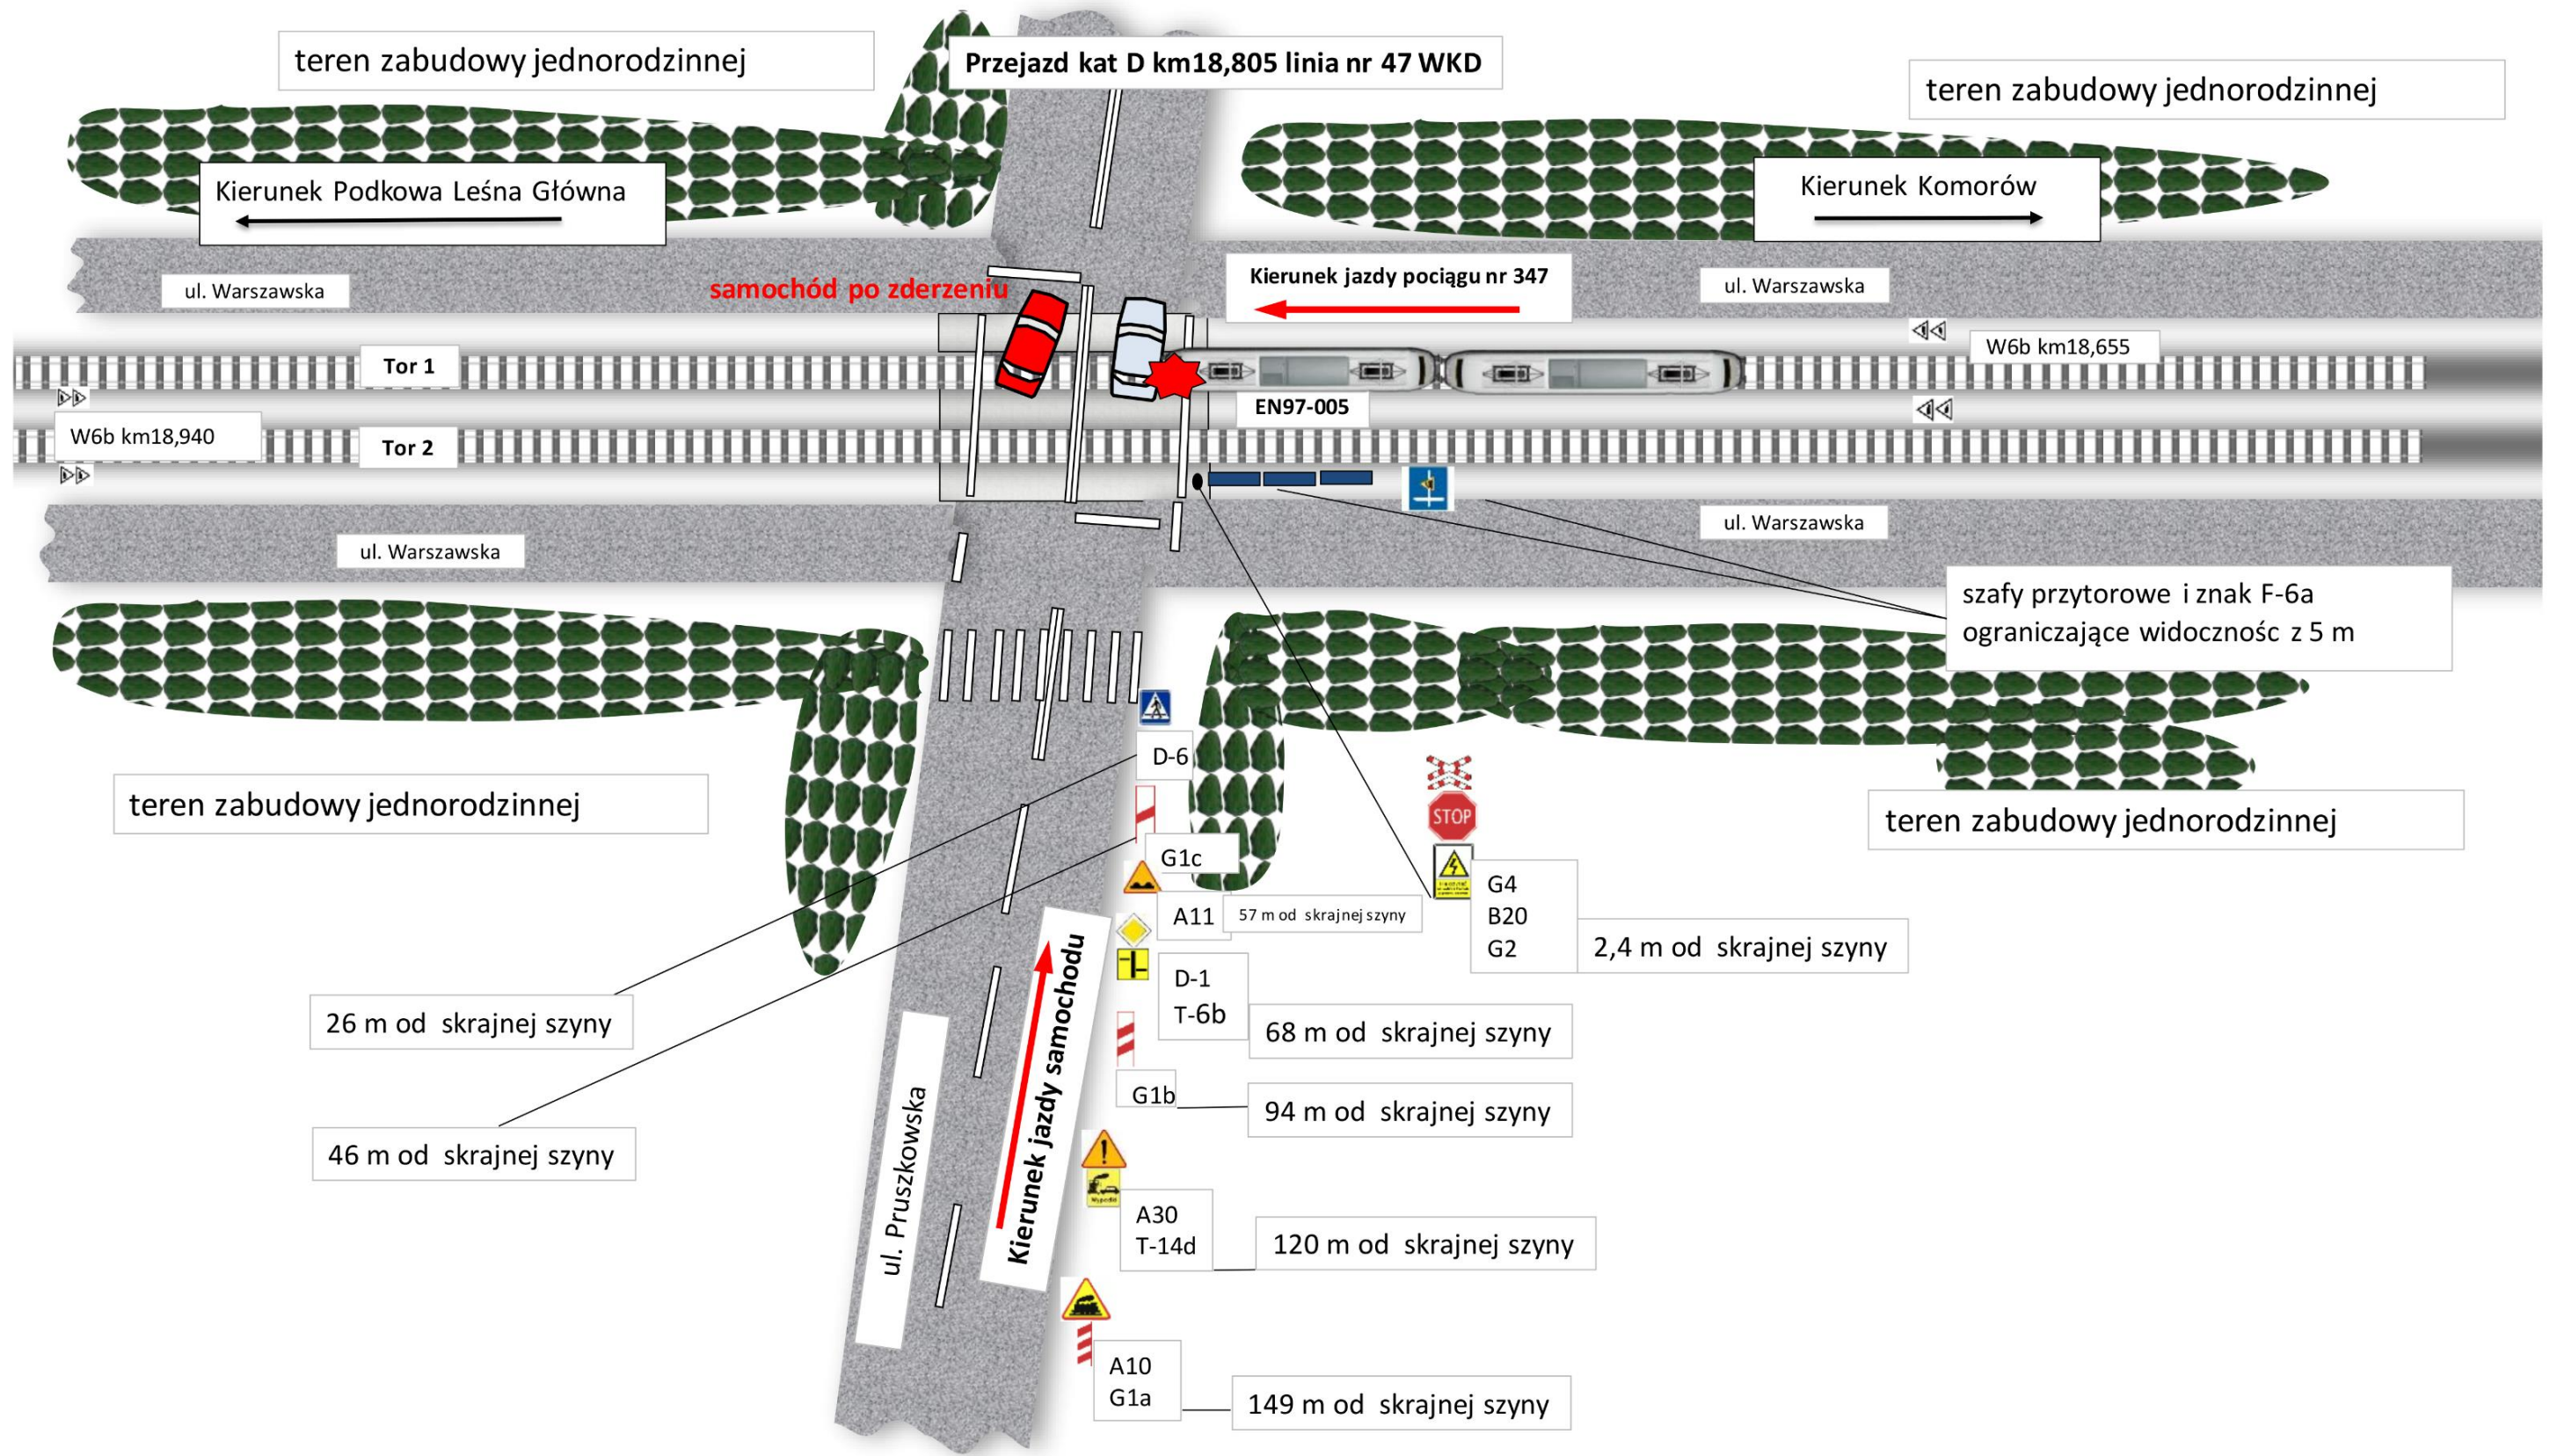
Figure 1 - A drawing of the accident (author: PKBWK)

**Description:** An occurrence at a Category D road-railway crossing (hereinafter referred to as "level crossing" in accordance with the Road Traffic Act) in which a Toyota Corolla passenger car entered the level crossing from its left side directly in front of the head of an oncoming train operated by carrier Warszawska Kolej Dojazdowa sp. z o. o. (hereinafter referred to as "WKD"), which caused a collision with the oncoming rail vehicle.

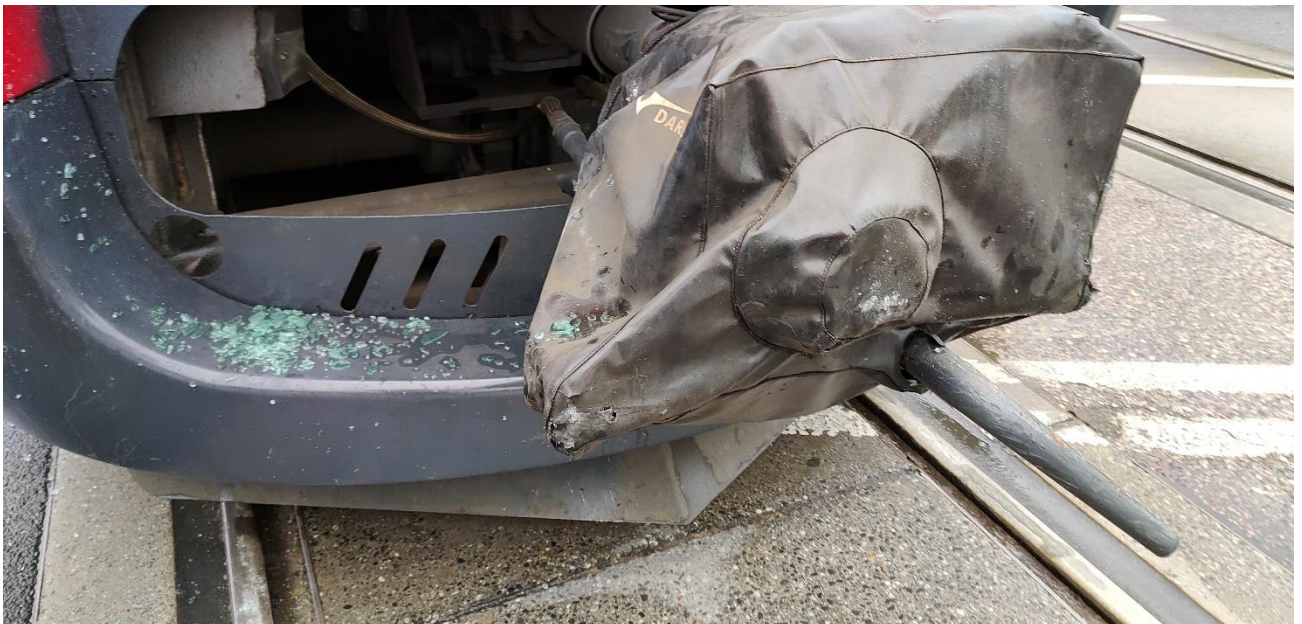
The train was not derailed. The head of the EN97-005 electric multiple unit, on side of Cabin "a", sustained damage to: paint coat on the front fender, coupler cover, paint coat on the coupler, and the coupler limiter.

Photograph 5 A view of the damage to the rail vehicle after the accident (source: documentation made by the railway commission)

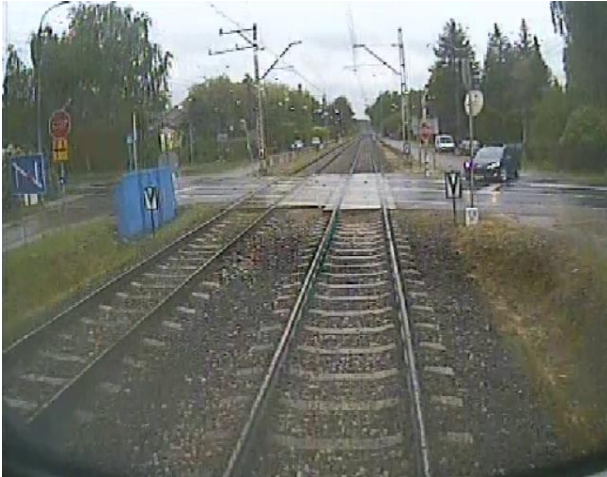
**Photograph 6 - A view of the foreground at around 2 s prior to the accident recorded by the rail vehicle's camera (source: the railway commission)**

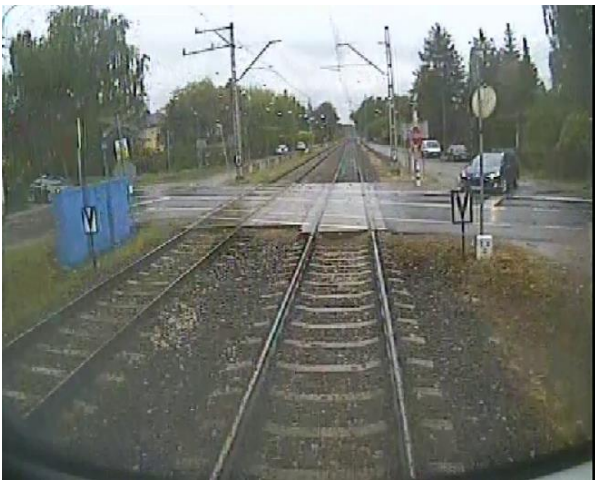
**Photograph 7 - A view of the foreground at around 1.5 s prior to the accident recorded by the rail vehicle's camera (source: the railway commission)**

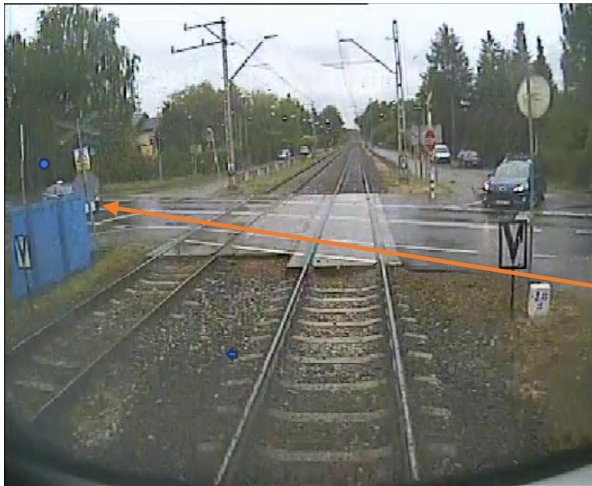
The passenger car involved in the occurrence

Photograph 8 - A view of the foreground at around 1 s prior to the accident recorded by the rail vehicle's camera (source: the railway commission)

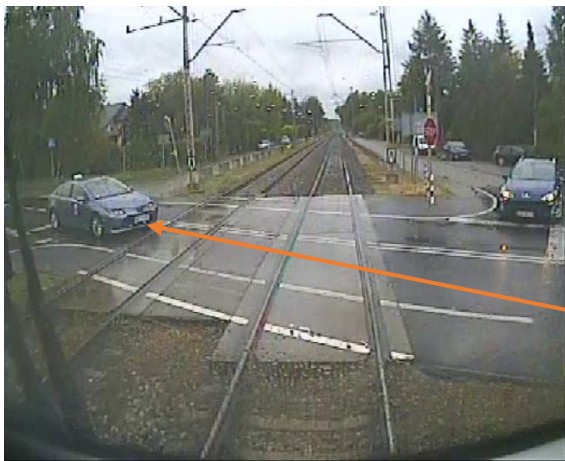
The passenger car involved in the occurrence

Photograph 9 - A view of the foreground at around 0.7 s prior to the accident recorded by the rail vehicle's camera (source: the railway commission)

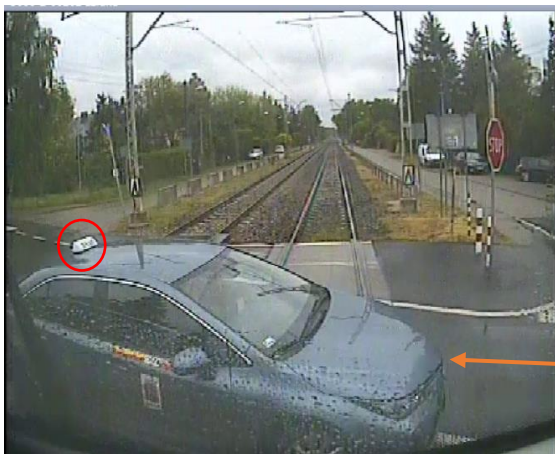
The passenger car involved in the occurrence

Photograph 10 - A view of the foreground at the moment of the accident recorded by the rail vehicle's camera (source: the railway commission)

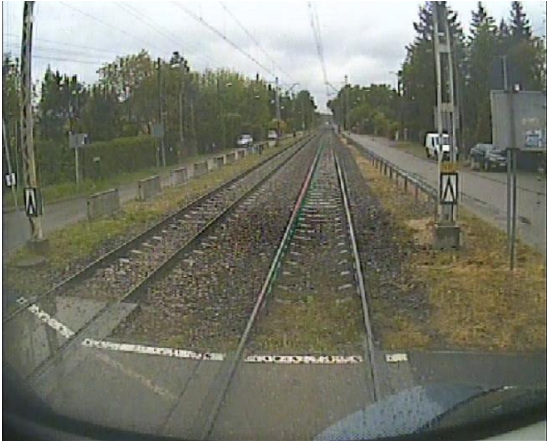
Photograph 11 - A view of the foreground after the train stopped following the collision (source: the railway commission)

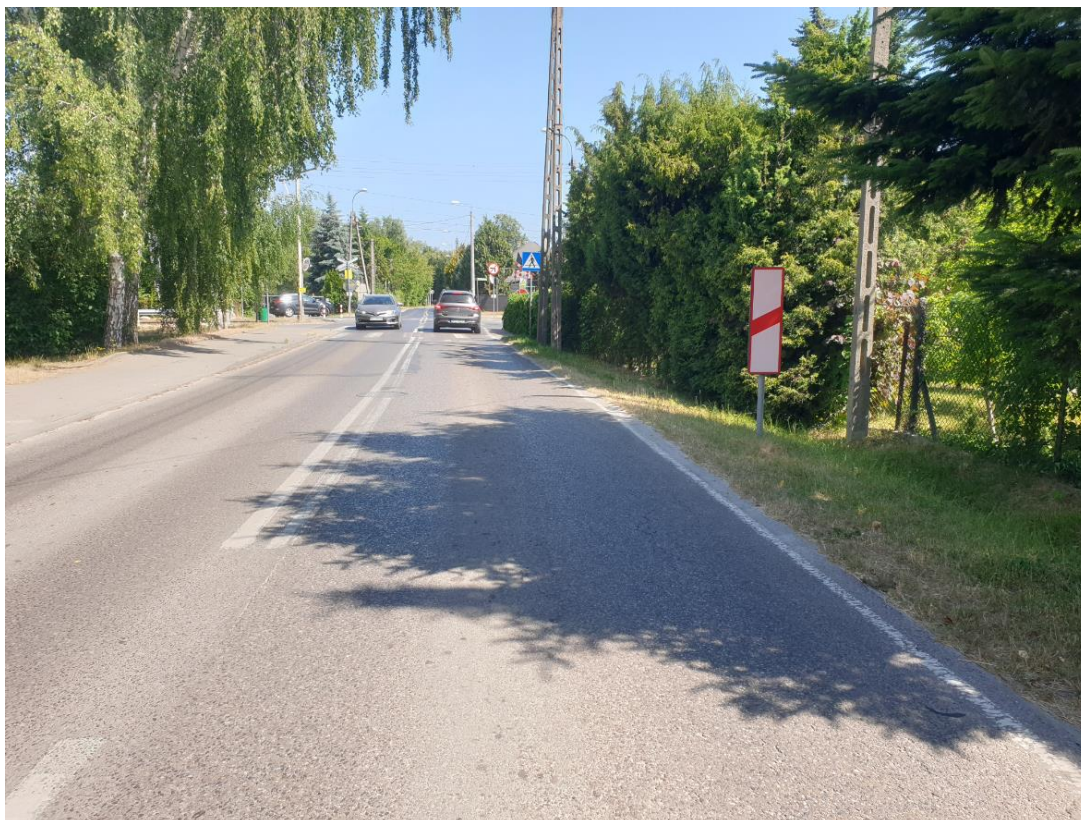
The B-20 signs before the level crossing were positioned to low – on the left side at the height of 1 m, on the right side at the height of 1.5 m instead 2 m as prescribed by applicable regulations. The T-6d and B1 boards standing at the county road on the left side of the level crossing mislead drivers because they did not inform them about the railway line. The Investigation Team found the above circumstances to be other irregularities. In the opinion of the Investigation Team, hindered observation of the head of the oncoming train on the part of the driver of the passenger car from the distance of 5 metres from the outermost rail was an environmental contributing factor due to:

- photograph 12 - the B-20 ("Stop") and G4 stops obscured by a hedgerow, and the D-6 road sign from 60 m (from the outermost rail),
- photograph 13 - the B-20 sign obscured by a hedgerow from 40 m,
- photograph 14 – full visibility of the B-20 ("Stop") and G4 signs from 30 m.

**Photograph 12 – Visibility of the level crossing from 60 m (source: PKBWK own material)**

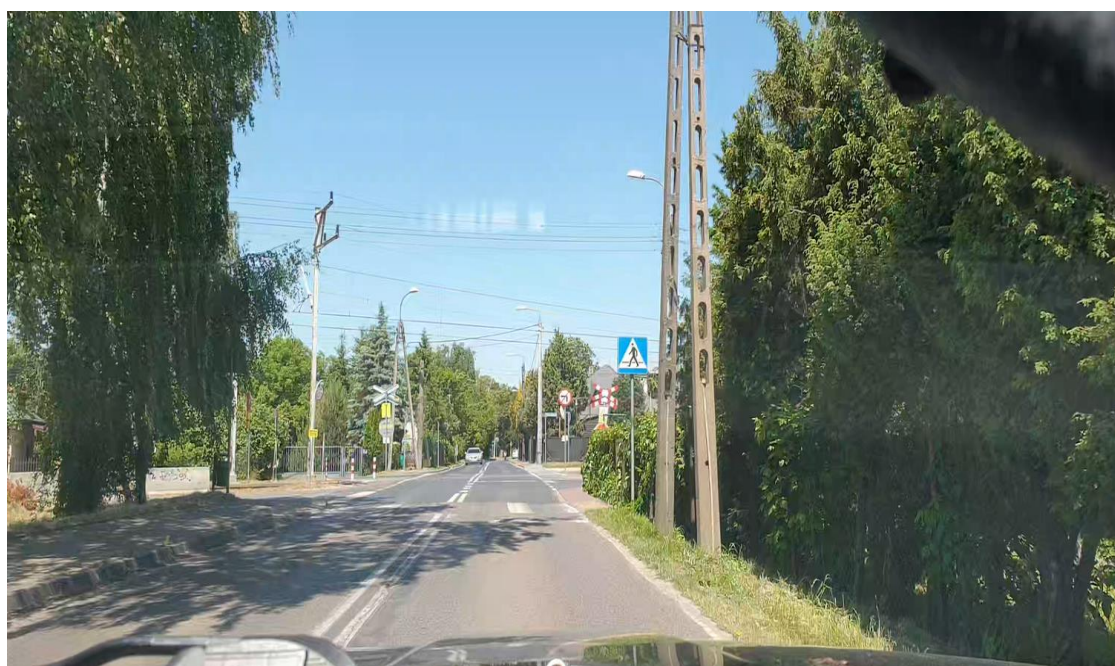
**Photograph 13 – Visibility of the level crossing from 40 m (source: PKBWK own material)**

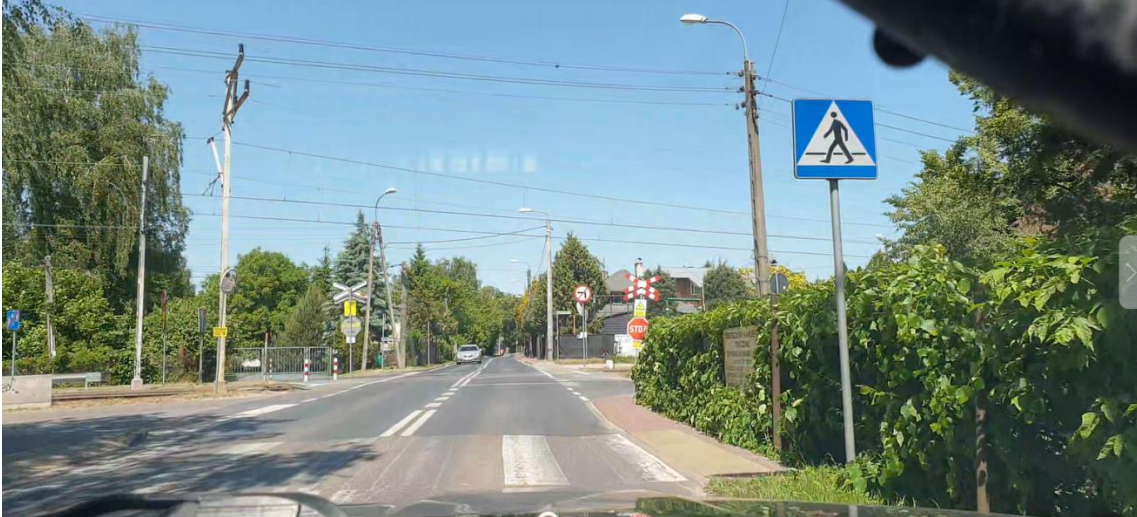
Photograph 14– Visibility of the level crossing from 30 m (source: PKBWK own material)
