NOTE

Date 27-02-2024
Casenr. 2023-163

English translation of chapters 1. Report summary, 5. Conclusion and 7. Recommendations from the Danish report "2023-163 Redegørelse, Roskilde-Viby Sj, Sporbeliggenhedsfejl efter styret underboring (28-02-2023)"

A Horizontal Directional Drilling (HDD) created a vertical irregularity on the track and led to a risk of derailment. (28-02-2023).

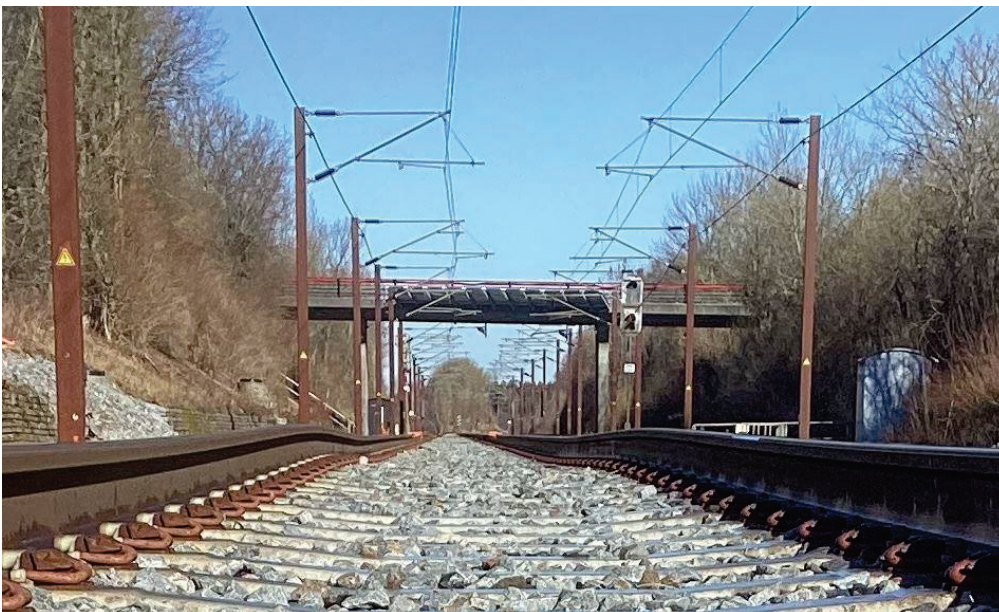
When regional train 2233 passed kilometer (km) 39,817 on the track between Roskilde and Viby Sj. a vertical irregularity on the track led to a risk of derailment. The vertical irregularity had occurred as a result of a "blow-up" from a HDD. The blow-up probably happened because the drilling route passed by an unrecognized area with a newly established drainage pipe and previously excavated soil.

Foto 1. Right track, Roskilde - Viby Sj. Seen in direction towards Roskilde. Foto: Banedanmark.

When train 2233 passed the site of the HDD at km 39.817 between Roskilde and Viby Sj., a vertical irregularity of 55 millimeters (mm) for wavelengths $\lambda=25-70$ meters (m), and 19 mm for wavelengths $\lambda=3-25$ m, had emerged

The vertical irregularity was a result of a blow-up, where return fluid had forced its way out of the drilling and into a layer of soil below the tracks. This probably happened when the drilling passed close to an area where the soil layers had been excavated in connection with establishment of a drainage pipe along the west side of the track in 2022. The establishment of drainage pipe was not included in the risk assessment of the HDD project because the drainage was part of an overall track project which had not yet been completed. Therefore the geographical coincidence between the projects was not identified. As a result, adequate risk management could not be carried out.

AIB Denmark recommends that the Danish Transport Authority ensures that Banedanmark, through risk management of the activity Horizontal Directional Drilling, while taking human factors into account, introduces sufficient and effective proactive and/or reactive barriers to reduce the risk posed by track irregularities to an acceptable level.
