**Railway Accident
Investigation Unit
Ireland**

**Broken Rail near Emly,
County Tipperary, 22nd February 2023**

RAIU Investigation Report No: 2024-R002

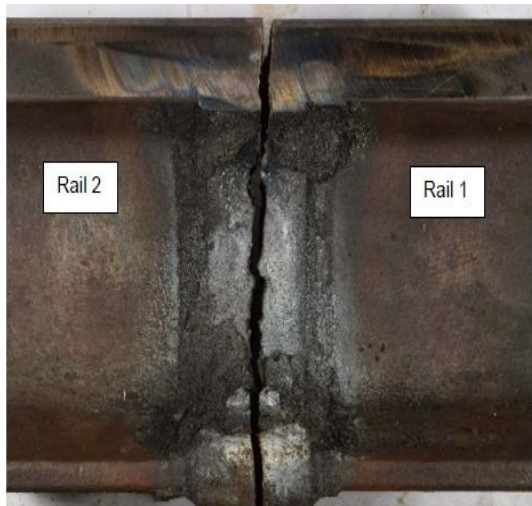
87 A visual inspection indicated that the weld suffered a complete transverse failure through the approximate centreline (see Figure 9) with a pronounced hollow in the foot of the rail which was partially filled with luting sand (see Figure 10).

Figure 9 – Transverse failure through the centreline of the weld

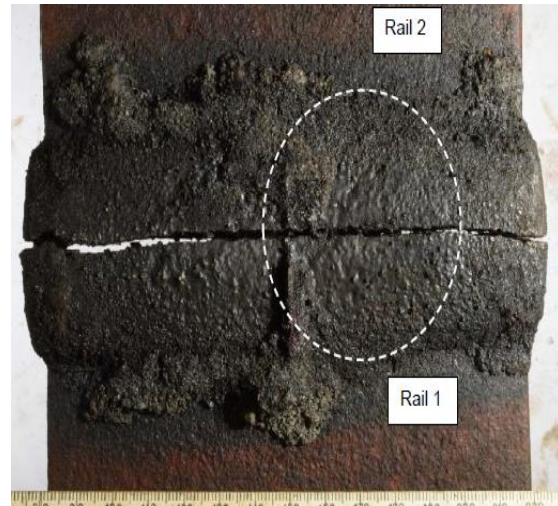
Figure 10 – Underside hollow partially filled with luting sand

- 95 The Serco Report states that “it appears some difficulties¹² had been experienced obtaining a good fit between the mould and the rail, as copious amounts of luting sand had been applied especially around the underside of the foot where an unusual ‘hollow’ had been created in the final weld. There is no evidence to suggest that this had become a leakage path for hot metal during the welding”.

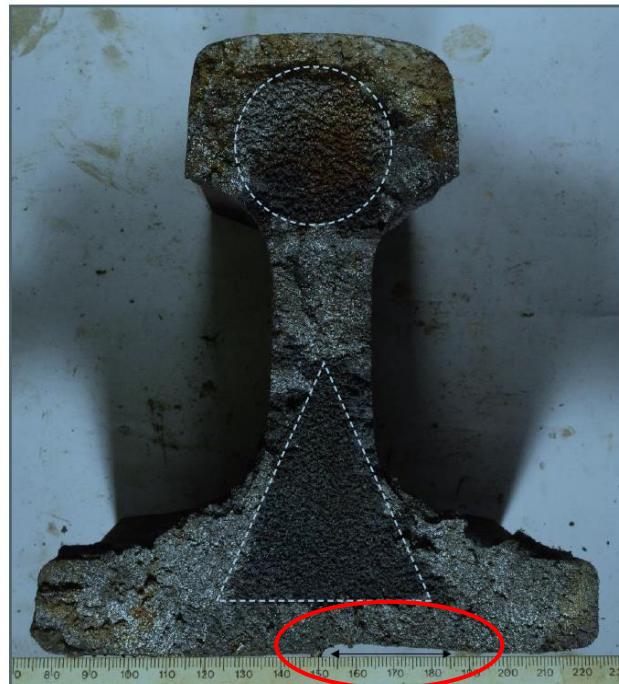
88 There were two darkly oxidised regions found on the fractured face of the weld. A triangular shaped area at the foot/web transition and a circular area occupied most of the head area (see Figure 11). The remainder of the weld showed signs of a recent rapid *overload*. And a “hollow” was present across the bottom of the foot (circled red in Figure 11).

Figure 11 – Fracture face

89 The oxidised region at the web/foot transition were described in the report as consisting of a multitude of sharp “peaks” with dendritic areas in the “valleys” although towards the apex, entirely dendritic regions were also identified in the web indicative of shrinkage. This was distinctly different to the surrounding fracture that was crystalline in nature.

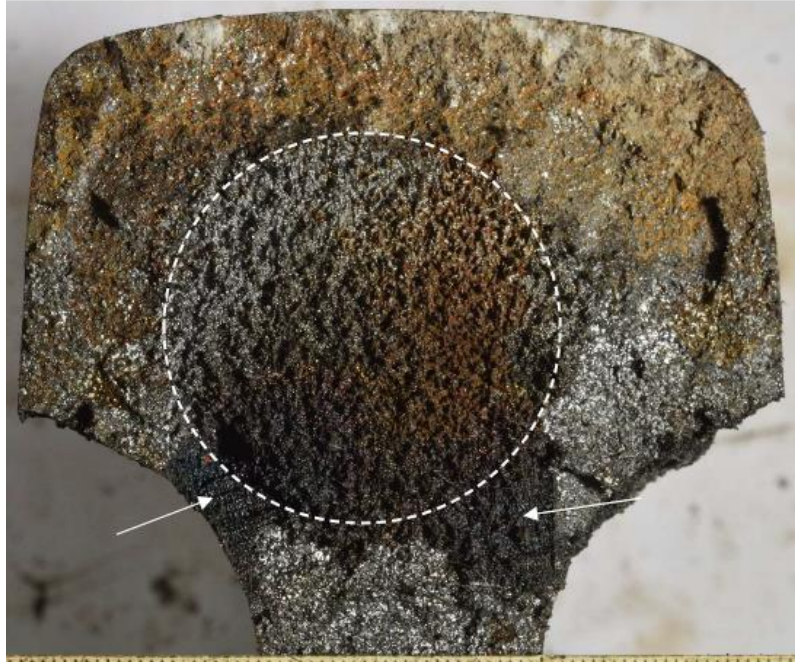
90 The defect in the head (see Figure 12) had a similar appearance to the triangular feature in the web/foot (sharp peaks and dendritic valleys). Unlike the triangular feature only a proportion of the surface was darkly oxidised with the remainder either being lightly oxidised or relatively free of oxidation.

Figure 12 – Fracture face in the head

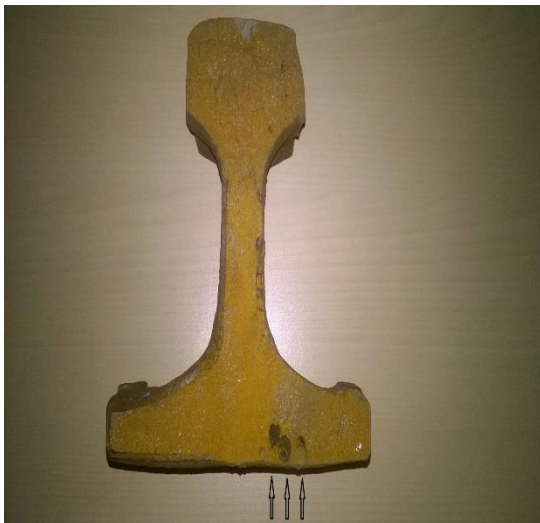
Figure 13 – Rail foot defects

134 The conclusion of the broken rail report on the 14th January 2015 was that the proximity of the defects that broke the weld in the foot area would be outside the ultrasonic range of the Sperry Vehicle Testing equipment and the inclusions in the web (see arrows in Figure 14) and head areas would most likely be undetectable, or too small.

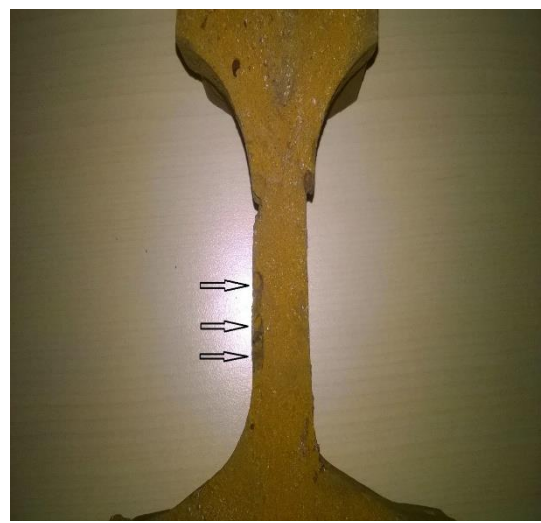
Figure 14 – Web defects
