# JNS Normal Procedure

## “Accident Gotthard base tunnel - broken wheels”

Final report | version 2.0 | 11.07.2024

**Outcome of the Joint Network Secretariat Normal Procedure**  
**“Accident Gotthard base tunnel - broken wheels”**

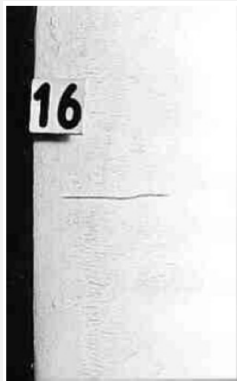
**Description:** The tread exhibits cracks at an angle of approximately 90° to the circumference of the wheel and have a typical length of 30mm or more. Transverse cracks generally develop at the surface in either straight or slightly crooked lines and can penetrate radially (usually of thermal origin in these cases) or branch out in a circumferential direction (usually of mechanical origin in this case). They occur individually and can be distributed at several points around the circumference. [EN 15313, §C.2.6 ]

Transverse crack revealed by magnetic particle testing [EN 15313, §C.2.6 ]

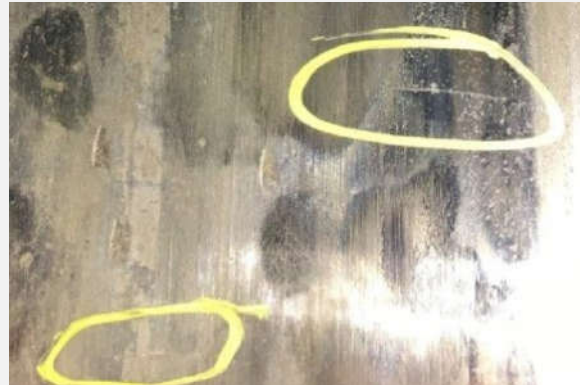
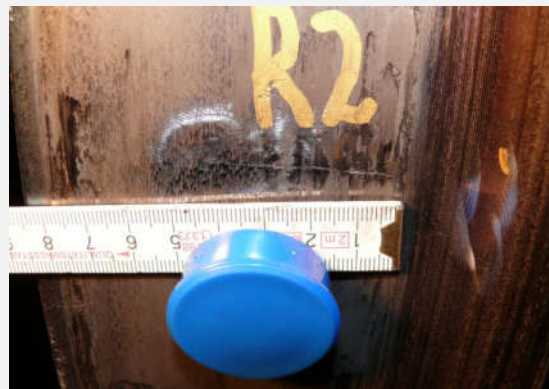
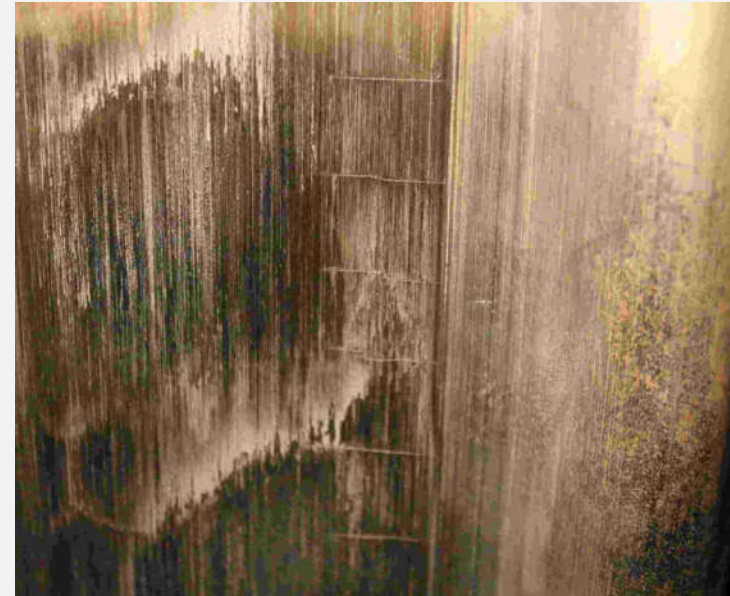
Example for single cracks on the wheel tread by visual inspection

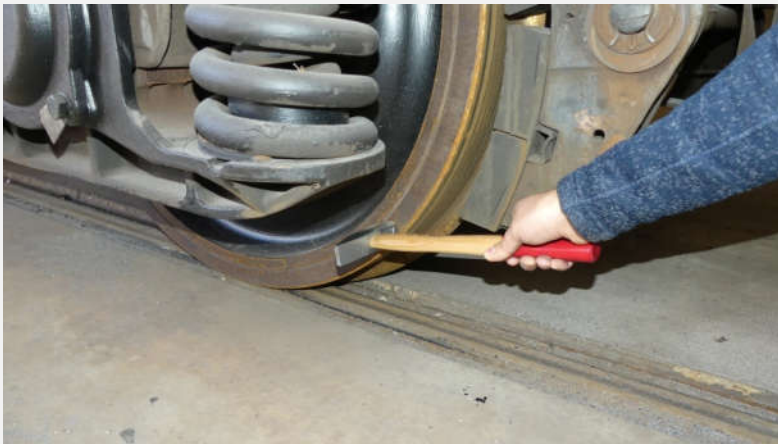
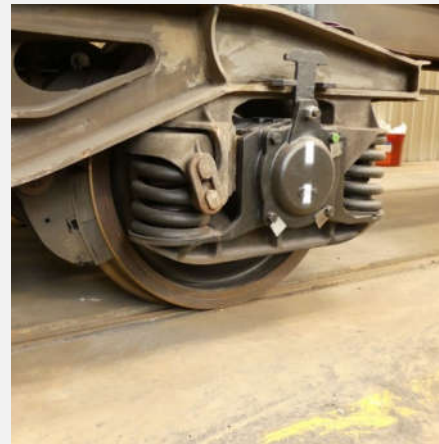
- The test on the 12 o'clock position (upper position of the wheel) sounds always thud/ damped.
- Wheelsets with applied brake blocks or not fully released brake blocks sound also thud/ damped. In this case the full release of the brake blocks has to be checked.
- In case of a thud / damped sounding wheel it is necessary to inspect the whole wheel more carefully.

The sound-test can be adapted in special cases as additional method to detect a cracked rim and broken wheels.
