Safety Investigation Report

Death by electrocution of a private tree trimmer
Quévy - 10/07/2023

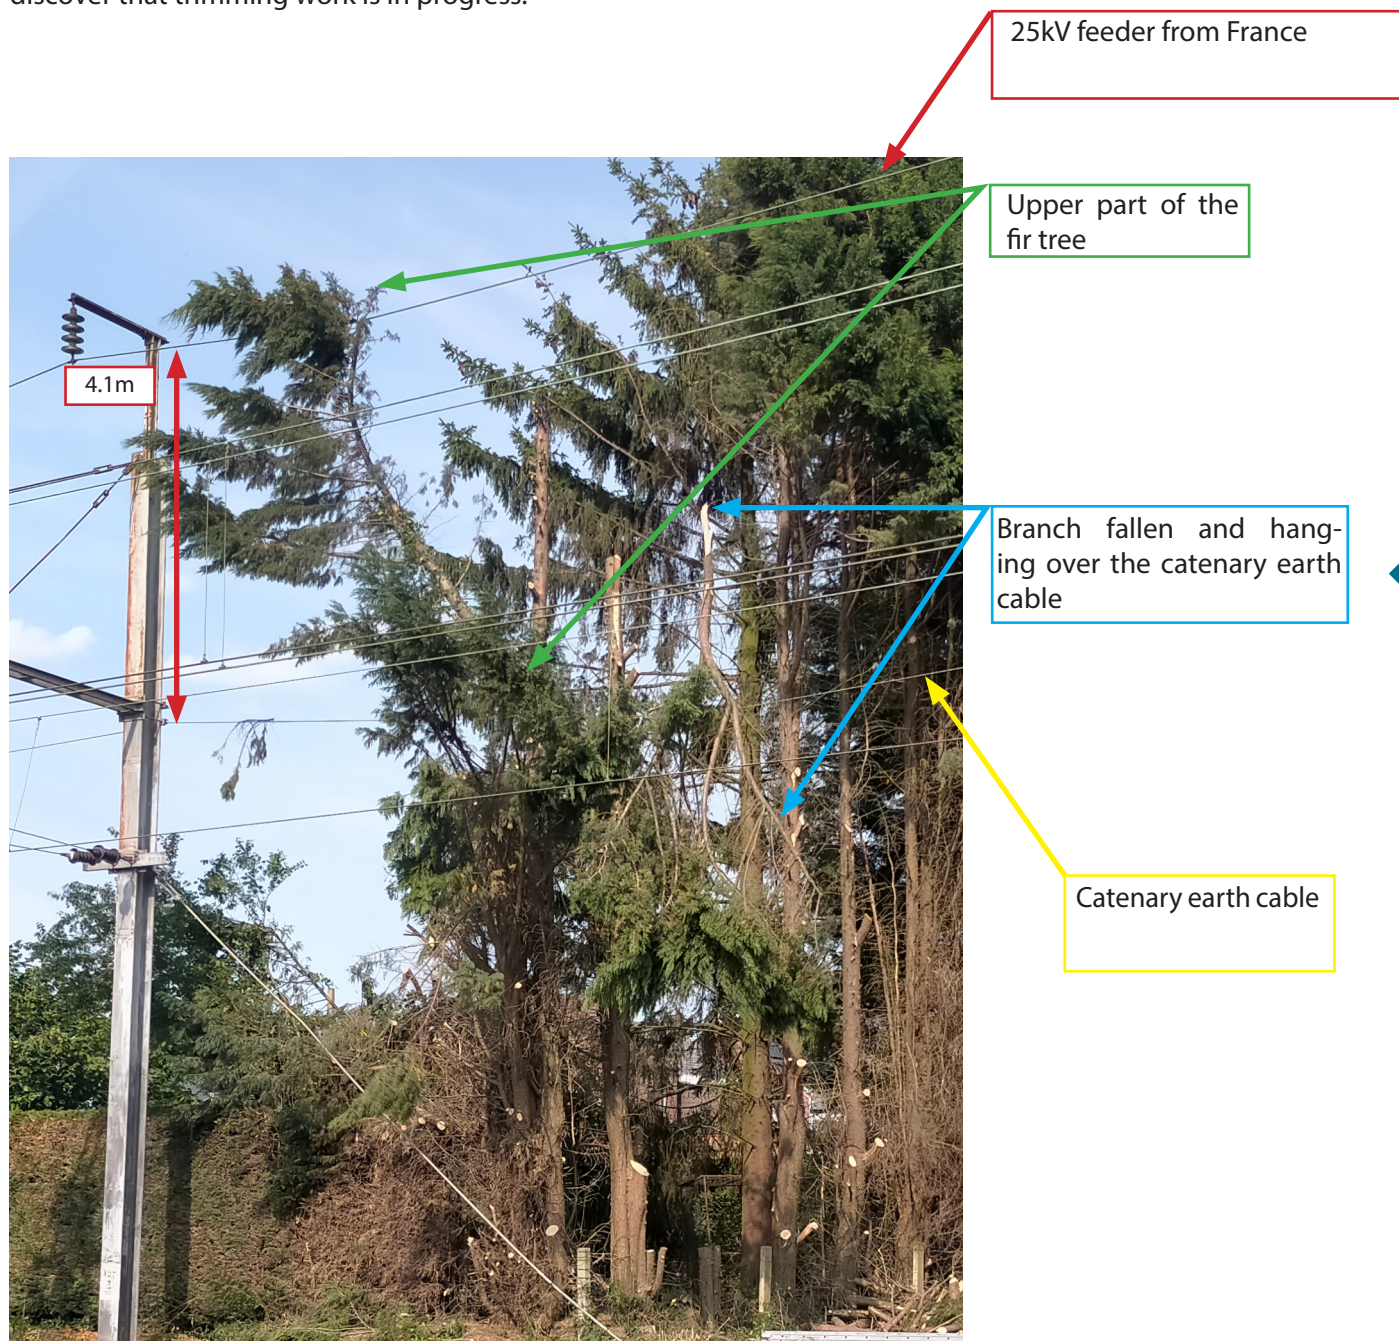
On 10 July 2023, at around 2:06 p.m., the upper part of the tree cut by the tree trimmer falls onto the feeder supplied by a voltage of 25 kV AC and the resulting electric arc causes the electrocution of the tree trimmer.

Photo of the site of the accident, taken after the intervention of the emergency services

At the place where the branch was to be removed by the tree trimmer, the distance between the earth cable (over which the branch hanged) and the feeder was 4.1 m.

This distance is greater than the distance delimiting the prohibited zone: according to the regulations of Infrabel on safety distances, the prohibited zone is defined as 1.5 m from a 25 kV AC cable.

- he was supposed to remove a branch that had fallen onto a catenary cable, and not to cut off the upper part of the tree;
- no measures were taken to prevent the upper part of the tree from falling onto the feeder once it was cut.
