**STATE COMMISSION ON RAILWAY ACCIDENT INVESTIGATION**  
**Ministry of the Interior and Administration**

**REPORT No. PKBWK 5/2024**

**on the investigation of a railway accident  
that occurred on 12 April 2022 at 09:22 hrs at Poznań Główny station  
at turnout no. 140 in track 51, at km -0.181 of railway line no. 351  
Poznań Główny - Szczecin Główny,  
the area the infrastructure manager PKP PLK S.A. Railway Line Plant in Poznań**

**WARSAW, 10 June 2024**

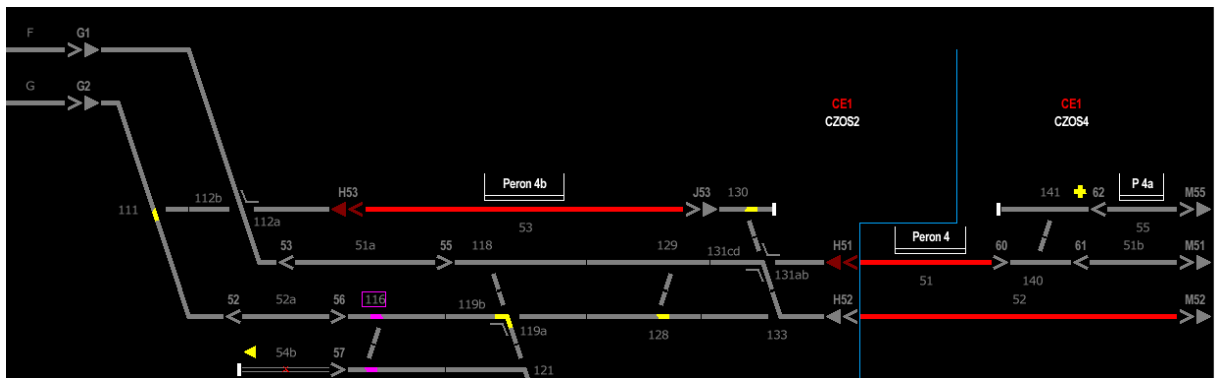
At 09:21:41 hrs, the "station C" signaller issued the special order "ZW" to release the route from Tm60 to signal M51 with the train proceeding at approximately 26 km/h.

Figure 5 - Released route, 09:21:41 hrs (source: Thales)

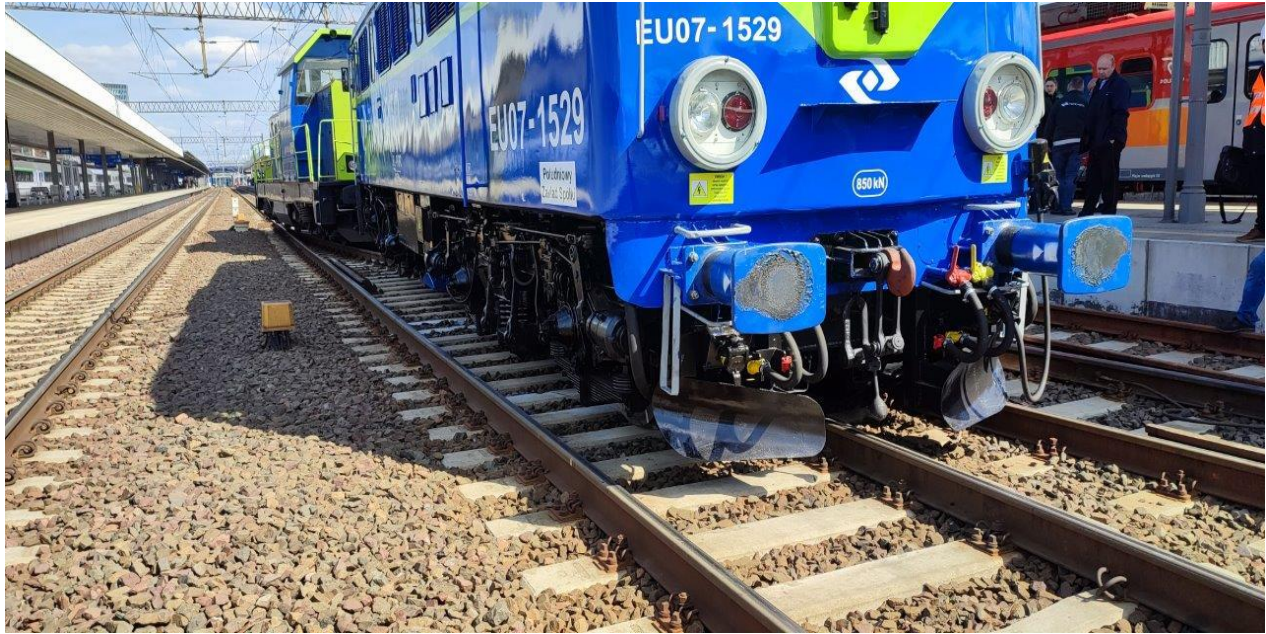
As a result of the double-tracking, the wheel-rail contact is lost and the right wheel of the second wheelset of the first bogie is derailed into the inside of the turnout. As a consequence of the derailment, the said wheel hits the right guide rail of the turnout and the first bogie is displaced to the inside of turnout no. 140. As a result of the impact on the guide rail, the locomotive bumps up violently, the bolt coupling is disconnected and the first wheel set of the second bogie falls inside the turnout, according to TELOC speed recorder at 09:22:35 hrs at the speed of 6.5 km/h. The second wheelset of the second bogie of the first locomotive did not derail. The second locomotive did not derail because it entered the already switched switch of turnout no. 140. Locomotive EU07-1529 travelled approximately 19 m in the derailed state. As a result of the derailment, the bolt coupling between the locomotives was disconnected and they were only connected by the brake coupling.

**Photograph 2 - A view of the train after the derailment (material provided by the railway commission)**

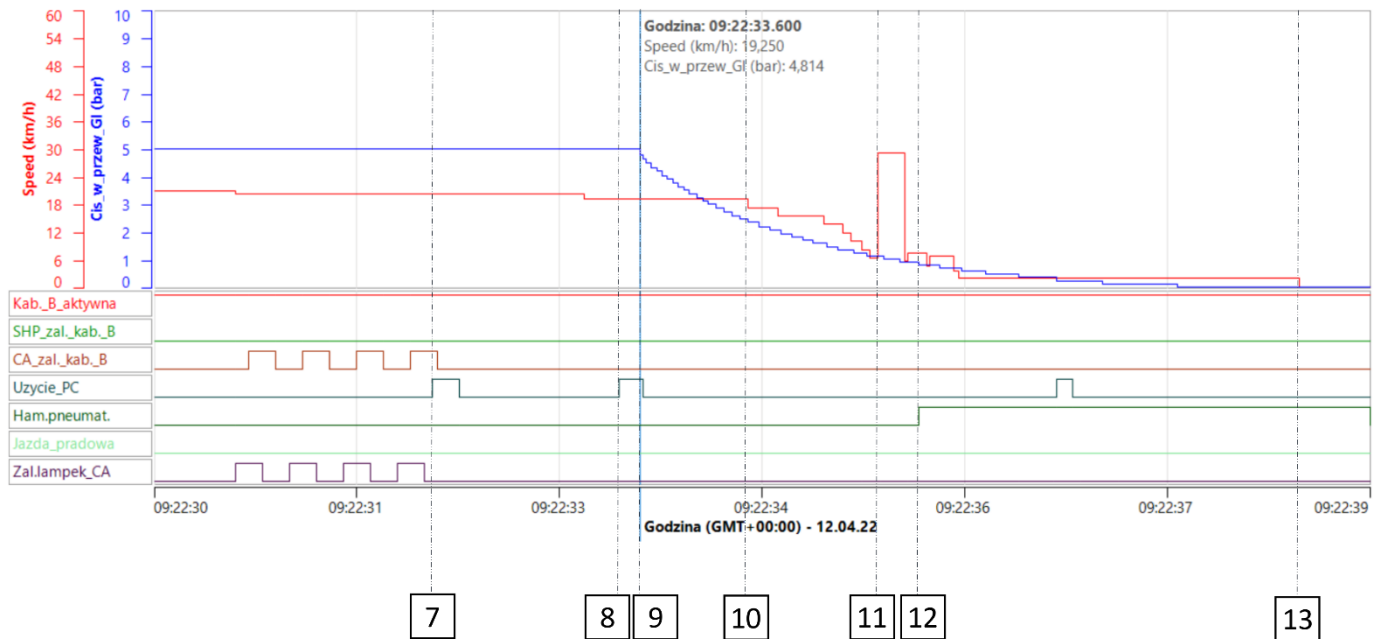
**Figure 9 - The locomotive's driving parameters during the occurrence**

7. 09:22:32 hrs - use of the passive vigilance button (PC) at the speed of 20.48 km/h
8. 09:22:33 hrs - use of the PC button at the speed of 19.25 km/h
9. 09:22:33 hrs - the locomotive enters turnout no. 140 at the speed of 19.25 km/h; pressure drop in brake main line from 5.032 [bar]
10. 09:22:34 hrs - the speed drops to 6.5 km/h
11. 09:22:35 hrs - a sudden increase in the speed to 29.39 km/h (the moment the axle of the set was rolled over due to loss of contact between the wheel and the rail)
12. 09:22:35 hrs - implementation of braking from the speed of 7.56 km/h
13. 09:22:38 hrs - the locomotive stops

The speed values given in Points 11 and 12 are derived from the parameters recorded at the time of free-rolling and are not actual speeds. It is therefore not possible to establish, on the basis of the driving parameter readouts, a reliable distance travelled from the time of the derailment until the time the locomotive stopped.

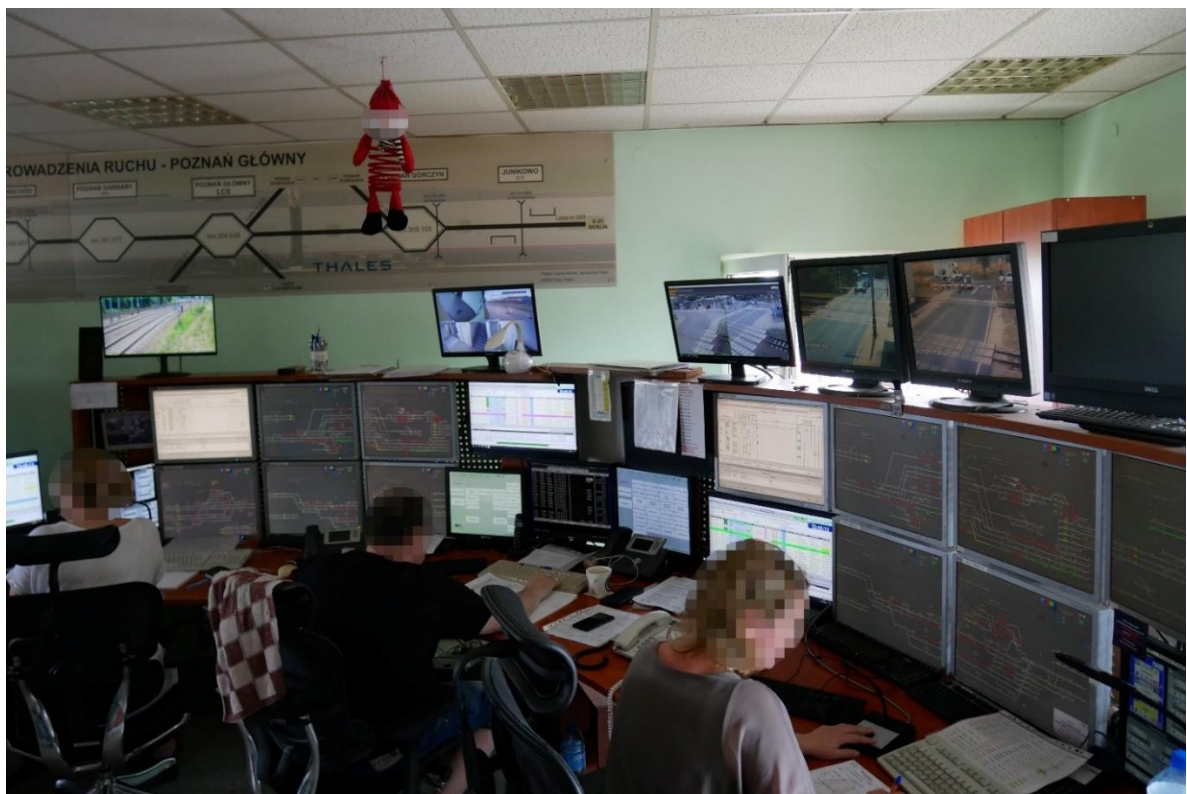
**Photograph 6 - Operator stations of signallers C and D, and operating station of the dispatcher**

The ergonomics of the signaller workstations at the PoA command box is inappropriate.

The PoA command box room is constantly occupied by six employees who operate train movements and shunting in the assigned sections. Due to the lack of workstation separation, the employees are exposed to noise and distraction. Continuous twelve-hour shift work in such conditions compromises the working comfort, which may lead to a threat to the safety of train traffic.

- 8) PKP PLK S.A. IZ Poznań shall take actions to rectify the irregularities referred to in Point 3.4 of Chapter IV, i.e. to improve the ergonomics of the workstations of signallers at the CTC signal box of Poznań Główny station.
- 9) Authorised infrastructure managers shall include in the Hazard Record the hazard associated with inappropriate ergonomics of signaller duty stations. In addition, they shall verify the ergonomics of signaller duty stations where several duty stations are located in close proximity in the same room; and if any irregularities are detected, they shall take actions to improve the working conditions of signallers.
