STATE COMMISSION ON RAILWAY ACCIDENT INVESTIGATION
Ministry of the Interior and Administration

REPORT No. PKBWK 06/2024

**on the investigation of a railway accident that occurred on 24 August 2023 at 12:05 hrs
at Skierniewice station, at turnout no. 13, at km 64.282
of railway line no. 1 Warszawa Zachodnia - Katowice
the area of the infrastructure manager PKP Polskie Linie Kolejowe S. A.
Railway Line Plant in Łódź**

WARSAW, 1 August 2024

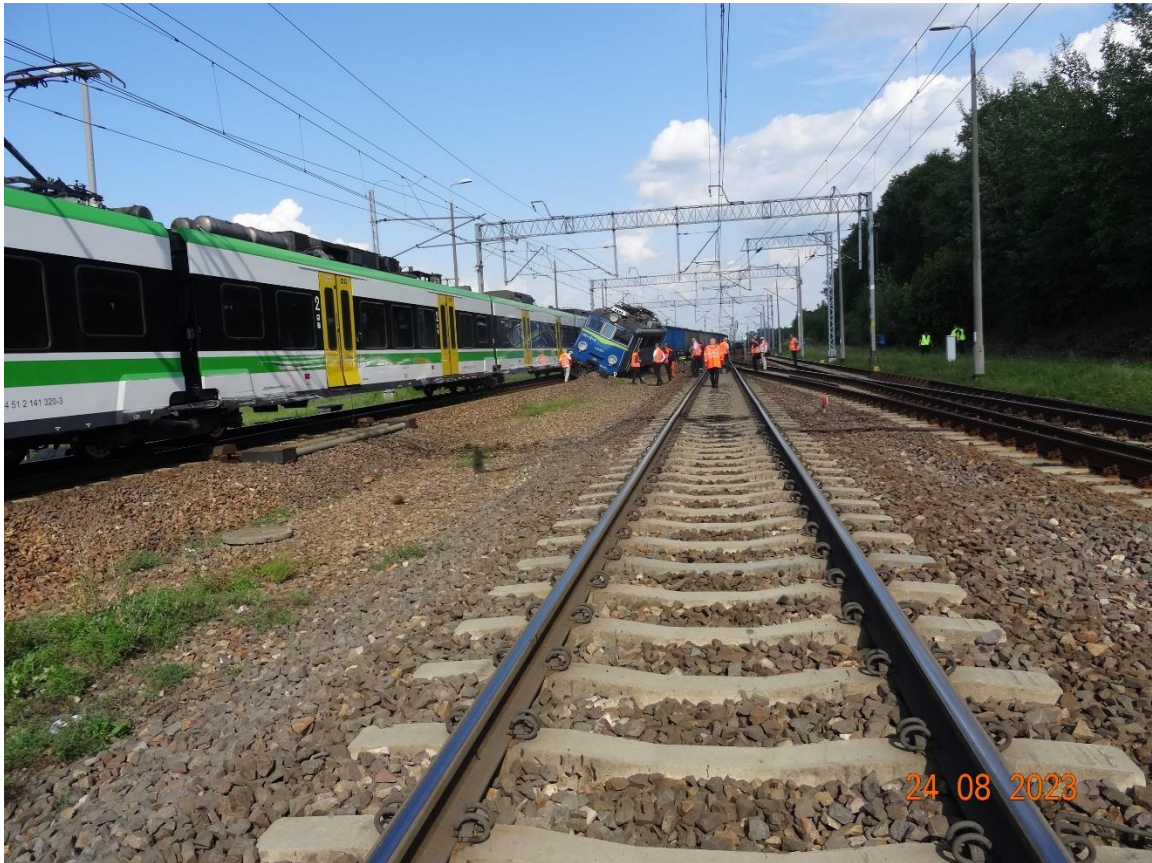
Photograph 1 - The site of the occurrence (source: documentation of the railway commission)

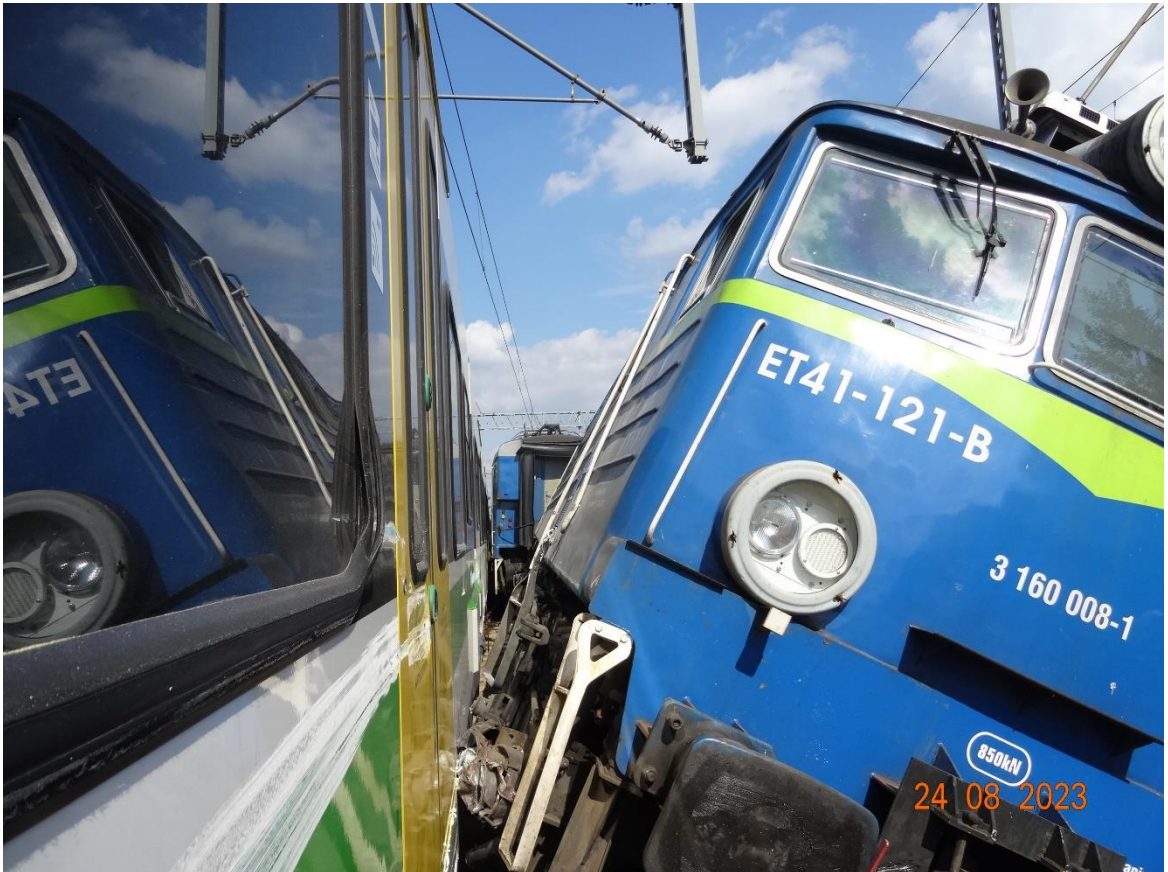
The occurrence resulted in the derailment of the first B section of the ET41-121 locomotive with all bogies and the second A section of the locomotive with one bogie. The derailed section B was tilted by an angle of approx. 30° from the vertical to the left, looking in the ride direction. Sections A and B of the locomotive were partially uncoupled. Section A of the locomotive was coupled by a screw coupling and air hoses to the train set. Damage was sustained by:

- locomotive body: damaged section B skin, steps, handrails, battery box, gangway between sections, outer floor skin under cab B;
- bogie frames: torn off fender on bogie 4 - right hand side, damaged front fenders on section B, side supports on bogies II, III and IV, brake cables and sand tubes on bogies III and IV;
- wheelsets: structure bonding brushes on bogies II, III and IV, structure bonding cables, installation from the Mirel system transmitter to the connection box;
- braking equipment: brake cylinders on bogies II, III and IV - right-hand side, pneumatic piping of brake cylinders;
- current collectors and WS: II and III current collector - bent DSA-150 heads.

Photograph 5 - A view of the damage to the railway vehicle after the accident (source: documentation prepared by the railway commission)

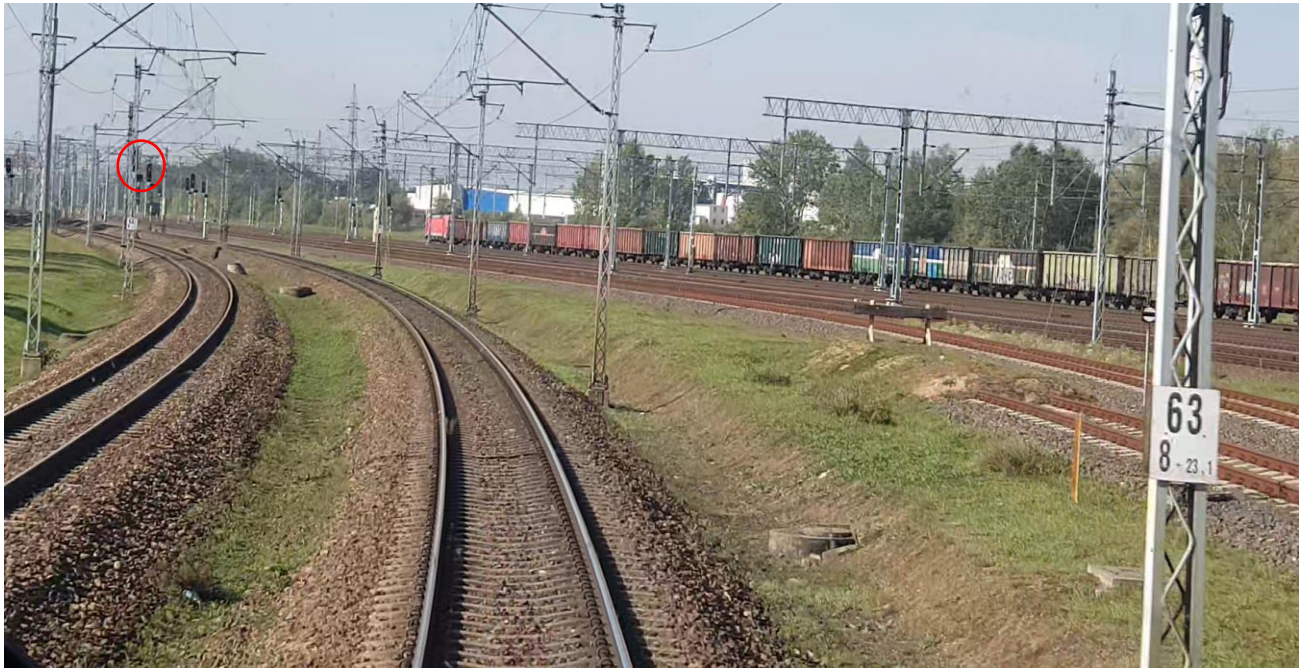
The catenary poles positioned in the curve of the railway line make it difficult for train drivers to see, the aspects shown on the intermediate signal J1^{1/2/3/m} from the required distance (375 m), which the Investigation Team finds to be a contributing factor.

Photograph 11 - A view of the signal J1^{1/2/3/m} 340 m (own material of PKBWK)

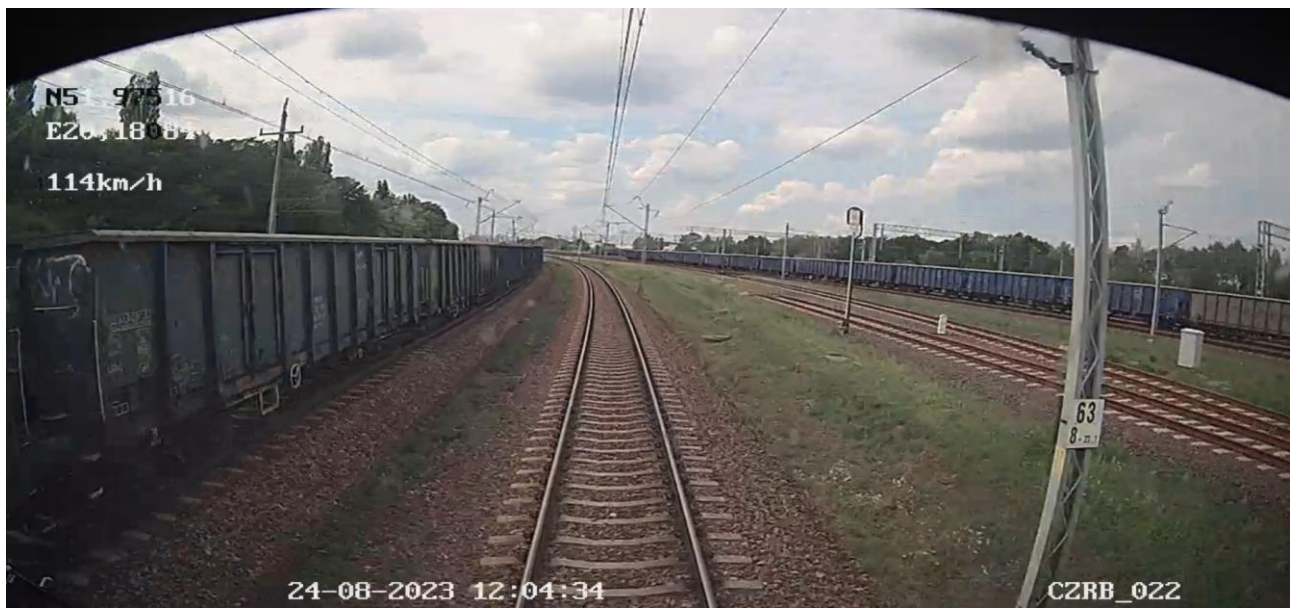
Photograph 12 - A view of the signal J1^{1/2/3/m} from 340m on the day of the occurrence, with another train running on the adjacent track at the same time.

Other trains travelling on track 2 (the other one) are an additional reason why the visibility of the signal J1^{1/2/3/m} is hindered.

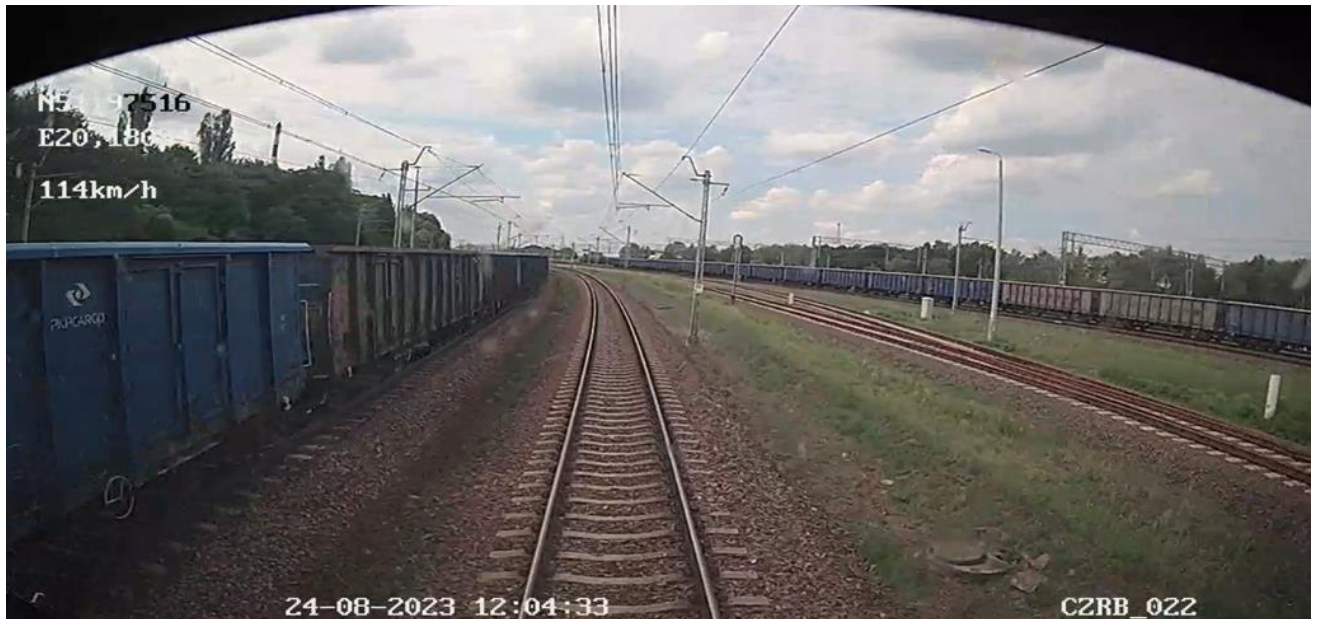
- 4) Lack of visibility of the aspects displayed by the intermediate signal J1^{1/2/3/m} from the required distance of 375 m (the signal aspects are obscured by catenary poles positioned at track two as well as by trains running on that track).
- 5) The fact that the driver of train no. 93965 took a telephone call from continued the conversation with the dispatcher of the Rolling Stock Repair and Operation Section Warszawa Grochów while approaching, on track one, the intermediate signal J1^{1/2/3/m} showing the aspect S1 "Stop", in contravention of the internal regulations of the railway carrier.

Photograph 13 - Visibility of the intermediate signal J1^{1/2/3/m} from 375 m on the day of the occurrence

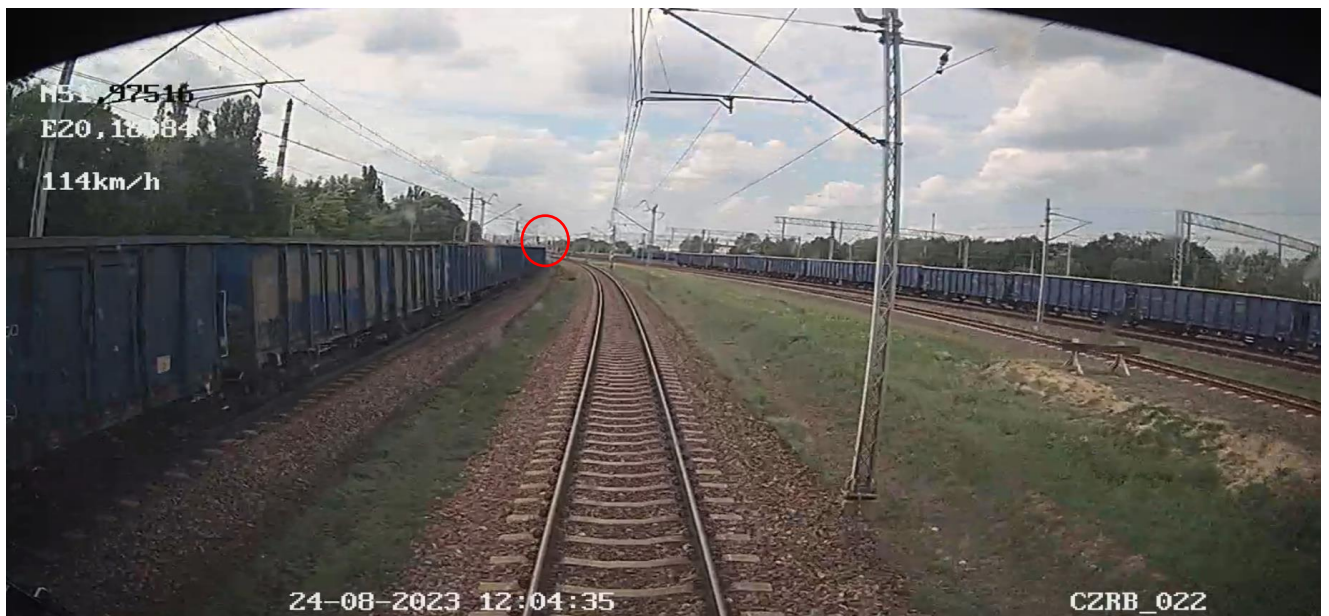
Photograph 14 - A view of the intermediate signal J1^{1/2/3/m} from 300 m on the day of the occurrence.
