REPUBLIC OF BULGARIA
NATIONAL AIR, MARITIME AND RAILWAY TRANSPORT, ACCIDENTS
INVESTIGATION BOARD (NAMRTAIB)

FINAL REPORT

**Investigation of railway accident – derailment of IDFT № 46660 between the stations Lyubenovo
transmission station – Radnevo on 03.02.2024**

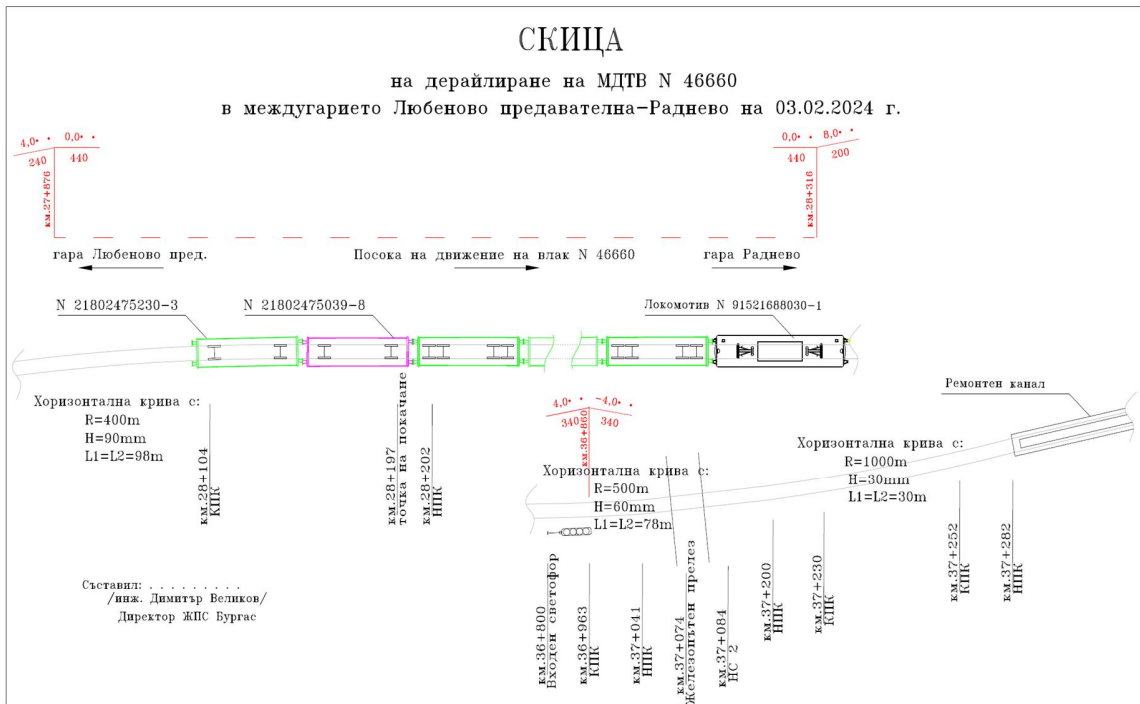
The event occurred between the Lyubenovo transmission stations - Radnevo station at km 28+197 in a transitional curve at 10:28 a.m. on 03/02/2024. The derailment zone of the wagons is in a right curve with length $L=98$ m, radius $R=400$ m, super elevation $H=90$ mm and profile $=0$ ‰. The rail track is laid with rails type S49 – 25 meters, reinforced concrete sleepers mixed type ST-4 and ST-6, fasteners mixed type PAK-68I and SKL-14 (fig. 1.1 and 1.2.).

Fig. 1.1. Scheme of the derailment location of IDFT № 46660

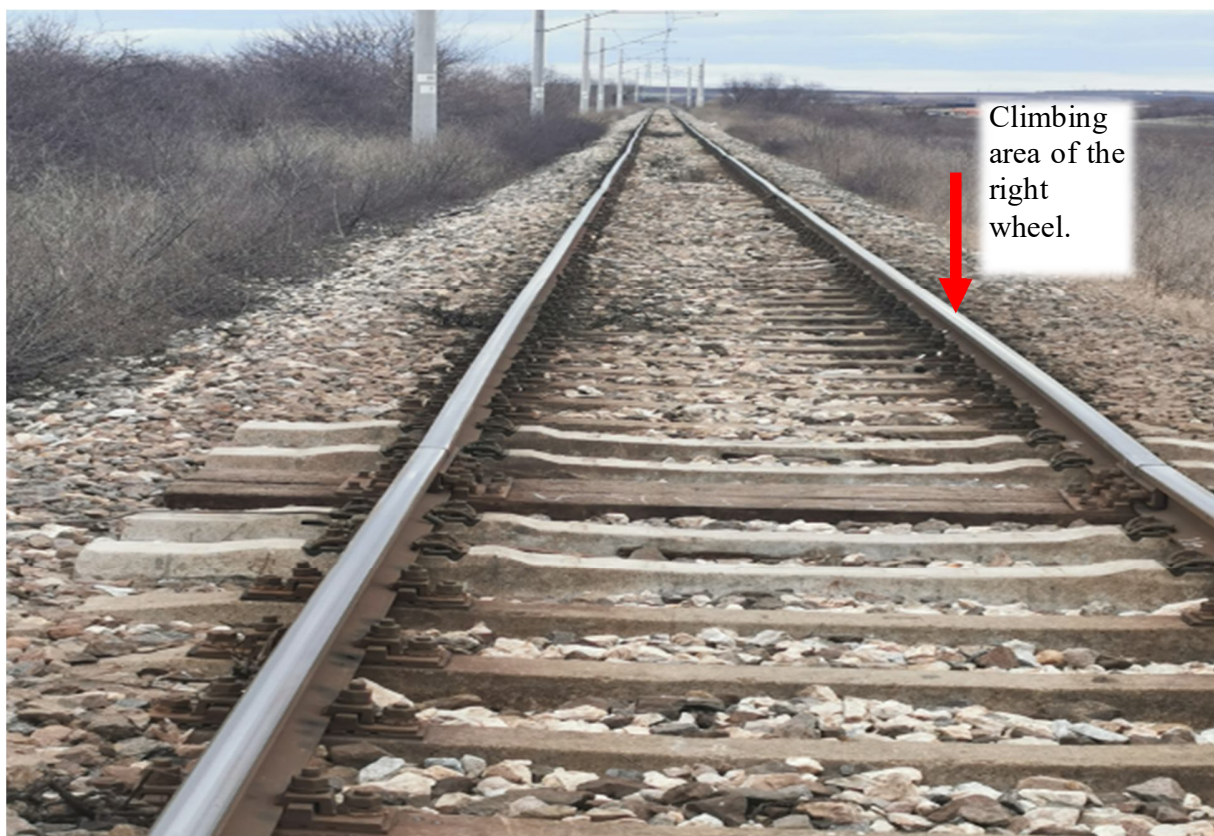
Fig. 1.2. The area of derailment of wagon № 21802475039-8 of IDFT № 46660

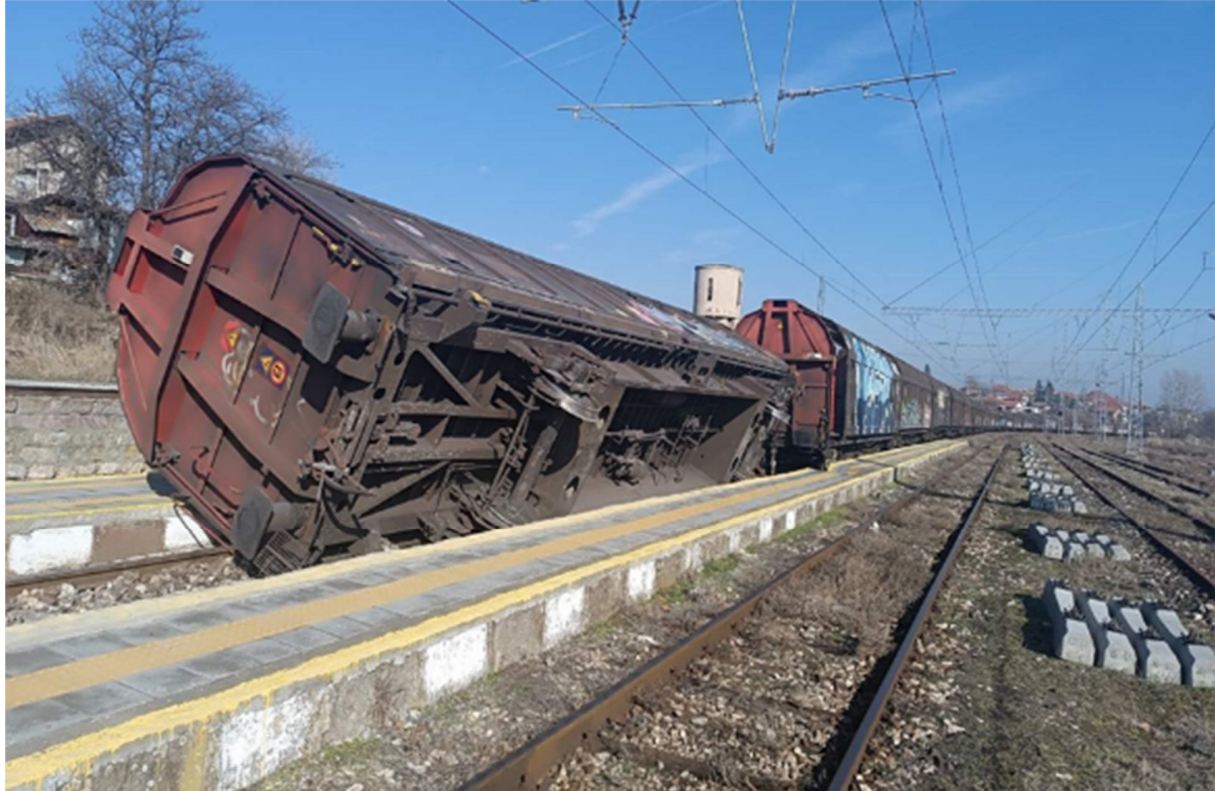
The last wagon No. 21802475230-3 was caught by the first derailed and it derailed with both wheel-sets while passing through the entrance switches and the technical canal of the second track and tilted to the left on the platform of the track, at which time the locomotive driver felt the pull of the train and initiated braking (Fig. 2.1).

Fig. 2.1. Derailed two last wagons of IDFT № 46660

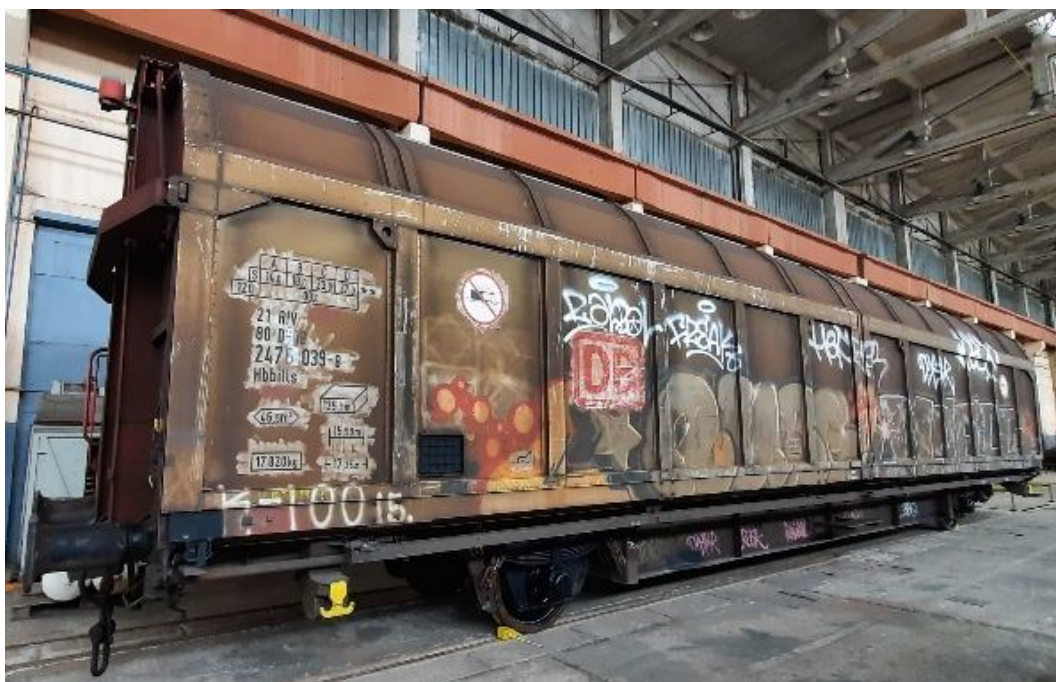
Fig. 2.5. Wagon № 21802475039-8 in RBCO Karlovo after the performed repair of the draft gear

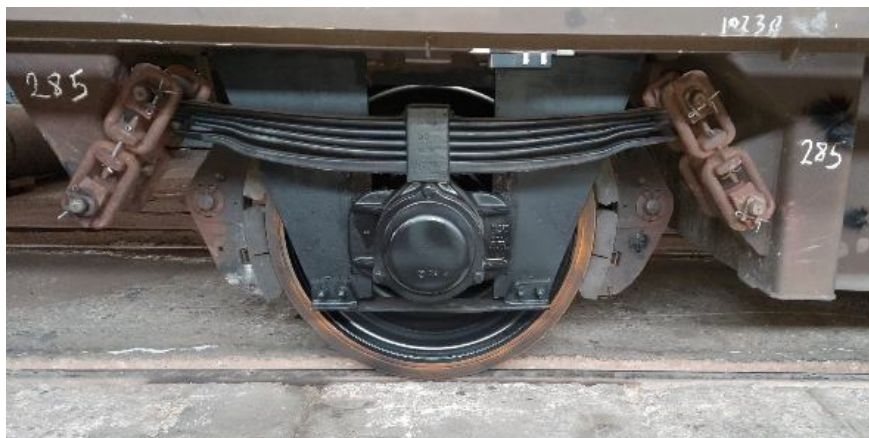
Fig. 2.6. The repaired draft gear of wagon № 21802475039-8 in RBCO Karlovo

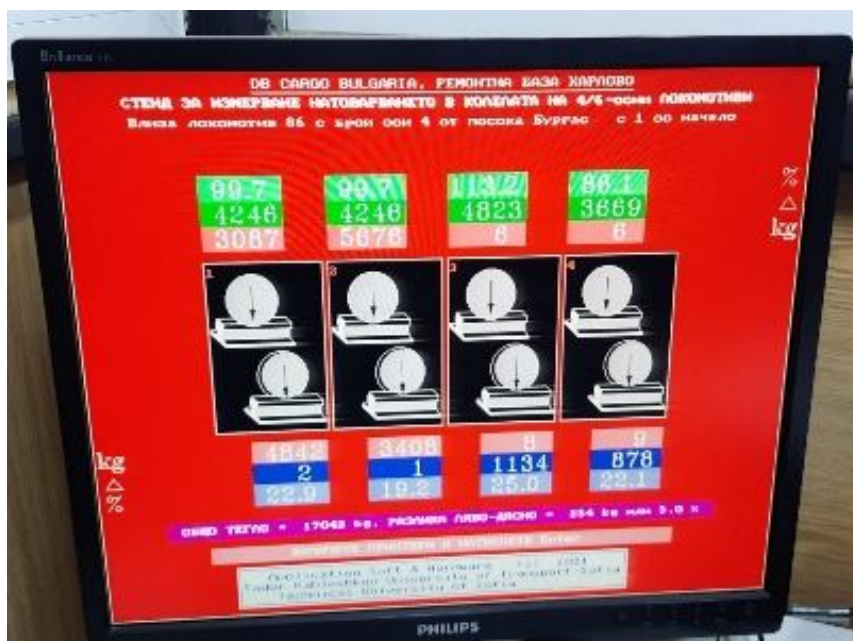
On 09 and 10.05.2024, in the presence of the Investigation Commission in RBCO-Karlovo, after the recovery of the derailed 31st wagon No. 21802475039-8, new control static weight measurements of the electronic scale on wheels and axles were carried out for the purpose of establishing and comparing of the differences in the static load of the wheels, for which a protocol was drawn up with the reported control results (fig. 2.5, 2.6, 2.7).

Fig. 2.7. Results from the measurement of the static loading of the wheels of № 21802475039-8 of RBCO Karlovo on 09.05.2024

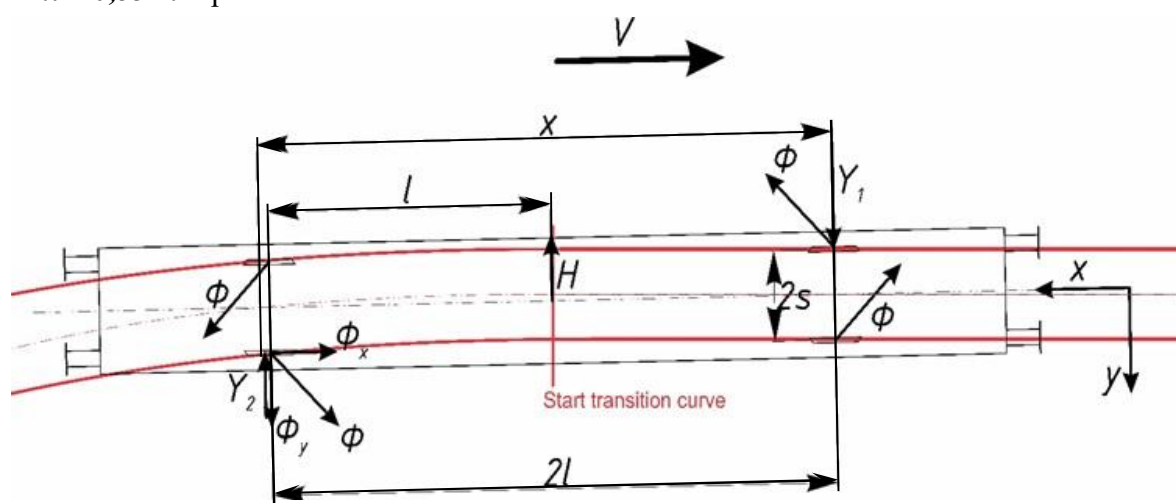
Fig. 4.17.

From the calculations made and from figure 4.17, it is clear that at the moment of ascent, the second wheelset touches the right rail, as a result of which the transverse guiding force Y_2 , arising in the right wheel of the second wheelset in the direction of movement, is directed inward to the gauge, i.e. there is maximum crossing type wagon positioning. At the same time, the frictional force Φ_y at the same point is directed outward from the gauge and has a greater value than the guiding force Y_2 . All this causes a shift of the rear part of the wagon (its second wheelset) towards the center of the transition curve, i.e. inward (to the right) in the curve. The situation is combined with the galloping of the wagon, caused both by the rail track (whose parameters are within the thresholds set by the normative documents), and by the spring suspension (also within the thresholds set by the norms) and the small mass of the wagon (empty).
