Translation of an excerpt of the investigation report

“Train derailment Bietigheim-Bissingen on 24/09/2020”

Status as of 11/11/2024, version 1.1.

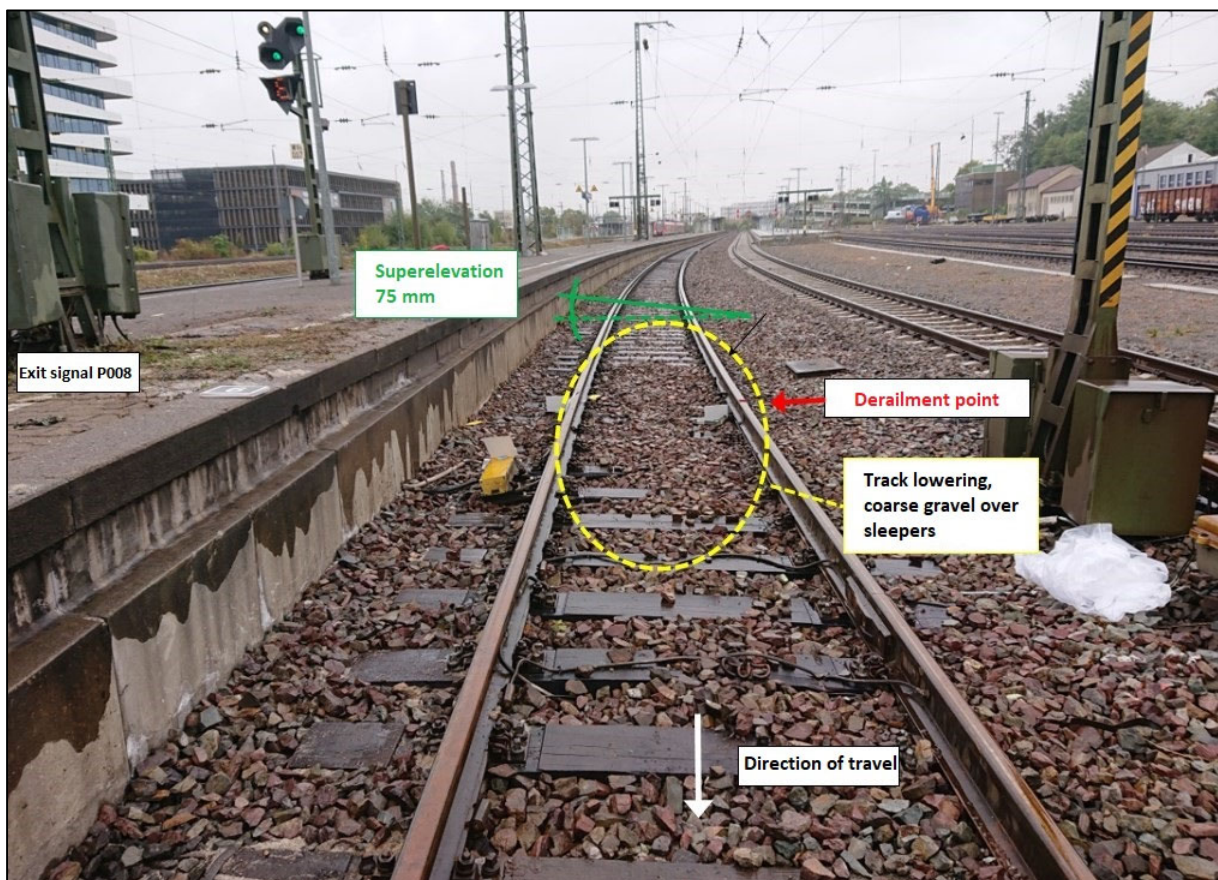
At several points before and in the area of the derailment, build-ups of sand were found on the wooden sleepers. In the area of the derailment point there were noticeable problems on the left of the right rail. Several wooden sleepers were exposed here roughly to the base of the sleeper on the ballast. At the derailment point itself, the sleepers were sunken and covered with gravel as shown in the Figure below.

Figure 1: Gravel covering at the lowering of the track

Taken together, the issues identified indicated a muddy area in the substructure in the area of the derailment point. The very coarse gravel present in this area also indicated that maintenance work had already been carried out to stabilise the track.

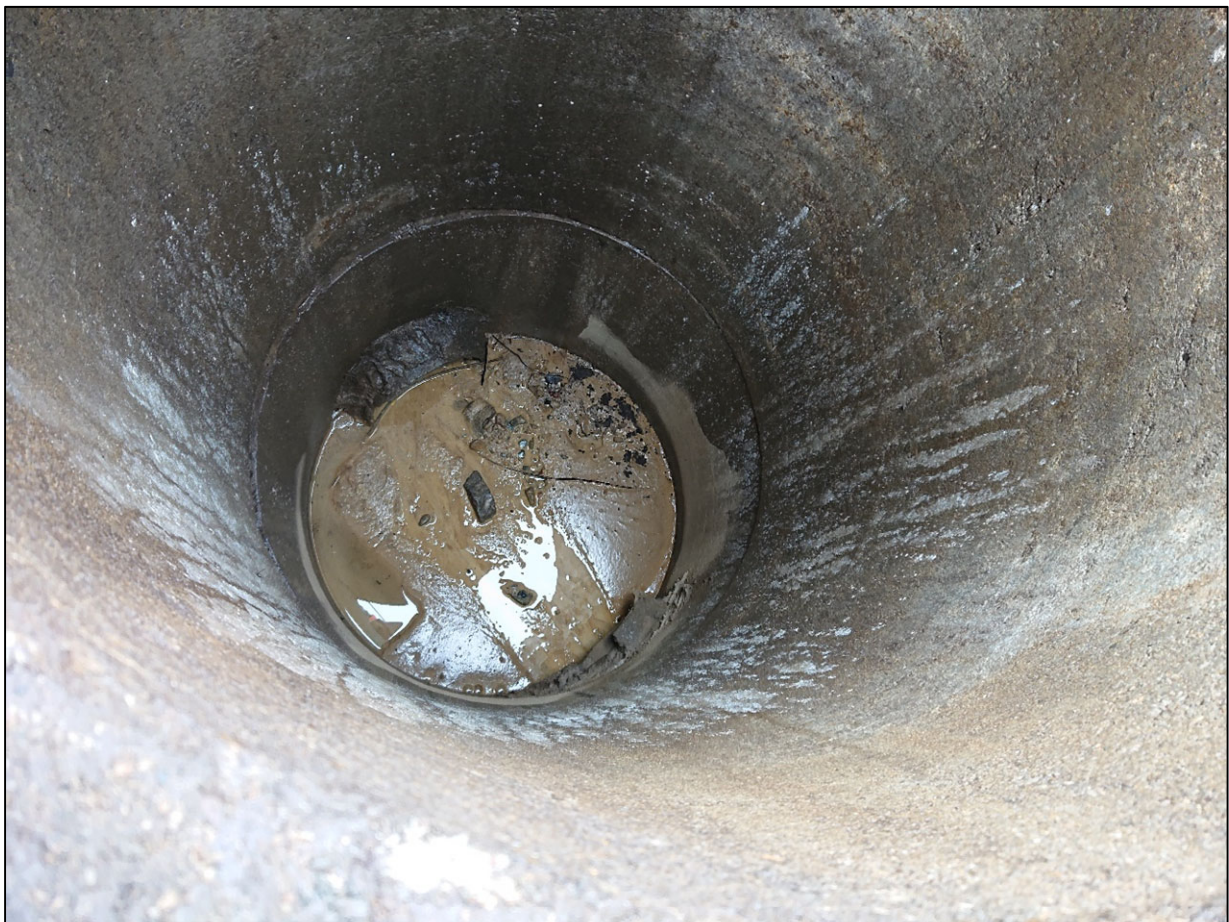
Further investigations into the cause of the muddy area showed that the pipes for the deep drainage were blocked with very fine grain material, meaning that there was no longer sufficient water drainage via the drainpipes.

Figure 2: Blocked deep drainage pipe

Due to the silting up of the drainage systems, these systems were not able to drain away the accumulating water to the intended extent. Due to the failure to inspect the deep drainage, this issue was neither identified nor rectified. This resulted in muddy points in the track area, which reduced the load-bearing capacity of the substructure.

In July 2023, DB Netz AG arranged for the deep drainage pipes to be rinsed and for the drainpipes to be inspected with a camera.
