# Assessment of freight train derailment risk reduction measures:

## Part A Final Report

Report for European Railway Agency  
Report No: BA000777/01  
Rev: 01

21 July 2011

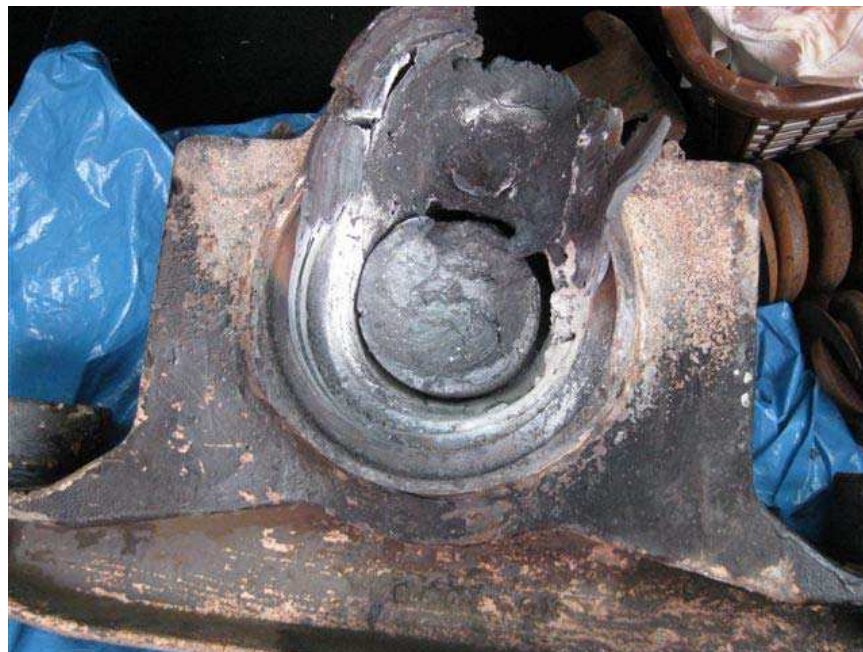
**Figure 3: Example of a Bearing Failure<sup>6</sup>**

- Sheared or increased friction in bearing causing overheating of the axle box and rupture or shearing of the axle journal (i.e. the parts of the axle that are outside of the wheel). This type of failure can be discovered by trackside detectors (hot axle box detectors or acoustic bearing failure detectors). If a bearing is damaged a hot axle box can develop very quickly.
- Rupture of axle shaft or axle journal due to fatigue. This type of failure is often initiated by a mechanical scratch to the axle material or a corrosion attack due to a fault or mechanical damage to the corrosion protection layer of the axle. The crack initiation is slow but maybe difficult to detect unless it has a visible cause. Once the crack has grown to a size that can

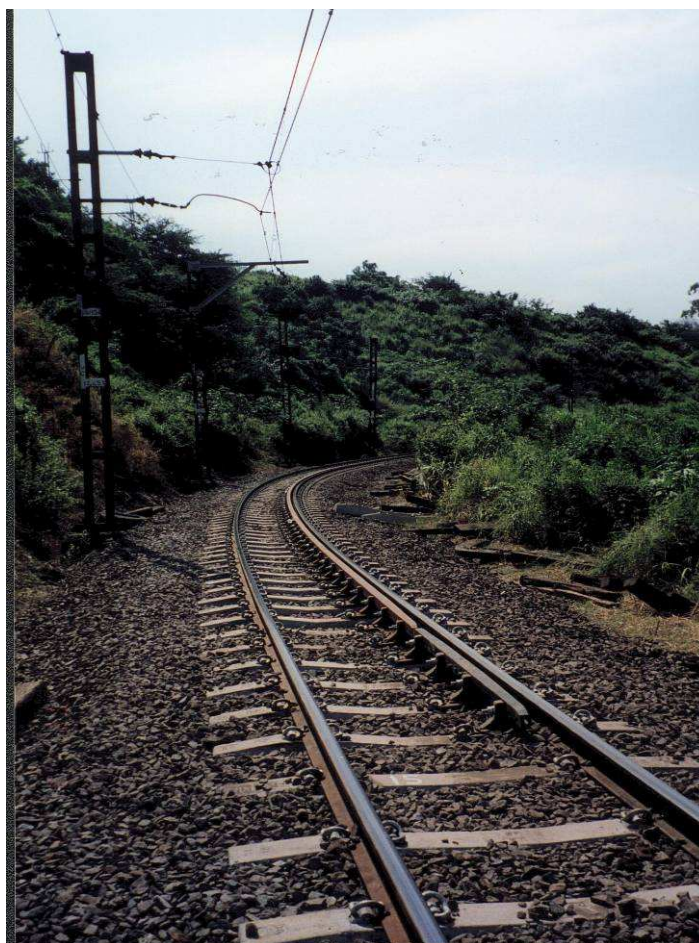
**Figure 7: Example from RSA showing Check Rail installation in Curved Track**

RSSB's Railway Group Standard GC/RT5021 [11] Track system Requirements specifies that track in passenger lines with a radius of 200 metres or less should be fitted with a check rail to reduce the risk of derailment.

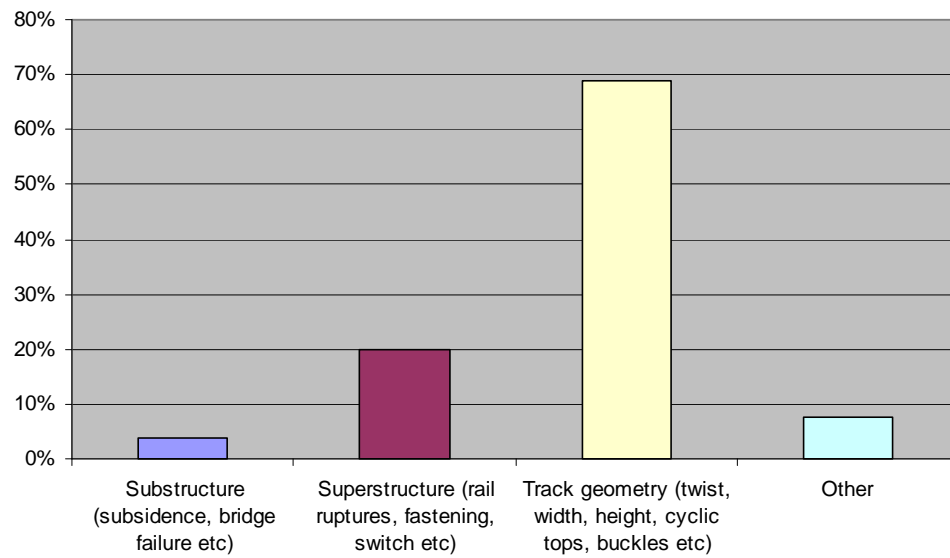
**Figure 13: Infrastructure Failures Leading to Freight Train Derailments**

This analysis indicates that of the 36% of derailments caused by infrastructure failures, nearly 70% of those are caused by track geometry defects. (Therefore  $36\% \times 68\% = 25\%$  of all freight train derailments across Europe are caused by, or have track geometry, as a significant contributory cause).

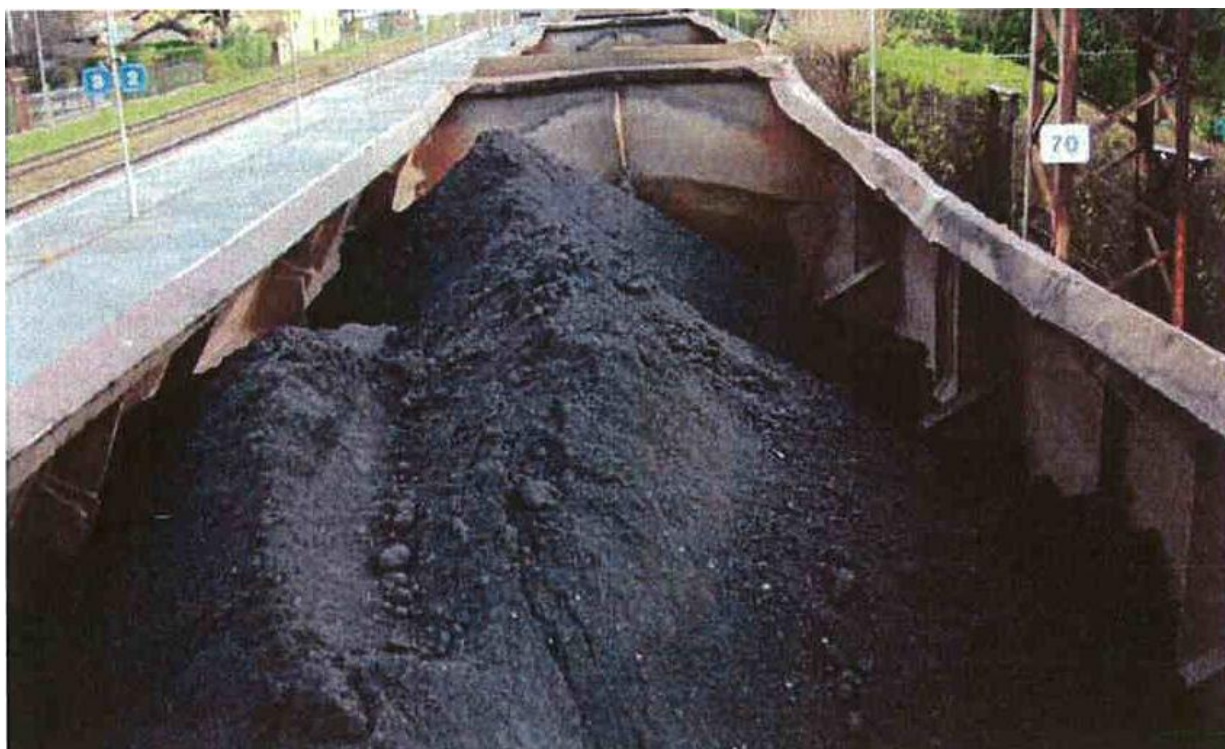
**Figure 1: Skew loaded hopper car**

An increased use of containers and swap bodies however makes it difficult to control the load distribution. An increased use of large front wheel loaders for loading of hopper wagons also represents a new challenge with regard to controlling against skew loading, as loading of hopper wagons by front wheel loaders can cause significant skew loading. Due to a high centre of gravity this can be particular critical under certain track conditions. An example of a skew loaded hopper car is shown in Figure 1.

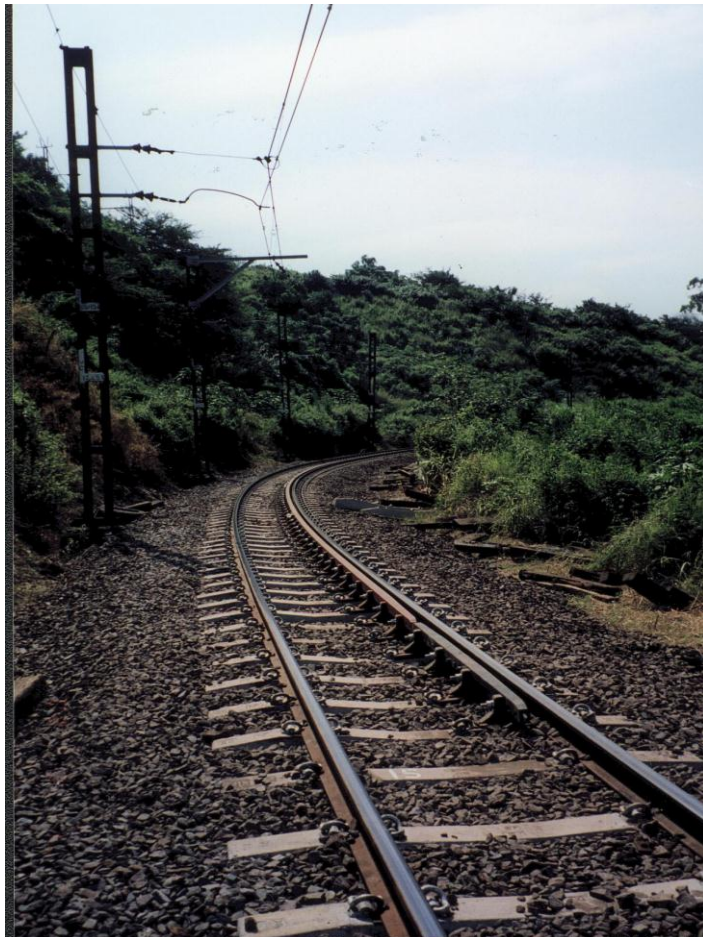
**Figure 2: Example from RSA showing check rail installation in curved track**

A picture from the Republic of South Africa taken from Voest Alpine net page shows how check rails can be applied in curved line sections /19/.

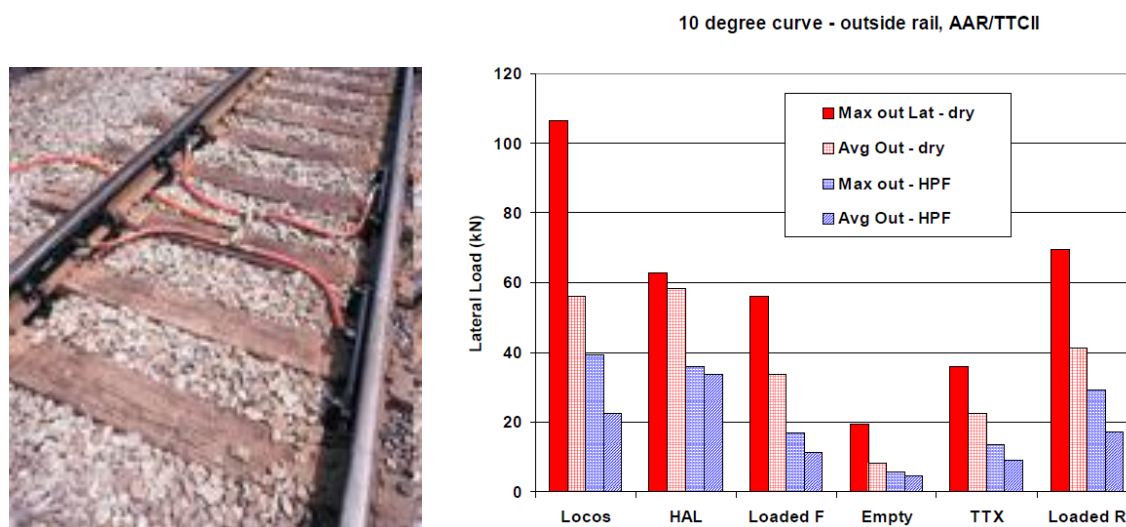
**Figure 3: Track mounted lubrication installation and test results from narrow curve**

The reduced lateral track force in narrow curves should cause less wear, less noise and less risk of derailment.

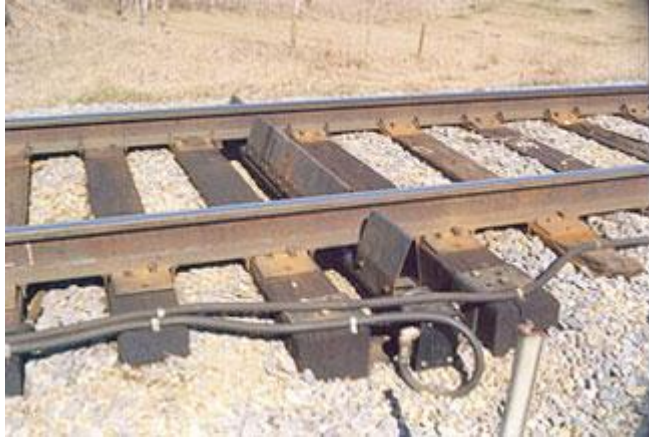
**Figure 5: Typical US derailment and dragging object detector**

The derailment and dragging object detectors will also detect derailments and are also included as a mitigating measure.

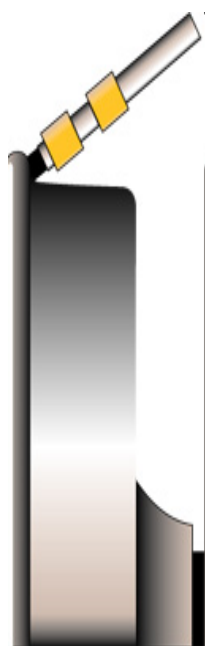
In some countries, in particular countries with a high proportion of curved tracks, there is a requirement to fit main traction units with flange lubrication to reduce the friction of the contact between wheel flange and rail. Specification for flange lubrication requirement for traction units and type of lubrication is found in the Network statements of SBB & BLS /29/ & /30/.

Reduced friction between wheel flange and track also reduces the necessary traction force and energy use on curvy track sections /23/. Other countries with less narrow curves and a more level network do not apply flange lubrication to the same degree.

The Austrian railways ÖBB has the following specification for flange and track lubrication as introduced in the software of locomotive type “Taurus” /7/:

- “< 20 km/h: no flange lubrication.
- $v > 20$  km/h normal flange lubrication.
- $v$  in range 73 – 90 km/h for more than 2 minutes: increased flange lubrication (Mode Berg 2).
- $v$  in range 30 – 72 km/h for more than 3 minutes: strongly increased flange lubrication (Mode Berg 1)”.

Recent accident investigations in Austria /7/ have found that the above lubrication programme may not give sufficient lubrication at localised difficult track geometries at low speed e.g. at track with reduced speed or in sparsely used tracks at stations. Added lubrication might therefore be required at curvy track in the above mentioned speed classes.

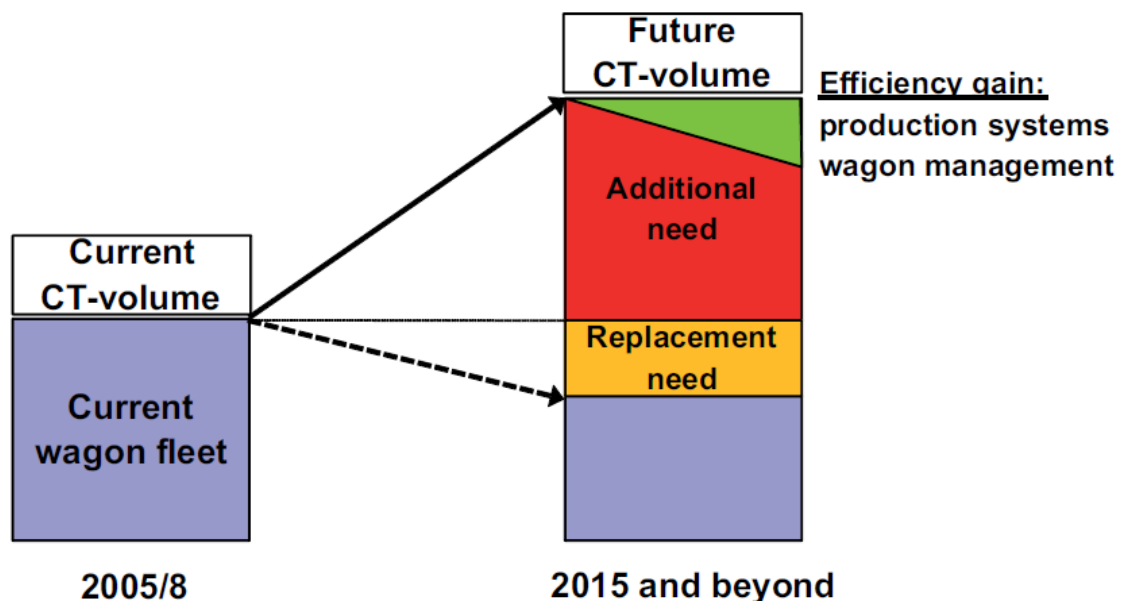
Figure 1: Expected Development of EU Rolling Stock Need for Intermodal (CT) Transport

A significant new building of rolling stock for intermodal transport is expected over the coming years to account for traffic growth and to replace old wagons. Hence, it is possible to introduce new solutions and technology if such can improve the competitiveness of rail freight. The expected development from 2005/08 towards 2015 is subjectively indicated in Figure 1, [16].

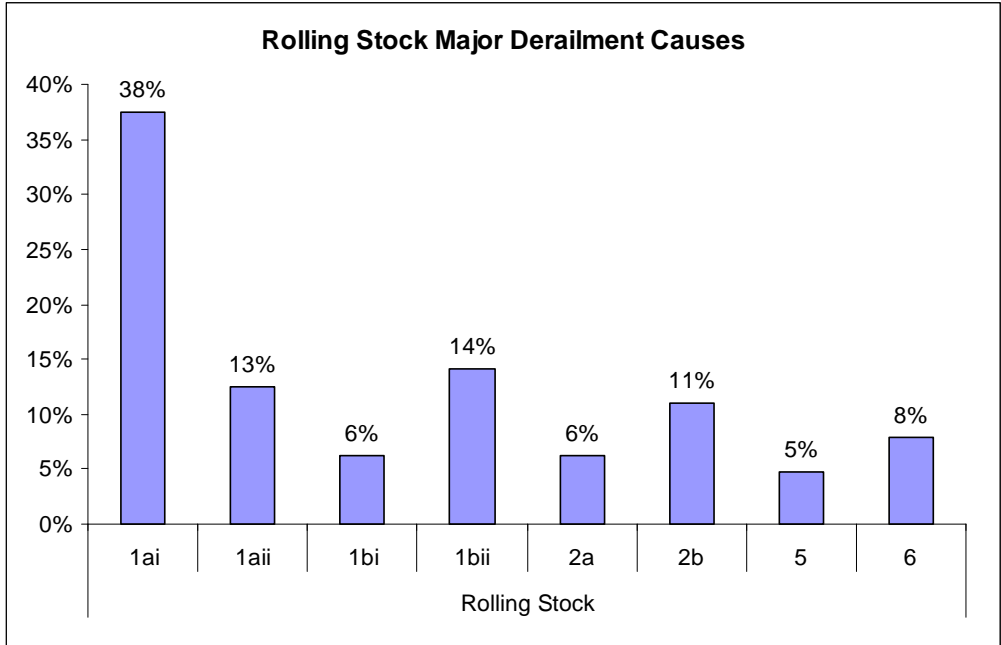
**Figure 7 Freight Train Derailment – Rolling Stock**

#	Description (only those contributing >3% shown in diagram)
1a	Wheelset failures (wheels and axles), comprising: i. Hot axle box and axle journal rupture ii. Axle shaft rupture
1b.	Wheel failure: i. Rupture of monoblock wheel ii. Failure of composite wheel with rim and tyre
2	Bogie and suspension failures, comprising: a. Failure of bogie structure and supports b. Spring & suspension failure
5	Brake component failure
6	Other or unknown rolling stock derailment cause
