#### SPECIALIZED UNIT FOR INVESTIGATIONS OF ACCIDENTS AND INCIDENTS IN RAILWAY TRANSPORT AT MTITC

#### FINAL REPORT

**investigation of a railway accident – a collision of a passenger train № 19205 with a car at a guarded level crossing between Krumovo and Asenovgrad stations - on November 12, 2019**

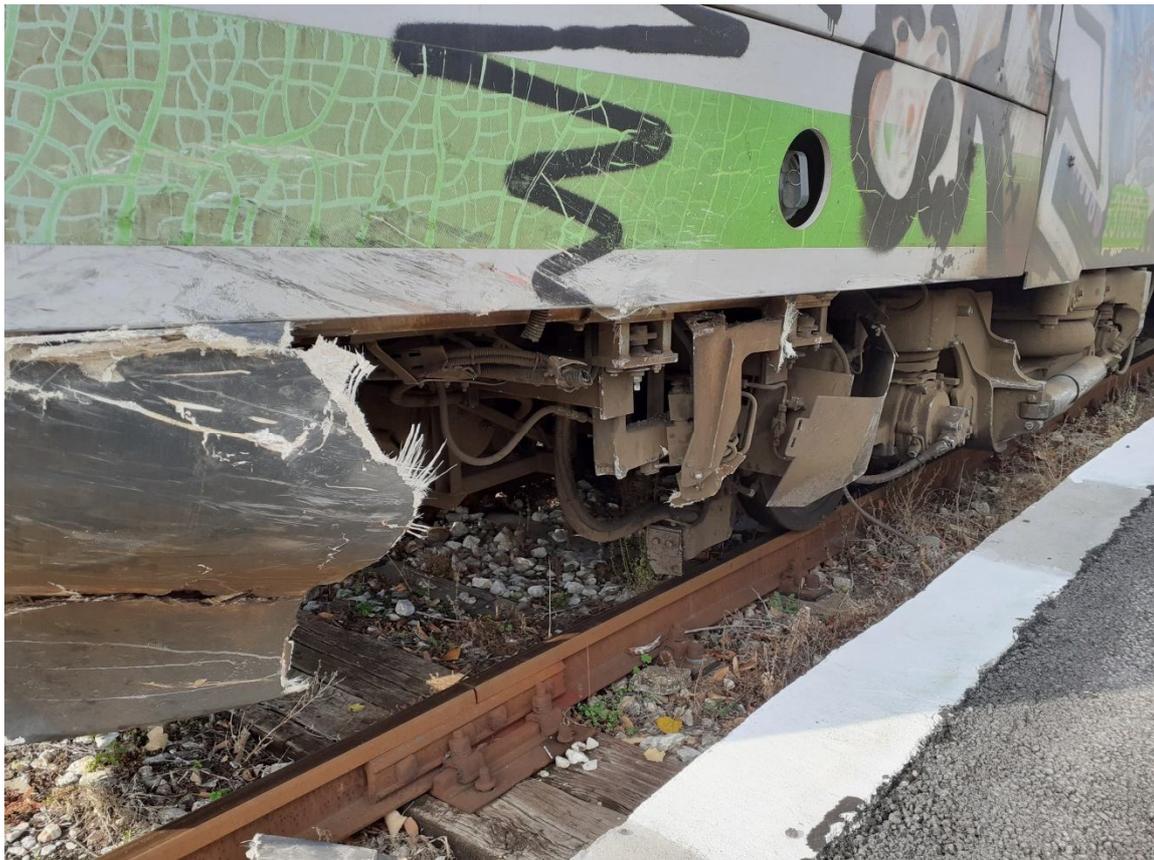
Fig. 1

A driver and two passengers has been traveled in the car, next to the driver, and on the back seat. As a result of the subsequent collision, the passengers in the car receive serious injuries and are taken to Plovdiv for emergency medical treatment. After a four-day stay in the hospital, one of the passengers, the one who has traveled next to the driver, dies and the other two are discharged after a three-day stay. The train driver is not injured. Damage is inflicted on the left side of EMT (Fig. 1) and severe damage to the car (Fig. 2).

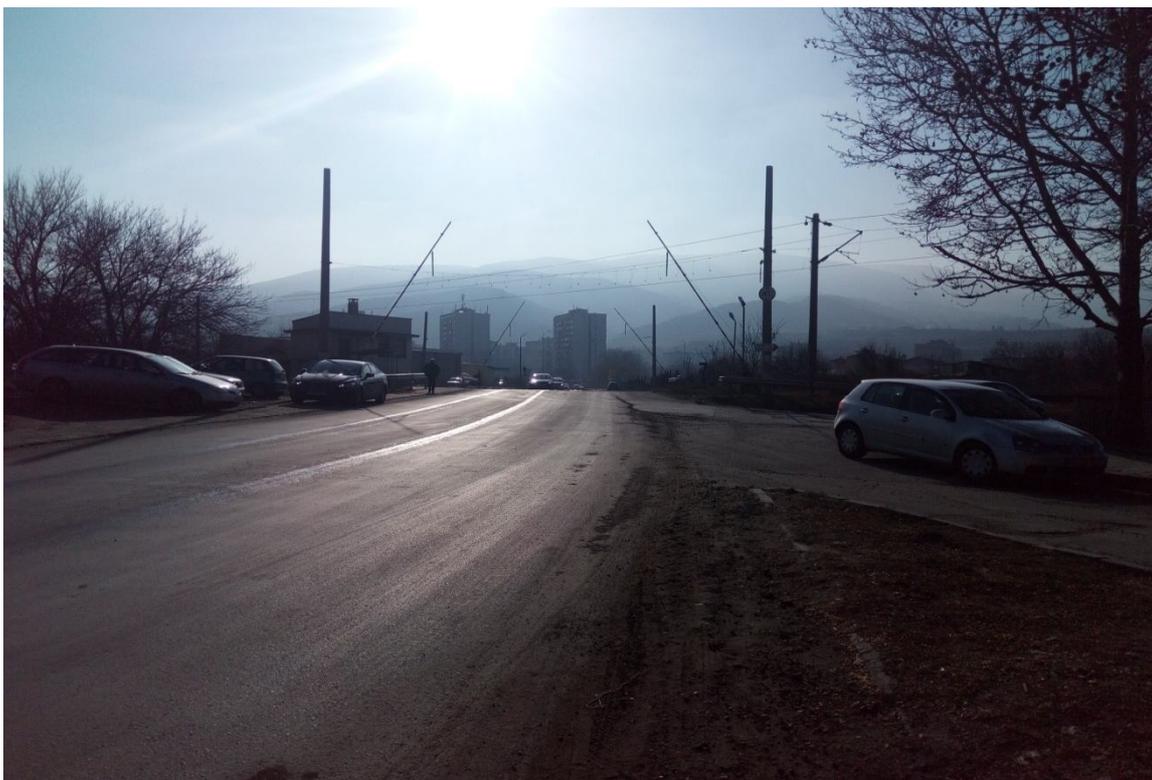
**Fig. 3**

The event takes place in the railway section Krumovo - Asenovgrad at "km 8 +<sup>830</sup>" crossing guarded by guards, at a single electrified railway. The level crossing is a first category one, with an intensity of 5883 motor and road vehicles per day. The crossing partitions the city from the industrial zone of the town of Asenovgrad (Fig. 3).

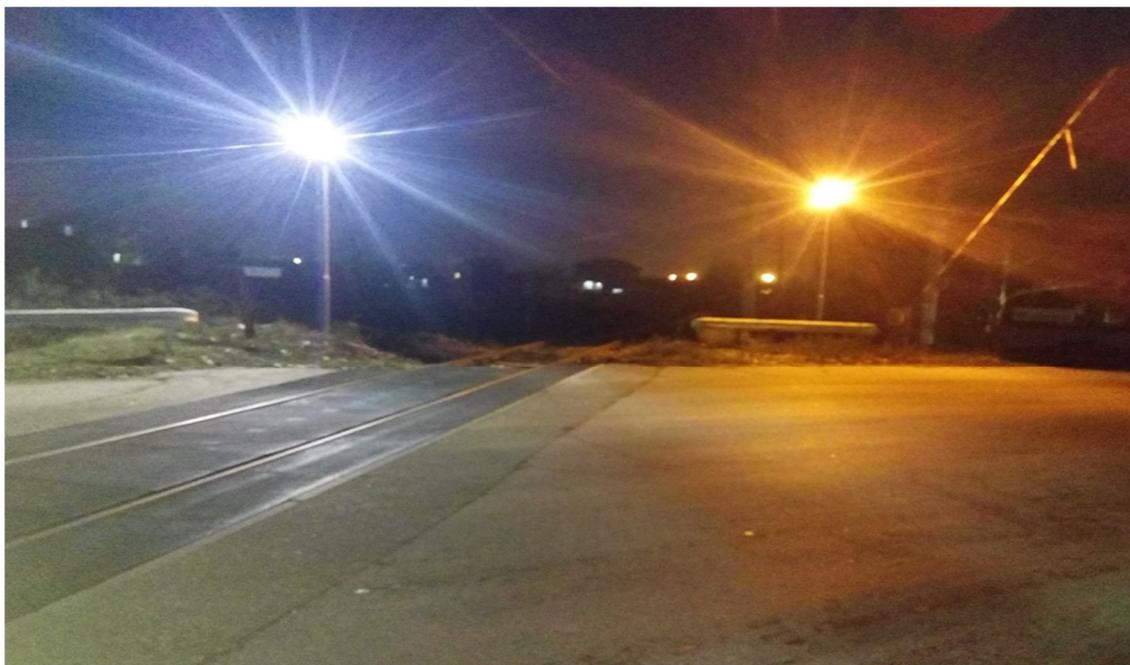
**Фиг. 4**

Subsequently, inspections were carried out in the dark part of the day, around 18:00 hrs at "km 8 + 830" crossing in order to establish the visibility and illumination at the place of the event (Fig. 4).

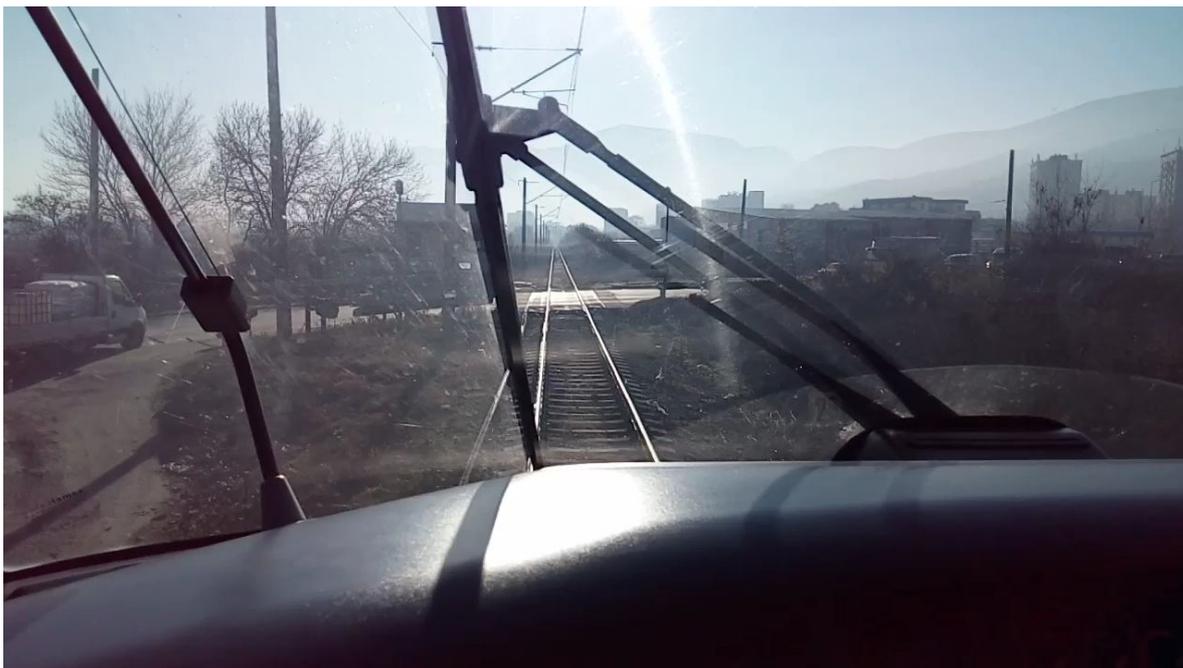
**Fig. 5**

On December 18, 2019, at the request of the commission for investigation, a speed-braking test of EMT 31-005 / -006 is performed in the railway section Krumovo - Asenovgrad to establish the braking distance of the train from the place of impact (level crossing axis) to the final stop of the train in connection with the witnesses given by the motorman. The test is conducted in the presence of representatives of "BDZ-Passenger Transport" EOOD and NRIC (Fig. 5). An interview is also conducted with the head of Asenovgrad station to clarify additional issues.

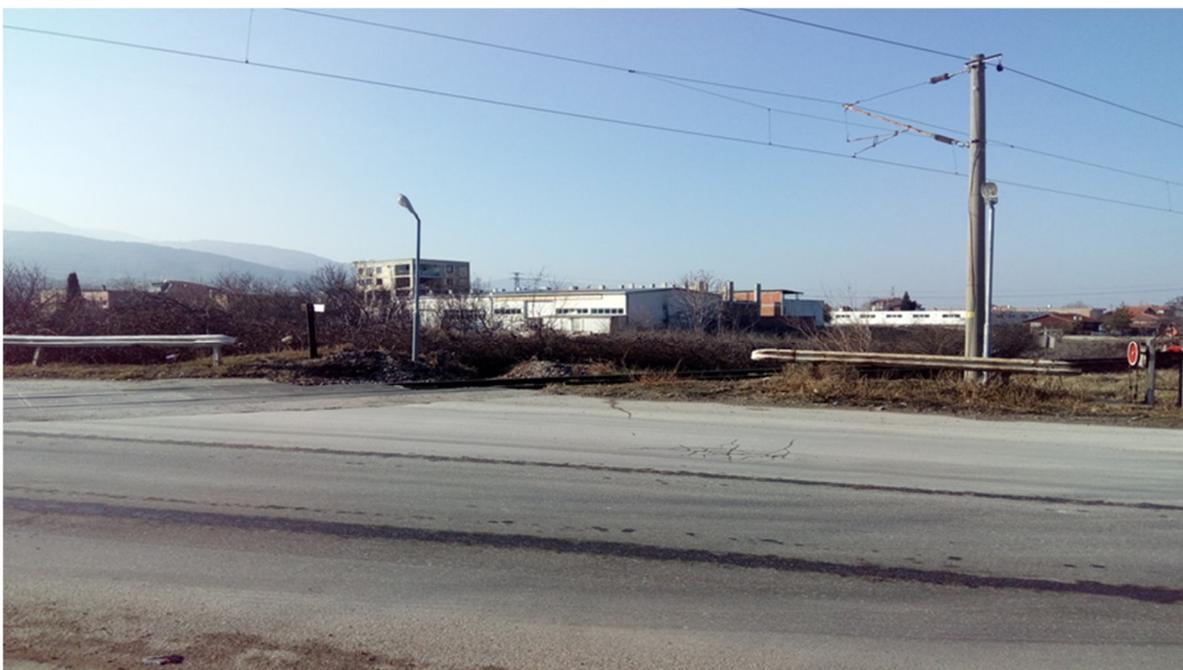
**Fig. 6**

A re-inspection of the facilities and the road signalization from the two approaches of the level crossing is performed (Fig. 6). A meeting is held with the management of RTMSA - Plovdiv regarding the operation of the level crossing and the personnel working at the crossing.

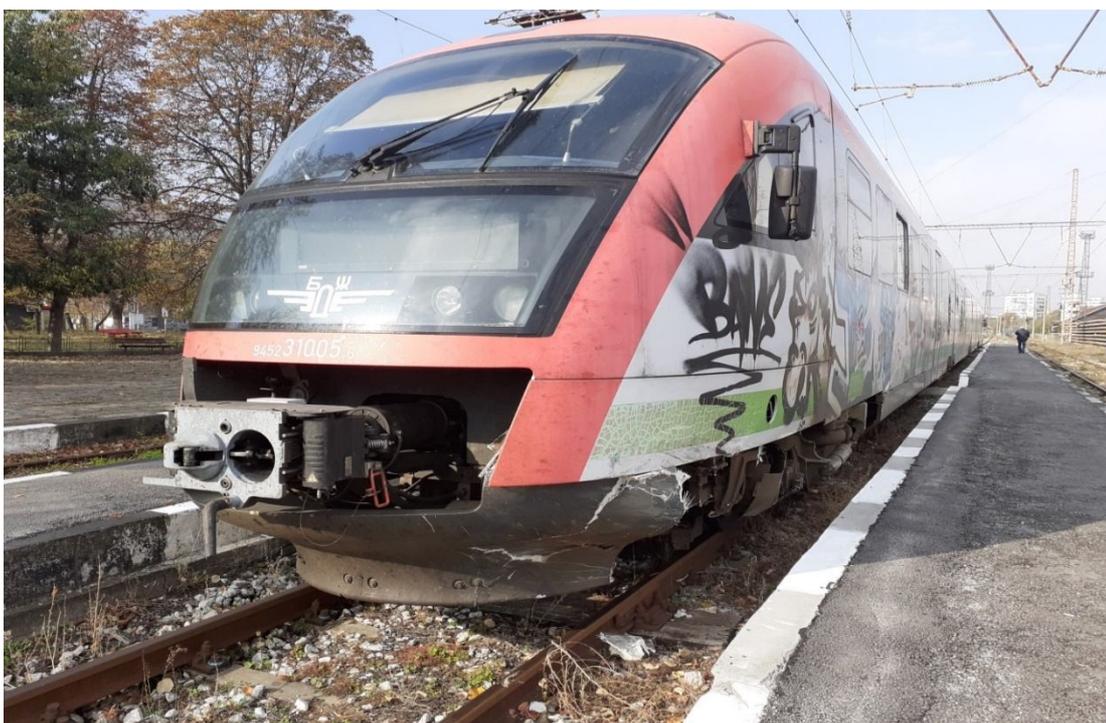
**Fig. 7**

- electric motor train with four wagons - "SIEMENS" series 31-005 / 006 with regular registration in the register of vehicles (Fig. 7);

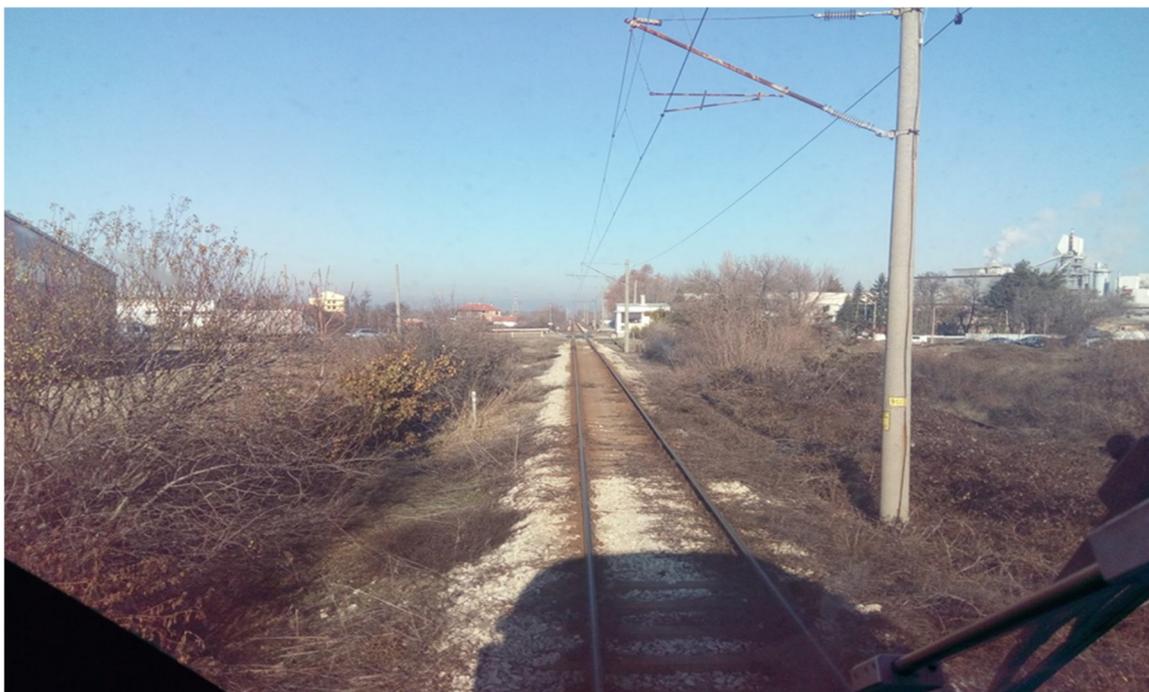
**Fig. 8**

- the railway at km 8<sup>+830</sup> level crossing in the section Krumovo - Asenovgrad is on a concrete sleepers grid with sleepers type ST-4 and rails type S 49, with an authoritative slope of 8.6 ‰ uphill to Asenovgrad station. The Permissible speed for the movement of trains in the mentioned interstation is 80 km/h (Fig. 8);

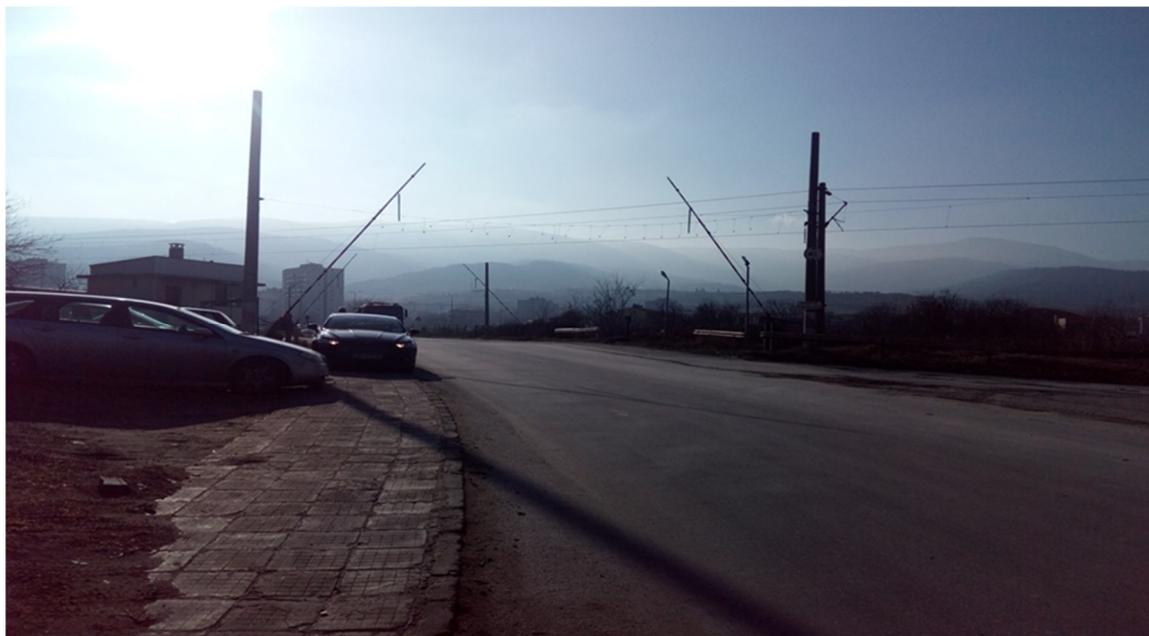
**Fig. 9**

- the level crossing is equipped with four manual barriers, mechanically operated, which cover the entire traffic lane and are serviced by a duty crossing guard (Fig. 9).

Recommendation № 3 proposes by taking into account the category and intensity of vehicles passing through the level crossing, and in order to minimize the human factor, NRIC should re-equip the level crossing at km 8 +<sup>830</sup> in the interstation Krumovo - Asenovgrad with an automatic crossing device (ACD) equipped with four automatic barriers' mechanisms and an on-duty crossing guard on shift.

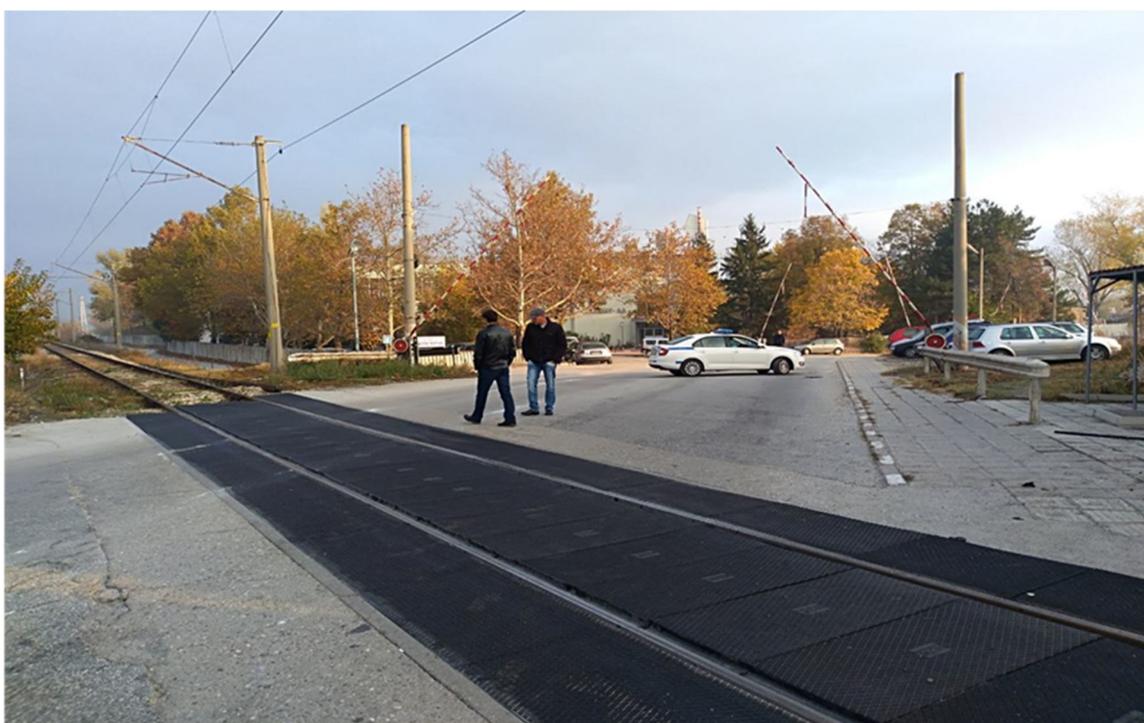
**Fig. 10**

driver of the vehicle, to the incoming train :  
from the left, along the mileage - 400m; and back - 600 m;  
from the right, along the mileage - 400 m; and back - 600 m;  
The floor of the level crossing is on an elastic rubber base type STRAIL (Fig. 10).

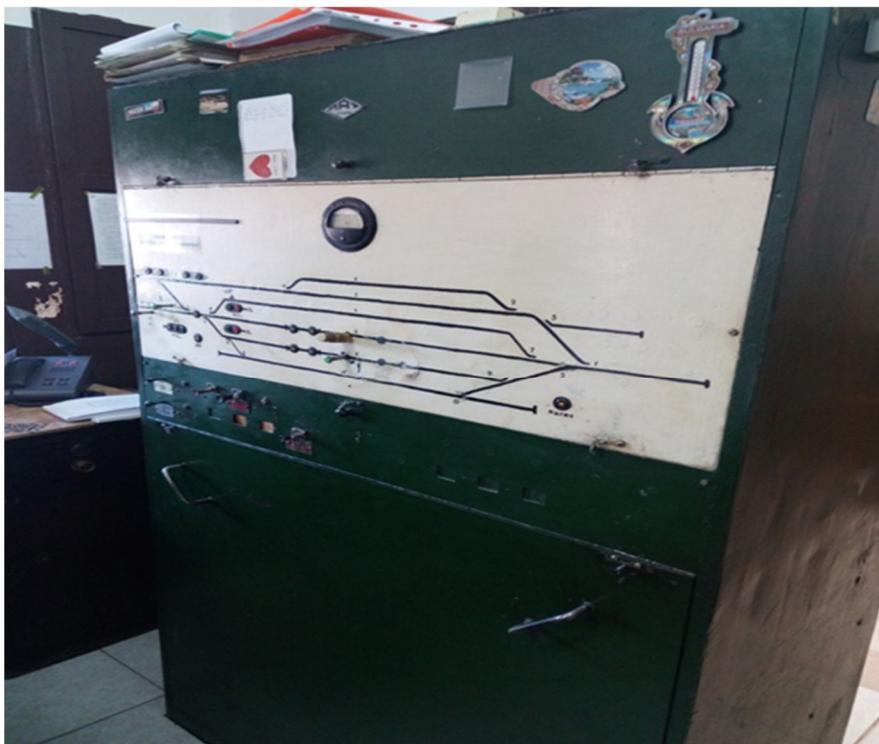
**Fig. 11**

- Krumovo station is equipped with a Route-computer centralization (RCC) "ELECTRA2";
- Asenovgrad station is equipped with a Relay system with key dependencies (RSKD) (Fig. 11);
- Krumovo – Asenovgrad section is equipped with an automatic blocking and axis counters without duct capacitor signals;

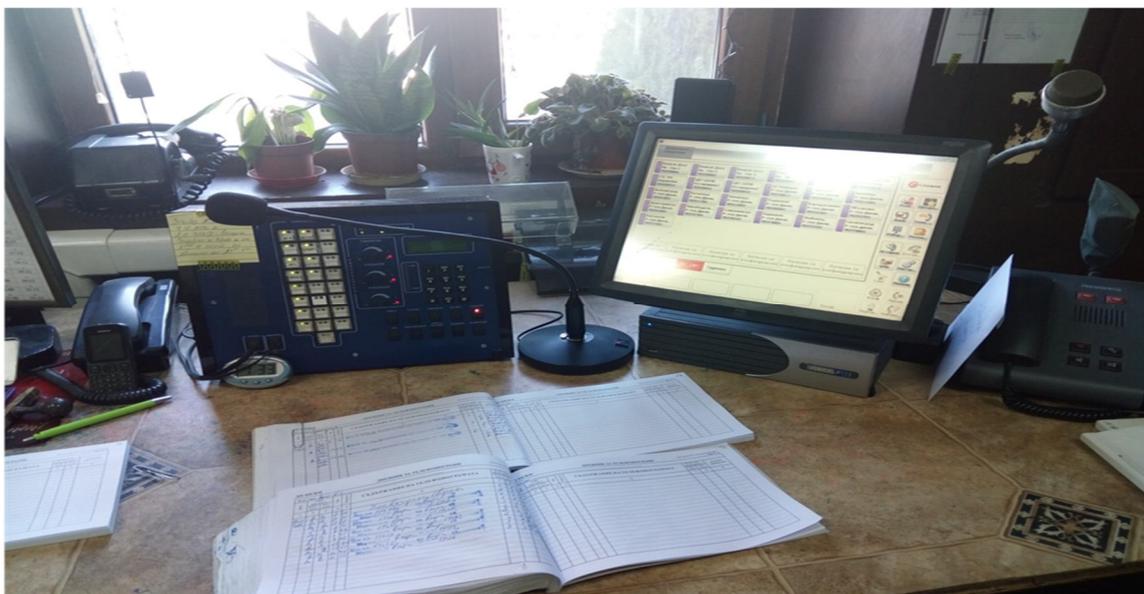
**Fig. 12**

- in Krumovo and Asenovgrad stations - the station and between station connections are performed by systems such as “Dicora” and “Topex” (Fig. 12), in both stations official mobile phones are provided;
- the communications between the level crossing at km 8 + 830 and Krumovo and Asenovgrad stations are carried out bilaterally with a crossing-communication connection type “Topex”;

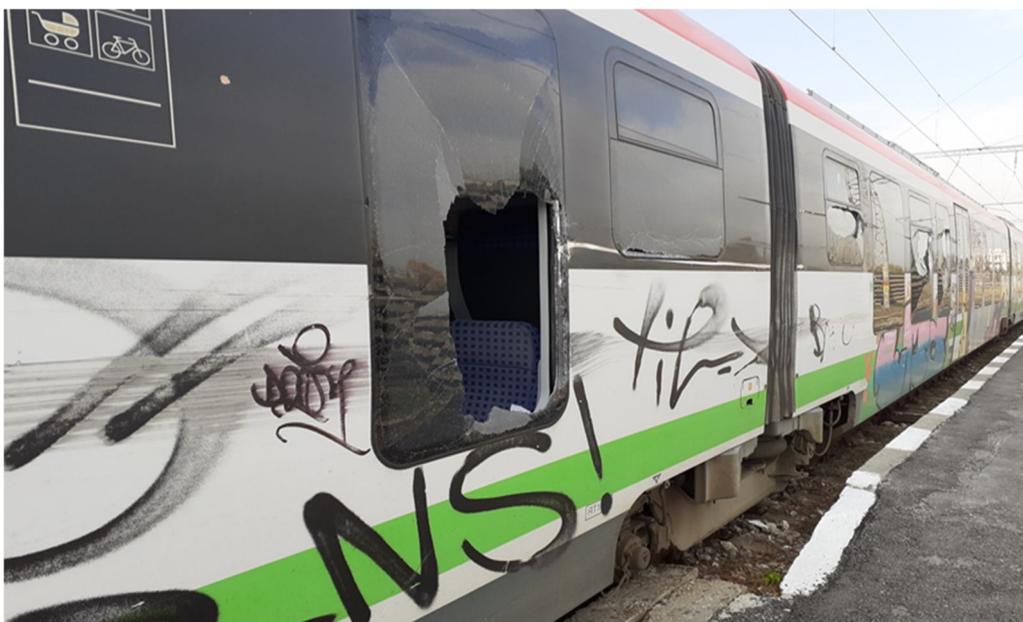
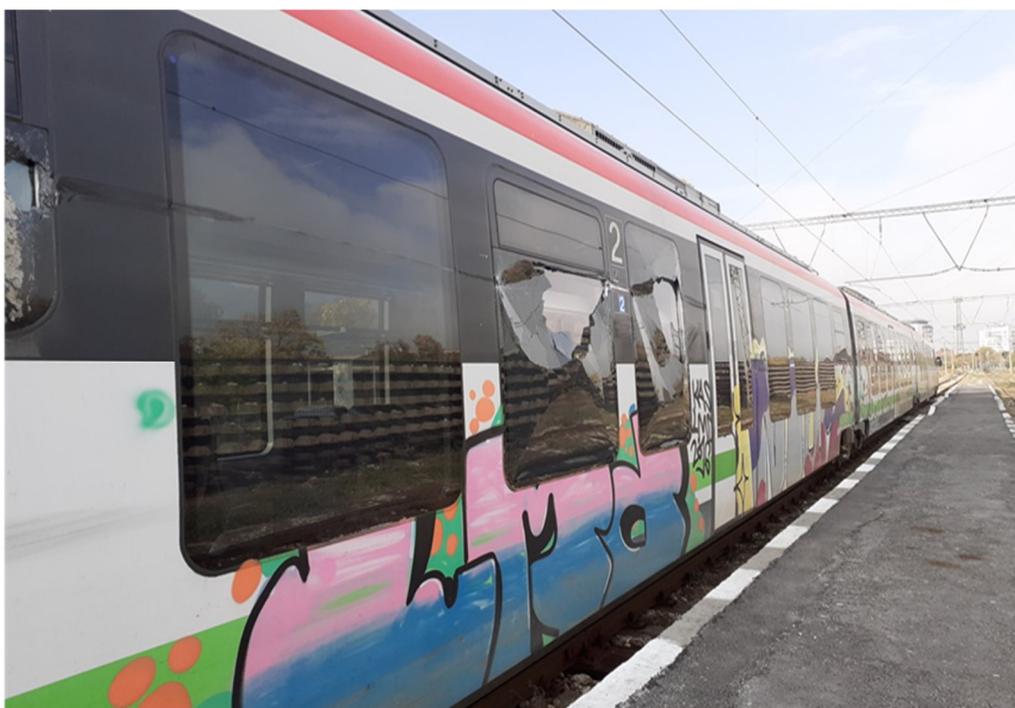
- passenger train EMT 31-005 / 006 has damages of 2 pcs. of front spoilers, 4 pcs. of side windows are broken and a tachogenerator cable of the electric train is torn (Fig. 13, 14);

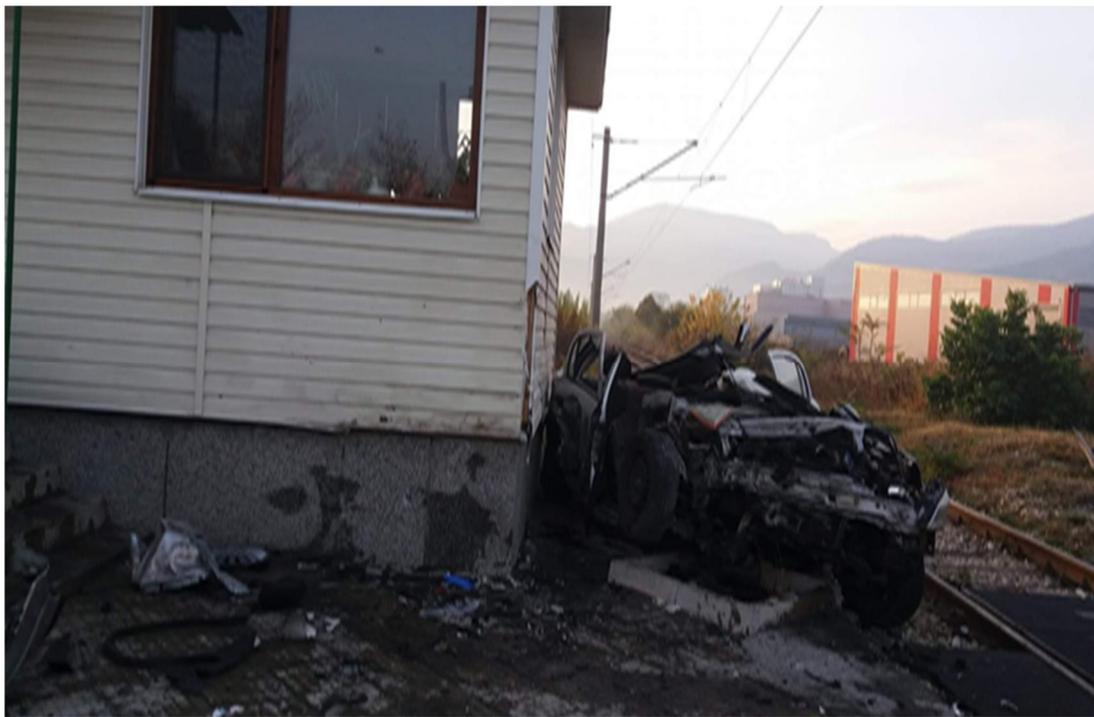
**Fig. 15**

- Vehicle - an Opel "ASTRA" with severe damage (Fig. 15);

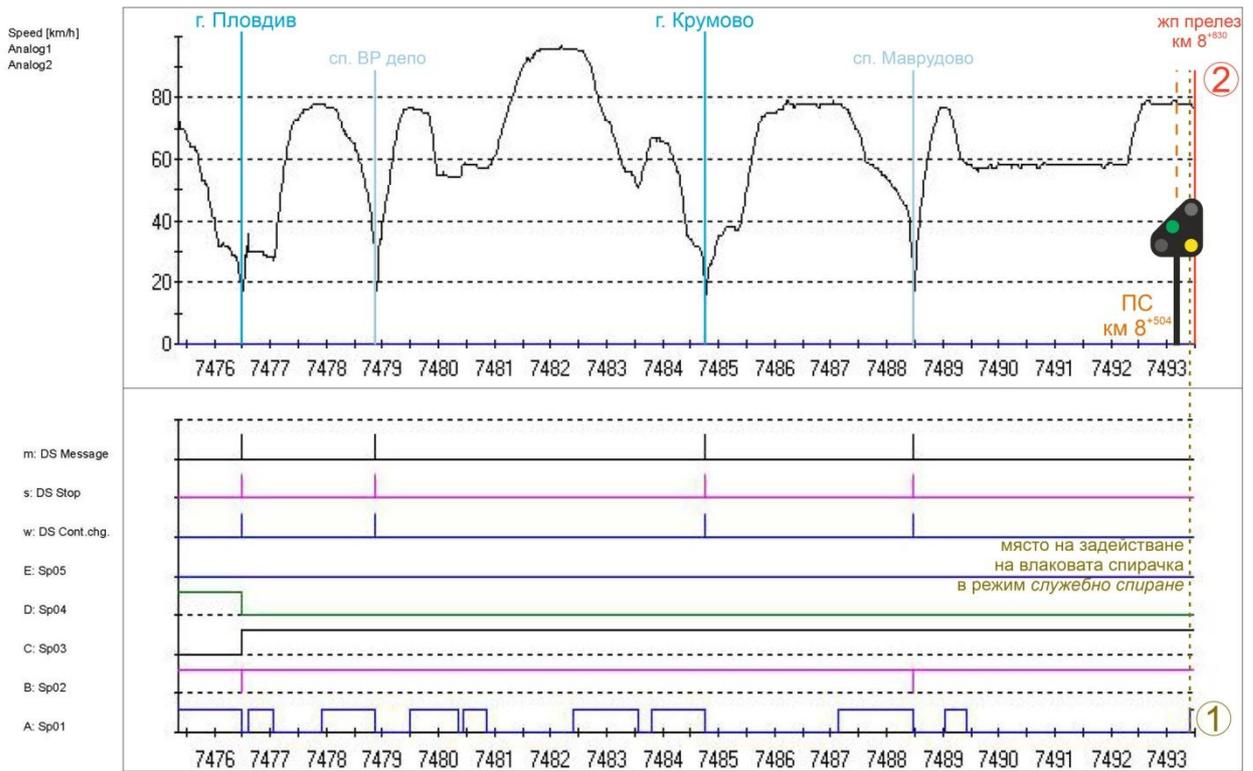
Fig. 17

At 06:53:51hrs the train № 19205 passed through the level crossing at km 8<sup>+830</sup> at a speed of 77 km/h (Fig. 17, pos. 2, fig. 18, fig. 19, pos. 2), where a collision with the vehicle follows, after which the recording of the recording device stops and the train continues its movement. From that moment on, the recording of the recording device stops and what are the further actions of the motorman can only be guessed. According to the testimony of the motorman, the trainmaster and the conductor, after holding the train brake in the fast stop position, the train stops 100 meters before the entrance signal at Asenovgrad station. Given that the level crossing is located at km 8<sup>+830</sup>, and the entrance signal at Asenovgrad station is at km 9<sup>+504</sup>, it can be argued that the motorman has not applied the train brake in a fast stop mode, as the train stops approximately at km 9<sup>+400</sup>, i.e. its braking distance is 670 meters, which does not correspond to a fast braking mode, but to a service braking mode.

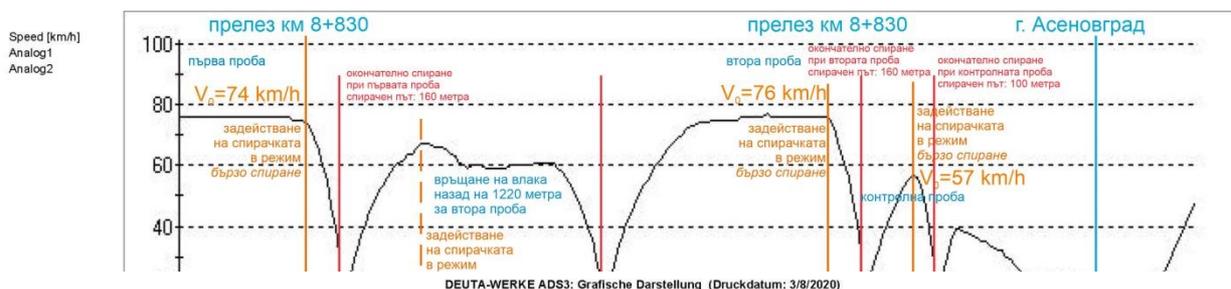
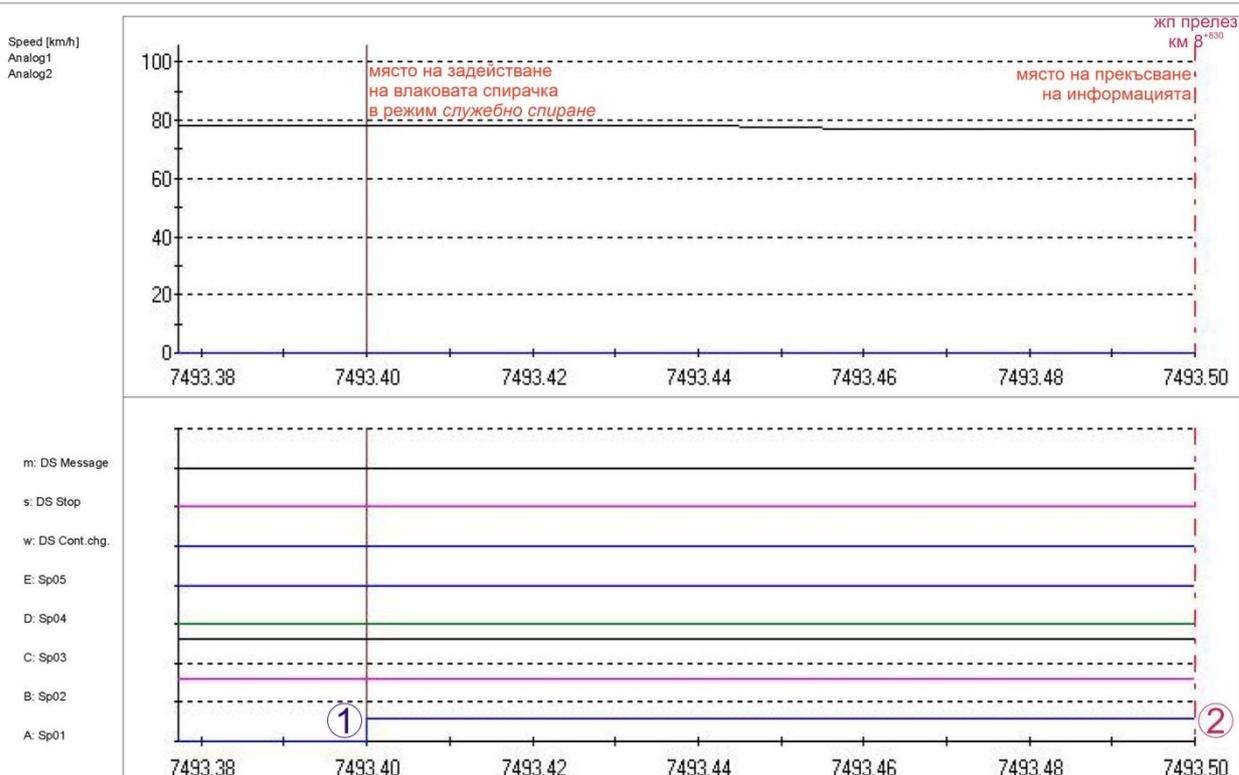
Fig. 19

At the scene of the accident (the axis of the roadway, which intersects with the railway line of the crossing) from a speed of 74 km/h, the brake of EMT 31-005 / 006 is applied in fast stop mode. The brake is applied at 10:47:24 hrs at km 418,040 (according to the EMT mileage), and the train finally stops at km 418,200 (according to the EMT mileage) at 10:47:41hrs, i.e. the stopping time is 17 seconds and the braking distance is 160 meters. The train is returned at a distance of 1220 meters. The stop is made in official stop mode from 10:50:49 hrs to 10:51:51 for 1 minute and 2 seconds with a braking distance of 840 meters. After changing the direction of movement, the EMT is accelerated again. A second stop follows at the same place at a speed of 76 km/h and in the same brake mode (quick stop). The brake is applied at km 420,480 (according to the EMT mileage reading) at 10:54:30 hrs. After the detention, EMT is stopped at km 420,640 (according to the kilometer reading of the EMT) at 10:54:46 hrs, i.e. the stopping time is 16 seconds and the braking distance is again 160 meters. After the departure in the direction of Asenovgrad station, a third, control stop is made in quick stop mode with the indirect train brake (purely pneumatic) from a speed of 57 km/h. The stop is realized in 13 seconds and the braking distance is 100 meters. In all three cases, the braking distance of EMT 31-005 / 006 is reported both under the EMT transcript and under the railway mileage.
