Summary  
Safety Investigation Report  
Derailment of a Lineas freight train  
Aubange - 19 May 2017

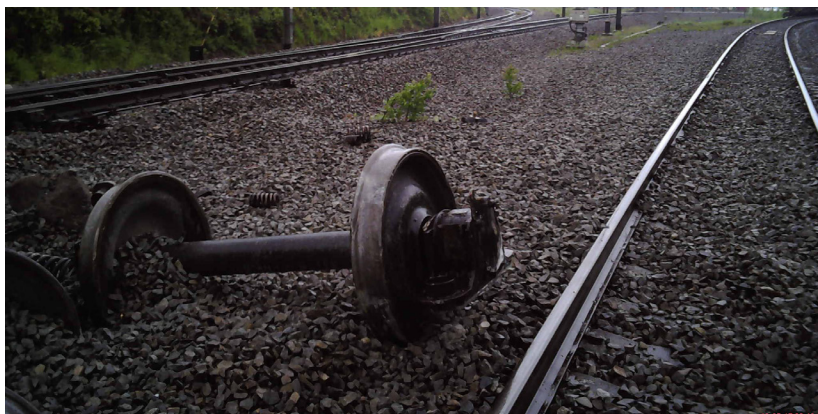
The inspection of the train by the driver reveals that the two last wagons of the train have derailed. The initial inspections of the rolling stock, of the tracks and of the area surrounding the tracks reveal that one of the wheels of the penultimate wagon broke some 17 kilometres from the train's stopping point, causing the derailment of the wagon.

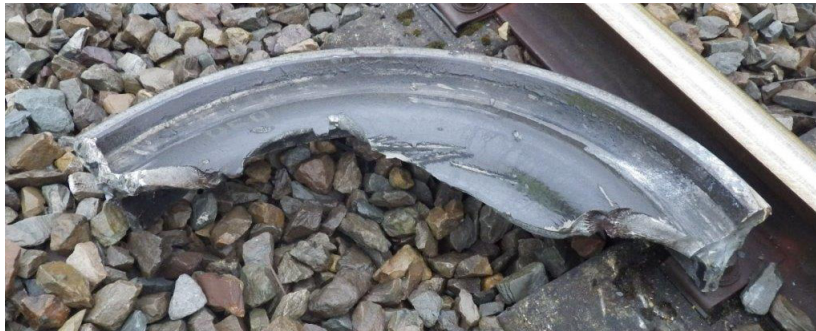
Fragment n°	Borne Kilométrique (BK)	
1	127.800	
2	127.000	
3	124.000	
4	124.000

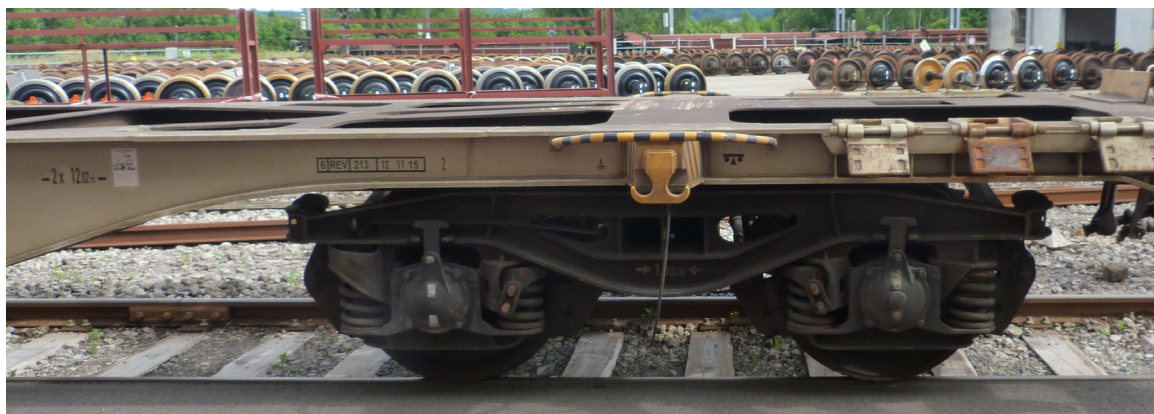
The wheel’s design does not facilitate its inspection: the following photo shows the visible portion of the wheel of a wagon of the same type as wagon 33 68 4952 072 9.
