**REPUBLIC OF BULGARIA**  
**NATIONAL AIR, MARITIME AND RAILWAY TRANSPORT, ACCIDENTS**  
**INVESTIGATION BOARD (NAMRTAIB)**

**FINAL REPORT**

**Investigation of railway accident – fire in locomotive № 91520043309-1, serviced fast train  
№8632 between the stations Svoboda – Tchyrpan on 25.08.2024**

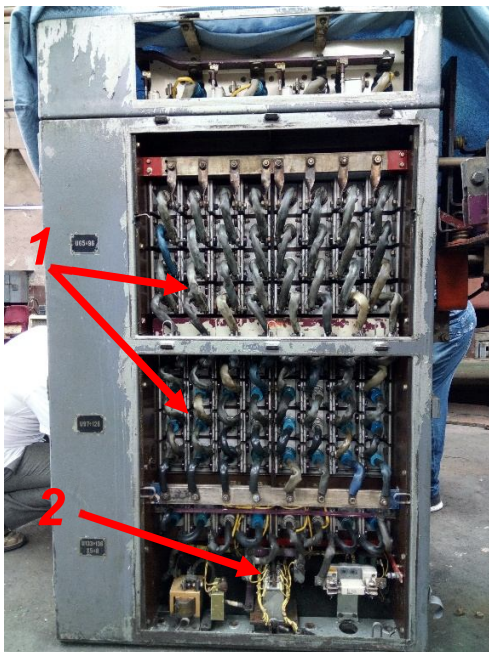
**Fig. 4.16**

The rectifier groups in the 44 series locomotives are cabinet type, with each cabinet being designed to work with a separate traction group. The interior of the cabinet can be conditionally divided into three parts: upper, lower and side. The upper part houses the valves of the traction bridge, which operate in traction mode together with the traction motors (Fig. 4.16, pos. 1). The lower part houses the elements of the four auxiliary bridges, which are included in the circuits of the auxiliary machines (Fig. 4.16, pos. 2), and the side part houses signal lamps, blinker relays and R-C groups, which consist of resistors and capacitors (Fig. 4.17).

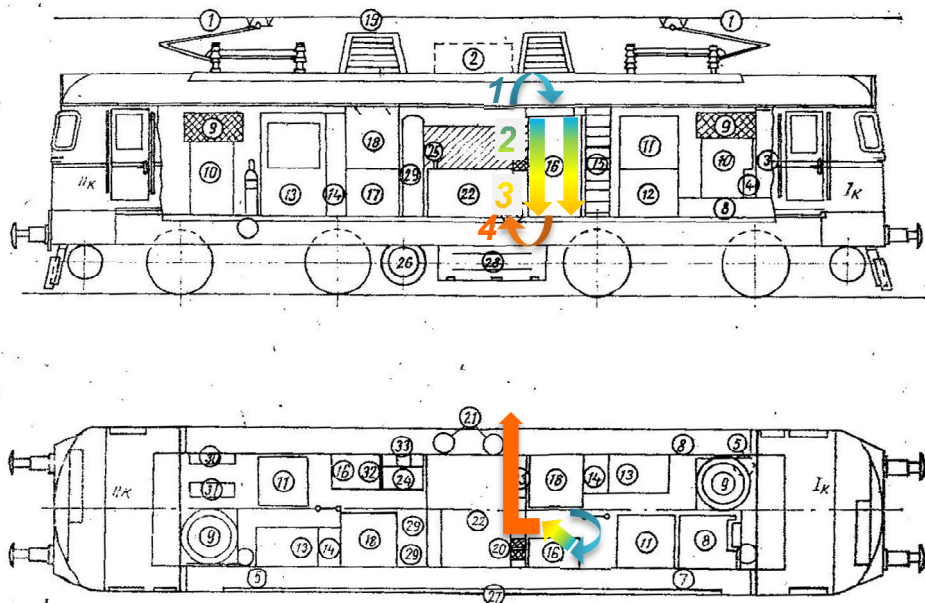
**Fig. 4.18. Air flow diagram for cooling one of the rectifier units.**  
**Arrows indicate the direction of airflow through the rectifier units.**  
**The colours illustrate the temperature of the air flowing through them:**  
**cold, heated, warm, hot air.**

The cooling of the units is forced with air that is sucked from the engine room (Fig. 4.18, pos. 1), enters through the upper opening of the cabinet, passes through it downwards, taking away part of the heat released by the valves of the traction axle (Fig. 4.18, pos. 2), already heated passes downwards to cool the valves of the auxiliary axles (Fig. 4.18, pos. 3) and exits through the suction under-basket horizontal fan (Fig. 4.18, pos. 4). The side part of the unit is not cooled. In the scheme described in this way, the way in which the operation is carried out is particularly important, because improper handling of the cooling system causes overheating of the rectifier unit, especially in its lower part, where the rectifier bridges for the auxiliary machines – fans and compressors – are located. When the locomotive is loaded in traction mode, the valves heat up and release a large amount of heat, which is transferred to
