The Rail Safety
Inspection Office

NIB ANNUAL REPORT 2011

according to Article 23(3) of Directive 2004/49/EC

September 2011

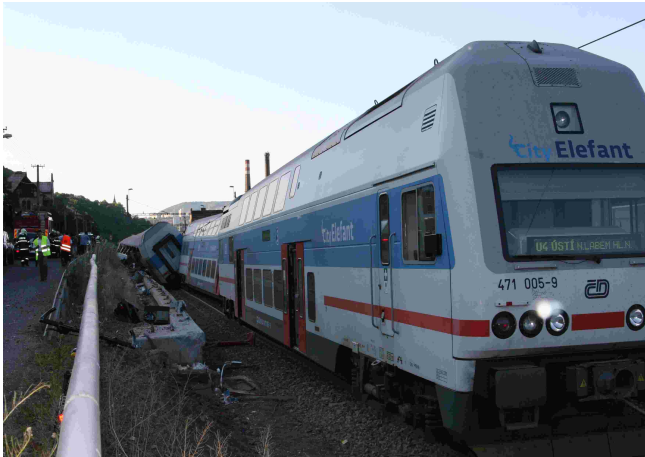
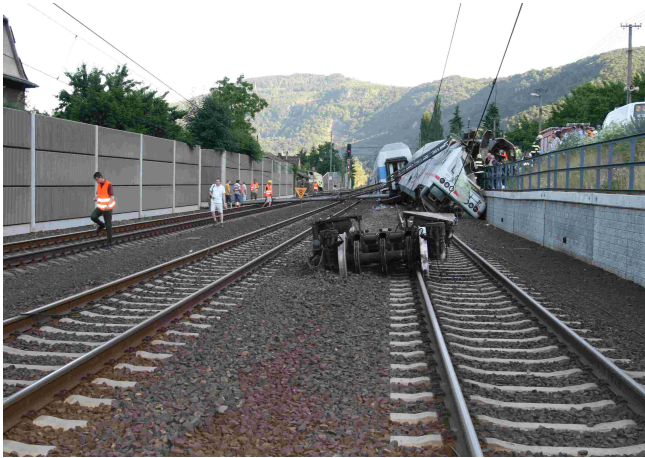
Root cause:	none
Recommendations:	
1)	Addressed to Správa železniční dopravní cesty, státní organizace (infrastructure manager) and České dráhy, a. s. (railway undertaking): <ul style="list-style-type: none">● It is recommended don't use the services of the doctor who incorrectly issued a certificate of medical qualification to the engine driver of the train No. 2316● It is recommended to re-examine health of all employees who were examined by this particular doctor● It is recommended that the above re-examine health of all employees will be found error, notify the NSA to extend the safety recommendations for railway undertakings and infrastructure managers who are concerned.
