Ministry of
Construction and Transport

ANNUAL REPORT 2022
Transportation Safety Bureau
Hungary

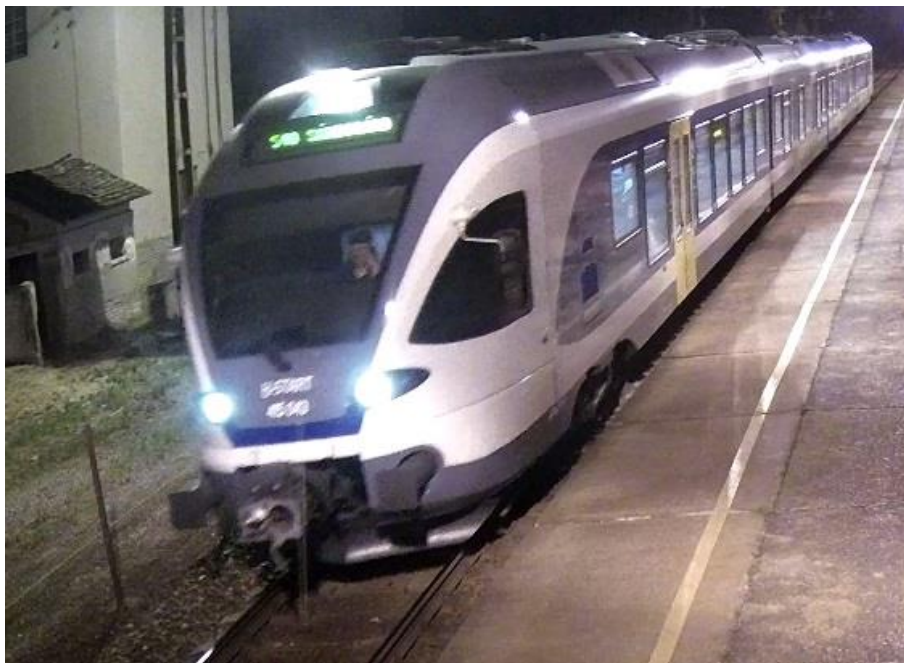
SUMMARY OF OCCURRENCE № HU-10070

<i>Grade:</i>	<i>Railway accident</i>
<i>Date and time:</i>	<i>18 June 2021 (09:03)</i>
<i>Location:</i>	<i>Mosonszolnok - Jánossomorja (line)</i>
<i>Occurrence type:</i>	<i>Collision of train with obstacle within the clearance gauge</i>
<i>Movement type:</i>	<i>Regional passenger train</i>
<i>Description:</i>	<i>Train no. 39847 collided with a sleeper-screw driver between Mosonszolnok and Jánossomorja stations. No injuries occurred, because the track workers could manage to escape from the structure gauge in the last moment before the crash.</i>
<i>Consequences:</i>	<i>0 fatality / 0 serious injury Total damage < 150.000 EUR</i>
<i>Parties:</i>	<i>GYSEV Zrt. (IM) GYSEV Zrt. (RU)</i>
<u><i>Direct cause(s):</i></u>	<ul style="list-style-type: none"> <i>the foreman on watch did not detect the train coming from a sufficient distance and therefore did not warn the workers in time to leave the track clearance and remove the machinery</i> <i>the visible track section length was about a third of the standard stopping distance</i> <i>the safety coverage of the working area was not in accordance with the rules (the watchman had other activities in addition to watching and did not display the "Work in progress on the track!" sign)</i>

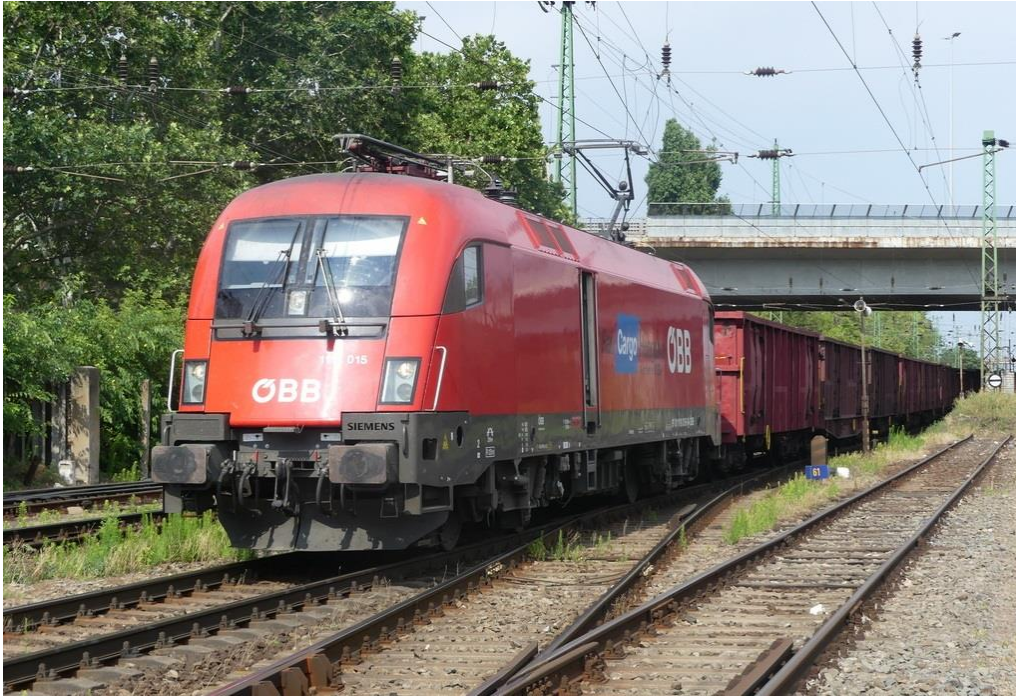
SUMMARY OF OCCURRENCE № HU-10088

<i>Grade:</i>	<i>Railway accident</i>
<i>Date and time:</i>	<i>13 July 2021</i>
<i>Location:</i>	<i>Rákospalota-Újpest (station)</i>
<i>Occurrence type:</i>	<i>Train derailment</i>
<i>Movement type:</i>	<i>Freight train</i>
<i>Description:</i>	<i>The 16th wagon of freight train no. 45296 derailed and turned on its side on point no. 23 at Rákospalota-Újpest station, while the train was leaving the station.</i>
<i>Consequences:</i>	<i>0 fatality / 0 serious injury Total damage 150.000 – 2.000.000 EUR</i>
<i>Parties:</i>	<i>MÁV Zrt. (IM) TRAIN HUNGARY (RU)</i>
<i><u>Direct cause(s):</u></i>	<ul style="list-style-type: none"><i>• the switch tongue in the switch № 23 was not properly aligned with the stock rail</i><i>• the wheels of the first freight wagon what derailed were worn, within limits but beyond the operational state so the wheels rolled up onto the switch tongue</i>
<i><u>Contributory factor(s):</u></i>	<ul style="list-style-type: none"><i>• none</i>

<i><u>Underlying cause(s):</u></i>	<ul style="list-style-type: none"><i>• none</i>
<i><u>Recommendation(s):</u></i>	<i>none</i>

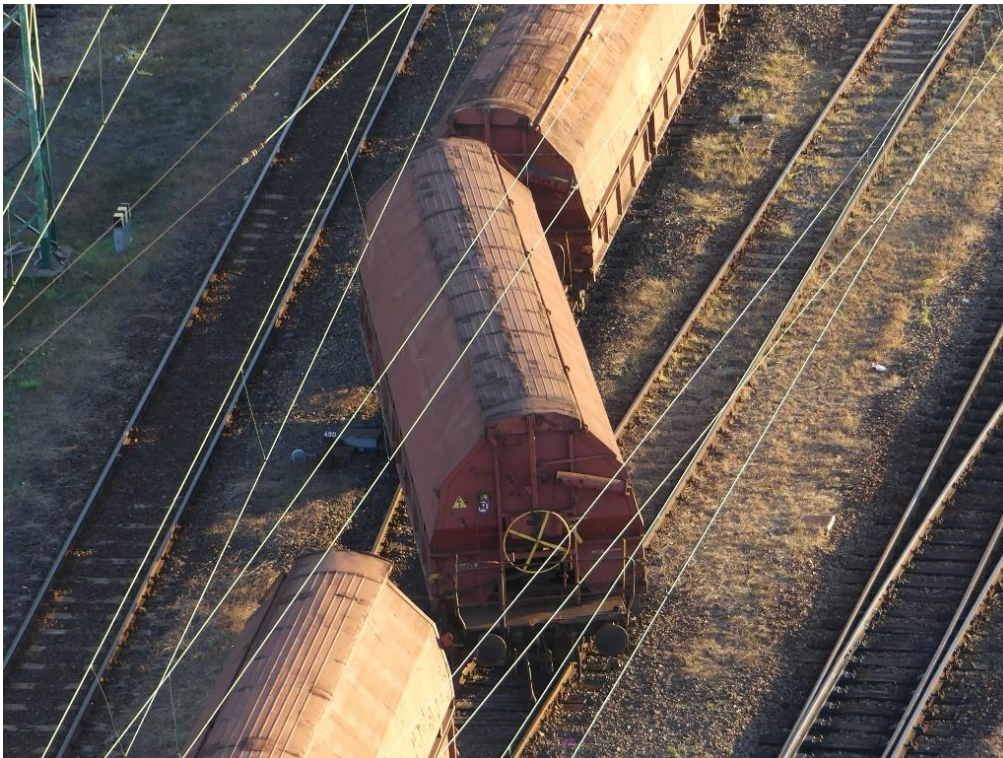
SUMMARY OF OCCURRENCE № HU-10148

Grade:	Railway incident
Date and time:	21 Oct 2021 (04:52)
Location:	Császárszállás (station)
Occurrence type:	Signal passed at danger
Movement type:	Freight train
Description:	Freight train no. 48402 passed the exit signal „V4” of track no. IV. at danger at Császárszállás station, and trailed point no. 7. No injuries occurred.
Consequences:	0 fatality / 0 serious injury Total damage < 150.000 EUR
Parties:	MÁV Zrt. (IM) RCH Zrt. (RU)

<u>Direct cause(s):</u>	<ul style="list-style-type: none"> the locomotive driver most likely failed to apply the brakes in time due to a micro-sleep; the reason for this was that he had been alert for a long time without adequate rest and had been involved in persistent monotonous driving immediately before the incident
<u>Contributory factor(s):</u>	<ul style="list-style-type: none"> the train control system did not stop the train when it passed an exit signal at danger, because the design of the safety equipment used at the station is not suitable on all tracks to stop the train in the case of passing the signal at danger, but may even give a signal that is explicitly misleading in such a case because of the non trailable two-way switch, the damage to the opened switch was greater than it would have been elsewhere
<u>Underlying cause(s):</u>	<ul style="list-style-type: none"> the infrastructure manager does not consider the shortcomings of the safety installation (resulting from its design) as a risk to be managed

<u>Recommendation(s):</u>	The NIB recommends MÁV Zrt. to consider reviewing the criteria used to determine the classification of station tracks as “equipped for train control”, taking into account whether those tracks perform the train control functions on which the relevant rules and instructions are based. On this basis, the necessary measures should be taken to ensure that the Station Instructions include correct information on the suitability of the tracks for continuous signalling.
