REPUBLIC OF BULGARIA
NATIONAL AIR, MARITIME AND RAILWAY ACCIDENTS
INVESTIGATION BOARD

FINAL REPORT

**Investigation of railway accident – fire in electric locomotive № 44094.8,
occurred while servicing fast train № 3621 between the stations Chernograd –
Aytoz on 28.09.2020**

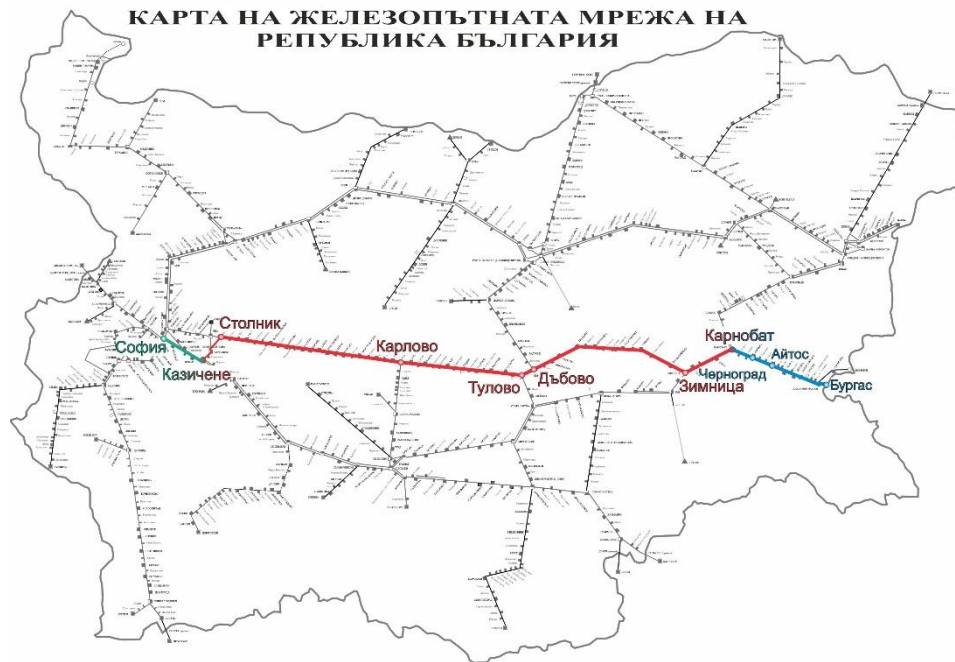
Fig. 3.1

At Karnobat station the train arrived at 12:53 p.m. and after a stay of two minutes, departed at 12:55 p. m. following the train operation schedule. During the movement of the train in the interstation Chernograd - Aytos on track № 1, the locomotive crew smelled smoke coming from the engine compartment. The locomotive driver took a quick stop and the train stopped at 13:07 p.m. at km 254 + 200, as can be seen from the records of the locomotive's recording device. The driver disconnected the battery and activated the fire protection system, but it did not start. The assistant locomotive driver and the locomotive driver tried to put out the fire with the portable fire extinguishers of the locomotive, but due to the thick smoke, they failed. The locomotive driver

called the national telephone number 112 to ask assistance from the fire services. The train was moving at a speed of 120 km / h, with a permissible speed of 130 km / h. During the movement of the train on the route from Sofia station to Chernograd station the operation of the locomotive was accident-free.

Chernograd and Aytoс stations are located on the eighth main railway line in the direction Plovdiv - Stara Zagora - Karnobat - Bourgas. The eighth main railway line is conventional with a speed of up to 130 km / h. The event occurred in a section of a double-track electrified railway line with a profile - 9.3 ‰ downhill (Fig. 3.1).

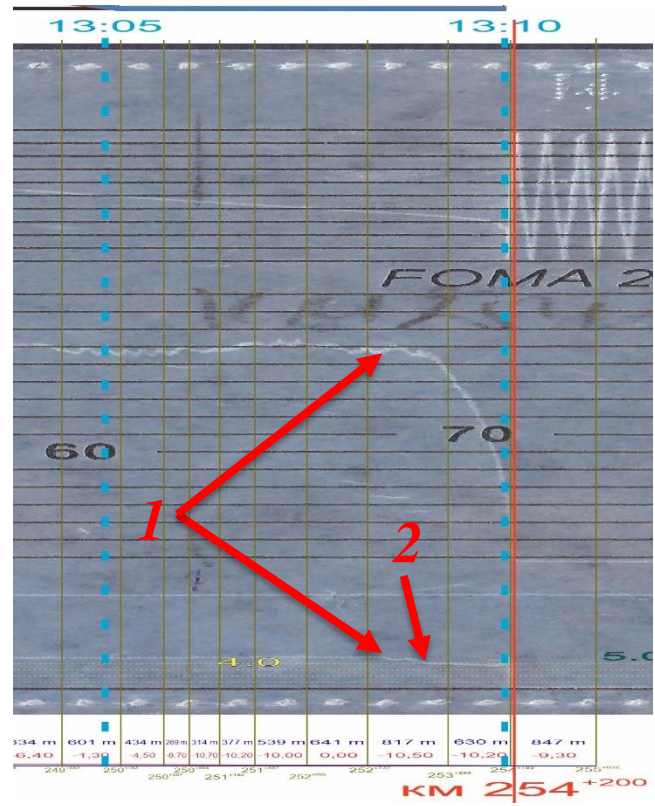
Fig. 4.5

At 13:06 p.m. at km 252⁺⁸⁰⁰ the locomotive driver applies the automatic train brake, reducing the pressure in the main air duct by 0.4 bar (Fig. 4.5, pos. 1). After traveling 250 meters for about 5 seconds, the pressure was restored to 5.0 bar. Almost immediately afterwards, the brake was applied again, reducing the pressure in the main air conduct by 1 bar and reaching 4.0 bar in 500 meters and 10 seconds. After another 10 seconds, the holding rate with the automatic train brake is increased by reducing the pressure in the main air conduct to 3.5 bar, i.e. complete detention has taken place. The speed starts to decrease steeply and the train stops at km 254⁺²⁰⁰ after traveling 1200 meters in 1 minute and 30 seconds.
