REPUBLIC OF BULGARIA
NATIONAL AIR, MARITIME AND RAILWAY ACCIDENTS
INVESTIGATION BOARD

FINAL REPORT

**Investigation of railway accident – derailment of locomotive № 46041 of
direct freight train № 30682 while entering in Kostenets station on 15.07.2020**

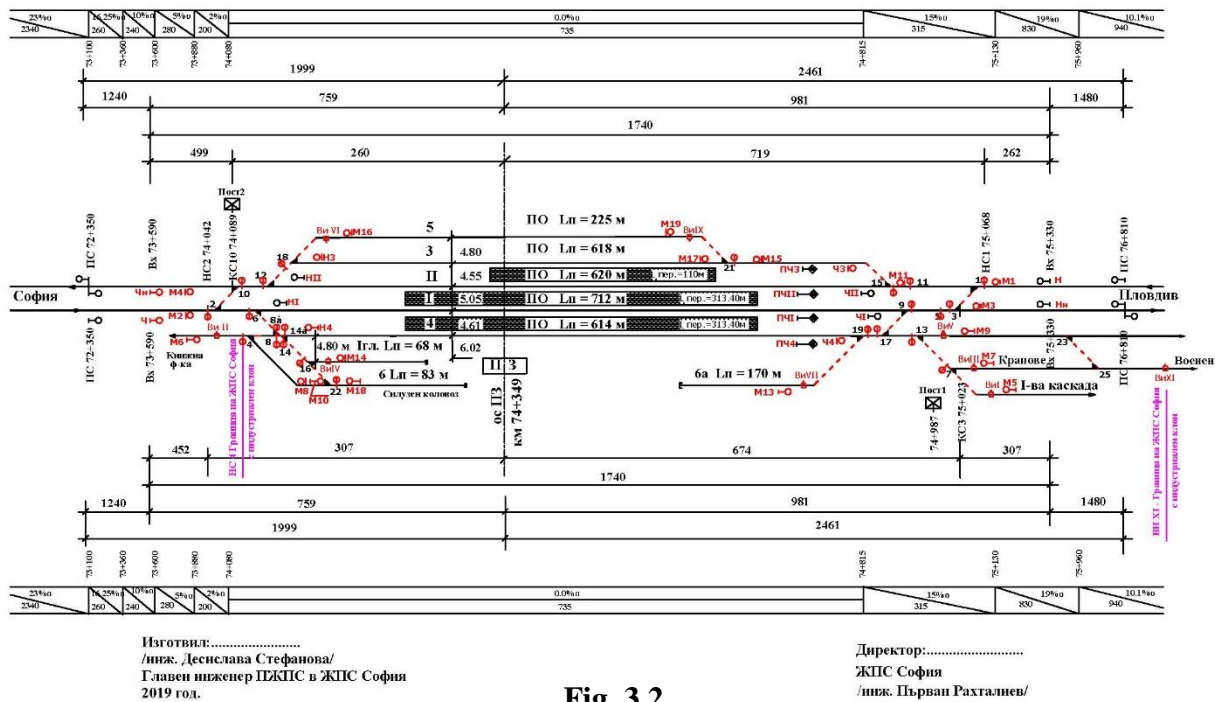
Fig. 3.2.

- Third acceptance-departure track in Kostenets station is with total length 618 meters, with cant from km 74+080 to 74+815 – 0 ‰, and then follows downhill inclination 15 ‰ in direction to Belovo station, equipped with exit signals on the speed signalling, included in the safety installation of the station, with overhead contact line/catenary (fig. 3.2).

- By recommendation 4 it is suggested SE NRIC to adjust third track in Kostenets station in accordance with the requirements of item 3.3.6 and item 3.3.12.7 stipulated in Instruction on the layout and maintenance of the rail track superstructure and rail switches (for counter-curves without cant without transition curves and without intermediate line).

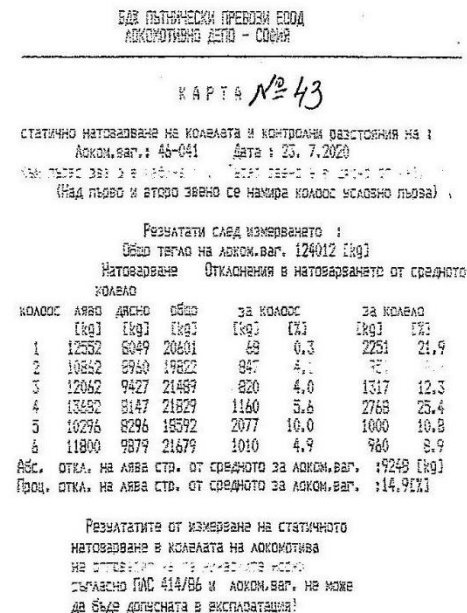
Fig. 4.12.

On 23.07.2020 again in Plovdiv locomotive depot were performed two control measurements of the static load of locomotive No 46041 under axles and again the results do not respect the technical norms (fig. 4.11 and 4.12).

The reasons for that are because of the fact that the measurements of the static load were performed on a stand for measurement of the static load of four-axle locomotives. In that case were necessary the measurement of six-axle locomotive to be performed separately per each wheel-set, which was related to the locomotive shifting for each measurement. That led to displacement of the locomotive draft-gear – position of the wheel-sets on the rail track, reallocation of the locomotive weight on the separate elements of the spring suspension that gave impact to the static load of the locomotive separate wheels.
