Technical Investigation Report
on the Train Collision that occurred on
11 October 2006
on the French/Luxembourg Border
at Zoufftgen (Moselle)

**Land Transport Accident
Investigation Bureau (BEA-TT)**

Case No.BEATT-2006-013

28 February 2009

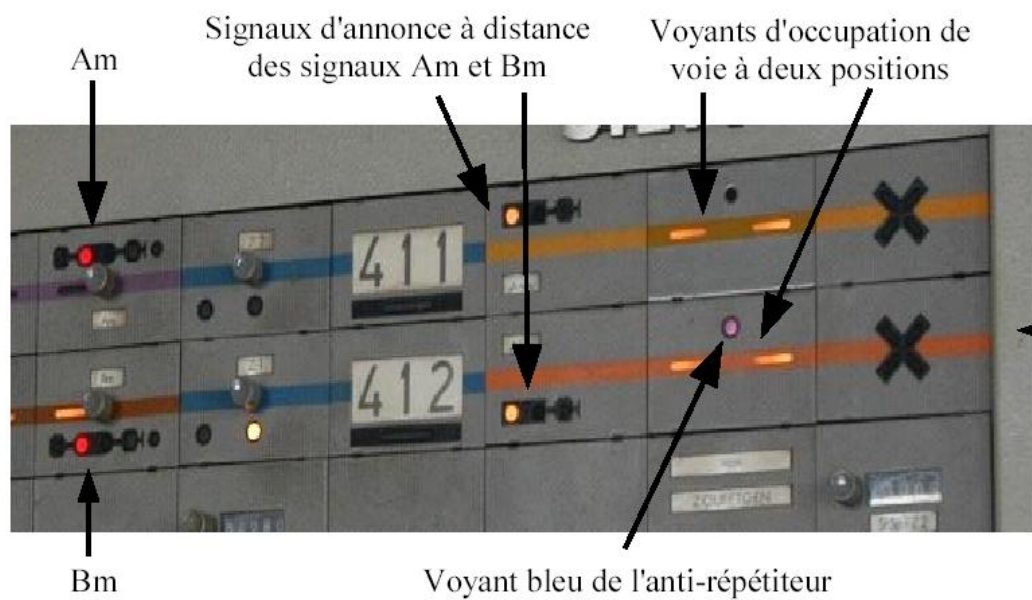
Figure 4: Detail of VCP, Border zone

By contrast, when the four lights (two per track) located at the right-hand end of the VCP (see Figure 4 of paragraph 3.3.2) on the tracks towards Thionville are white, this means that the portion of track being checked is clear of all trains but indicates nothing else. These lights are white, as well as others, even when a train is travelling on wrong-track working from Thionville until it passes DM 202.604.

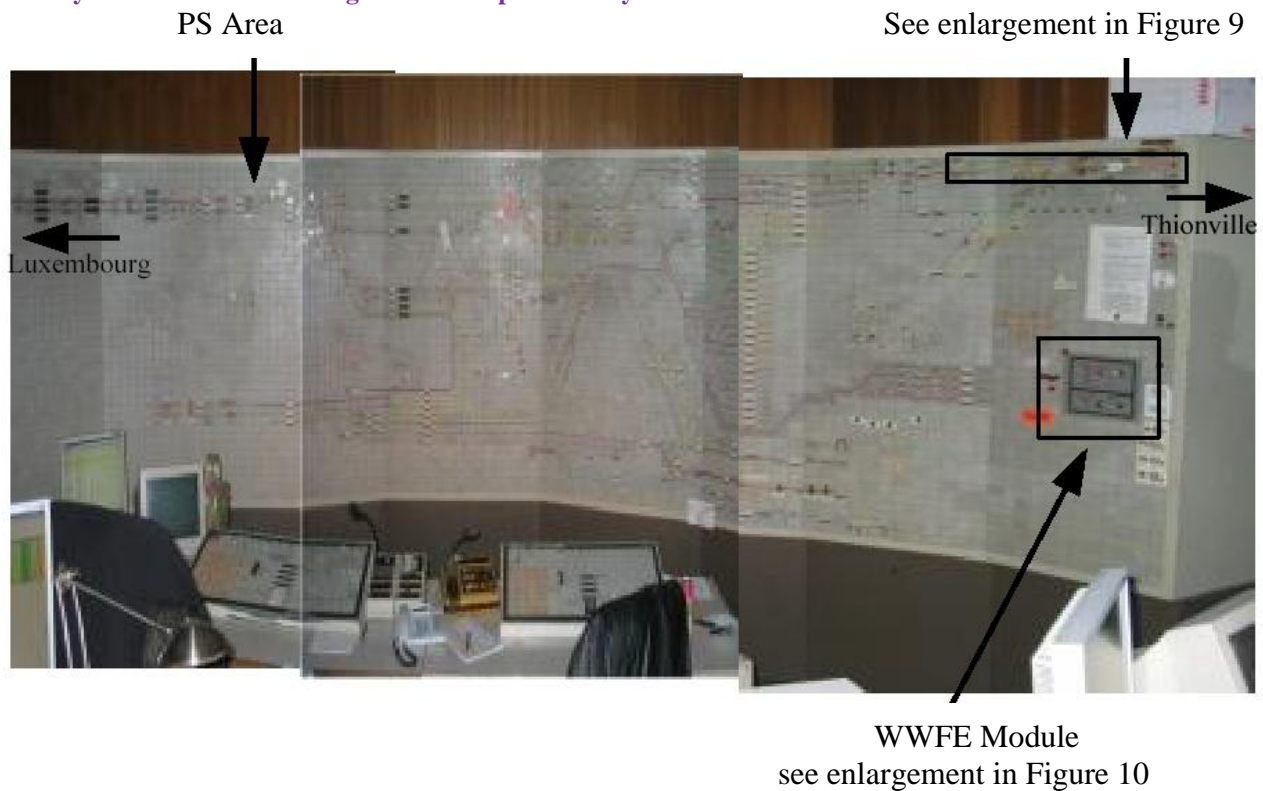
Figure 8: VCP at the Bettembourg CCP

At 11h40, the RET approached the Dm signal at ‘danger’ and braked to stop in front of it.
At this time:

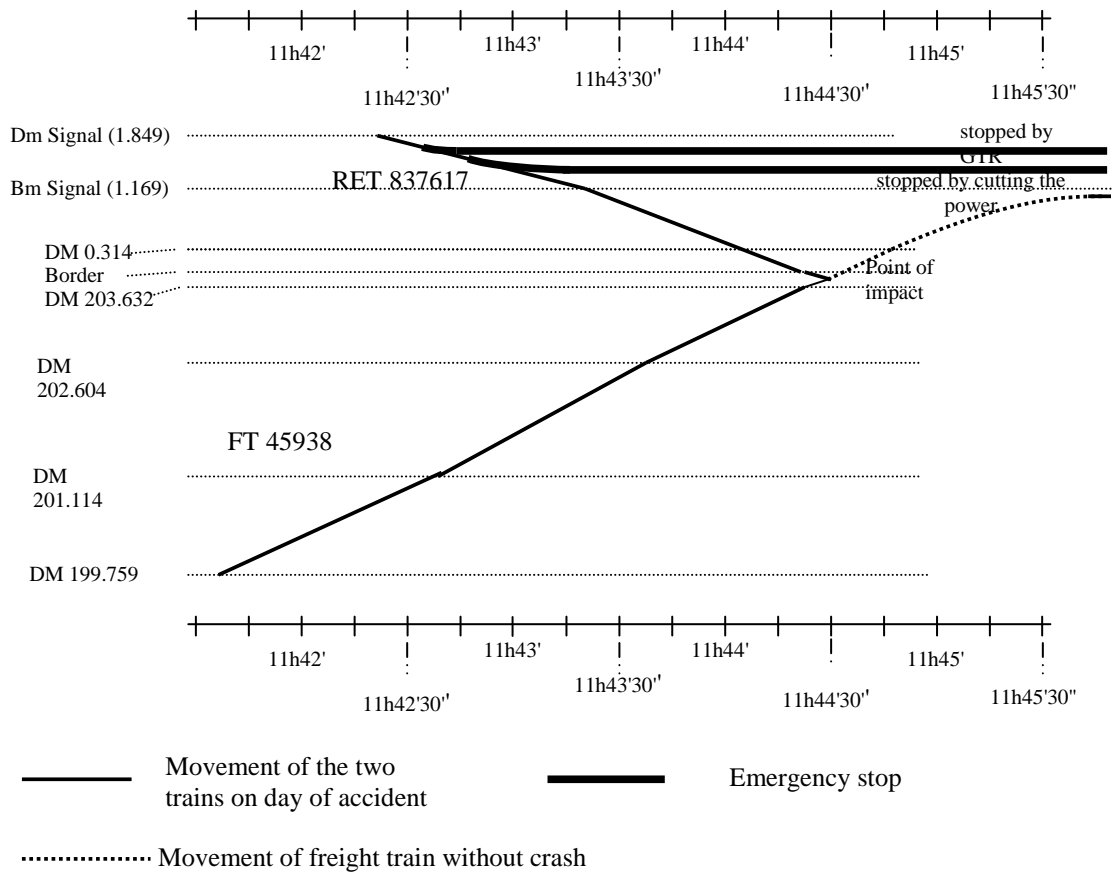
Figure 11: Movement Diagram 1
Potential effect of corrective actions at Bettembourg

Taking into account the times indicated in Annex 5, when the radio warning was issued the RET was near DM 1.7 located within the territory of Bettembourg Station. It is highly likely that the driver had not yet changed his radio frequency and was travelling at low speed (in the order of 20km/h). He was about 600m away from the Bm signal where the freight train had just stopped. As its emergency braking distance at this speed is in the order of about twenty metres, the RET would probably have stopped before the Bm signal, a signal where the freight train would have stopped about ten minutes later (see Figure 11 below).

In the absence of a warning from the GTR, the driver of the RET, in accordance with the instructions applicable to such a case, would have immediately applied the emergency brake around DM 1.3, where he was travelling at about 50km/h. As the emergency braking distance at this speed is about a hundred metres, the RET would probably have stopped at around DM 1.2 just before or just after the Bm signal located at DM 1.169. The crash would very probably have been avoided as the freight train would have stopped at the Bm signal (see Figure 11 above).

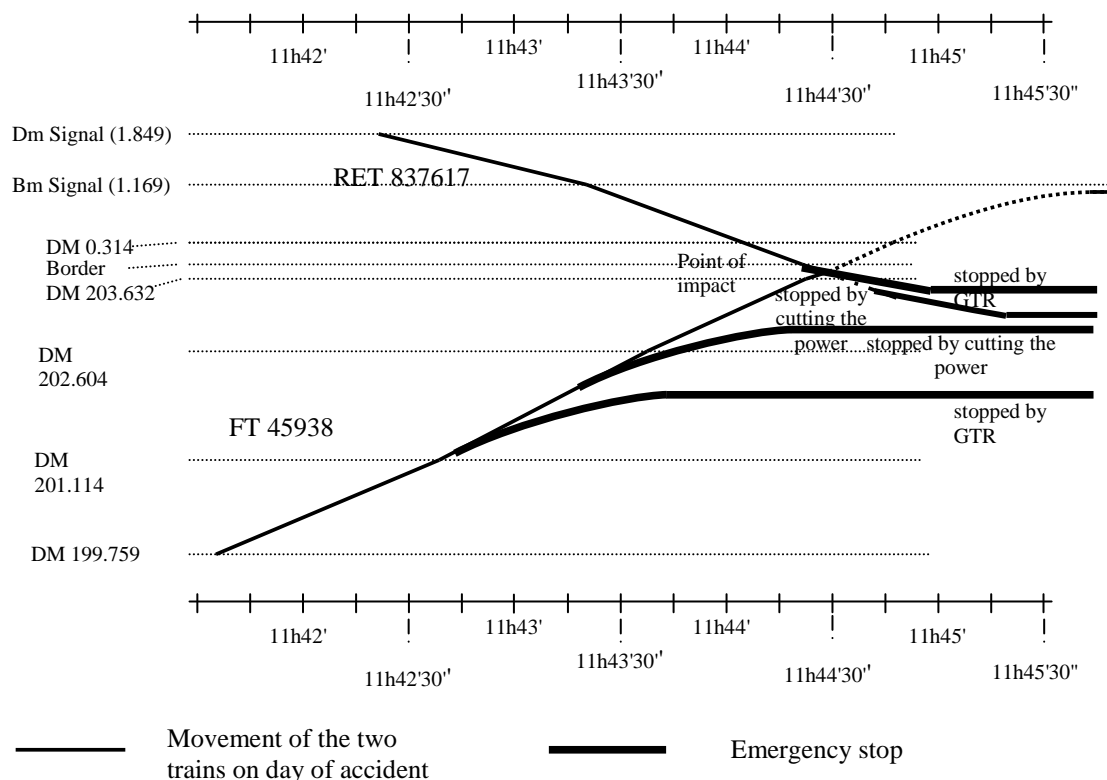
Figure 12: Movement Diagram 2
Potential effect of corrective actions at Thionville

Furthermore, assuming that the Thionville CCRP would have been alerted at around 11h42'45" by the Bettembourg CCP, it could have carried out the same corrective actions on its own territory (see diagram below, Figure 12).
