Investigation Report of Railway Accident

Collision of passenger train No 5307 with a shunting freight train
between
Hlinsko v Čechách and Ždírec nad Doubravou stations

Monday, 10 November 2008

Ref. No: 6-3715/2008/DI

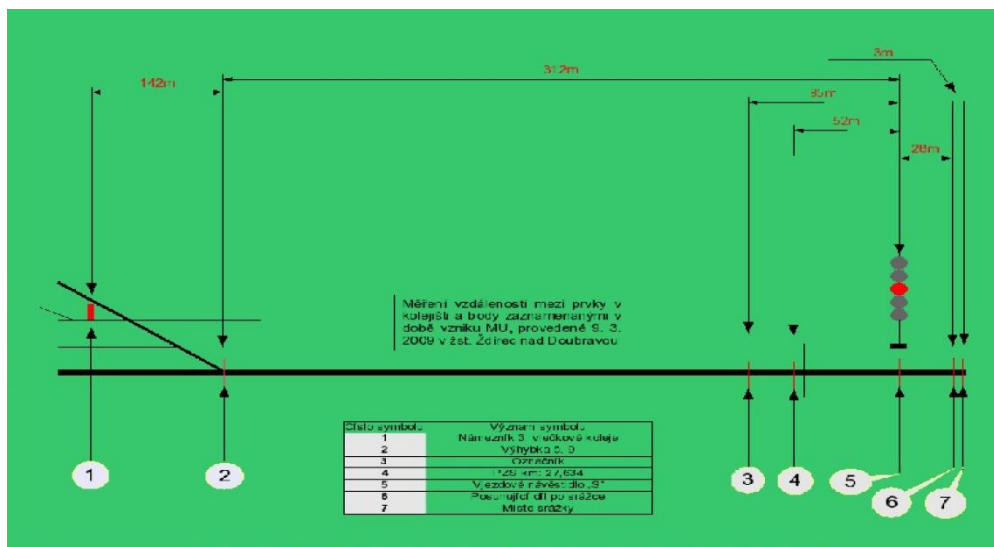
Appendix 3: Distances between the critical objects

Legend (text in the diagram): Distances between objects on the rail track and the points recorded at the time of the incident and measured on 9.2.2009 in Ždírec nad Doubravou station
