**Railway Accident  
Investigation Unit  
Ireland**

## **INVESTIGATION REPORT**

**Road Rail Vehicle occurrences on Iarnród Éireann Network  
from 2015 to 2018**

RAIU Report No: 2019 – R004

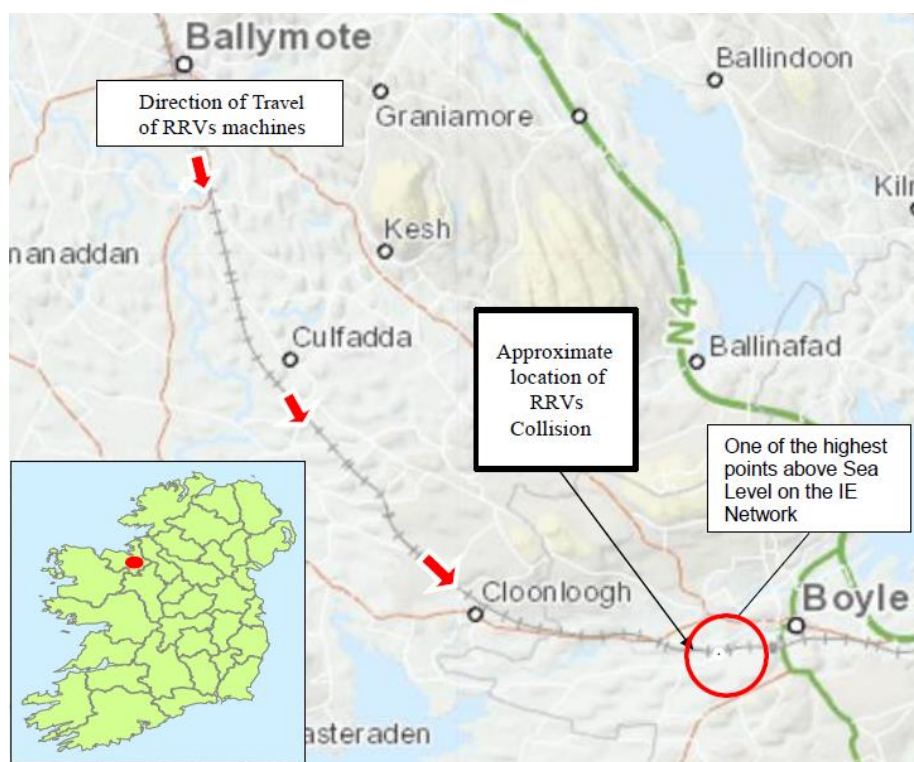
**Figure 11 – Location of the accident**

181 On the night of the 17<sup>th</sup>/18<sup>th</sup> November 2016, four members of IÉ-IM staff along with four contractor staff reported as a group at Ballymote Station for planned night work, see Figure 11. The planned works for the night entailed the distribution and sweeping of ballast at various locations along the section between Ballymote and Boyle Stations on the Sligo Line. A site safety and method statement briefing for the works was conducted by the TSC. The possession arrangements were organised by the PICOP and Controlling Signalman.

186 It is noted, that the location at which the accident occurred is close to one of the highest points above sea level on the IÉ network, see Figure 11.

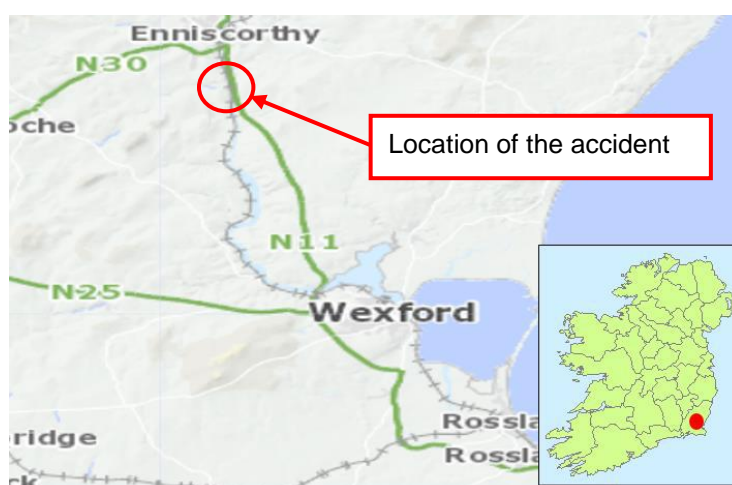
Figure 16 – Location of the accident

197 There were two worksites planned for the possession (see Figure 16 for location of the accident):

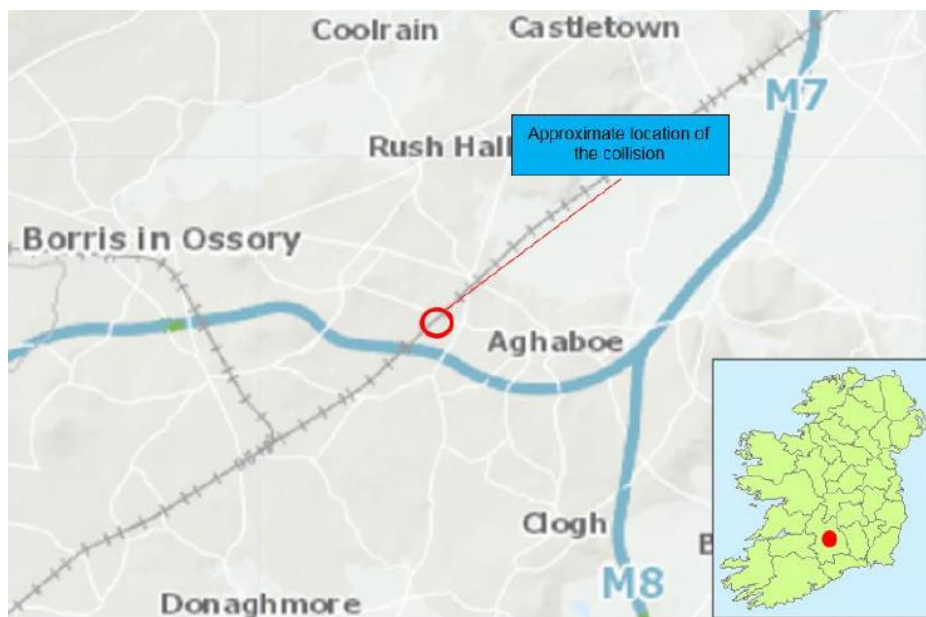
Figure 19 – Location of the accident

228 The work planned for the night of the 21<sup>st</sup>/22<sup>nd</sup> March 2018 was for embankment removal works as part of preparatory works for the Ballast Cleaning Programme at Kilbricken Compound, County Laois, on the Dublin to Cork Mainline located at approximately the 63¼ MP, see Figure 19 for location of the accident. The T3 Possession was to be arranged between Laois Train Care Depot and Thurles.

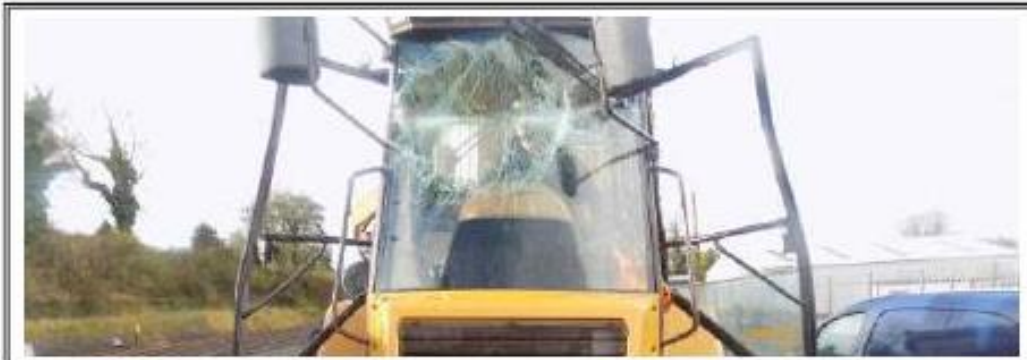
The main issues relating to the cause of these incidents include:

- Speed of the RRVs
- Inadequate distance between RRVs travelling in convoy
- Lack of proper co-ordination of RRVs travelling in convoy

**INSTRUCTION – PENDING INVESTIGATION FINDINGS:**

- RRVs travelling in convoy to a work location must keep a minimum distance of 100 mtrs from the RRV in front.
- RRVOs must pay particular attention to the RRV in front to watch for it either slowing or stopping as most RRVs are not equipped with brake lights while in Rail Mode.

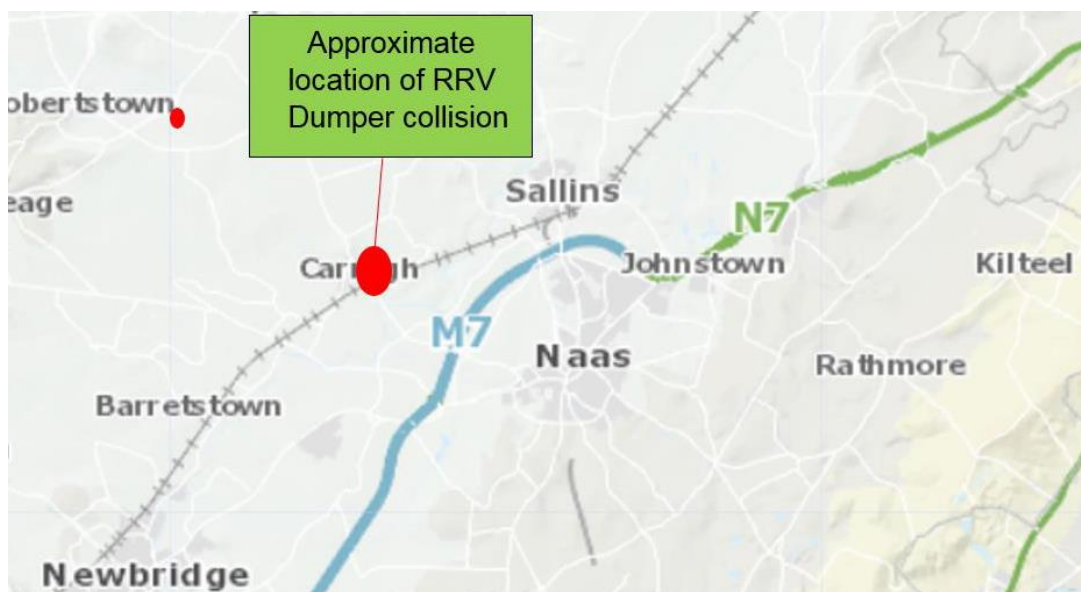
**Figure 22 – Location of the accident**

250 The works planned for the 10<sup>th</sup> April 2018 was for the ballast cleaning preparatory work at the CCE's Carragh Compound (County Kildare), on the Dublin to Cork Line, as part of the ongoing Ballast Cleaning Project, see Figure 22. A T3 Possession was to be granted was from Sallins to Portlaoise on the Up and Down Lines.

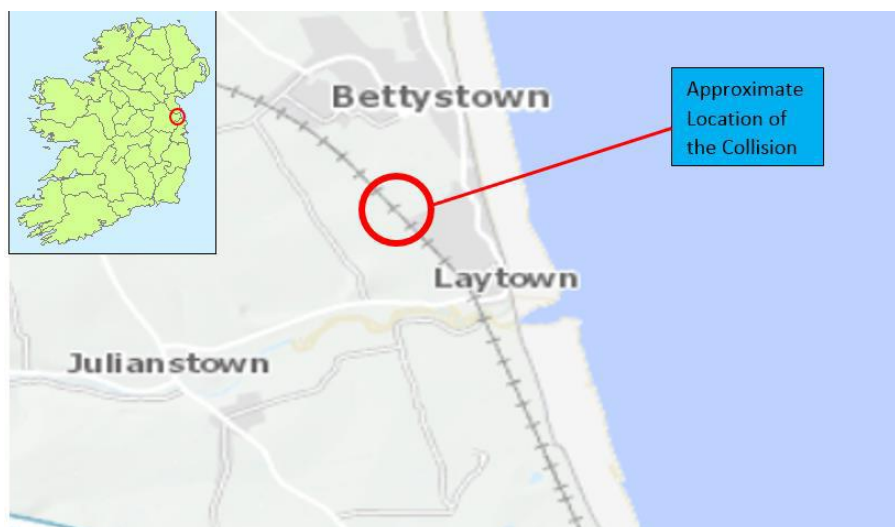
**Figure 23 – Location of the accident**

273 The accident occurred during the hours of darkness and at the time of the occurrence it was reported to be raining heavily, with Met Éireann (Dunsany) recording that there was 4.1 mm of rainfall and the mean wind speed was recorded at 11.8 knots; see Figure 23 for location of the accident.

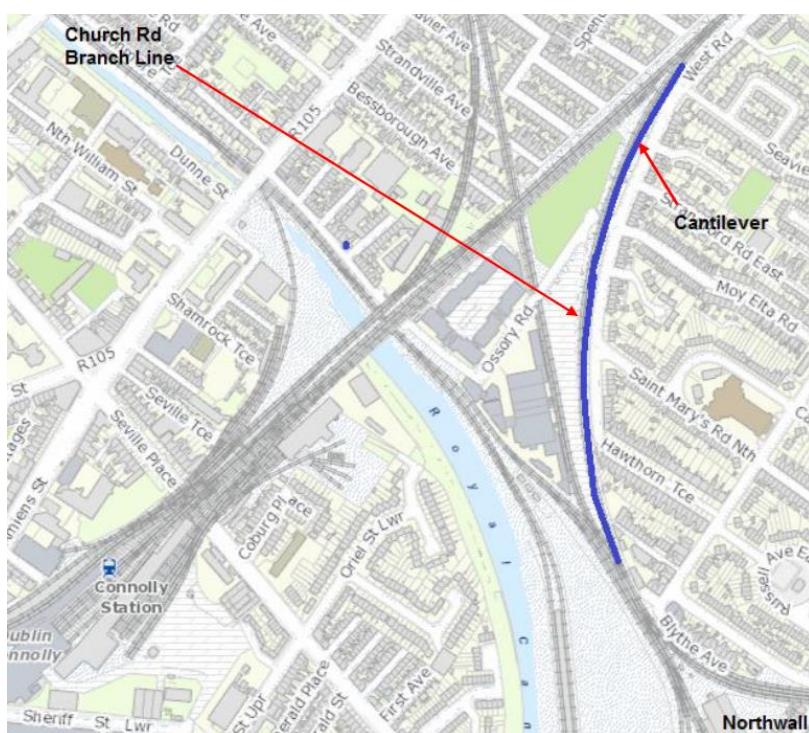
**Figure 25 – Location of the accident**

290 At 01:25 hrs on Sunday 14<sup>th</sup> February 2016 authority was given by the PICOP to the ES/PIC (who was undertaking the roles ES, TSC and PIC for seven RRVs) for work to start at the worksite at East Wall Bank, see Figure 25. The ES/PIC gave a safety briefing before work commenced, reminding the Operators of the RRVs about the presence of the OHLEs and the requirement to report any occurrences. The works to be carried out was panel relaying.

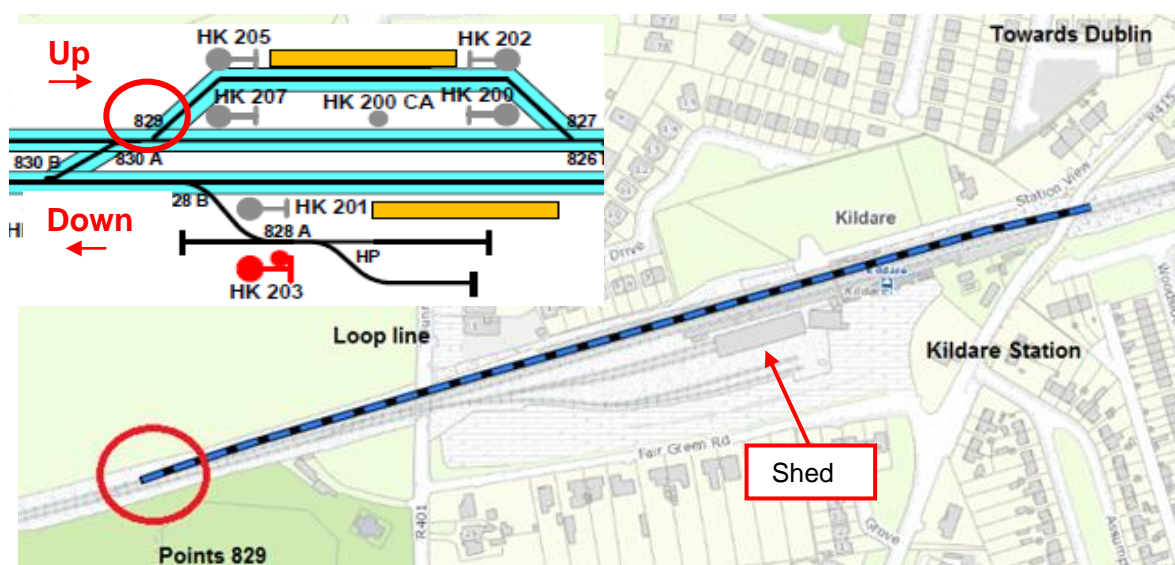
Figure 28 – Location of the accident

315 The works to be carried out involved the tamping of the track using the OTM (Tamper) close to Kildare Station (see Figure 28). The operation involves the lifting of the track while simultaneously compacting the ballast beneath the sleepers. Tamping had occurred the previous night resulting in the ballast being low, as a result an RRV Excavator with RRV Dumpers would travel ahead of the Tamper and drop loads of ballast (using the RRV Excavator bucket) along the track to allow for efficient tamping.

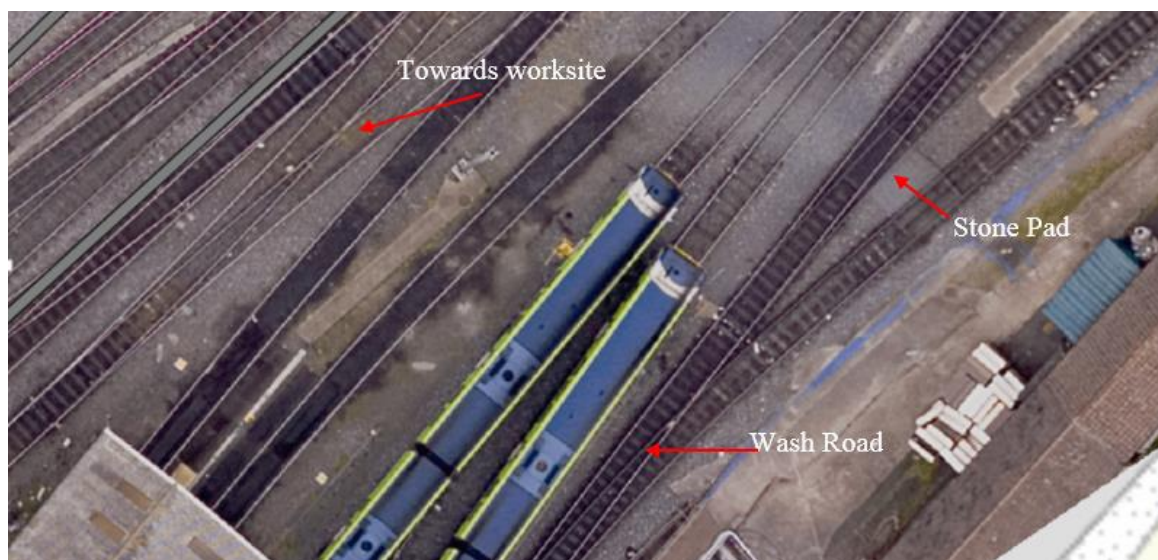
**Figure 29 – Manoeuvre locations at Connolly**

330 The T3 possession and T4 protections were granted at 02:14 hrs; and the RRVC commenced on-tracking the RRVs on Road No. 16; Once on-tracked the RRVs travelled on to the Wash Road and towards the stone pad. The RRVs upon arrival at the stone pad off-tracked from the Wash Road and drove across the stone pad, before on-tracking on the Down Belfast line and driving towards Platform 4 to the worksite at CY133 points, see Figure 29.

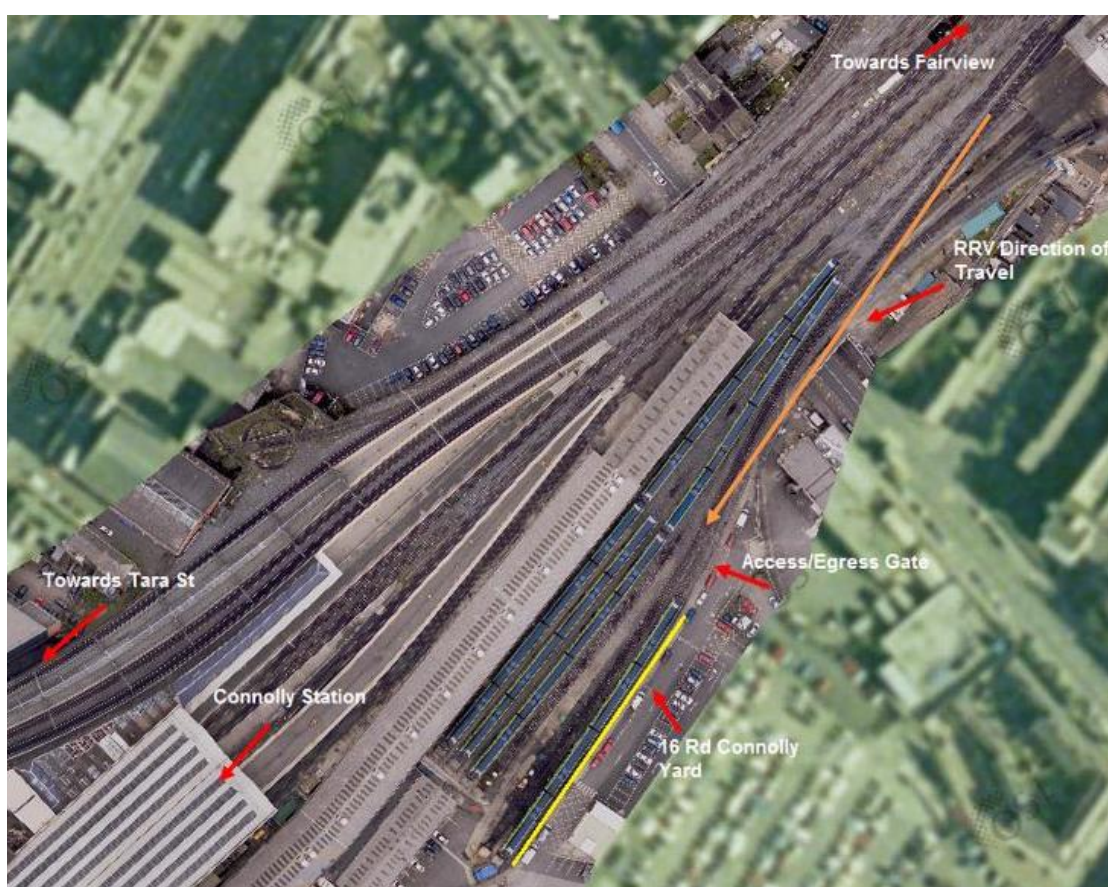
**Figure 30 – Off-tracking manoeuvres for the RRVs**

331 At approximately 04:00 hrs, upon completion of their work at the worksite, the PICOP/PIC gave permission to the RRVC for the three RRVs to leave the worksite at CY133 points to off-track at Road No.16. The RRVC informed the RRVOs that he would walk ahead of them as far as the stone pad, and upon arrival there he would get them to drive across the stone pad to on-track again on the Wash Road (see Figure 30). Upon arrival at the stone pad the RRVC brought the RRV Dumper across first and then proceeded to bring across the two RRV Excavators. Whilst the RRVC was in the process of bringing the final RRV across the stone pad, the RRV Dumper left the stone pad and began moving down the Wash Road towards the Road No.16 off-tracking location, which was located approximately twenty metres from the stabled 29000 DMU (see Figure 30).

332 On approach to the off-tracking point, approximately twenty feet from the stabled 29000 DMU, the RRVO of the RRV Dumper applied the brakes but was unable to stop; and, collided with the 29000 DMU, resulting in damage to unit 29109 (windscreen, wiper and some other superficial damage); there was no reported damage caused to the RRV Dumper.

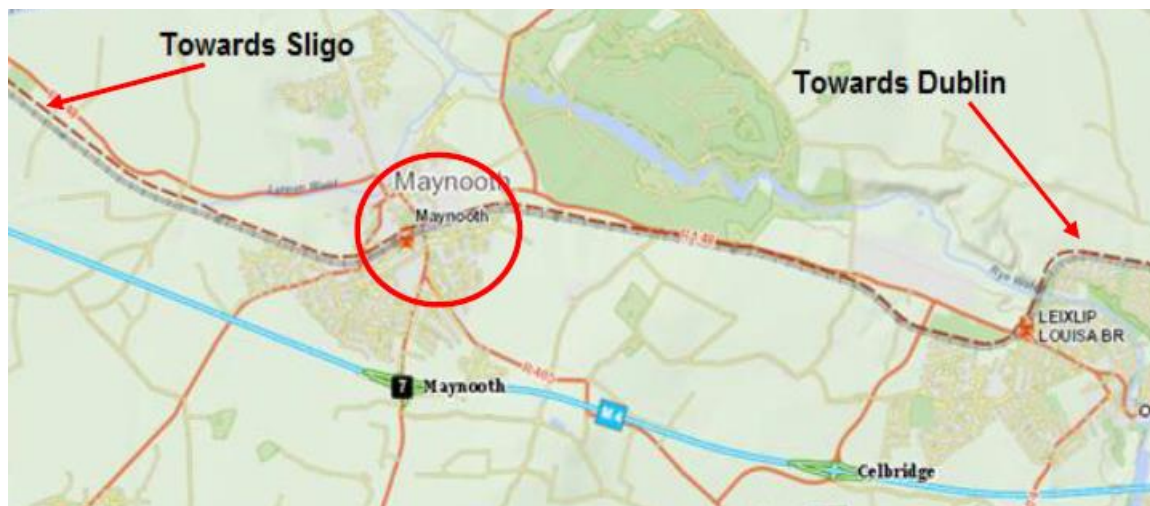
**Figure 32 – Location of the accident**

356 On the night of the 26<sup>th</sup> August 2016 the relevant CCE and contractor members of staff reported to Maynooth Station prior to the commencement of the works. There were three work sites planned for the possession and five RRVs were to be used in the possession. Worksite 1 and 2 were for ballasting works on either side of Maynooth Yard while Worksite 3 was for vegetation control work on the Dublin end of the possession, see Figure 32 for location of the accident.

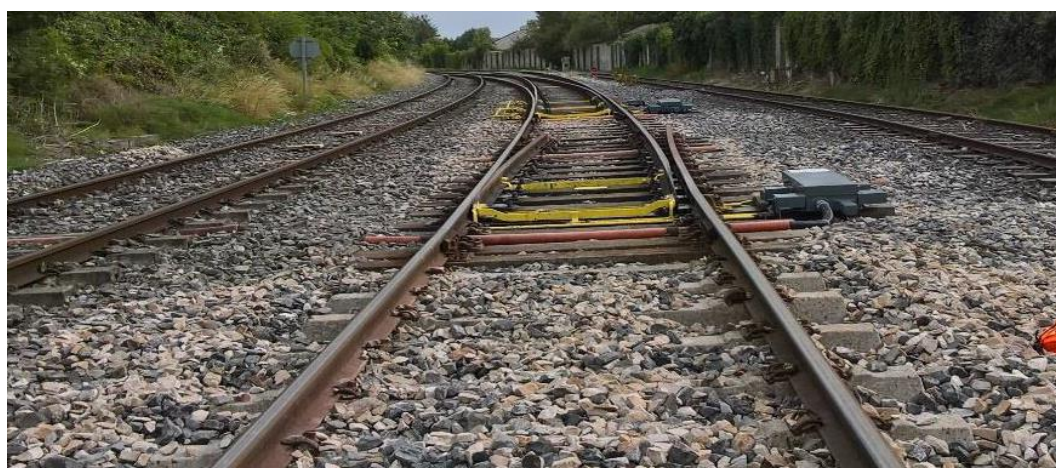
**Figure 35 – Point MN266**

361 Prior to the works commencing, the RRV Dumper unloaded a rail grab attachment and placed in the six-foot area between the machinery siding and the Long Siding, close to Trap Points MN266. The RRVs proceeded into the Long Siding at Maynooth Station to carry out the ballasting works controlled by the PICOP/ES/PIC. The ballasting works around Trap Points MN266 (see Figure 35) works were undertaken and completed.

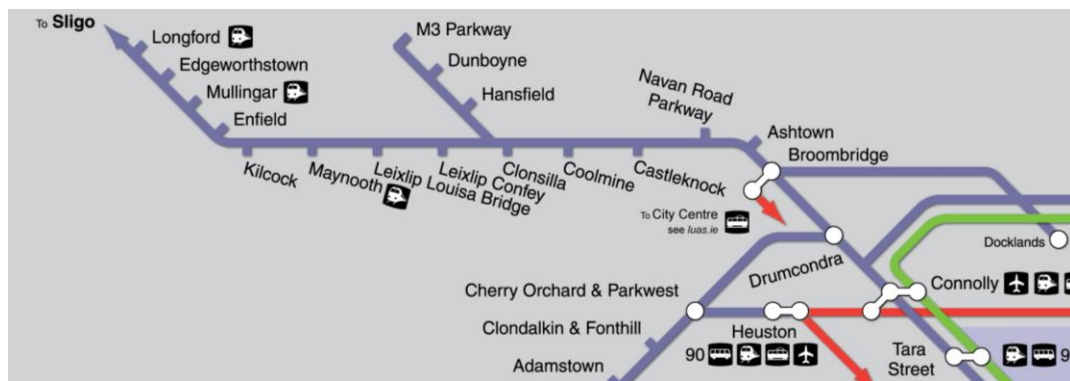
**Figure 38 – Location of the accident**

387 The section of track between Glasnevin Junction (west of Drumcondra Station) and Maynooth Station where the T3 possession was in place on the night is controlled by the Controlling Signalman located at Clonsilla Signal Cabin (to be referred to as the Clonsilla Signalman for this section of the report); see Figure 38 for the layout.

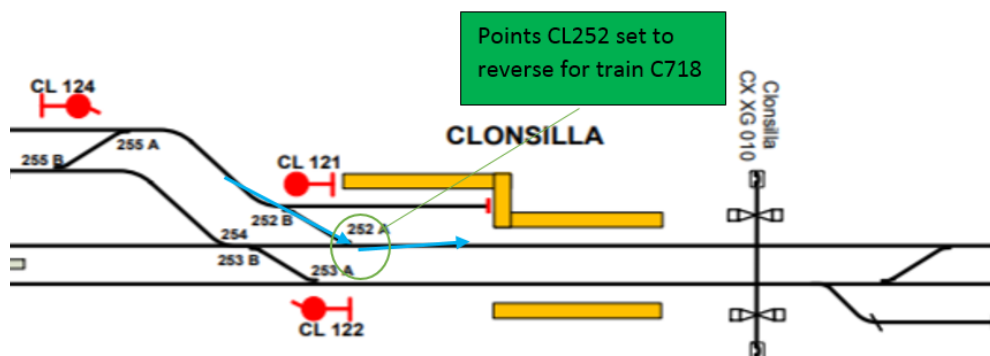
**Figure 39 – Points CL252 in reverse (figure taken from IÉ-IM report)**

385 By way of introduction to the location of the accident, Clonsilla Station is a junction station for the M3 Parkway branch and is located on the main Dublin to Sligo line; Clonsilla Yard is adjacent (see Figure 37).

390 At 00:23 hrs the PICOP contacted the Clonsilla Signalman, the T3 Possession arrangements were made and granted; during the set-up process the PICOP queried the Clonsilla Signalman on the positioning of the points in the possession which the Clonsilla Signalman said they were all in the normal position (however Points CL252 remained in the reverse position for the earlier train movement, Figure 39).

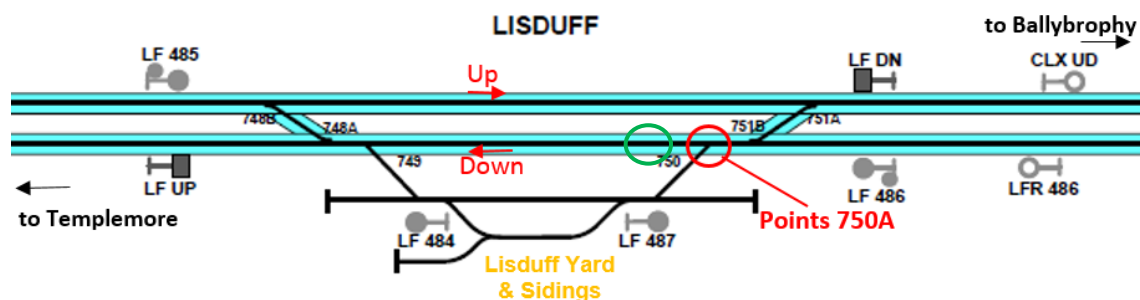
**Figure 44 – Layout at Lisduff**

409 Approximately twenty minutes after the OTM departed, the RRVO then on-tracked the RRV onto the Down line (see green circle for location in Figure 44) under the instruction of the ES/PIC; and the ES/PIC then boarded the RRV and instructed the RRVO to continue on the Down line (in the Up direction) to the worksite, see Figure 44.

412 The ES/PIC instructed the RRVO to off-track the RRV, beyond the points, and to park it safely. When the RRV was clear of the points, the ES/PIC examined the points for damage. During this examination, the PICOP phoned the ES/PIC to inform him that the Signalman had lost detection of Points 750A. The ES/PIC told the PICOP that the RRV had run-through Points 750A.

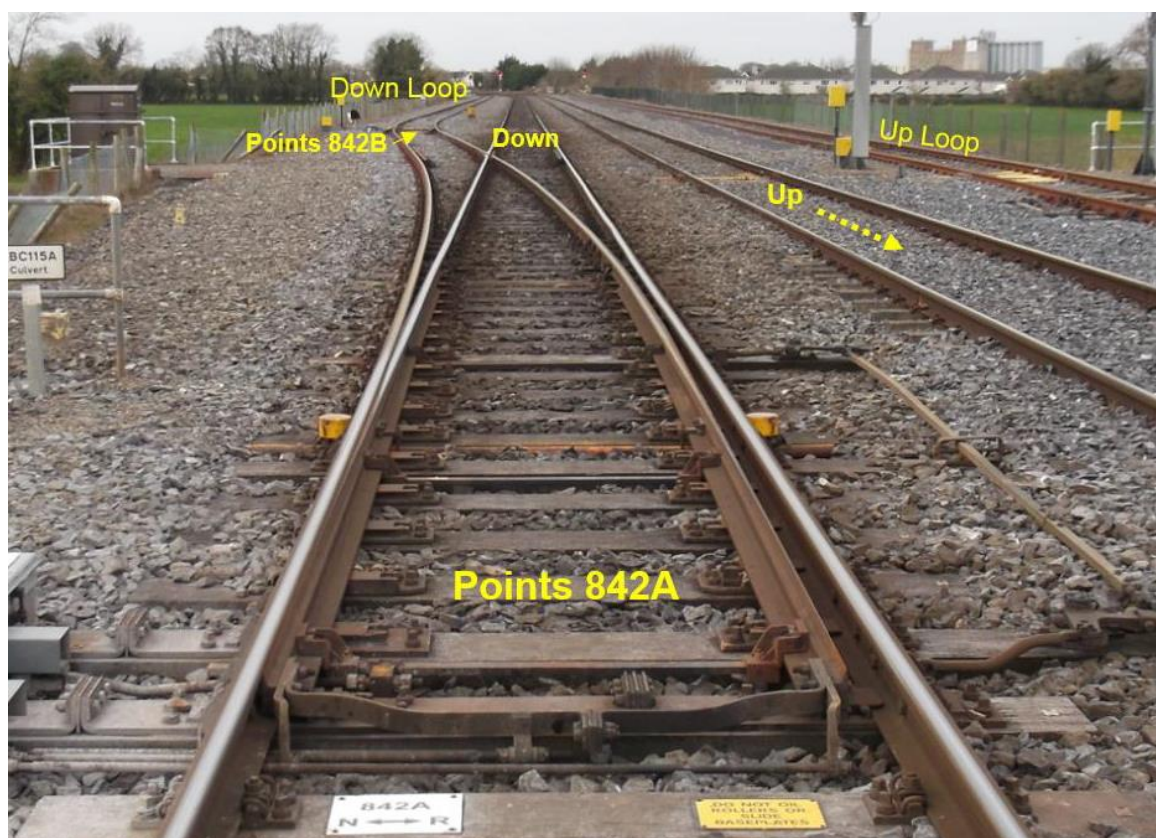
Figure 47 – Points at Portarlinton

422 The PICOP contacted the ES/PIC to advise him that the T3 Possession was granted and that the points were sets for the three RRVs to leave the siding onto the Down Loop and exit the loop at the Dublin end (via Points 842) and travel onto the Down Line; the PICOP also requested that the RRV Digger be on-tracked directly onto the Up Line (see Figure 47).
